# **TUTOR PROFESSIONAL INSPECTIONS**

## **Confidential Inspection Report**

**806 W 11th St**

# PROPERTY INSPECTION REPORT FORM

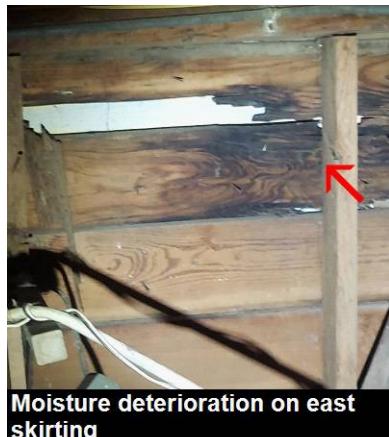
**Crawl Space Deficiencies-** There is moisture related deterioration on the skirting walls and beams where visible plumbing leaks were observed. There are indications of poor drainage and/or ponding in areas of the crawl space which could impact integrity of the piers. There was water standing in areas of the crawl space as a result of plumbing leaks and irrigation system draining into this area which is below the exterior grade. There is moisture deterioration observed on the skirting where plumbing leaks have been present for some time. One of the hinges is missing from the crawl space access door. There is significant moisture deterioration on the crawl space access door. There is damage to the block wall at the south end of the crawl space. There is a possible fallen pier observed along the south wall of the crawl space.

Moisture deterioration on east skirting

We recommend that you consult with a structural engineer and/or qualified foundation expert to determine if repairs may be needed.

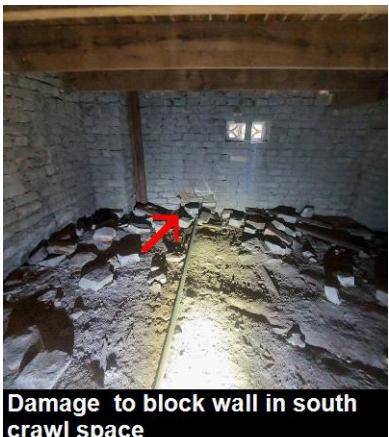
Damage to block wall in south crawl space

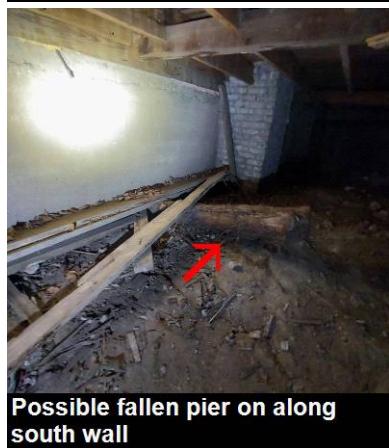
Indications of foundation movement were noted that included: significant deflection of floors in multiple areas of the interior building; doors that run when opening and closing; settling fractures observed around doors, windows, walls and ceiling around the home.

Possible fallen pier on along south wall

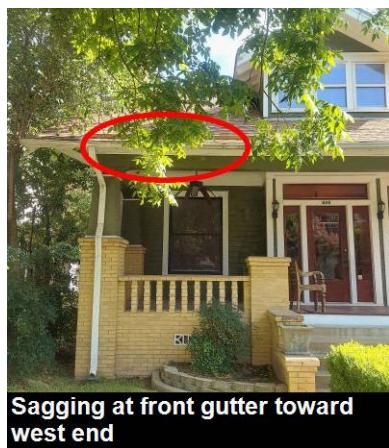
**GUTTER OBSERVATIONS:** Gutters around the home should be checked for proper pitch toward downspouts; there are sags in runs of the gutters which may inhibit proper drainage. Gutters are filled with debris around the home. (Leaves, sticks, and/or aggregate.) Debris may have restricted full viewing at some areas.

Sagging at front gutter toward west end

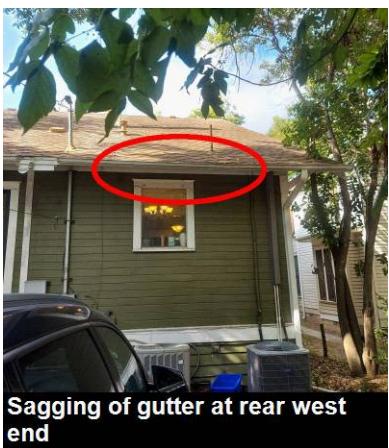
Sagging of gutter at rear west end

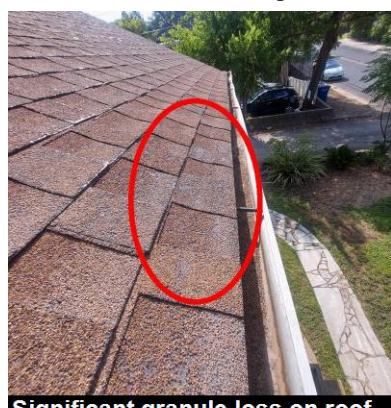
**ROOF COVERING OBSERVATIONS-** **The roof covering appears to be nearing the end of its useful service life.** A qualified professional roofing contractor should be consulted to make further evaluation and/or repair or replacement recommendations for current conditions. Tree limb(s) observed in contact and rubbing surface of roof. Trim tree limbs off roof 4-5 feet to reduce wear/damage to roofing materials. There is moisture deterioration observed on the shingle mold trim on the upper west side of the home.

Significant granule loss on roof surface

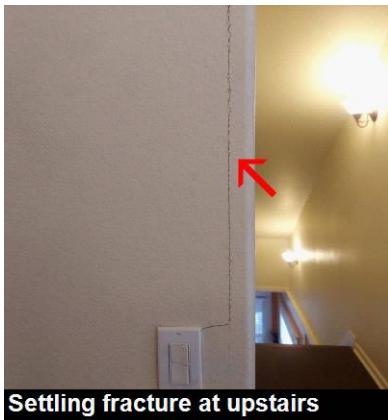
Settling fracture at upstairs corner bead

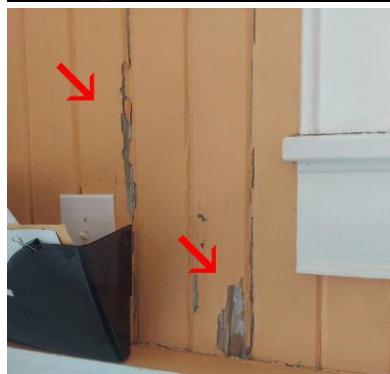
Moisture deterioration at lower NE walls

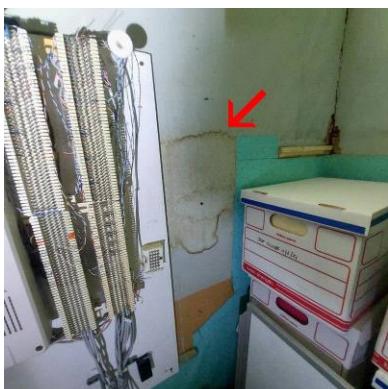
Moisture stains in office closet

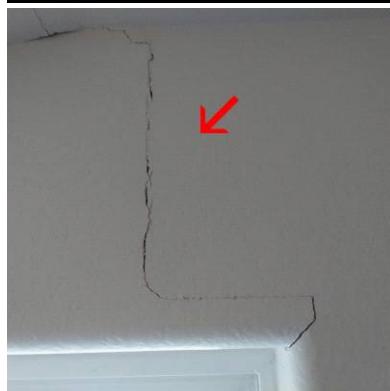
Settling fracture over up SW office window

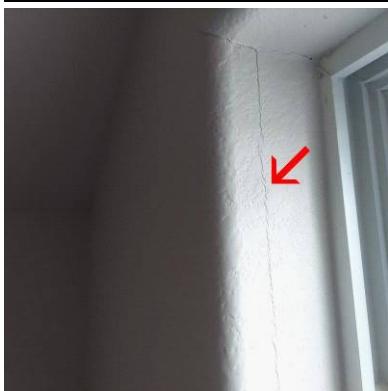
Corner bead fractures at SW office window

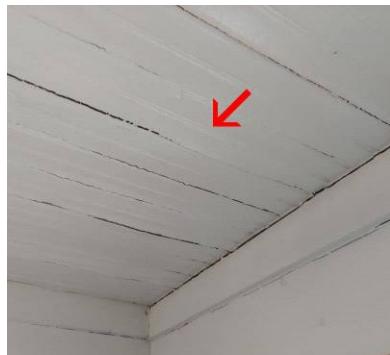
CEILING COVERING(S): Drywall / Wood. CEILING OBSERVATIONS- **There is a tapeline fracture in the ceiling at the front foyer. There is previous moisture deterioration in the ceiling of the closet at the northeast office. Area(s) checked with a moisture meter and no elevated moisture was noted at the time of the inspection. There is evidence of rodent damage at the ceiling inside the closet of the northeast downstairs office. There is a tapeline fracture in the coffer of the upstairs southwest office ceiling. There is evidence of possible moisture deterioration in the wood ceiling at the northeast downstairs area (at bottom of stairwell). There is a settling fracture in the ceiling of the west middle office.**

Possible moisture deterioration in ceiling

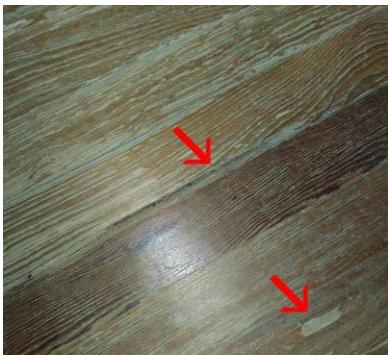
Damaged areas of hardwood flooring

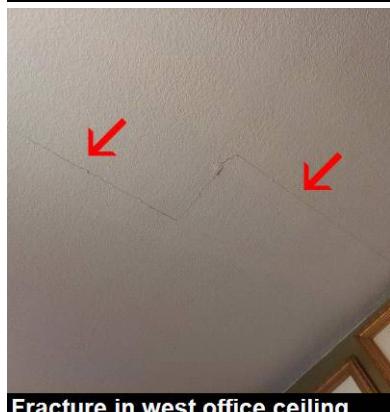
Fracture in west office ceiling

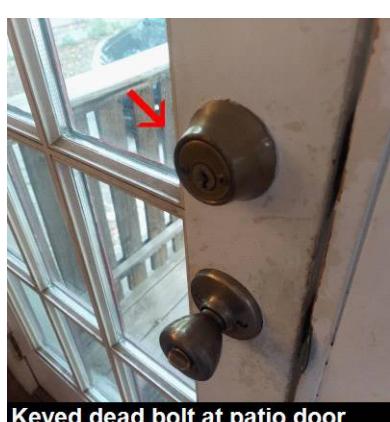
EXTERIOR DOOR OBSERVATIONS- Dead bolt on the patio door requires a key on the interior which violates current home safety standards. The patio door does not open complete due to rubbing on the floor where settling has raised the floor in this area.

Keyed dead bolt at patio door

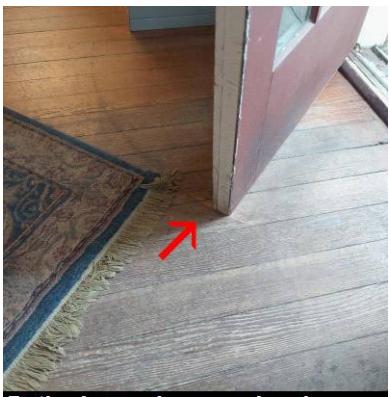
Patio door rubs on unlevel flooring

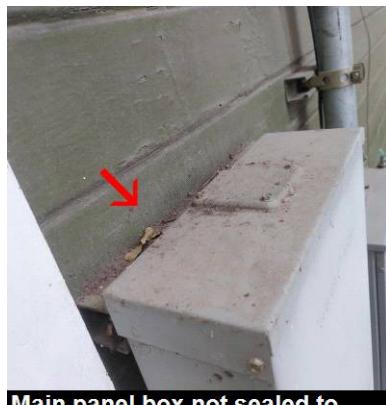
Main panel box not sealed to wall at top

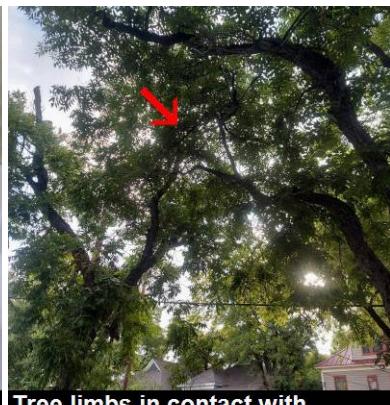
Tree limbs in contact with service drop

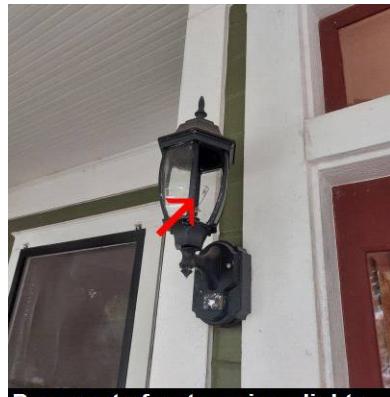
Damage to front carriage lights

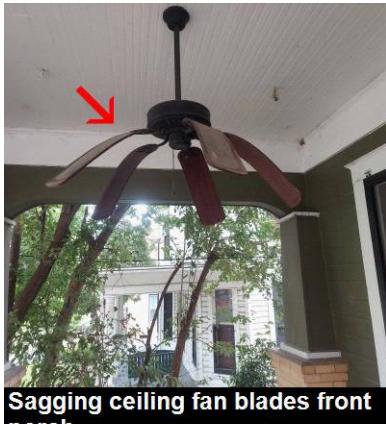
Sagging ceiling fan blades front porch

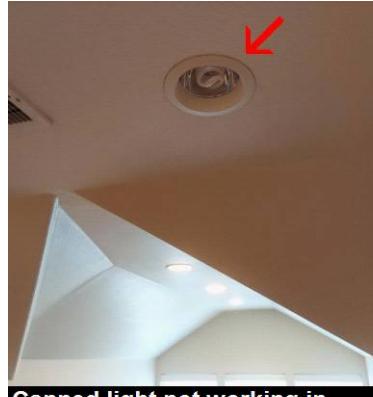
Canned light not working in conference

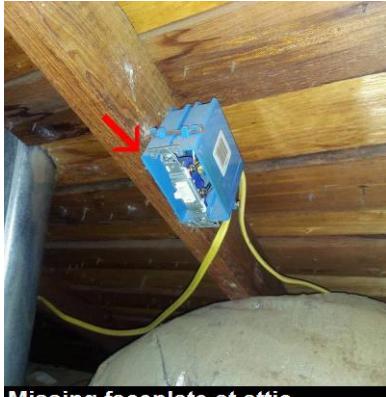
Missing faceplate at attic receptacle

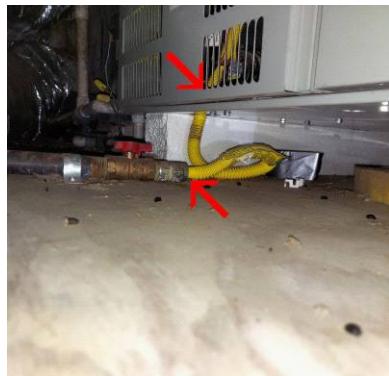
**The flexible gas line passes through the side of the furnace housing which is a violation of current standards that require that it be a solid pipe. There is no sediment trap on the gas line before the shutoff valve to the furnace. This a new requirement that began for home built after 2009, so this was not required at the time this home was constructed.**

**Flex line in cabinet / no sediment trap**

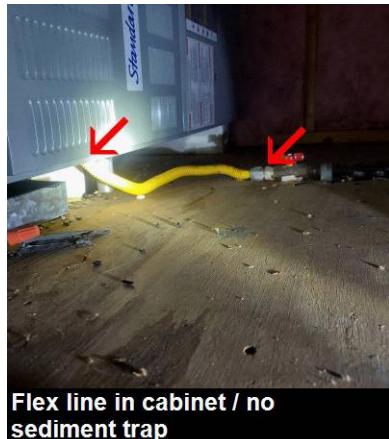
Thermostat Observations- The thermostat appeared to operate correctly at the time of the inspection. **The flexible gas line passes through the side of the furnace housing which is a violation of current standards that require that it be a solid pipe. There is no sediment trap on the gas line before the shutoff valve to the furnace. This a new requirement that began for home built after 2009, so this was not required at the time this home was constructed.**

**Flex line in cabinet / no sediment trap**

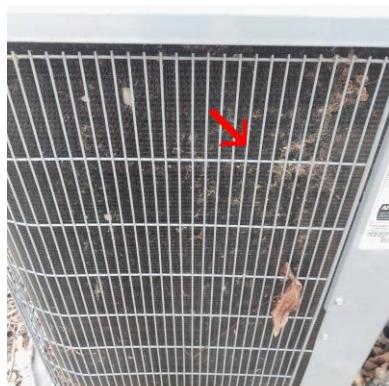
CONDENSER (EXTERIOR UNIT) OBSERVATIONS- **Condenser Deficiencies- Heat transfer fins were dirty/clogged and should be cleaned to promote efficient operation.**

**Clean heat transfer fins on upstairs unit**

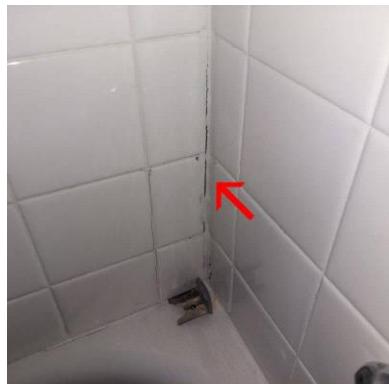
TUB/SHOWER ENCLOSURE- **Caulk the corners of the tub/shower in the downstairs bath where the grout/caulk is failing to reduce moisture intrusion.**

Caulk corners of downstairs tub enclosure

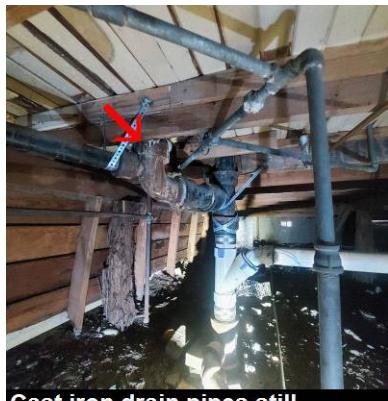
DRAIN/WASTE & VENT PIPING TYPE- Combination of materials, including cast iron. A home this age may have cast iron drain pipes that run from the home to the sewer. Given deficiencies noted, we recommend you have a licensed plumber run a camera test to determine integrity of the pipes.

Cast iron drain pipes still present

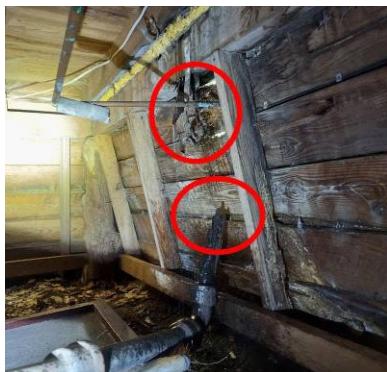
SEWER PIPE OBSERVATIONS- **Corrosion/deterioration was present on area(s) of the soil piping below the kitchen sink where water is dumping into the crawl space. There are leaks at the metal drain pipes under the downstairs bathroom drain pipes.** SOIL VENT PIPE

Water was run for 5+ minutes at kitchen sink(s) and no indication of slow or backed up drains was observed during this inspection. **The cast iron drain pipe is deteriorated to a point where there**

is at least 12-18" gap between the top and bottom sections. Water is dripping on the wood skirting both inside and outside of the crawl space and water is ponding in the crawl space whenever the kitchen sink is operated. A licensed plumber should be contacted to determine repair requirements in this area.

**Damaged/separated drain at kitchen sink**

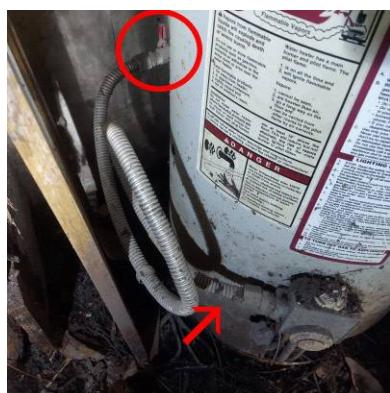
Water heater is located in the crawl space. **Water heater is not operational at the time of this inspection; gas valve was observed in the off position by inspector. There is significant wear/age on the unit and deterioration as a result of being located in this damp crawl space. A licensed plumber should be contacted to recommend options of replacement of the water heater unit for this building. There is corrosion taking place around the pipe fittings where the supply lines enter the water heater. The T&P drain line goes up hill and should run down hill continuously from the point of connection on the unit.**

Gas valve off / no sediment trap

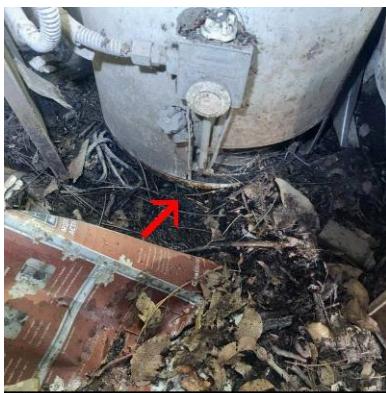
Deterioration on water heater unit

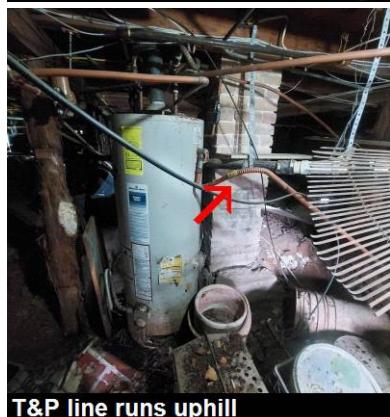
T&amp;P line runs uphill

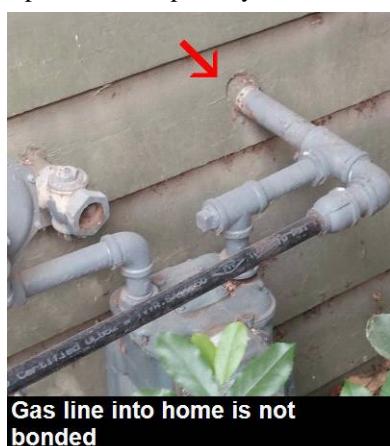
**The gas/propane line into the home is not properly bonded as required by current standards.**While this was not a requirement when this home was built, proper bonding of the gas meter is important to reduce the risk of stray voltage entering the home in the event of a lightning strike.

Gas line into home is not bonded
