1612 Frazier St, Conroe, Texas 77301 AEI Project Number: 458021

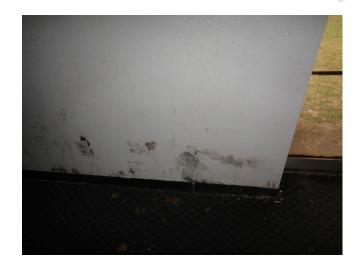
3. Moisture damage bldg 2

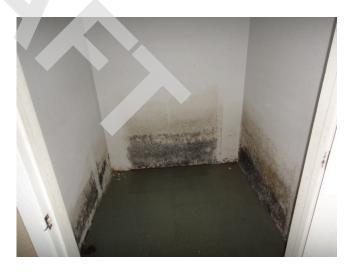
4. Mold damage bldg 2

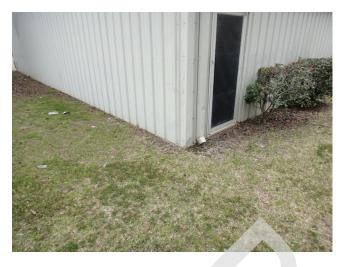
5. Poor drainage along southeast

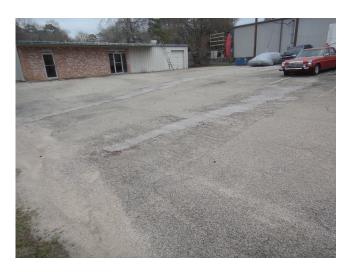
6. Fair asphalt paving

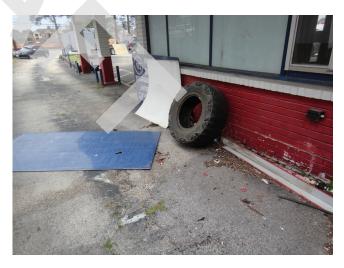
8. Trash and debris to be removed

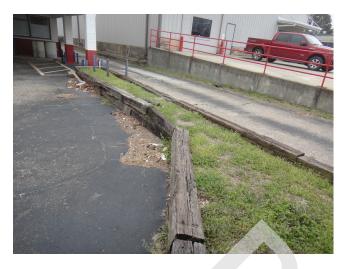
9. Damaged wood landscaping borders

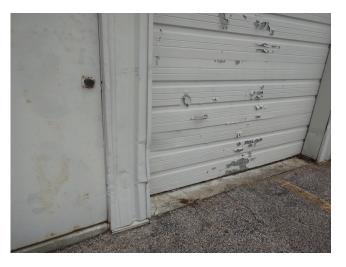
10. Fair to poor finishes

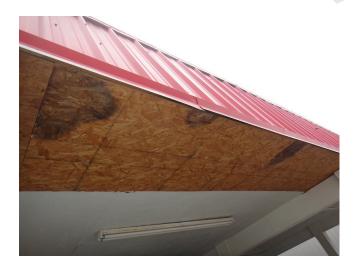
11. Damaged soffits

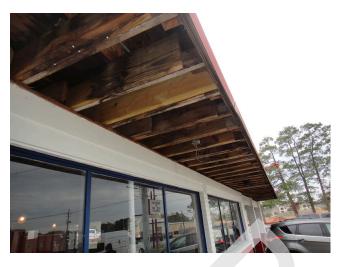
13. Soffits exposed

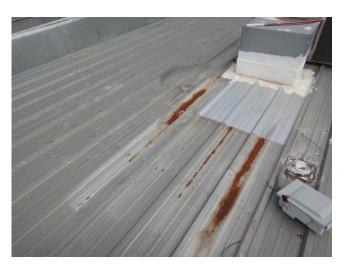
14. Roof surface rust bldg 1

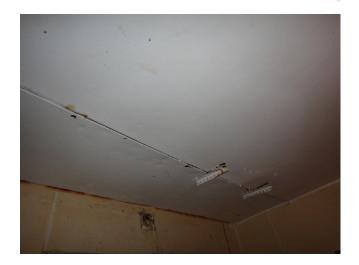
15. Roof leak bldg 1

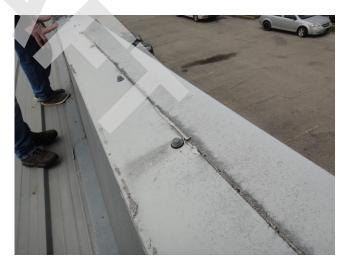
16. Roof coping poor

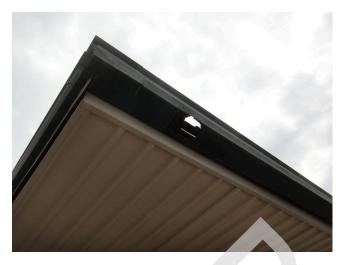
17. Damaged gutters

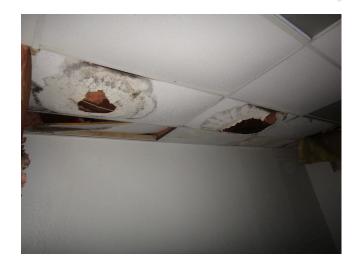
19. Past roof leaks bldg2

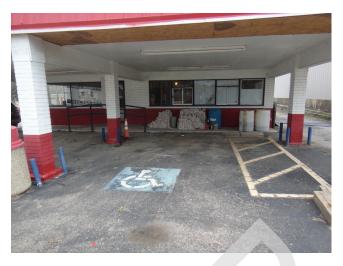
21. ADA signage needed

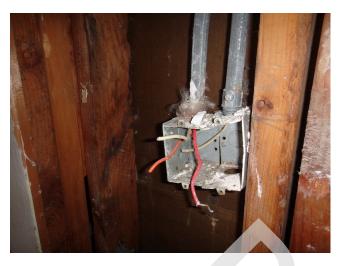
37. Electrical removed bldg 1

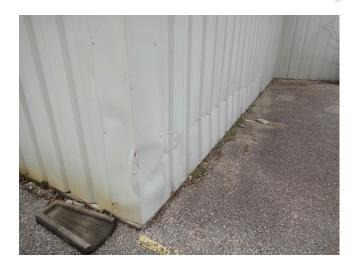
43. Metal panel wall damages

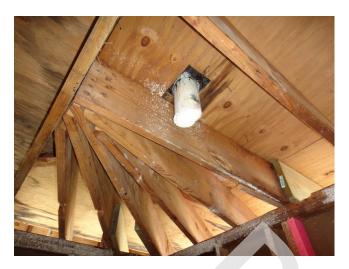
45. Plumbing removed bldg 1

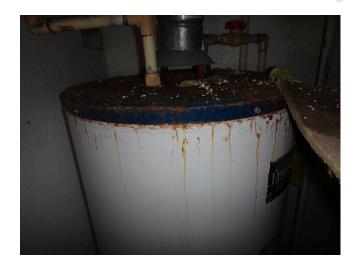
47. Poor water heater

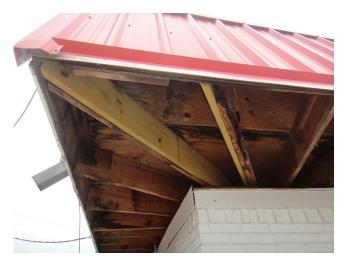
50. Recent framing repairs

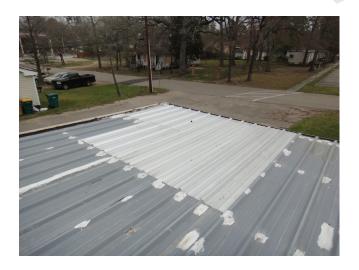
51. Recent roofing repairs bldg 2

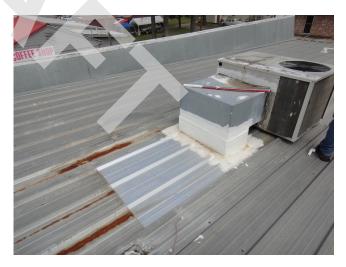
52. Roof repairs bldg 1

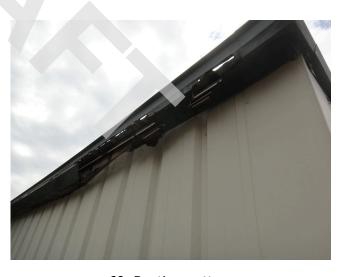
60. Rusting gutters

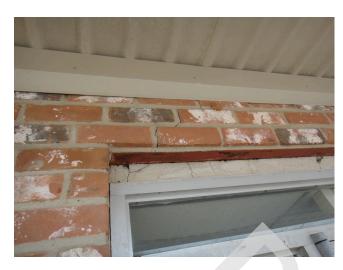
61. Minor brick crack at bldg 1
