#3 (RIGHT MIDDLE BUILDING)

835 Minnie St
Jacksonville, FL 32204

NOVEMBER 7, 2024

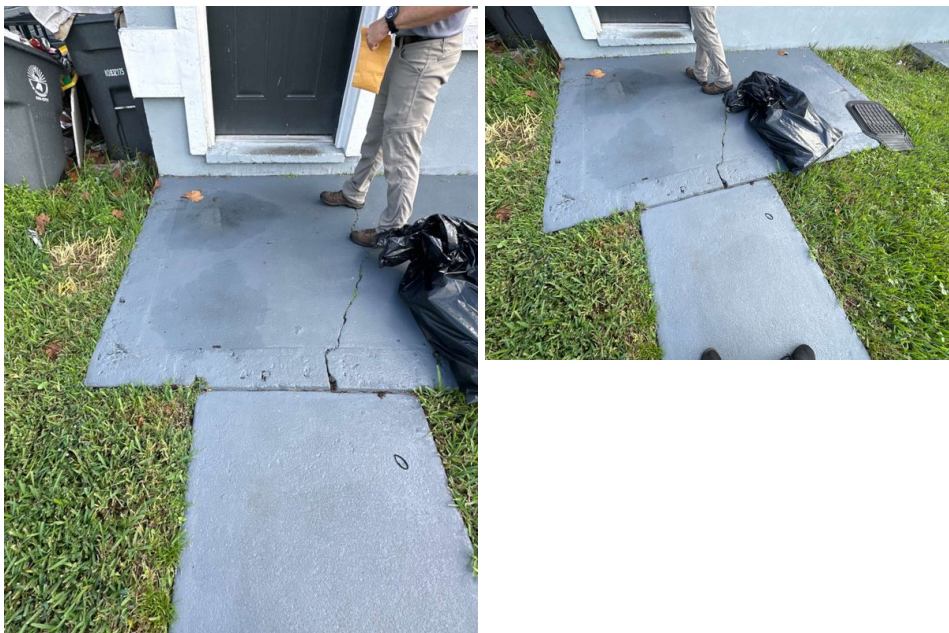
The concrete has settled at the exterior. The concrete is uneven or has sunken downwards in areas, which can cause a potential tripping hazard. Recommend repairing the concrete as needed or monitoring and being cautious of this.

Contact a qualified concrete contractor.

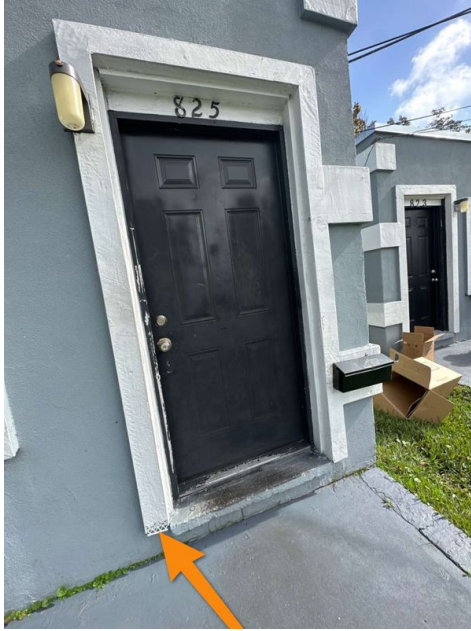
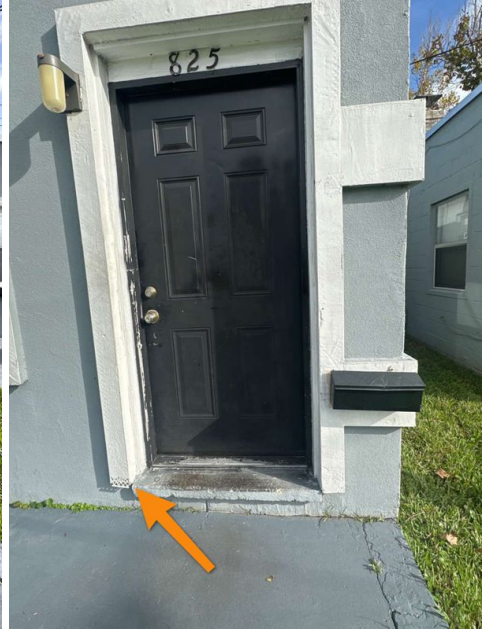
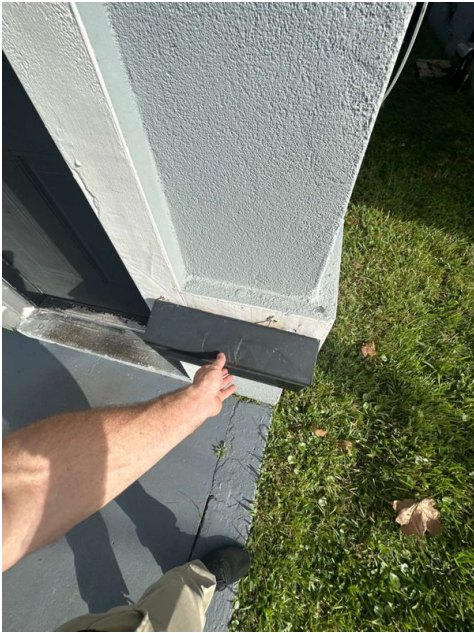
2.3.1 Siding, Flashing & Trim

DAMAGE AT SIDING/TRIM

Damage was present to the siding and/or trim in the areas pictured below. Recommend repairing the siding to ensure proper drainage and to allow for normal wear and tear.

Contact a qualified professional.

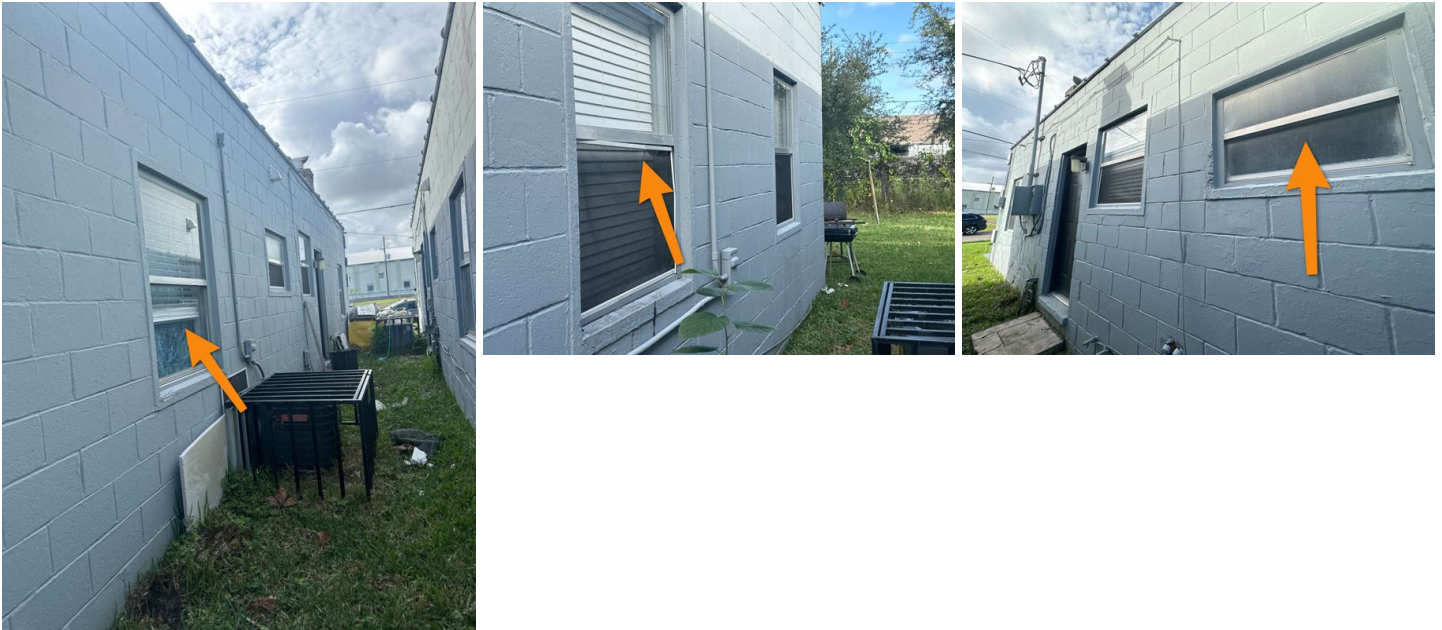
2.4.1 Windows

MISSING/DAMAGED WINDOW SCREENS

Some missing and damaged window screens noted. Recommend repair as desired to reduce possible pest entry when the windows are open.

Contact a qualified professional.

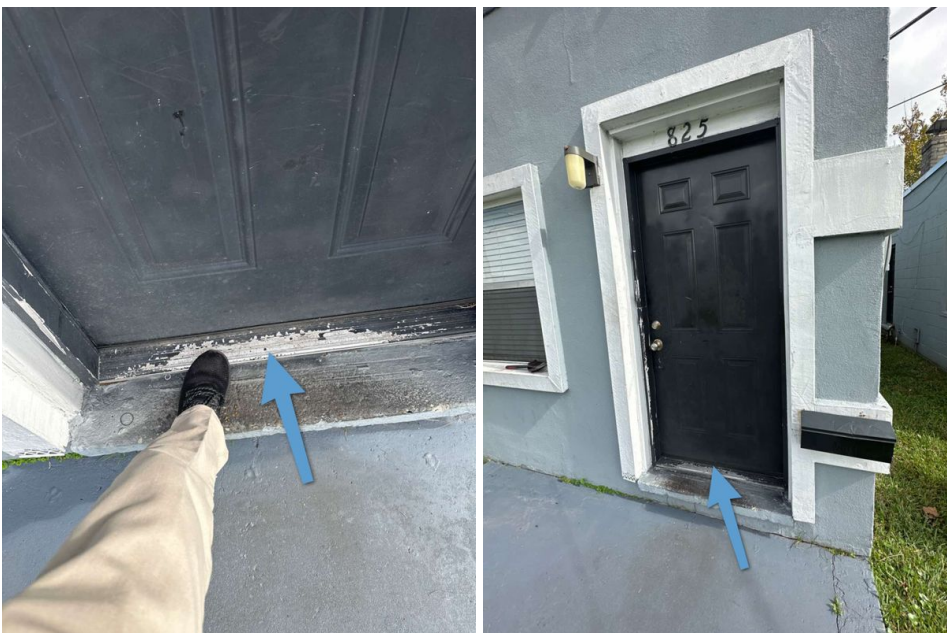
2.5.1 Exterior Doors

LOOSE THRESHOLD AT MAIN ENTRY DOOR

The lower threshold is loose at the main entry door. Recommend repair, so the threshold is secure.

Contact a qualified handyman.

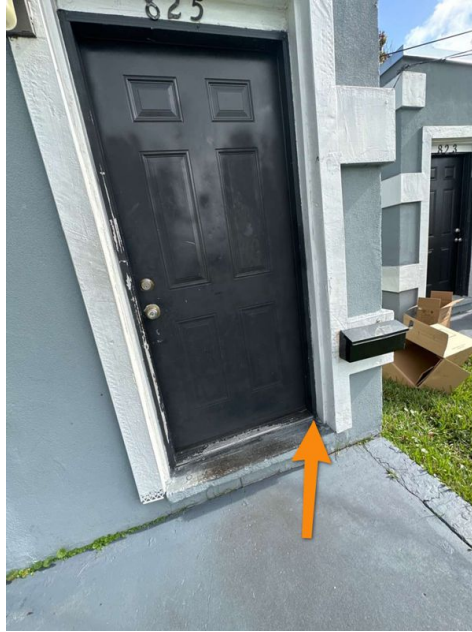
WOOD DECAY - LOWER DOOR TRIM

Wood decay noted at unit 825 exterior door's lower door jamb. Recommend repair to allow for normal wear and tear.

Wood decay is common for exterior doors with only a small roof overhang above it or where wind driven rain can enter. This can allow water to run down the seams during wind driven rain. This is a exterior rated door, so this is okay, but wood decay is commonly found at these doors after enough time. Adding storm doors or extending the roof overhang can help reduce this.

Contact a qualified professional.

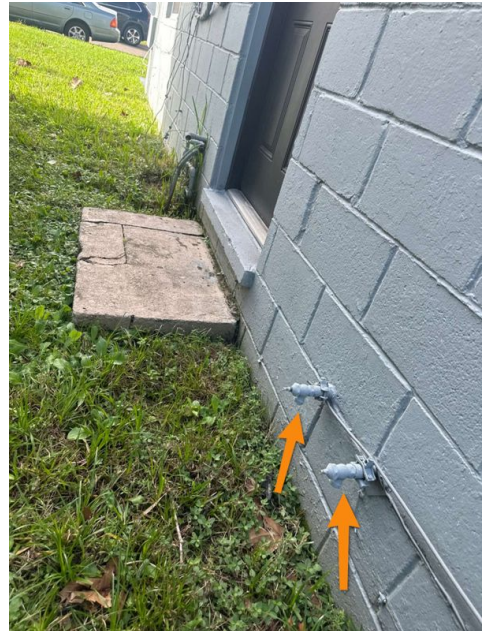
right side of home

The hose bibbs were inoperable at the right side of the home, likely due to the repiping of some of the plumbing components (the original pipes are disconnected, so the new pipes can be installed). This is typically okay, as it is assumed this is due to the supply pipe replacement. Recommend asking the seller for additional info.

Contact the seller for more info

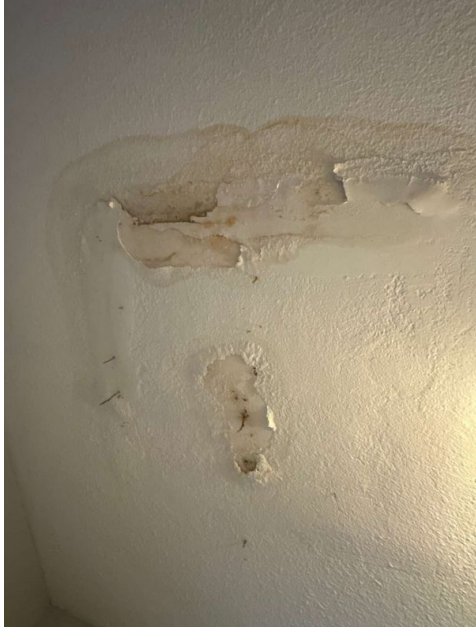
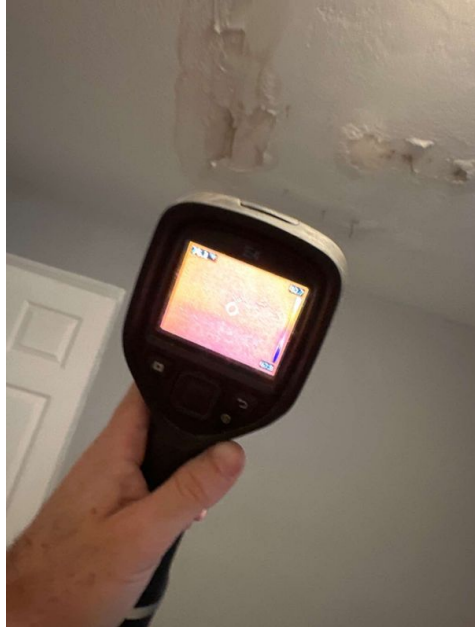
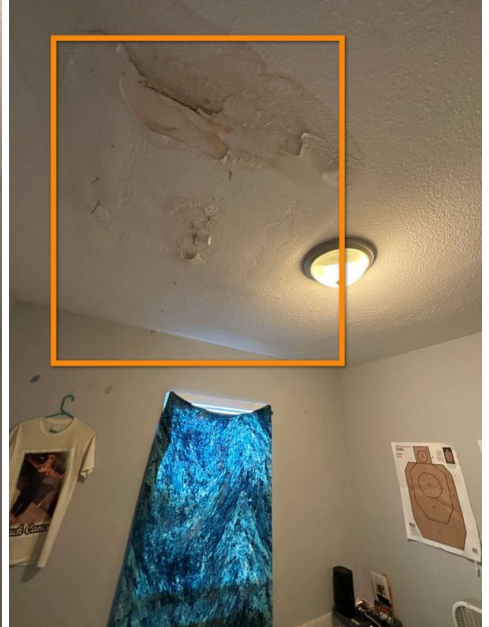
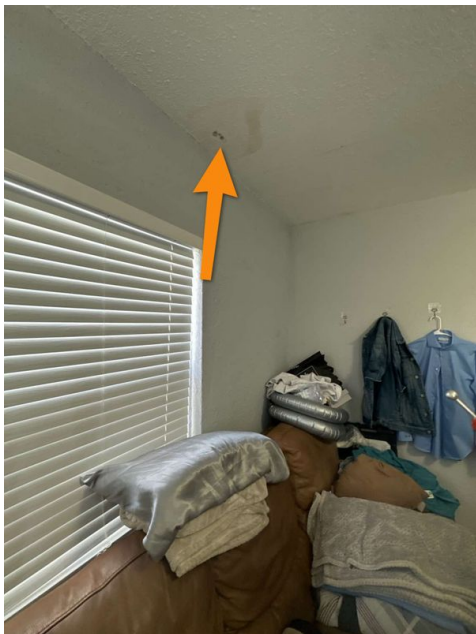
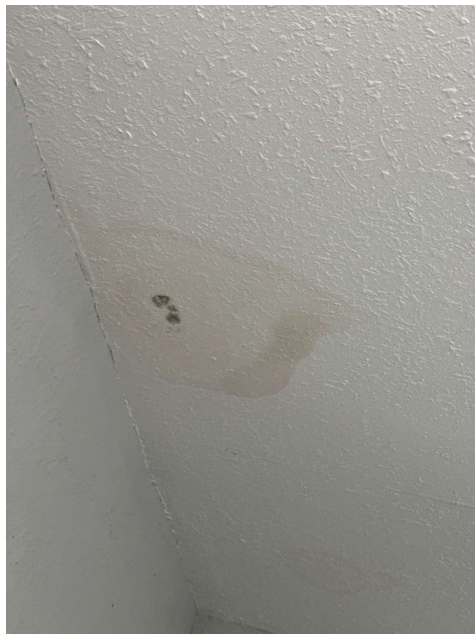
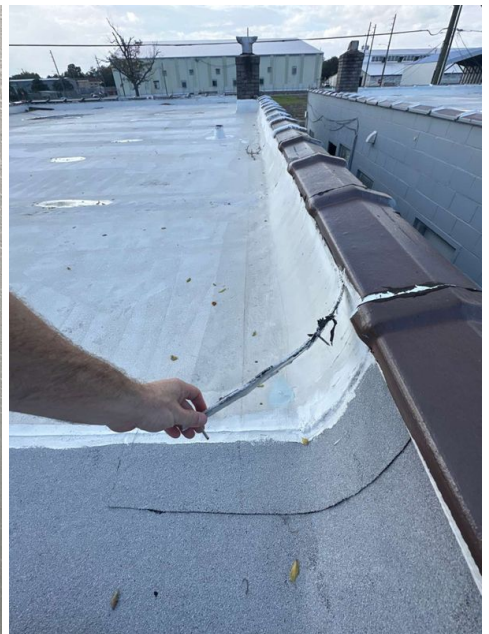
827

ROOF CONCERNS/LEAKS

Water stains noted on the ceilings and walls in multiple areas. The stains had low moisture levels according to the moisture meter, but in my personal opinion this likely will leak during very excessive rains or in the some-what near future. The roof covering shows multiple repairs around the roof. Sealants were applied, as well as elastomeric or silicone roof coatings, but this was a lot of different areas. The chimneys are no longer active, but still need to be maintained. The rain caps show corrosion. There is multiple areas of standing water. While some standing water can be common for flat roofs, but was a lot of different areas and the roof covering is bubbling in areas and moves when stepped on. Recommend further evaluation by a roofing contractor and repair or replace as needed.

Recommend monitoring.

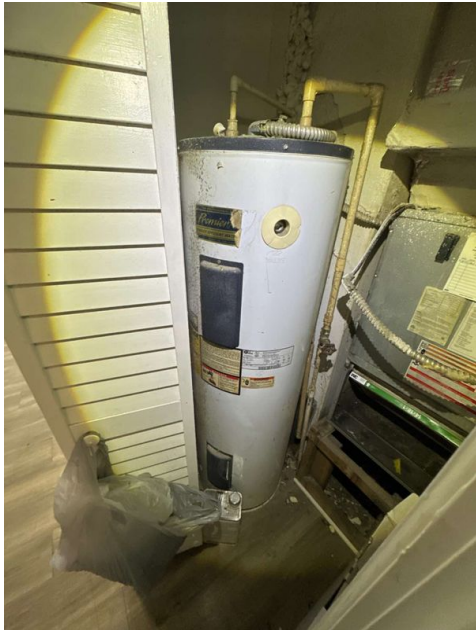
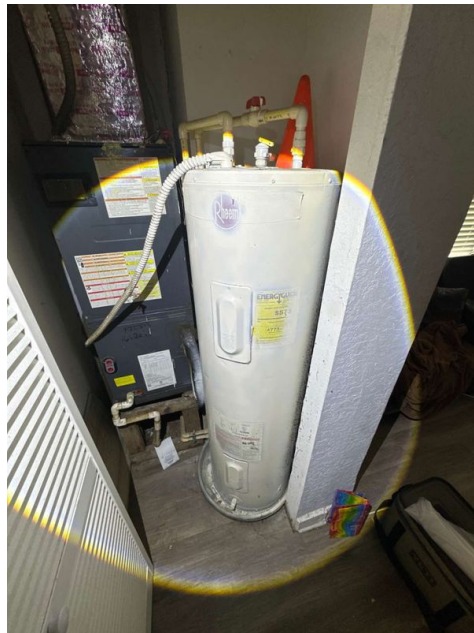
4.2.1 Water Heater Condition

The water heaters are older (2006 and 2014). The water heaters were operable during the inspection, but are older units. Recommend monitoring and budgeting for future replacement.

Recommend monitoring.

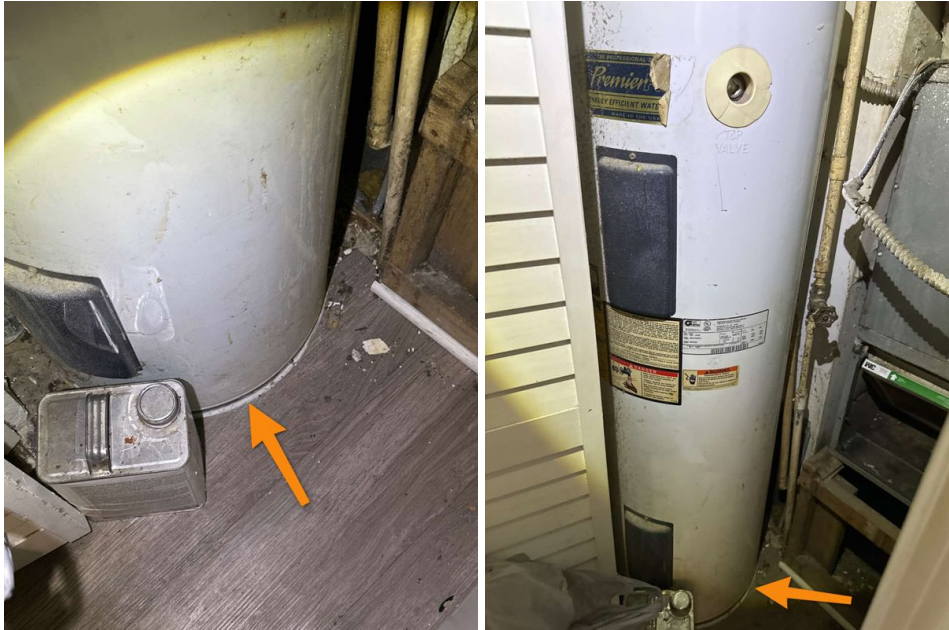
4.2.2 Water Heater Condition

Unit 827s water heater is located inside the home or is near components that could be effected if the water heater leaks overtime. Recommend installing a drain pan underneath the unit as a precautionary measure in case of leaks (no drain pan present).

Contact a qualified professional.

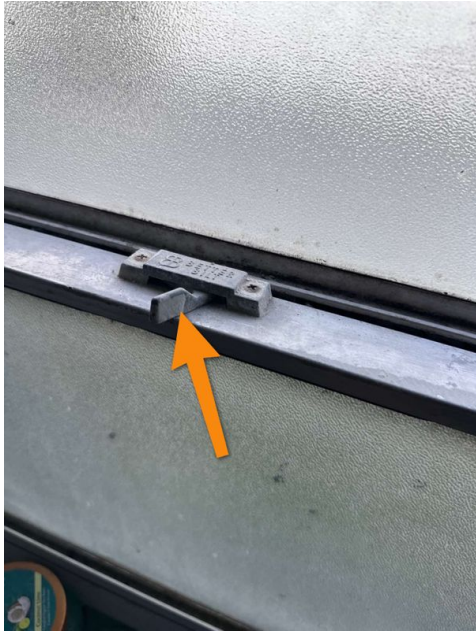
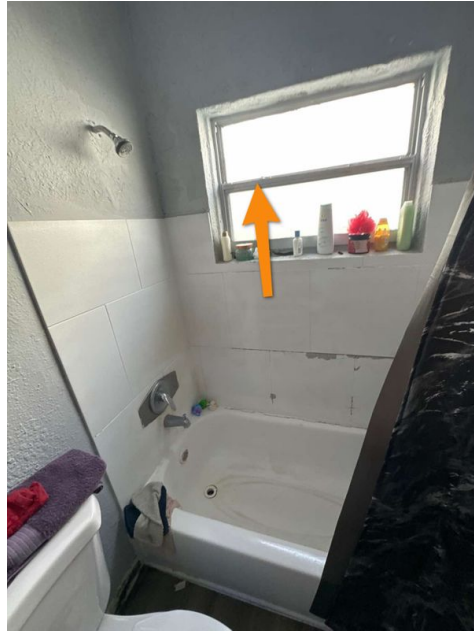
827

AGED WINDOWS SHOW GENERAL WEAR AND TEAR FROM THE OLDER AGE

There were windows present that were difficult to operate, did not operate as intended, and/or had other age related deficiencies. Some windows were tight and difficult to open, some windows were difficult to lock. The plastic window pane trim is loose or missing in areas. Some water stains and minor fungi growth were noted at the window frames, likely from condensation overtime which is common for windows of this age. Having older windows is okay, but perfect function should not be expected. Some replacement window panes noted, so there has been repairs. Recommend consider upgrading the windows in the future.

Contact a qualified window repair/installation contractor.

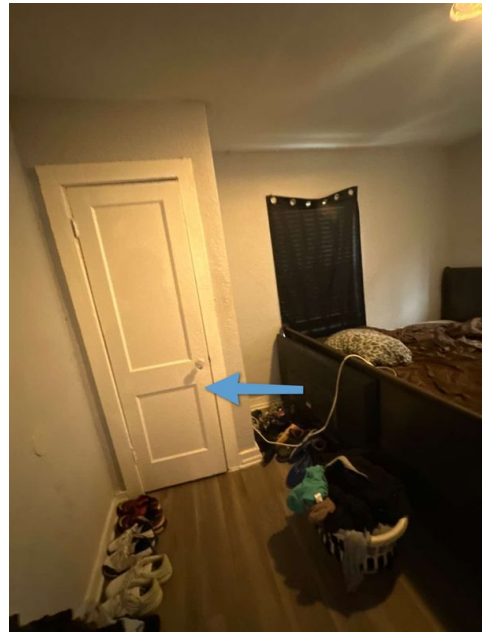
825

Unit 825s bedroom closet door rubs against or hits the door frame when opened/closed, making operation slightly difficult. Needs adjustment or repair to allow for a better clearance.

Contact a qualified handyman.

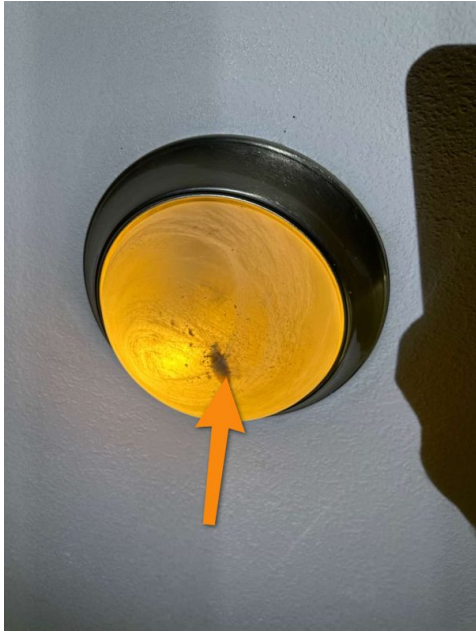
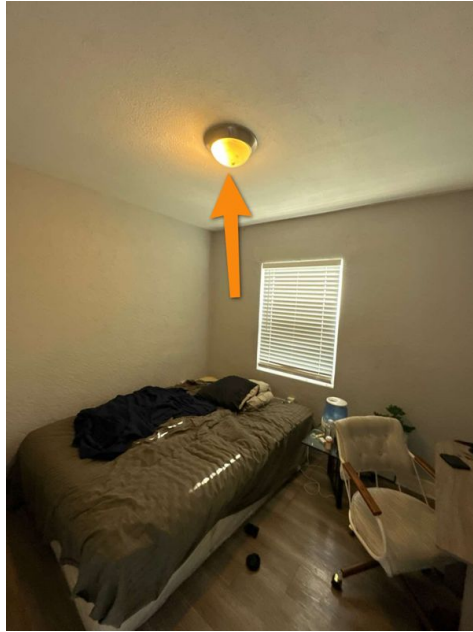
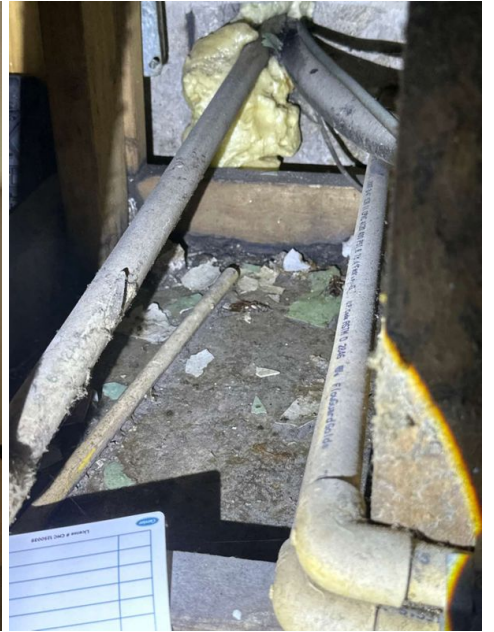
5.10.1 Surfaces - Overall

Dead roaches found in many areas. Recommend further evaluation by pest control company and repair or treat as needed.

Contact a qualified professional.

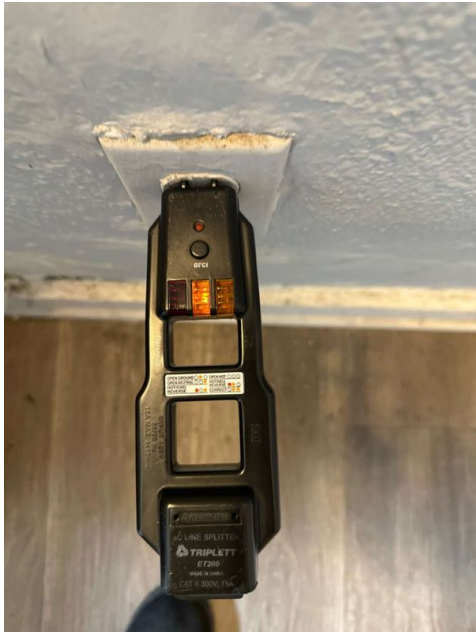
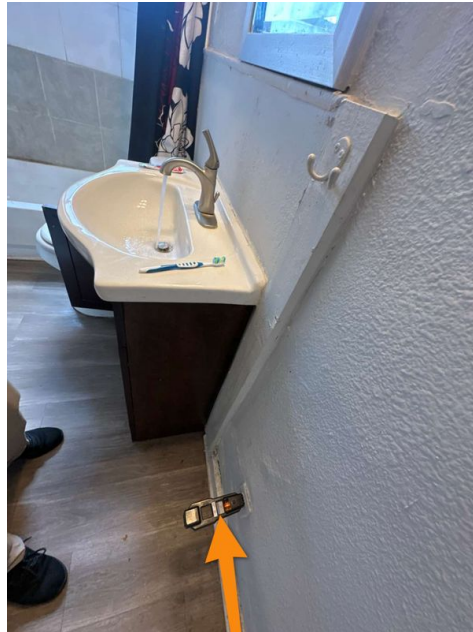
825

The electrical outlets pictured below showed an improper ground according to the receptacle tester. An open ground outlet can cause an electrical surge to the connected device resulting in damage or electrical shock. Recommend further evaluation and repair by a qualified electrical contractor.

Contact a qualified professional.

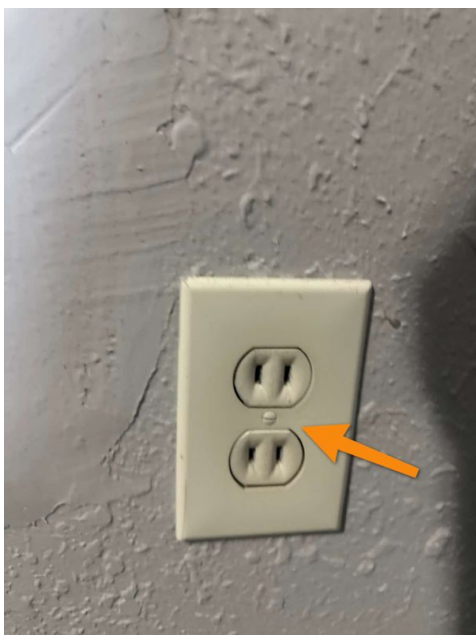
827

Unit 827s bedroom has a 2 prong receptacle. This type of outlets do not have a ground, which can be common for older homes (lack of grounds in the wiring). Recommend upgrading for safety.

Contact a qualified electrical contractor.

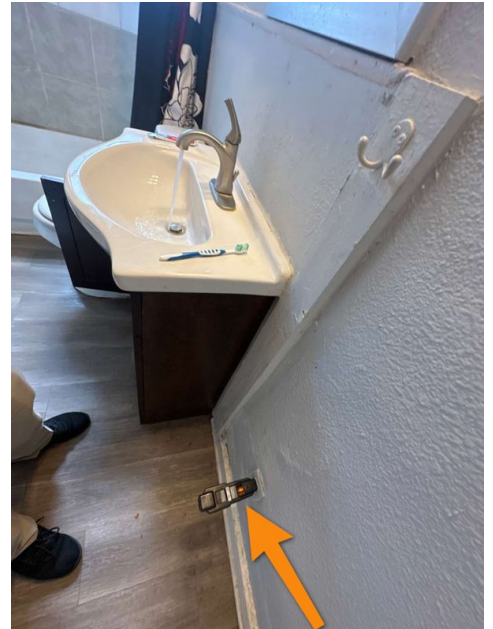
6.12.1 GFCI & AFCI

Recommend installing ground fault circuit interrupter (GFCI) protection to the electrical outlet in unit 827s bathroom. While this may have not been required when the home was built, upgrading is recommended for safety.

Contact a qualified professional.

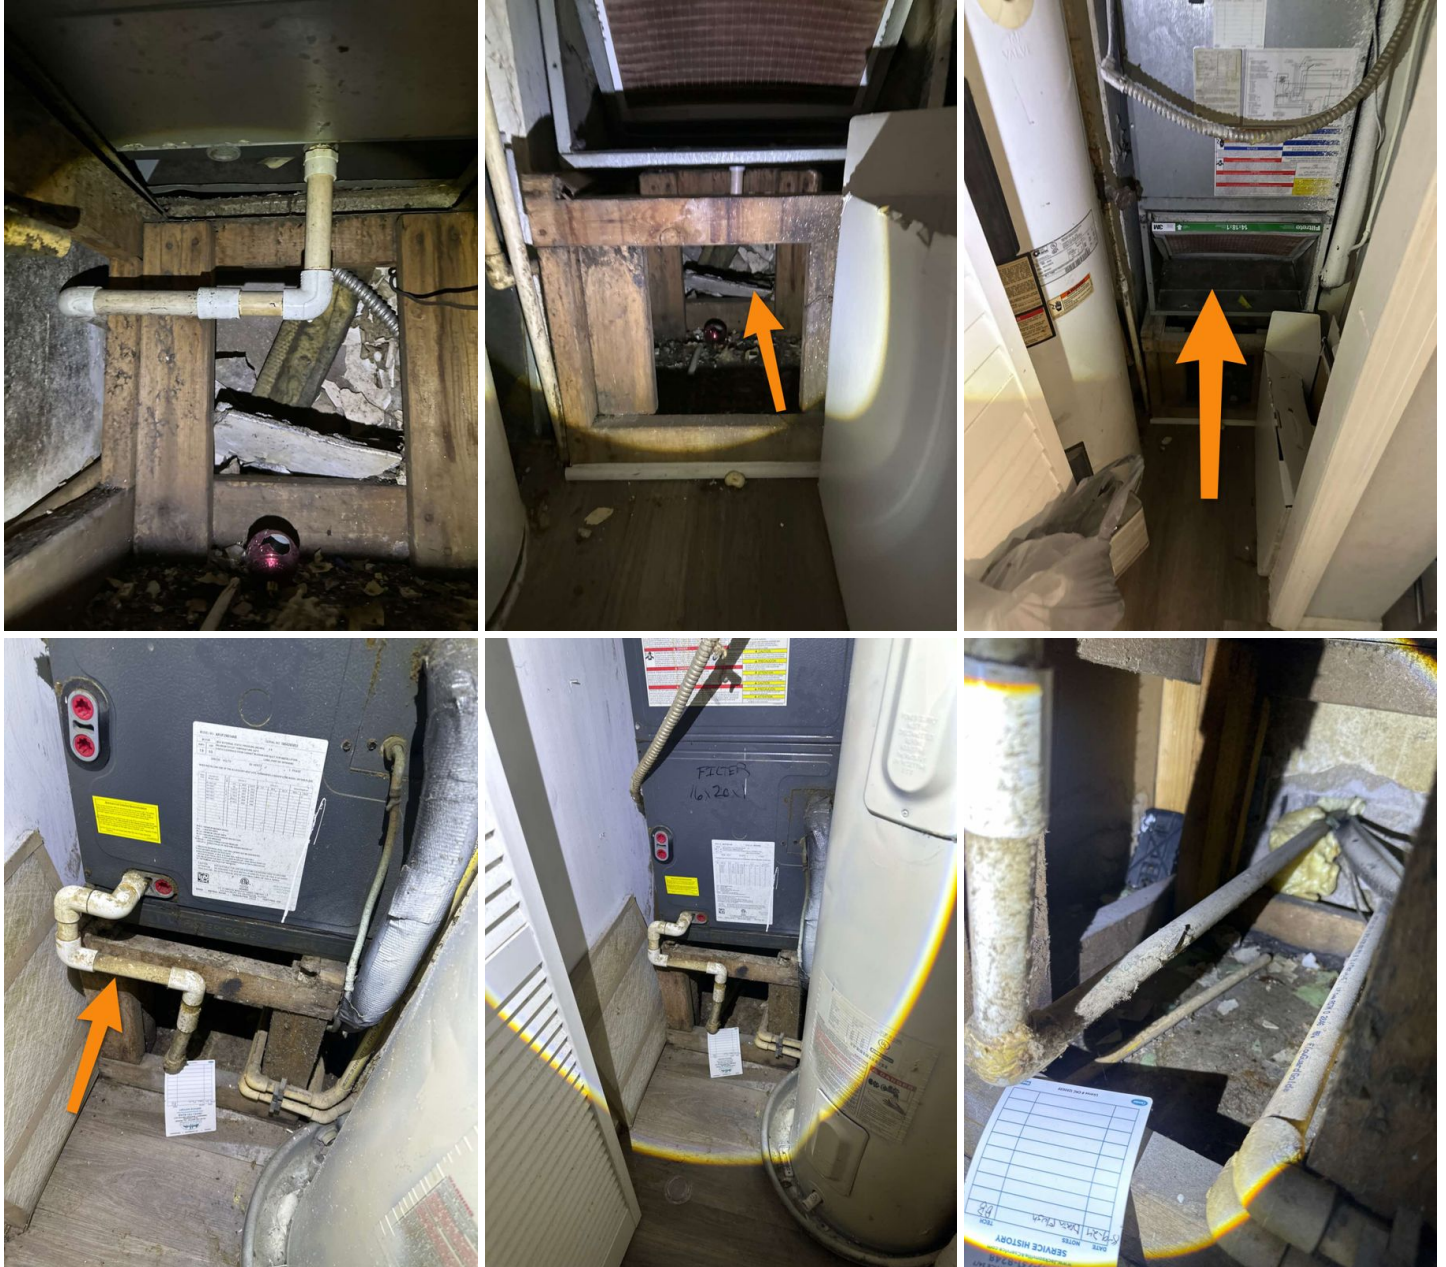
825

There is either no drain pan or no overflow safety float switch under the air handler in unit 827. This does not allow for any leak protection in case the unit leaks in the future. Recommend consider adding a overflow safety float switch or drain pan or at least being cautious of this and monitoring periodically. There are also signs of previous leaks. Recommend further evaluation and repair as needed.

Contact a qualified professional.

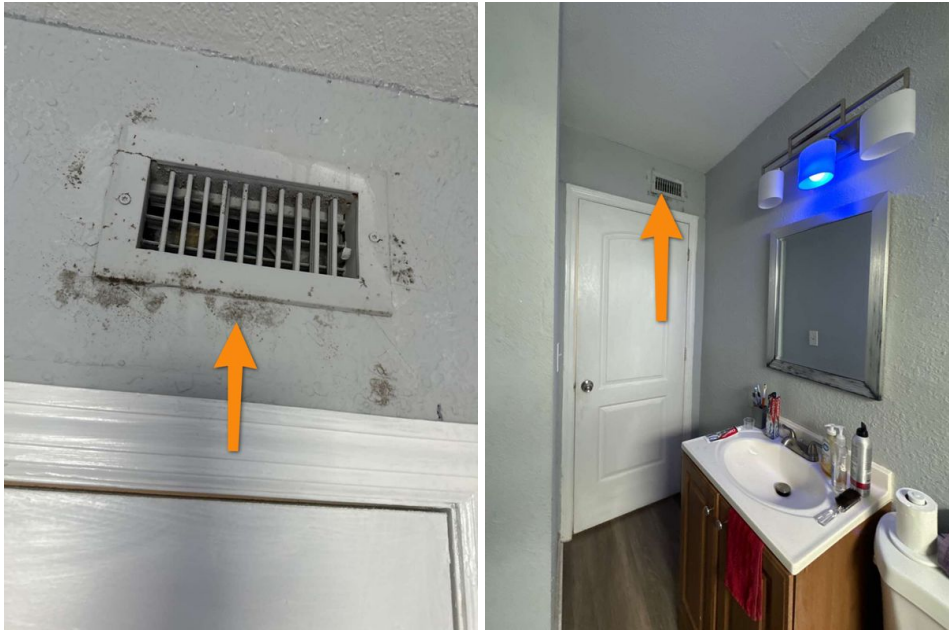
7.6.1 Air Supply/Registers

Fungi growth noted around unit 827s bathroom air vent, likely from typical condensation overtime. Recommend further evaluation and treatment or repair as needed.

Contact a qualified professional.

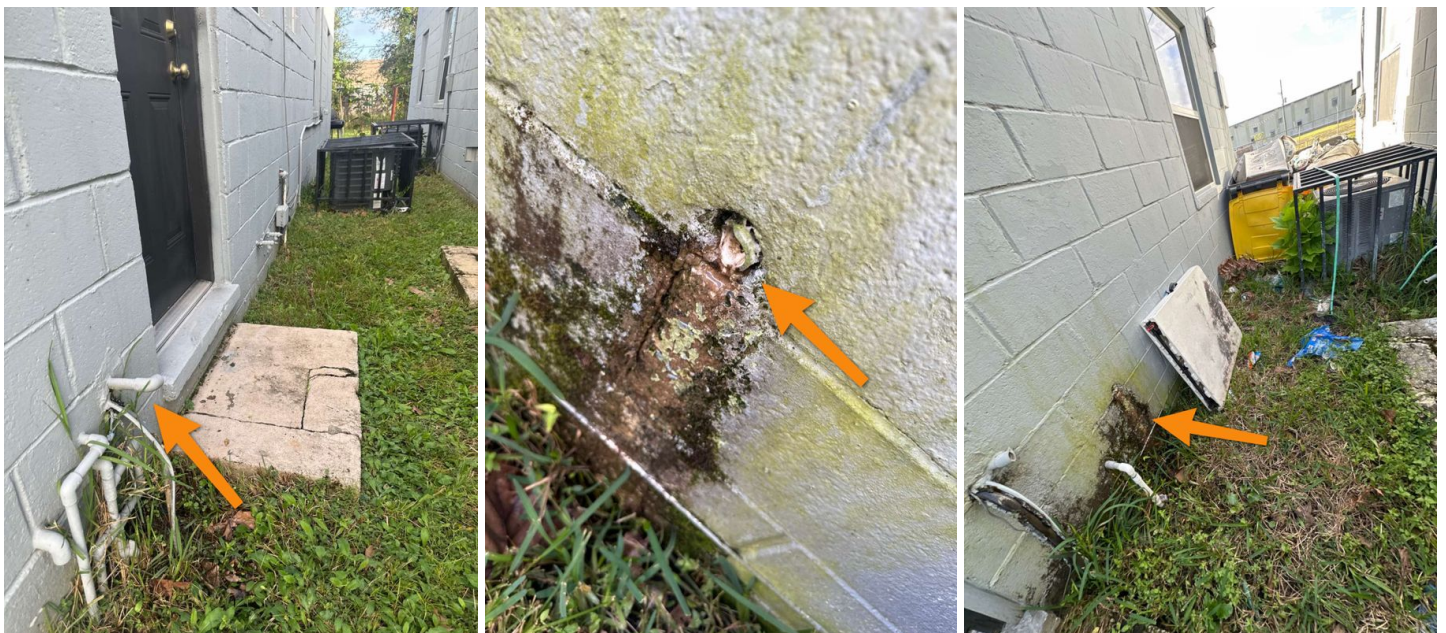
7.9.1 Condensate Drain Pipe

Moderate
CONDENSATE DRAIN PIPE TERMINATED NEAR FOUNDATION AND DAMAGED AT SIDING CONNECTION

The condensate drain pipe terminated at or near the foundation of the home. This can allow water to saturate the soil in this area, possibly entering back into or under the structure. Extending the drain pipe, away from the foundation, is recommended to be conducted by a qualified person as needed. The condensation drain pipe at the left side of the home is damaged at the siding, so water is running down the siding here and needs repair so water does not seep to the interior.

Contact a qualified professional.

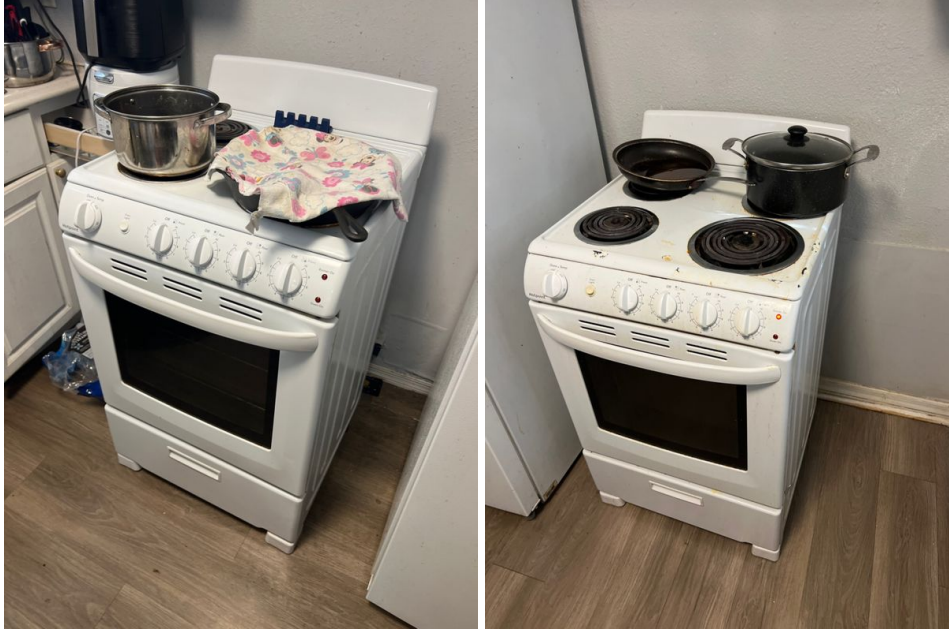
**ANTI-TIP BRACKET MISSING AT OVENS**

An anti-tip bracket was not present for the the range (for all 8 units, not just this report). An anti-tip bracket prevents the range from tipping over, if weight is applied to an open oven door, such as a child stepping or sitting on the door. Ranges contain a warning label on the inside of the oven door with more information. This bracket can be purchased at home improvement stores for approximately ten dollars. The installation of an anti-tip bracket is recommended for safety, but a minor concern.

Contact a qualified professional.

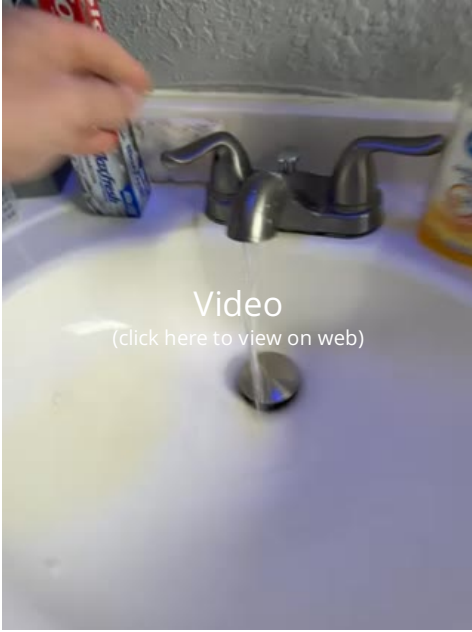
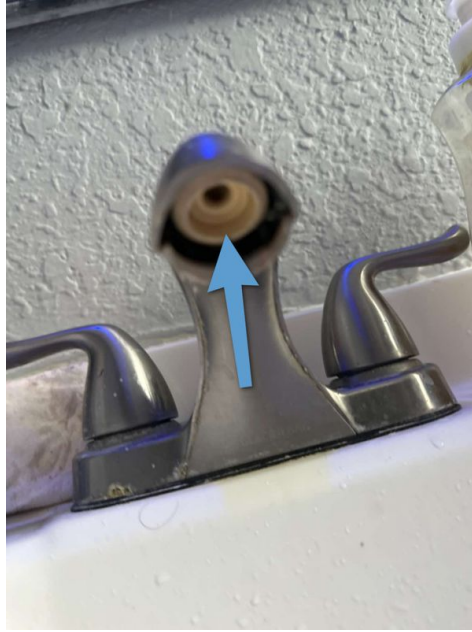
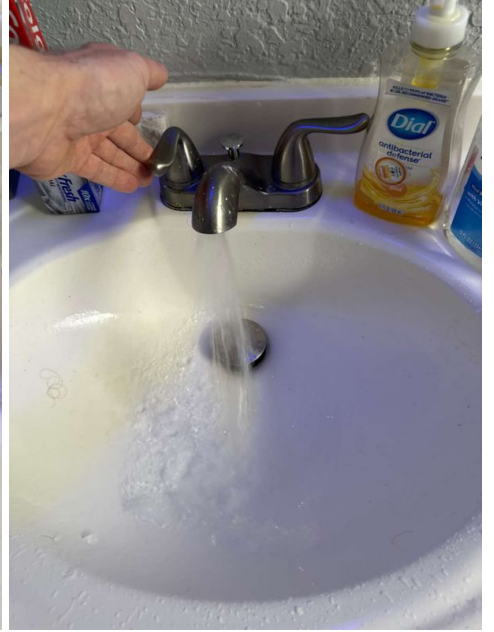
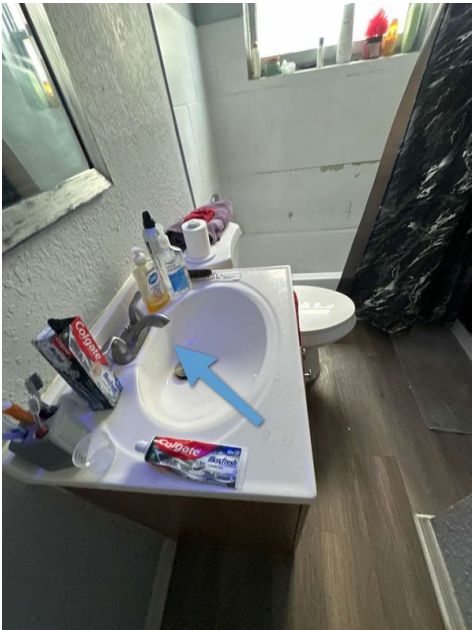
827

MISSING FAUCET AERATOR

Unit 827s bathroom sink faucet had an erratic flow. The aerator (the screen at the terminating end of the faucet that mixes air with water) is missing. Recommend repair as needed.

Contact a qualified plumbing contractor.

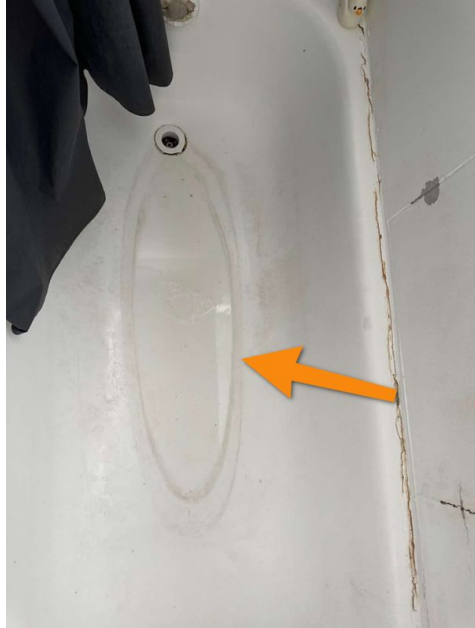
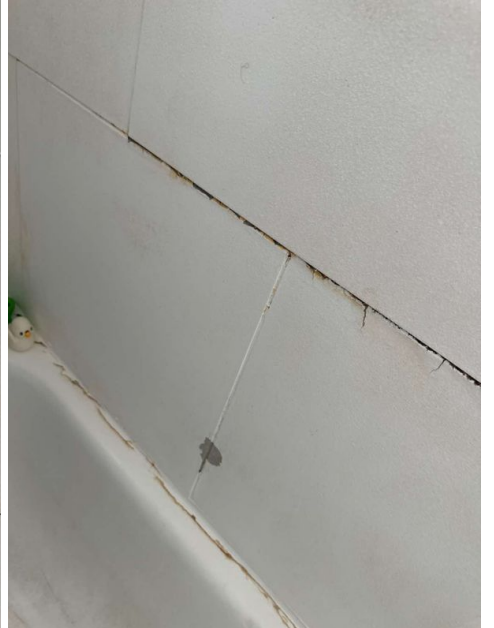
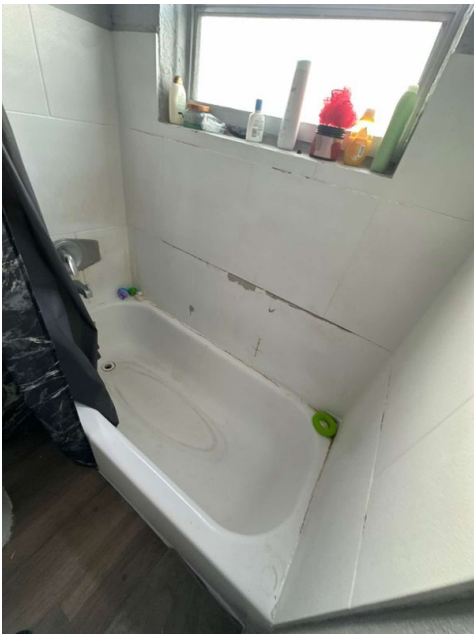
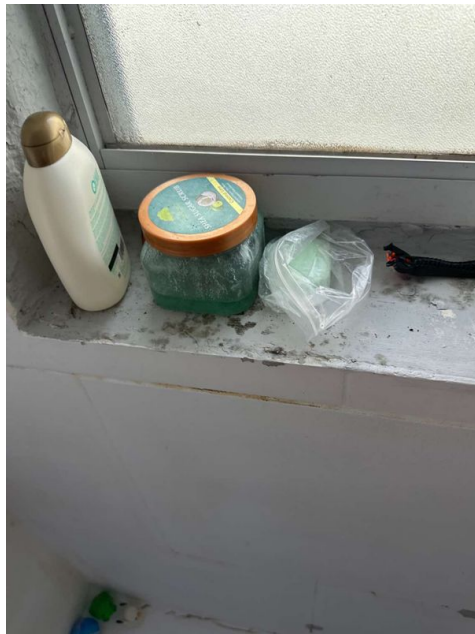
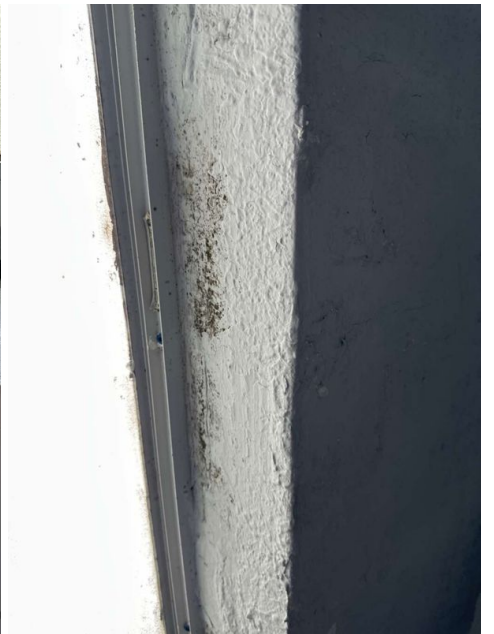
9.5.1 Shower walls and floor

WEAR AT BATHROOMS/SHOWERS

A paint type of refinish was applied to the shower walls and bathtub in unit 827, which is okay, but this coating has failed in areas and is chipped and peeling. Some areas need caulking as well. There is also wear at unit 825s bathtub, as well as standing water in both units bathrooms from an inadequate drainage pitch. Recommend repair as needed.

Contact a qualified professional.

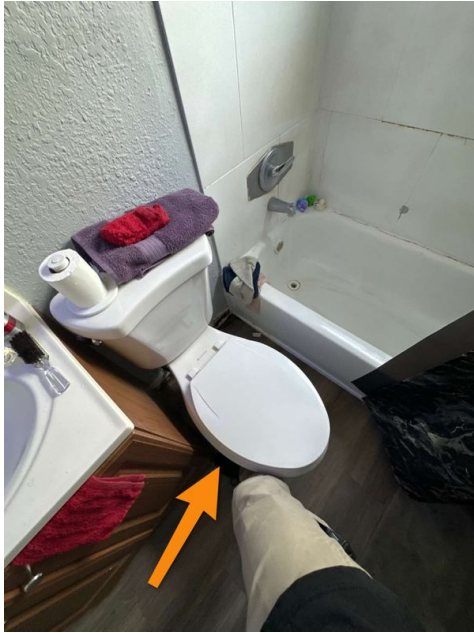
827

TOILET LOOSE AT FLOOR CONNECTION AND FUNGI GROWTH/LEAK

Unit 827s bathroom toilet is loose from the floor connection. Repairs may involve re-setting the toilet on a new wax seal. There is also fungi growth and a lot of water stains at the baseboard behind the toilet, so the toilet could be leaking from time to time if moved too far or there is excessive water overspray during showers, but needs further evaluation and repair by a plumber.

Contact a qualified plumbing contractor.
