## Summary Only

1402 Bear St.  
Madison IN 47250

This is not the complete home inspection report. It is only the Summary Items.

## LIMITATIONS SUMMARY

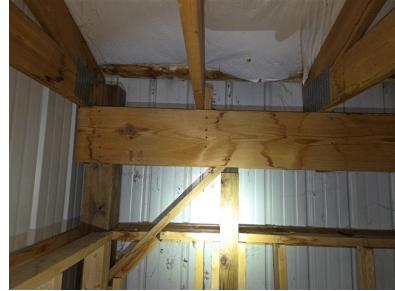
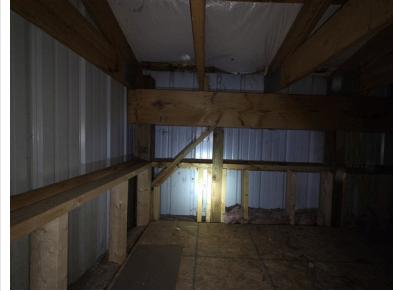
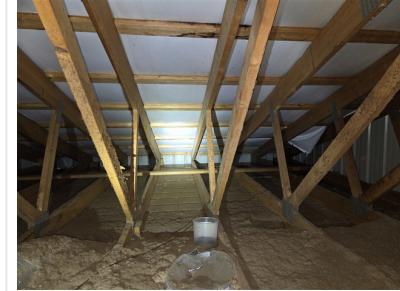
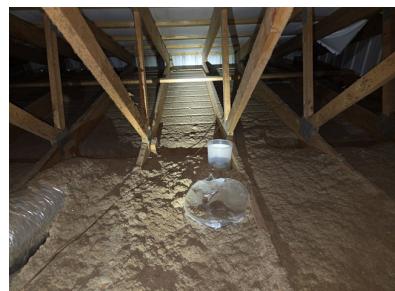
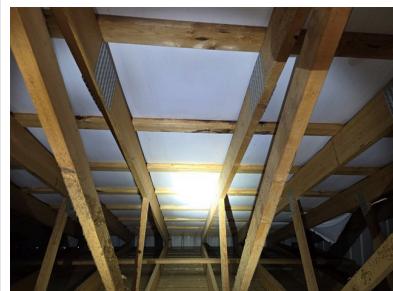
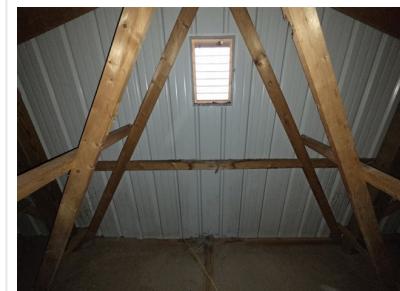
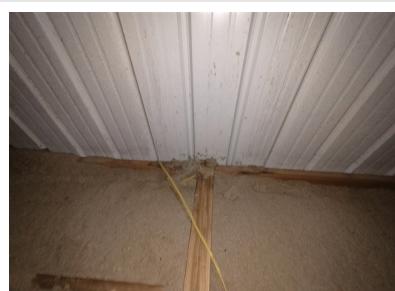
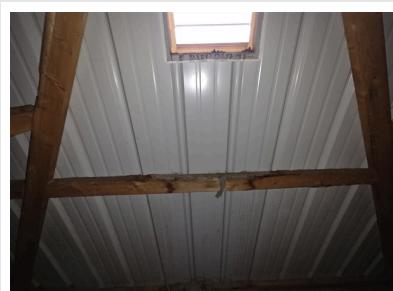
- Previous moisture stains present in attic space. (staining dry at the time of the inspection)

**Limitation:** (*I did not inspect or was only able to partially inspect or report on this item, area or component.*)  
*Further evaluation by a qualified contractor is recommended.*

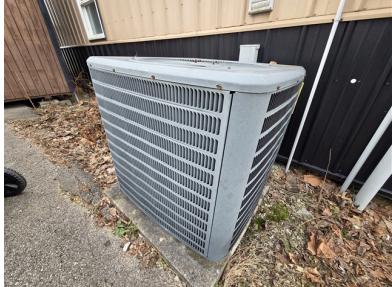
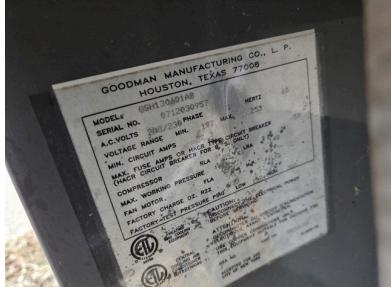
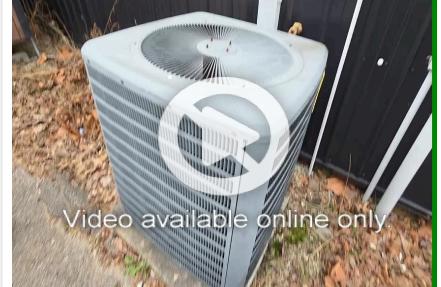
- The A/C was not tested due to the exterior temperature not being at least 65 degrees for 72 straight hours as required for testing. The unit was visually inspected only.

**Limitation:** ( I did not inspect or was only able to partially inspect or report on this item, area or component). Further evaluation by a qualified contractor is recommended.
