ROOF INSPECTION REPORT

1458 E 33rd Street, Oakland, CA 94602

INSPECTOR: Kyle J Reed

DATE OF INSPECTION: 9/29/2023

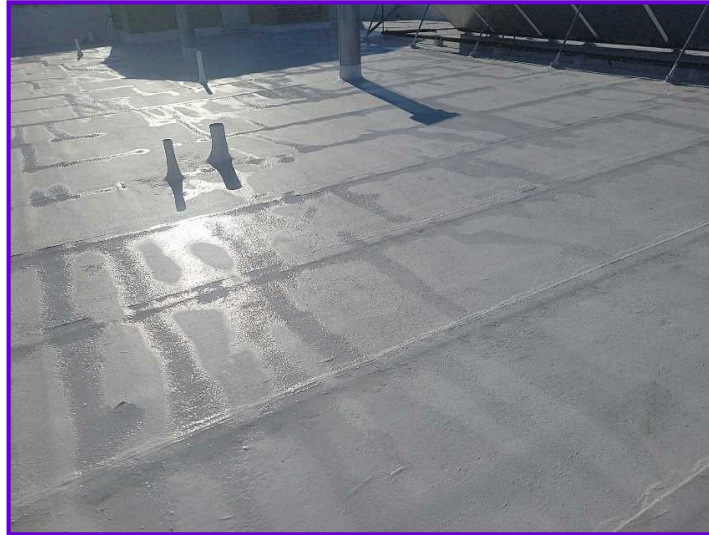
COMMENTS: The residence has what is commonly referred to as a 'flat' roof.

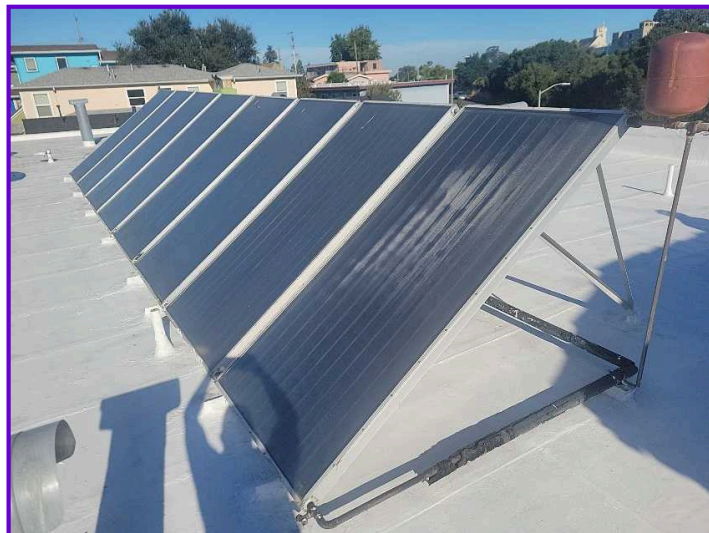
DEFERRED: The roof has hydronic panels which may limit areas of the roof that are visible for inspection.

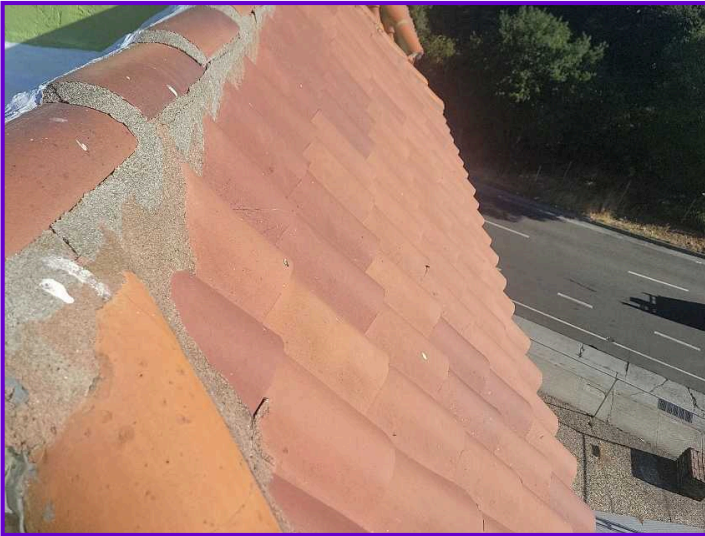
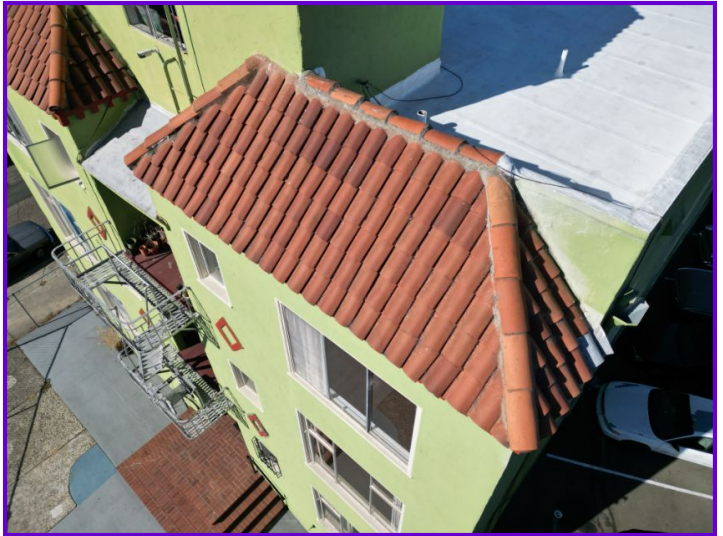
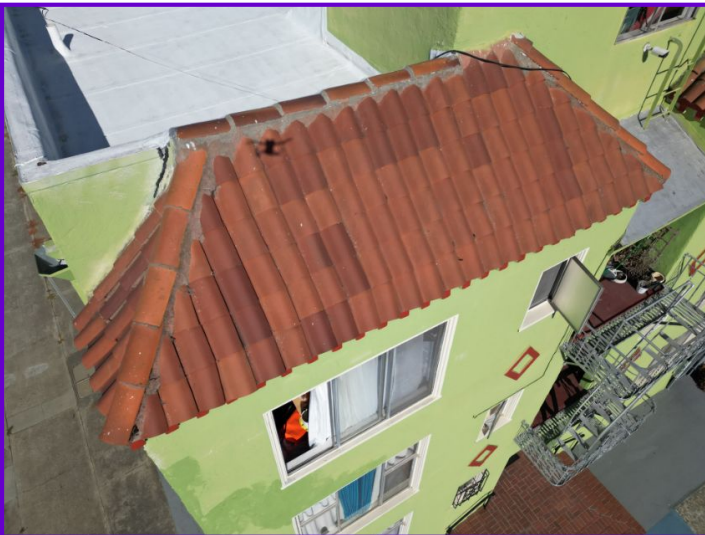
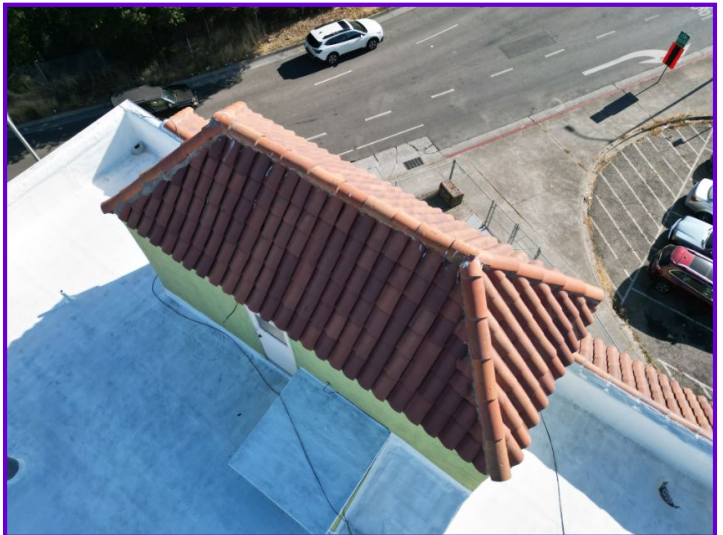
COMMENTS: The composite tile roofing material appears to be in satisfactory condition relative to its age.

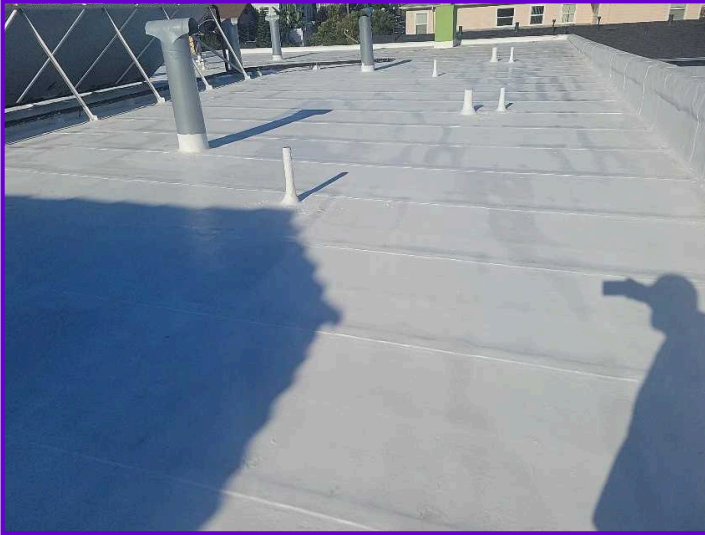
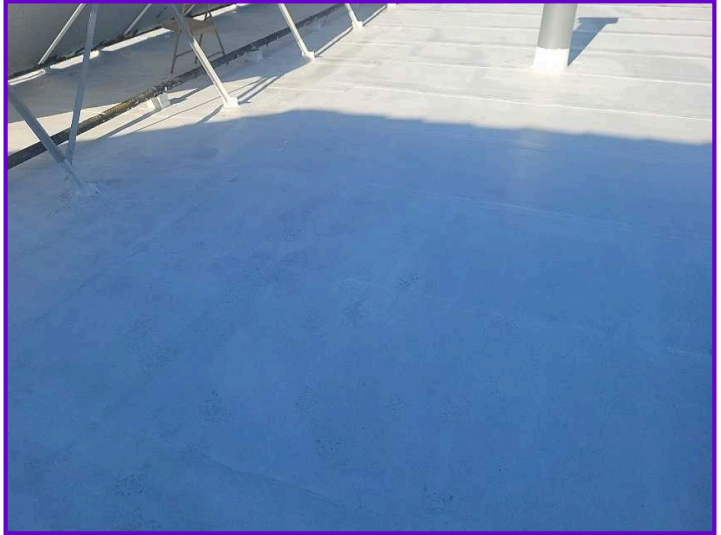
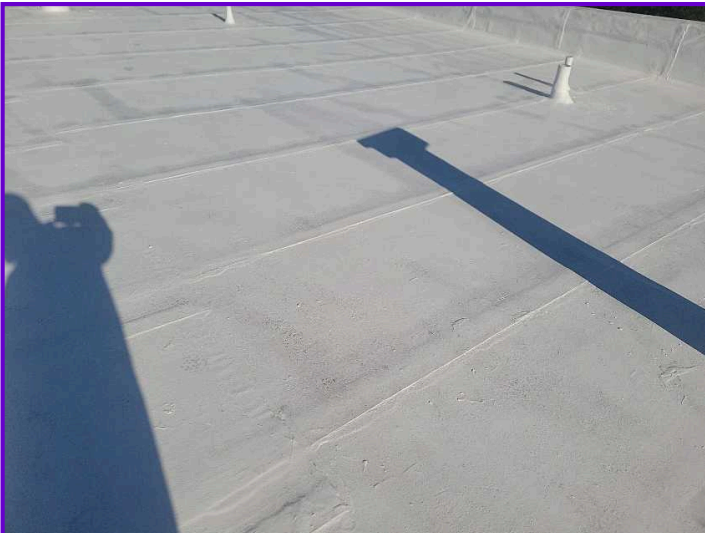
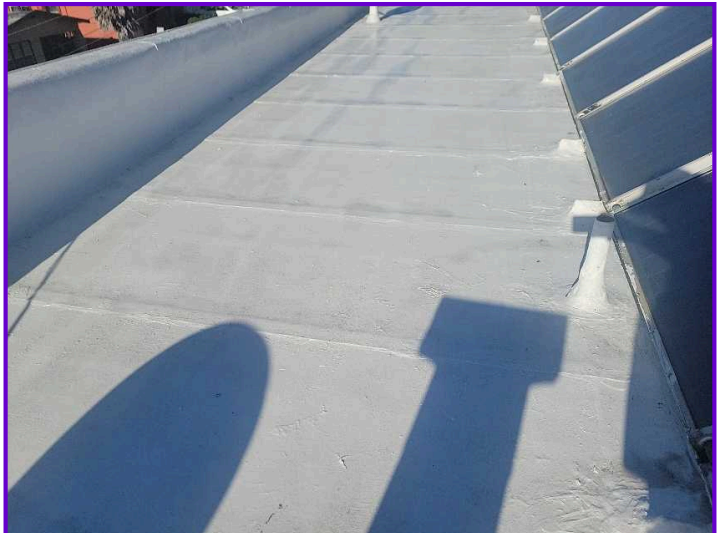
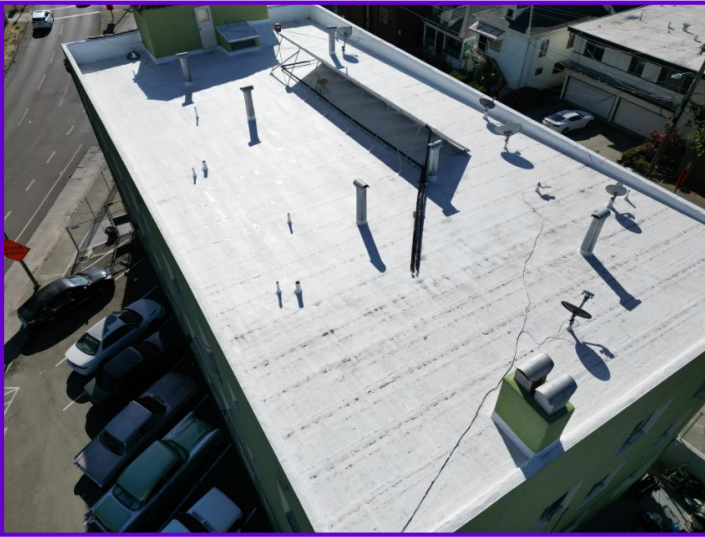
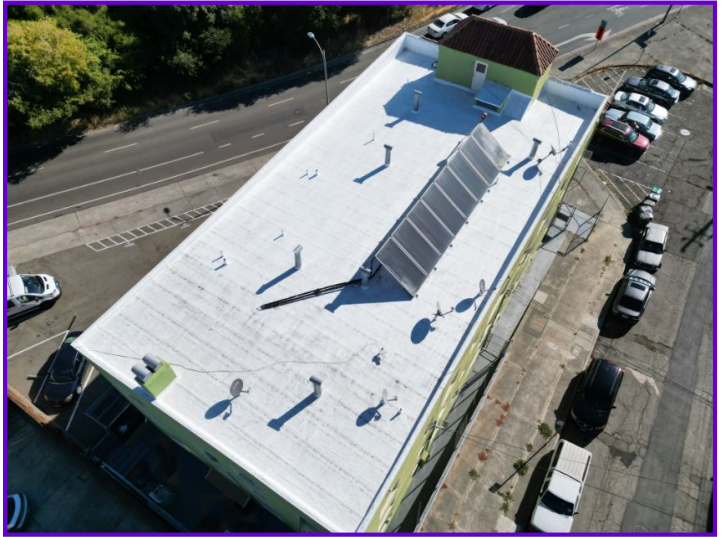
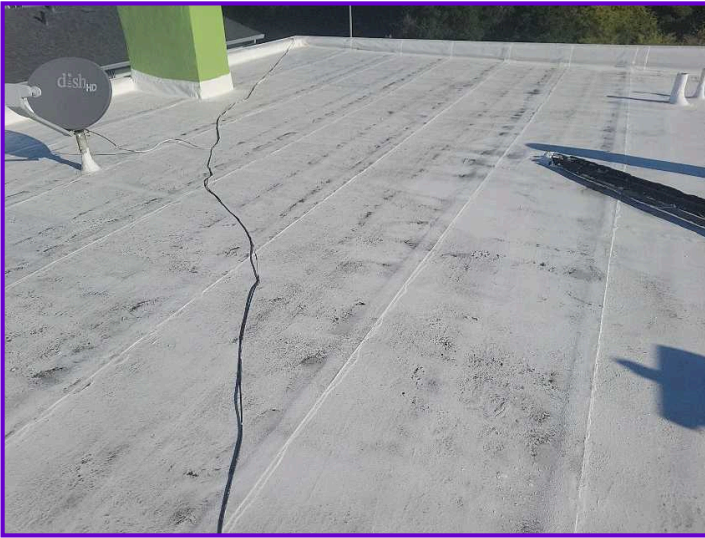
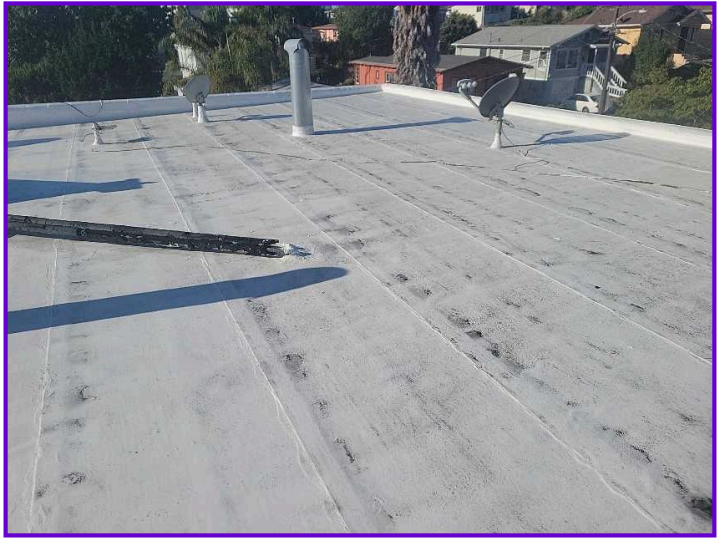
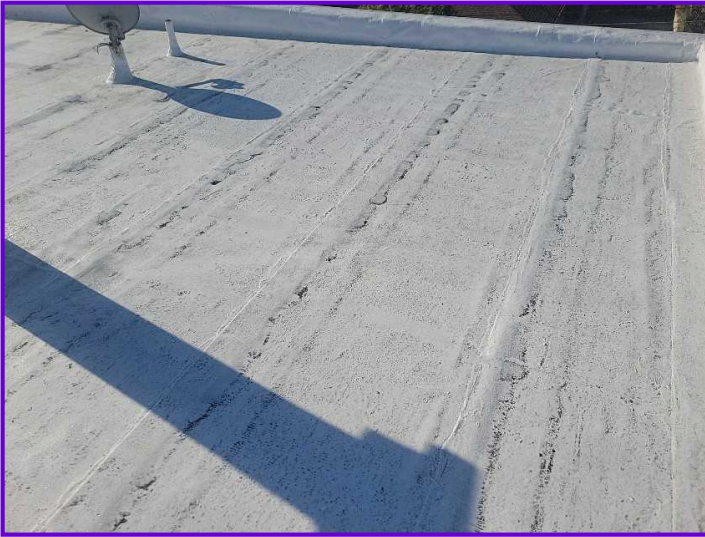
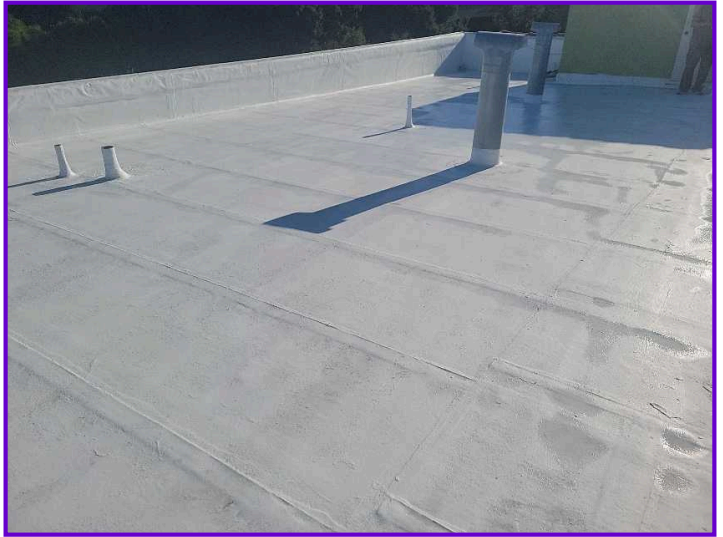
COMMENTS: The built-up roofing material appears to be in satisfactory condition relative to its age.

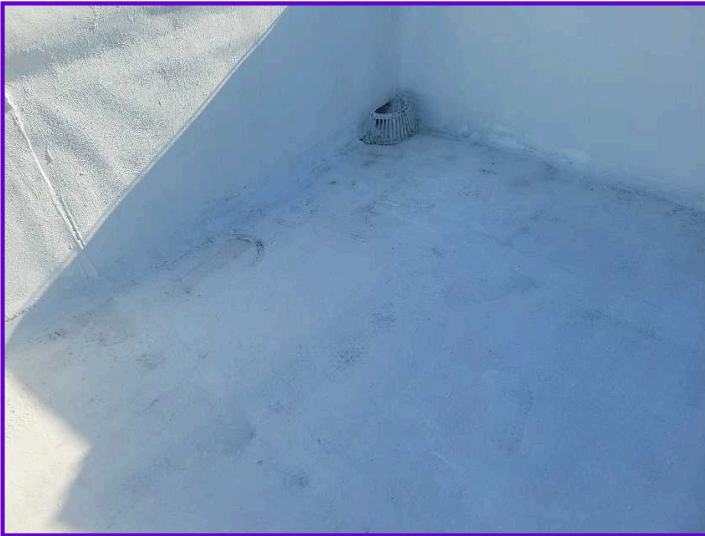
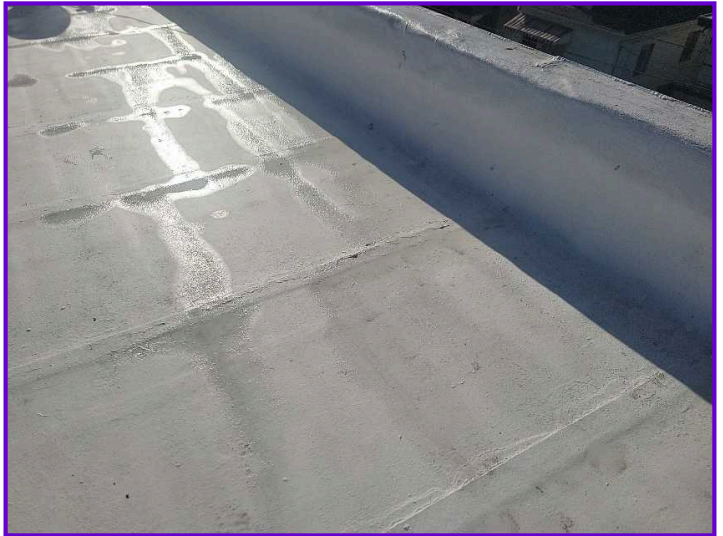
MONITOR: Water stains were noted in areas of the flat roof. This indicates water has pooled in the past and will likely continue to pool.

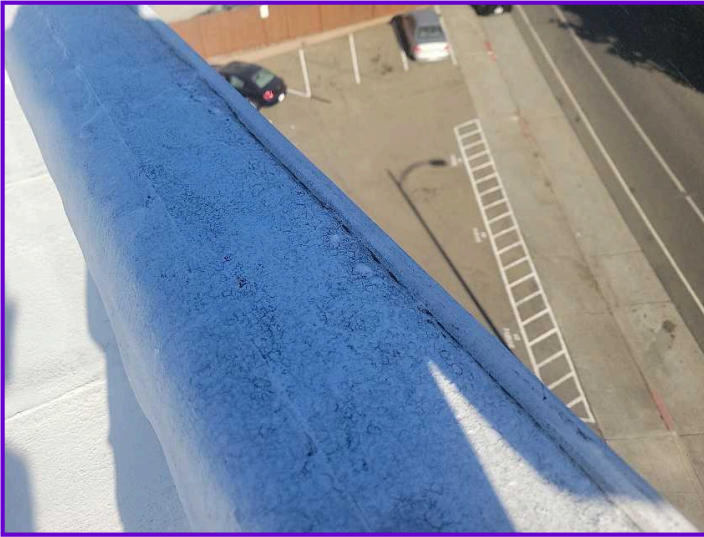
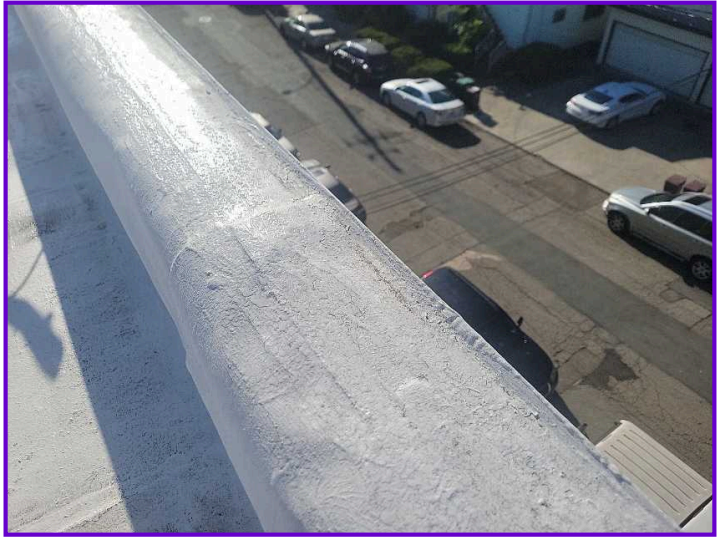
COMMENTS: The roof flashing, where visible, appears to be in satisfactory condition.

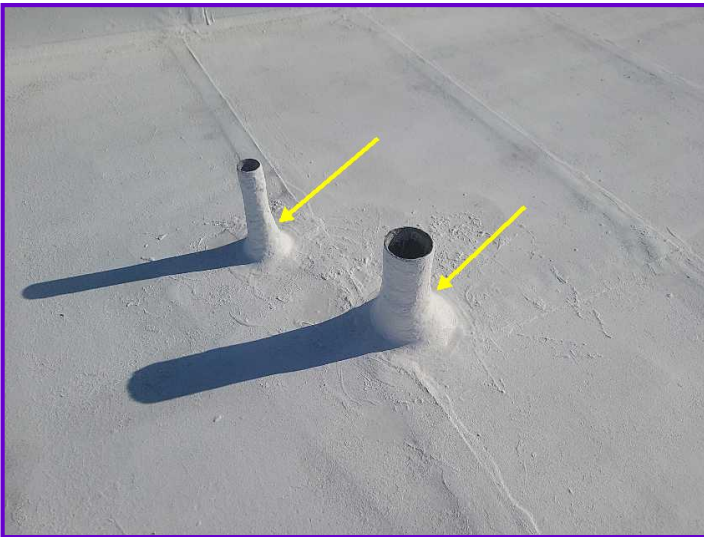
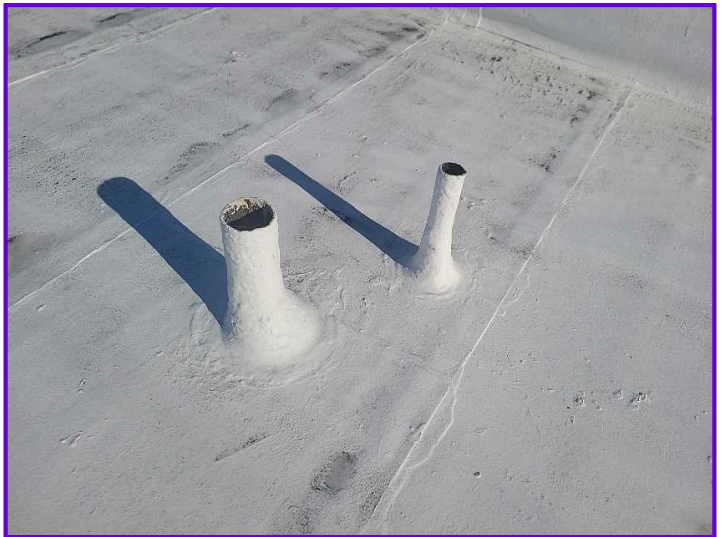
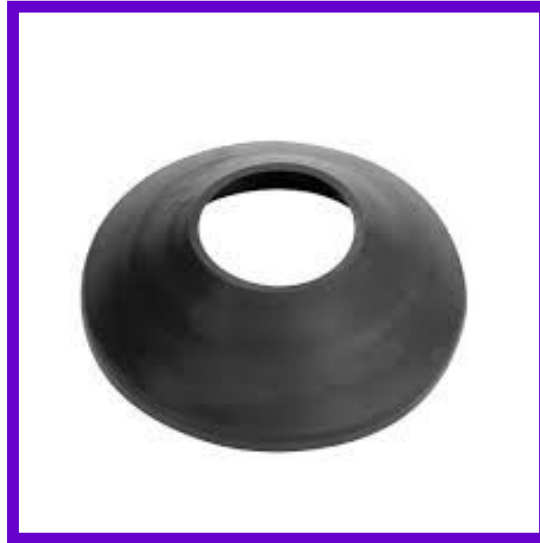
PREVENTIVE: The plumbing vent protrusions appeared to be properly flashed but lacked storm collars.

• **PREVENTIVE:** The plumbing vent protrusions appeared to be properly flashed but lacked storm collars. We recommend having storm collars installed for a better seal and to help prevent the possibility of leakage. These rubber gaskets are inexpensive and easy to install by sliding them down over the pipes.

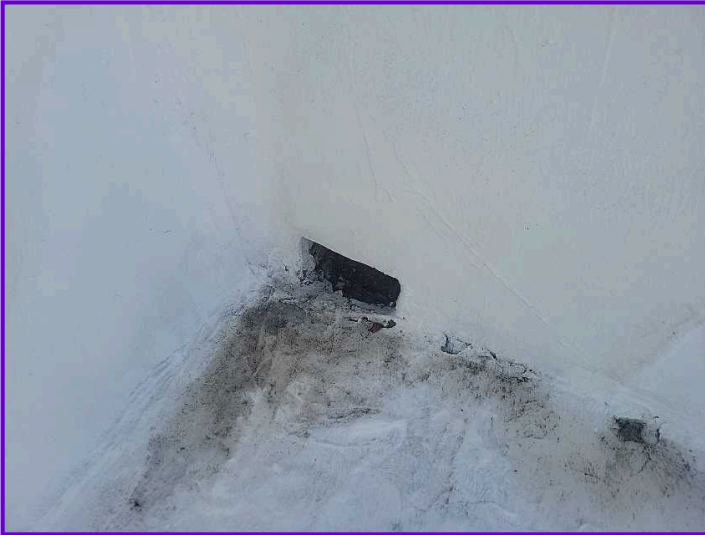
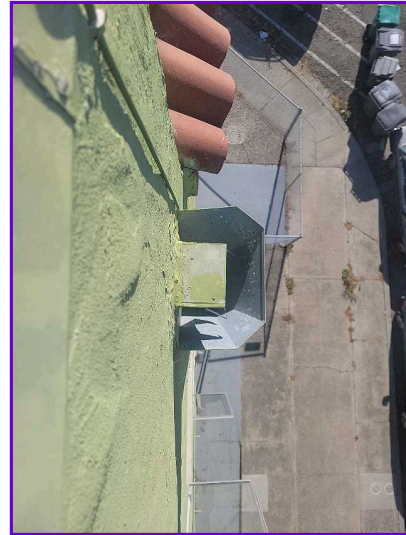
COMMENTS: The scuppers and downspouts appeared to be clear and in satisfactory condition.
