# **REAL ESTATE INSPECTION REPORT**

**Estate of Carol O'Brian**

119 S Adams St Glendale CA, 91205

DATE OF INSPECTION: 09/01/2026

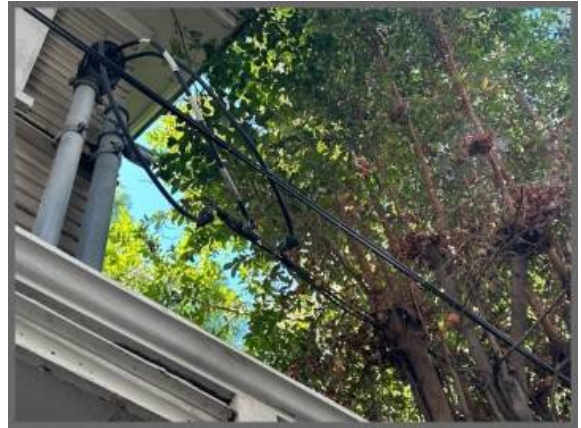
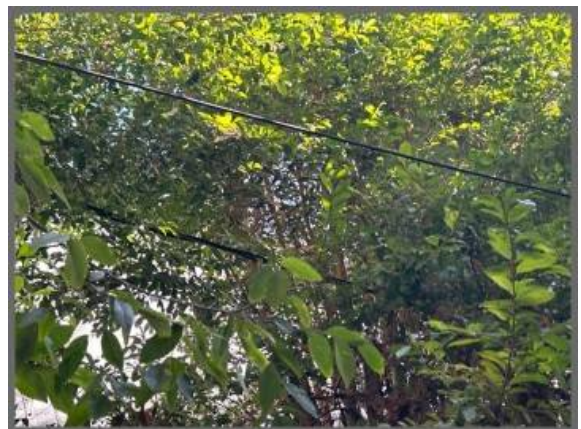
**NEEDS ATTENTION.** The main electrical line from the power pole to the building has some contact from tree branches and limbs and they may need to be trimmed back at times to keep them from putting pressure on the line

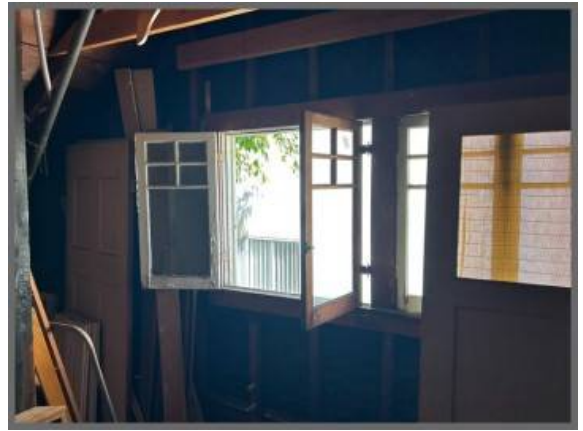
**NEEDS ATTENTION.** Although there is an openable window, there is no standard form of ventilation with a covered screen for air flow.

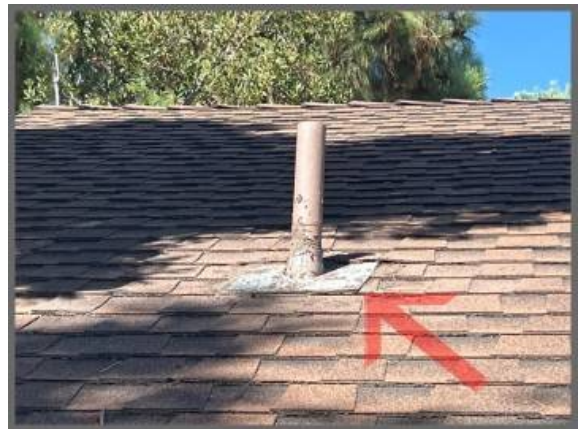
**NEEDS ATTENTION.** The flashing is not standard in areas and may not be reliable installations. The flashings will require regular maintenance to ensure that they remain leak free.

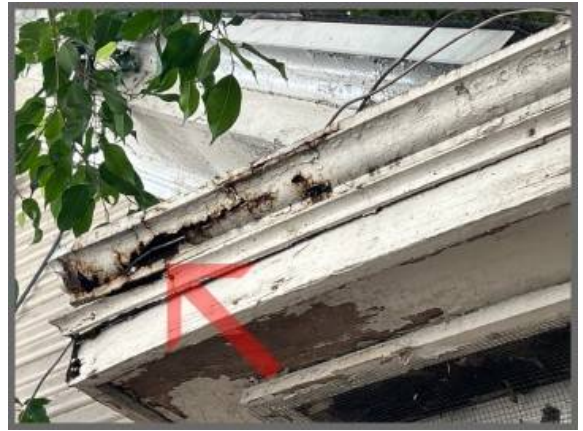
**NEEDS ATTENTION.** There are rusty areas in the gutter system.

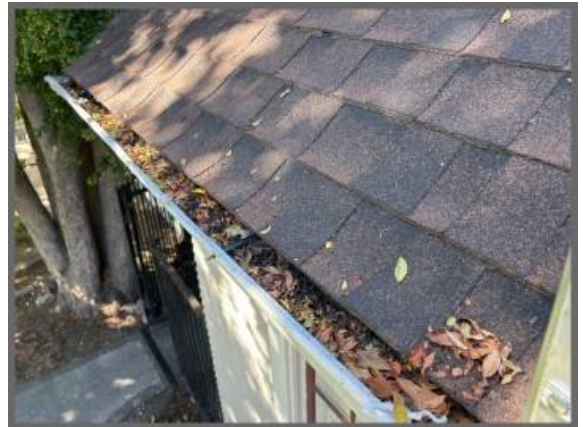
**NEEDS ATTENTION.** There are areas where the gutter system is filled with debris and needs to be cleaned out. This includes all accumulated roof debris on the roof itself.

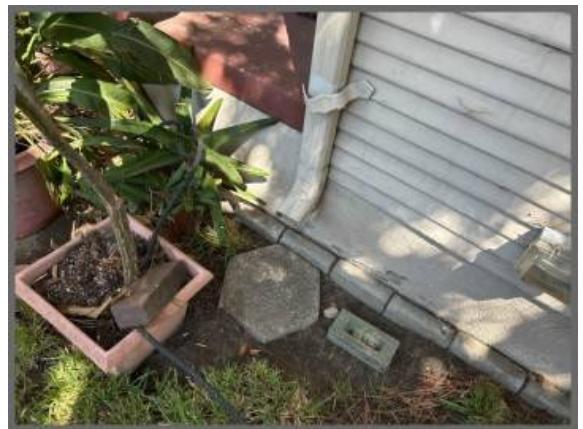
**NEEDS ATTENTION.** The downspouts do not route the water away from the building but instead deposit it next to the structure which commonly causes problems to the foundation over time. These should be extended away from the building.

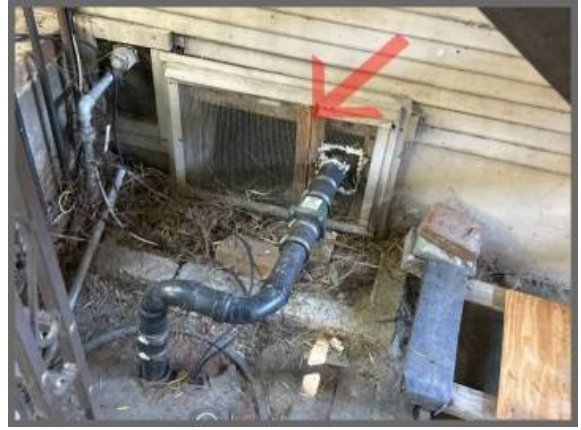
**NOT ACCEPTABLE.** There is a crawl space access at the back of the building, The under house crawl space access is difficult and smaller than current standards that require an opening of 24 x 18 inches minimum. As a result the crawl space could only be viewed from the basement in a limited capacity.

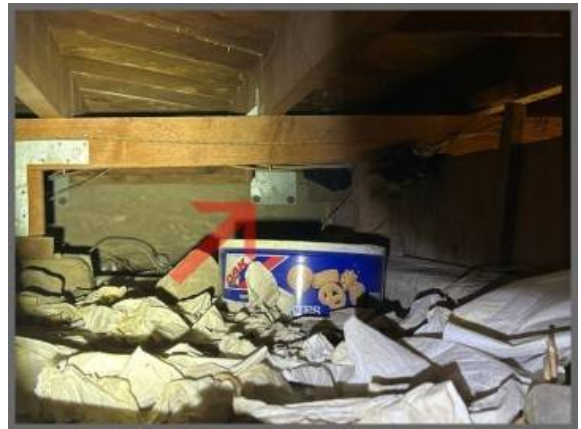
**NEEDS ATTENTION.** The seismic retrofitting of anchor bolts does not appear to meet current established standards. This should be evaluated by a foundation specialist to determine what additional work may be required.

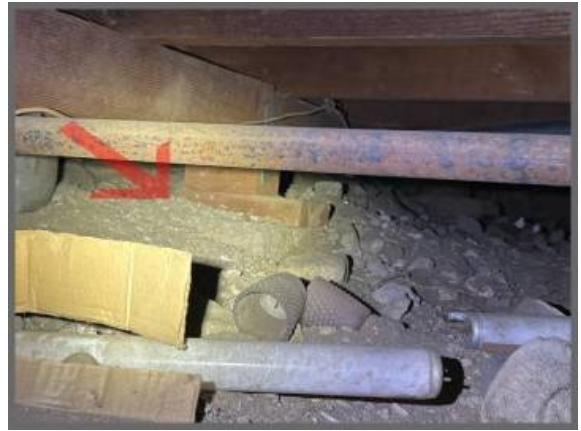
**NEEDS ATTENTION.** There is earth-to-wood contact observed on some of the posts. This can lead to moisture damage or termite spread. See structural pest control operator's report for more information.

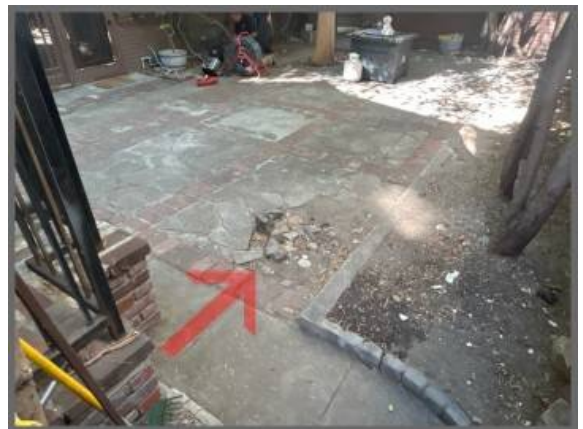
**SAFETY ALERT.** There are raised and shifted areas of the walkways that are a trip hazard, such as at the front sidewalk area.

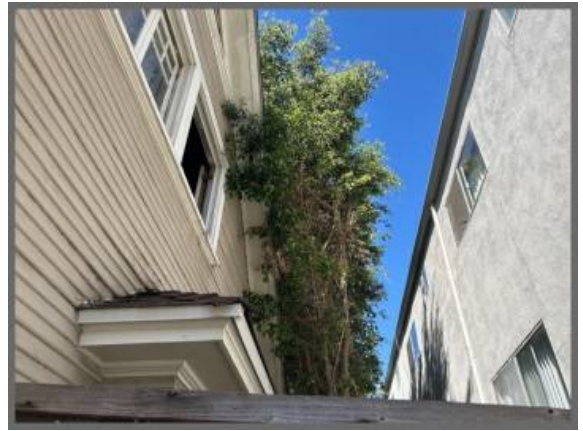
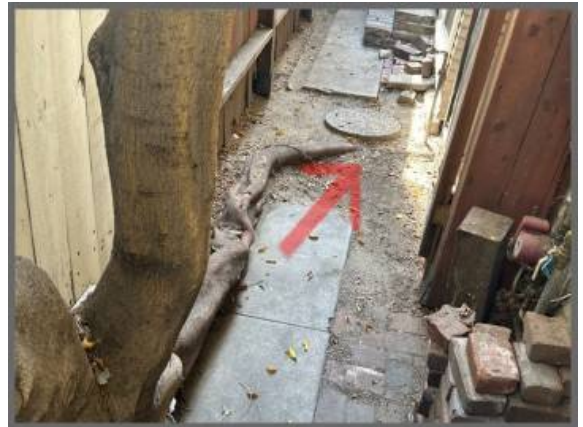
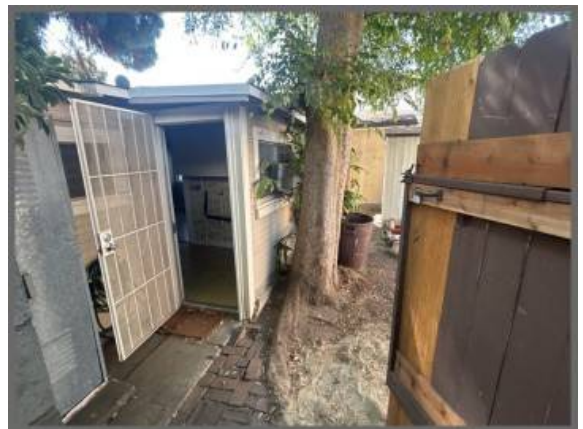
**NEEDS ATTENTION.** There are trees planted close to the structure. Tree roots systems may interfere with the foundation and plumbing systems over time as they continue to grow. Branches may rub or interfere with the roof or structure and should be trimmed.

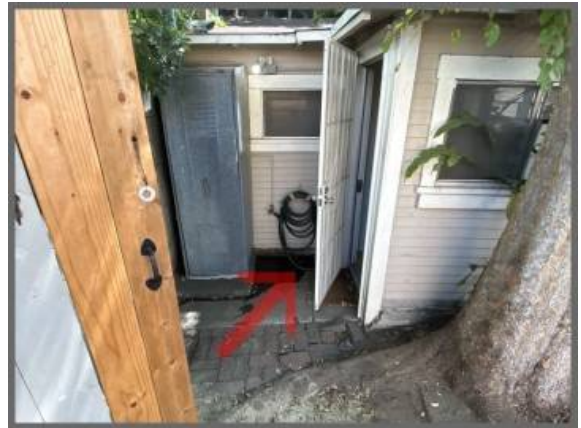
**NEEDS ATTENTION.** The landscaping slopes toward the structural foundation of unit 191 1/2 due to the tree roots pushing up the concrete. This can cause over-saturation of the soil at the structural footings which is the chief cause of foundation settlement. Slope should fall away from the foundation at a minimum of 1/4 inch per foot and extend 10 feet away from the foundation.

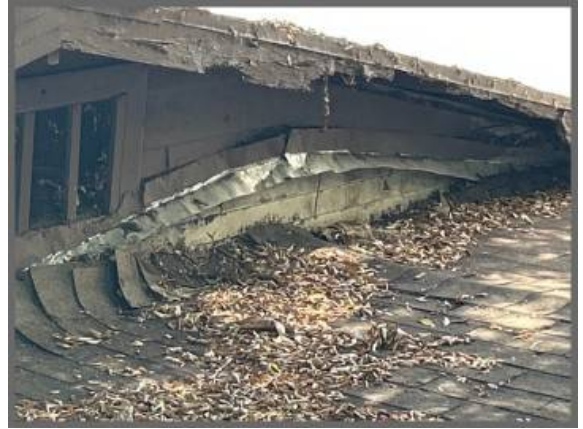
**NOT ACCEPTABLE.** The portion of the roof where the rear shed connects to the garage is compromised and water may enter through this area. It is advised a roofing specialist further evaluate this condition.

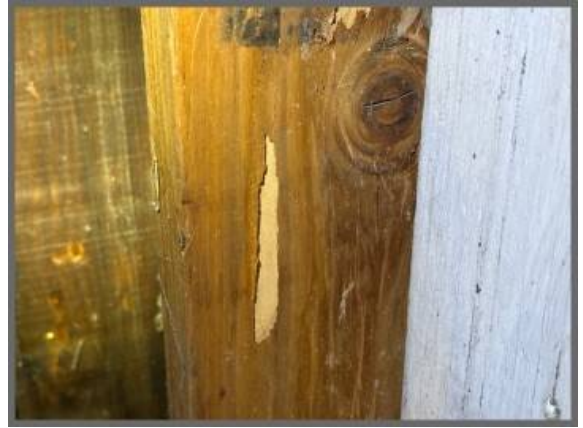
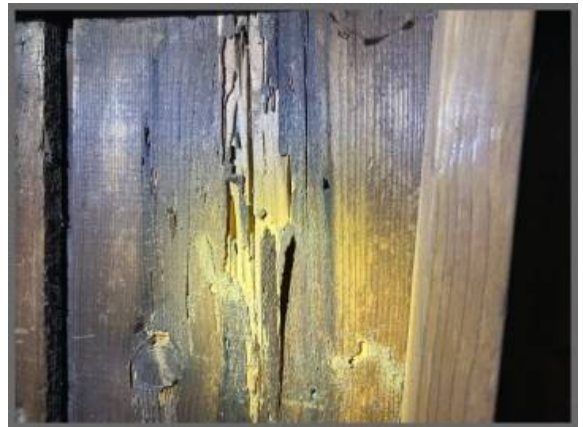
**NEEDS ATTENTION.** The garage framing has areas of deterioration such as to the framing and siding

It is advised to consult with a qualified specialist for more information and further evaluation.

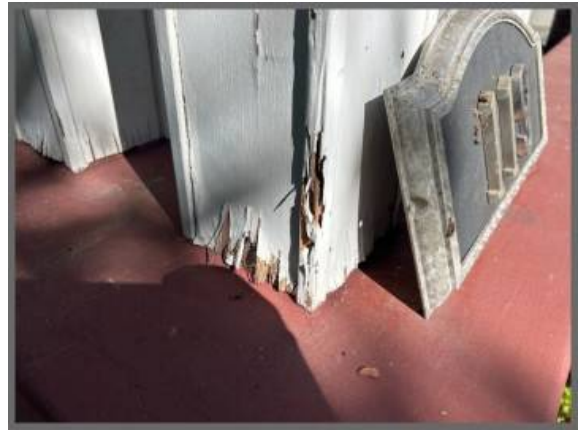
**NEEDS ATTENTION.** There is damaged wood such as for the front porch roofing support.

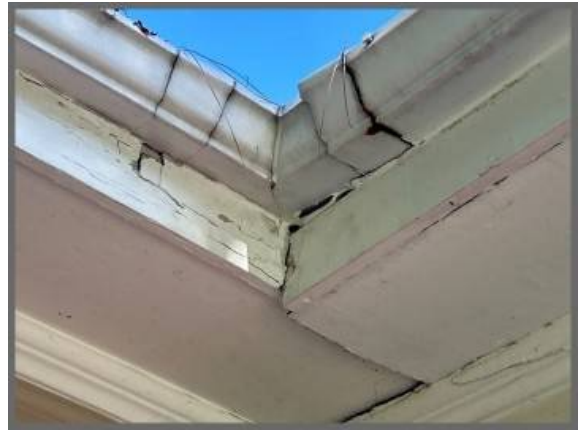
**NEEDS ATTENTION.** The trim is deteriorated in areas such as at the front near the main entry way.

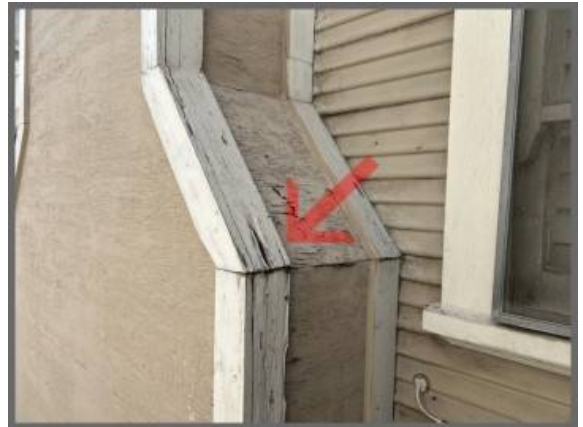
The trim is deteriorated in areas such as at the chimney chase.

It is advised that this system be further evaluated by a qualified specialist.

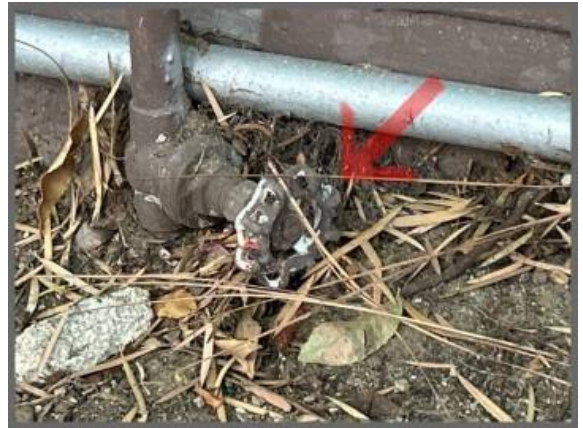
**NEEDS ATTENTION.** A gate valve was observed at the time of inspection. Gate valves are considered less reliable and should be periodically operated to ensure function. It is advised to have a qualified plumber operate this valve to determine its true condition.

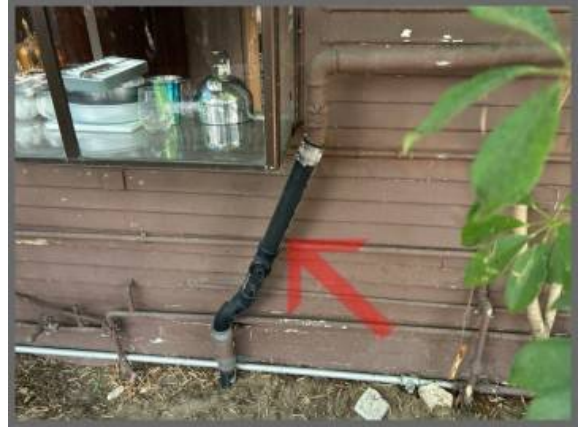
**NOT ACCEPTABLE.** There are areas of open exterior waste lines. This should be capped in order to prevent rodent intrusion into the waste line system.

There are areas of exposed plastic abs waste lines at the right side of the building. These sections of waste lines can become more easily damaged, and should be comprised of cast iron.

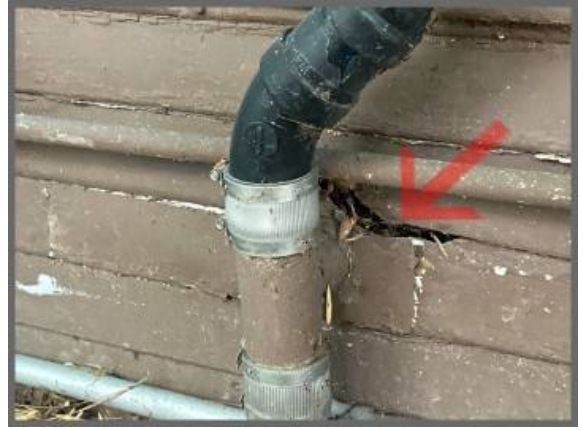
**NEEDS ATTENTION.** There are areas of gaps in the siding where rodents can enter.

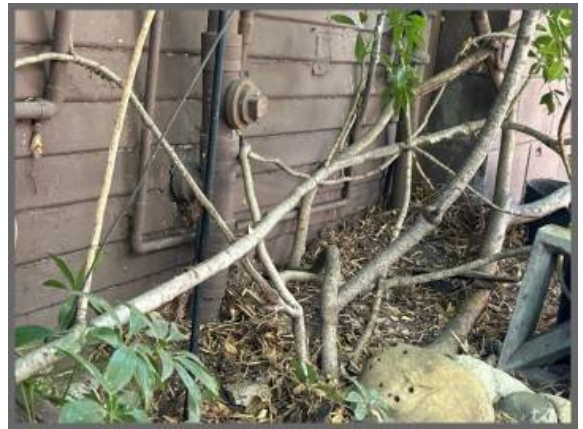
The earth against the side of the house is higher than it should be, and can transfer moisture to the wall, which can cause damage, deterioration, and can lead to mold or other problems. The earth should be 4 - 6 inches below the level of the house siding or stucco.

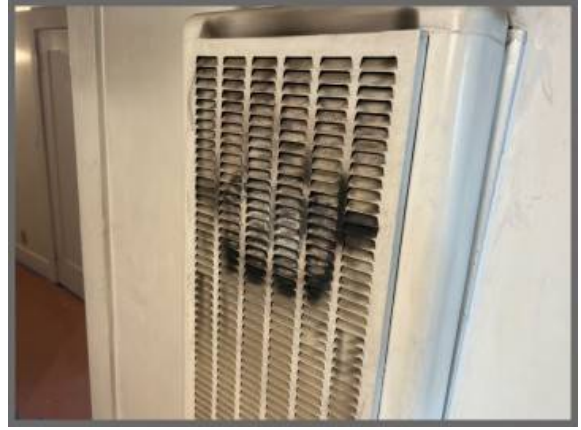
**NEEDS ATTENTION.** Although operable, furnace is very old, and appears to be very dirty as the front cover is discolored with ash.
