# WOOD DESTROYING PESTS AND ORGANISMS INSPECTION REPORT

BUILDING NO. <b>6310</b>	STREET, CITY, STATE, ZIP <b>THORNTON AVENUE, NEWARK CA 94560</b>	Date of Inspection <b>6/17/2024</b>	No. of Pages <b>9</b>
<b>TERMWRIGHT STRUCTURAL PEST CONTROL</b> <b>40797 Blacow Road, Fremont, CA 94538</b> <b>Ph: (510) 651-3702 Fax: (510) 490-6370</b> <b>Email: termwright@gmail.com</b> <b>www.termwrightstructuralpestcontrol.com</b>			
Firm Registration No. <b>PR 5130</b>	Report No. <b>6780</b>	Escrow No.	
Ordered By: COLDWELL BANKER 3440 WALNUT AVENUE #110 FREMONT, CA 94538 Attn: EVERETT ESLINGER 794-1300	Property Owner/Party of Interest GARY & COLEEN DONGES 6310 THORNTON AVENUE NEWARK, CA 94560	Report Sent To:	
COMPLETE REPORT <input checked="" type="checkbox"/> LIMITED REPORT <input type="checkbox"/> SUPPLEMENTAL REPORT <input type="checkbox"/> REINSPECTION REPORT <input type="checkbox"/>			
General Description: 1 story, single family dwelling with stucco siding, composition roof, vacant		Inspection Tag Posted: in subarea

6780

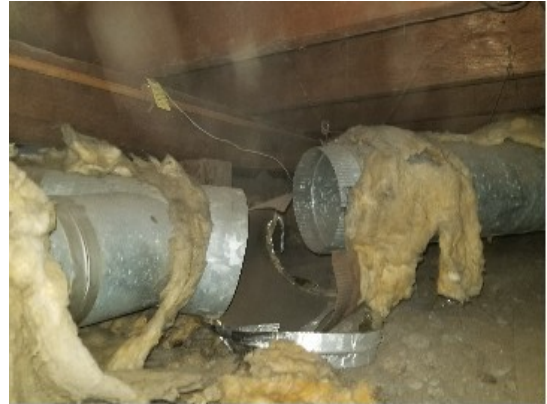
ITEM 1D The heat duct was noted to be disconnected.

RECOMMENDATION Owner to contact a properly licensed tradesperson for needed repairs.

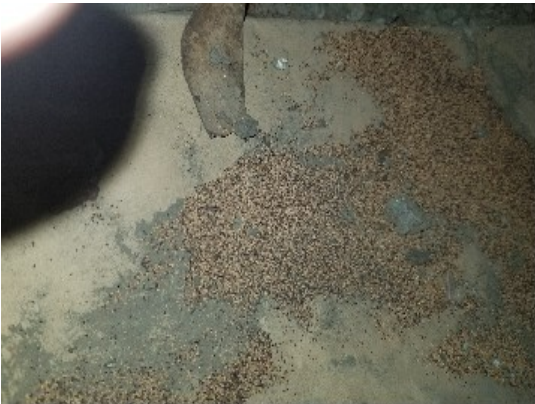
ITEM 1A Evidence of drywood termites was noted in the subarea, with evidence extending above floor line.

RECOMMENDATION Fumigate the entire structure. We will have the gas shut off prior to fumigation, however, it will be the owners responsibility to contact PG&E to have gas turned back on after fumigation process has been completed. We assume no liability for any damage to the roof covering, solar panels, tv antenna or plants adjacent to the structure. NOTE-When authorized, we will send a fumigation packet for you to read and sign. NOTE-The price quoted here is for fumigation only. Any prep work is the responsibility of the owner. NOTE-There is an additional charge for the NYLOFUME bags for food.

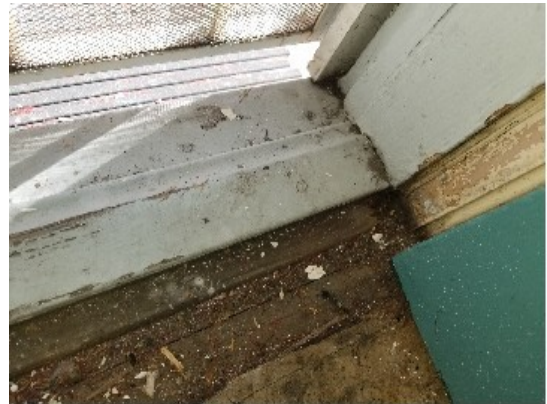
ITEM 10D Drywood termite and fungus damage noted to the threshold at side door. See item 1A.

RECOMMENDATION Remove the damaged wood. If no further damaged is exposed, replace with new material. Note-if damage is found to extend into inaccessible areas, a supplemental report will be issued with additional findings and costs.

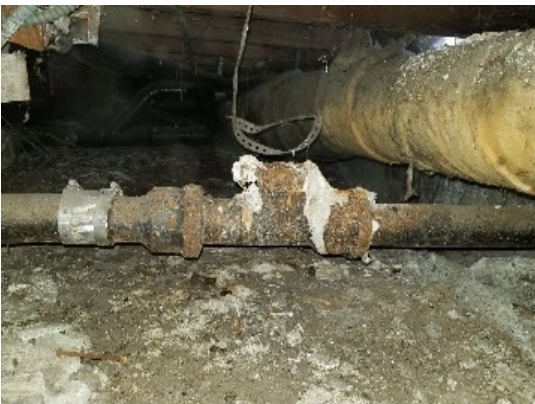
ITEM 1C A plumbing leak was noted at soil line.

RECOMMENDATION Others to contact a licensed plumber for repairs.

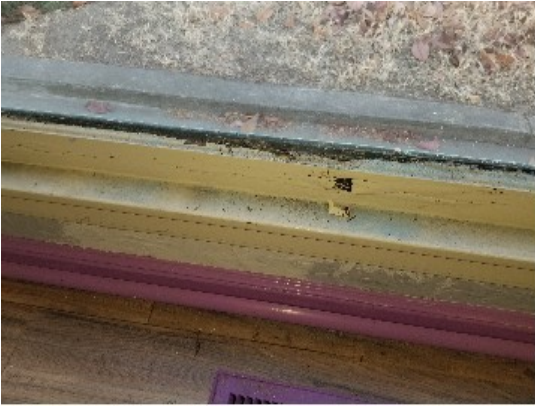
ITEM 10F Fungus has damaged the trim at the window.

RECOMMENDATION Remove the damaged wood. If no further damage is exposed, repair/replace with new material. No painting is included in this bid. Note-if damage is found to extend into inaccessible areas, a supplemental report will be issued with additional findings and costs.

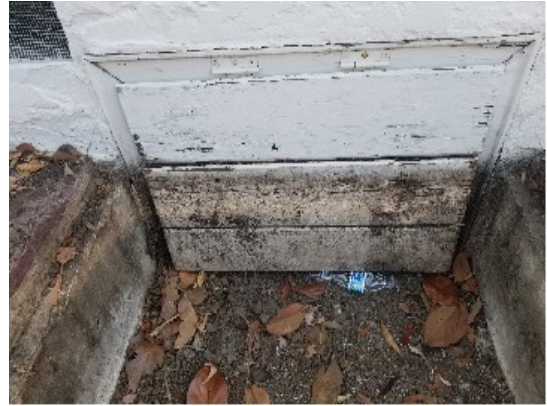
ITEM 11E Fungus has damaged the subarea access cover.

RECOMMENDATION Remove the damaged wood. If no further damage is exposed, repair/replace with new material. No painting is included in this bid. Note-if damage is found to extend into inaccessible areas, a supplemental report will be issued with additional findings and costs.

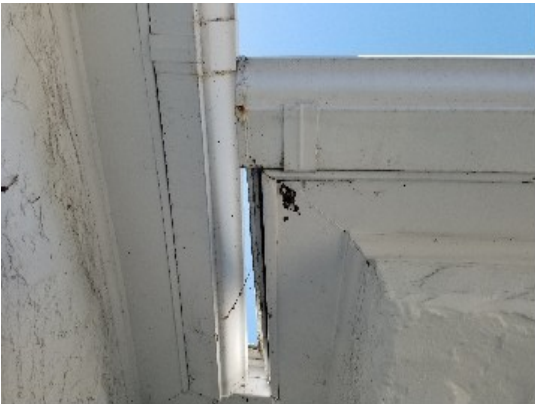
ITEM 11C Fungus has damaged the soffitng.

RECOMMENDATION Remove the damaged wood. If no further damage is exposed, repair/replace with new material. No painting is included in this bid. Note-if damage is found to extend into inaccessible areas, a supplemental report will be issued with additional findings and costs.

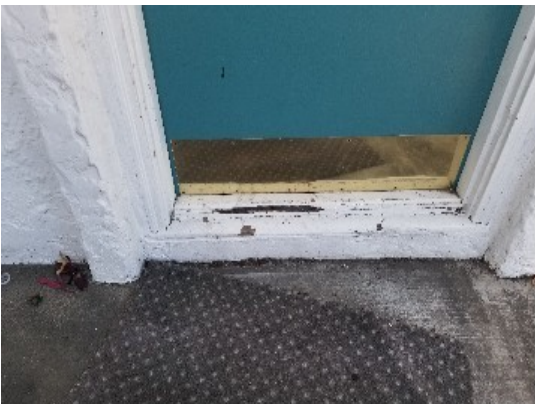
ITEM 11D Fungus has damaged the threshold.

RECOMMENDATION Remove the damaged wood. If no further damage is exposed, repair/replace with new material. No painting is included in this bid. Note-if damage is found to extend into inaccessible areas, a supplemental report will be issued with additional findings and costs.
