# *Inspection Reveal, LLC*

## Property Inspection Report

115 Tanglewood , Huntsville , Texas 77320

Date of Inspection: 5/21/2024 Time: 9:30am

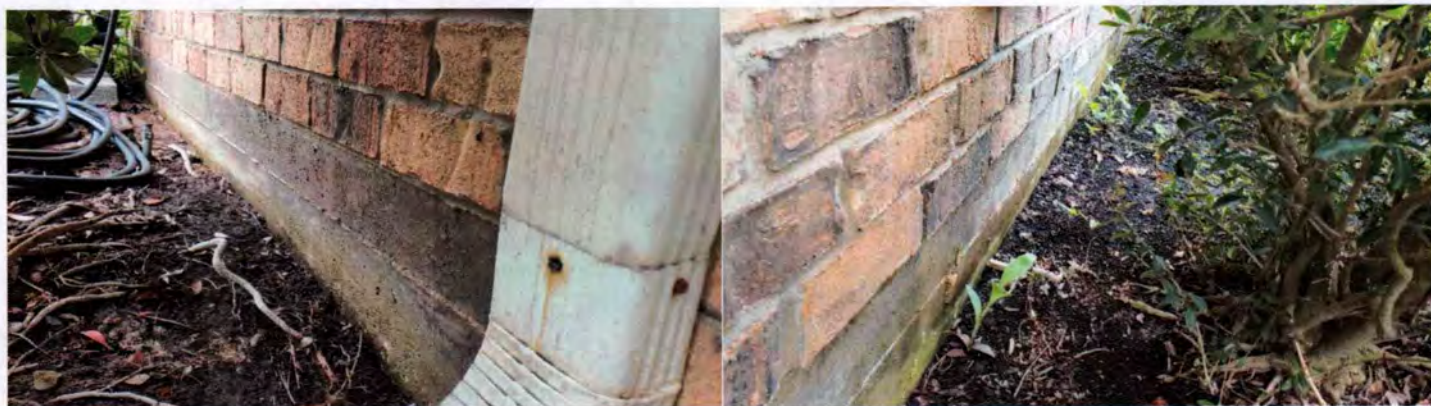
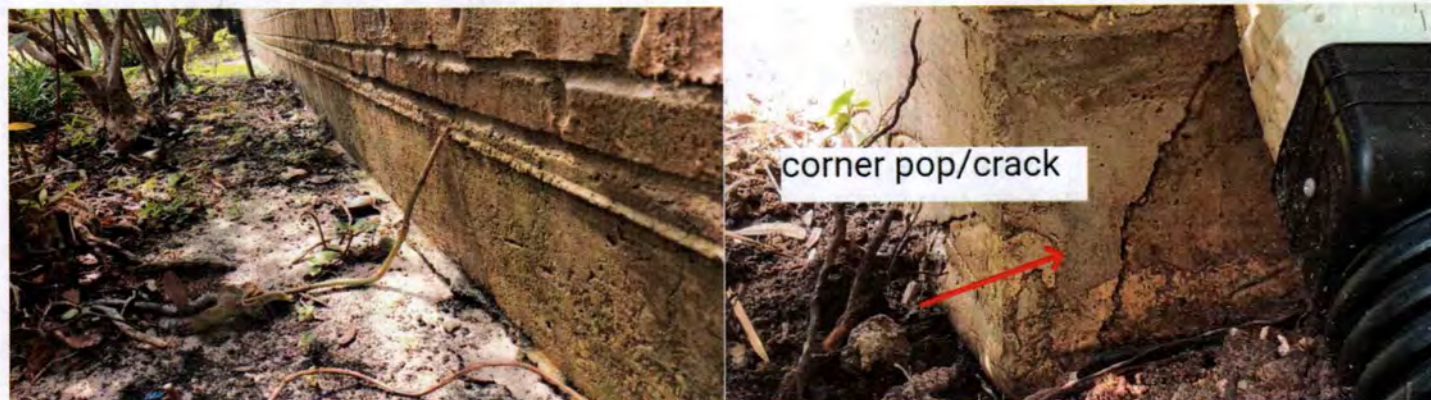
- Foundation appeared to be performing as intended at the time of the inspection.
- Corner pop/crack noted on one or more corners of the foundation. Corner pops did not appear to be affecting performance of foundation at the time of the inspection. Consideration may be given to having repaired when time and budget permits.
- Slab not visible due to floor coverings.

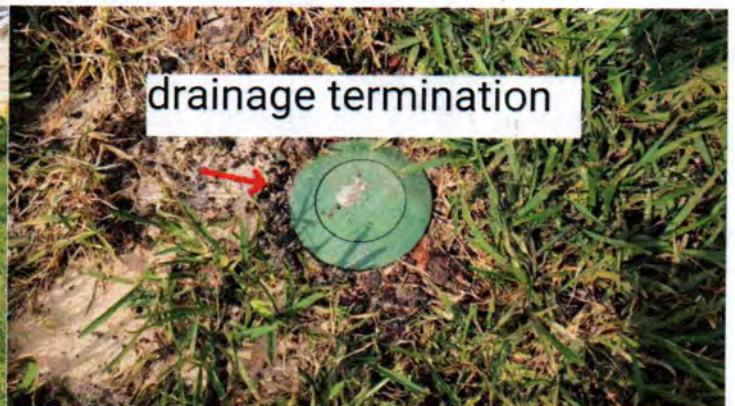
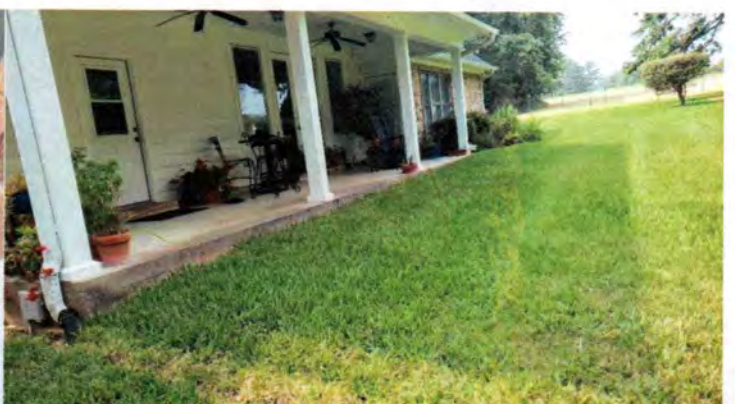
- Grading appeared to be performing as intended at the time of the inspection.
- A varmint hole was observed on the north side of the structure. Consideration should be given to having the varmint removed and backfilling the hole.
- High soil was observed around the structure in one or more locations. It is recommended that {4"} of foundation be visible below the bottom course of bricks. Grading improvements should be considered.

Varmint has been removed & hole has been filled

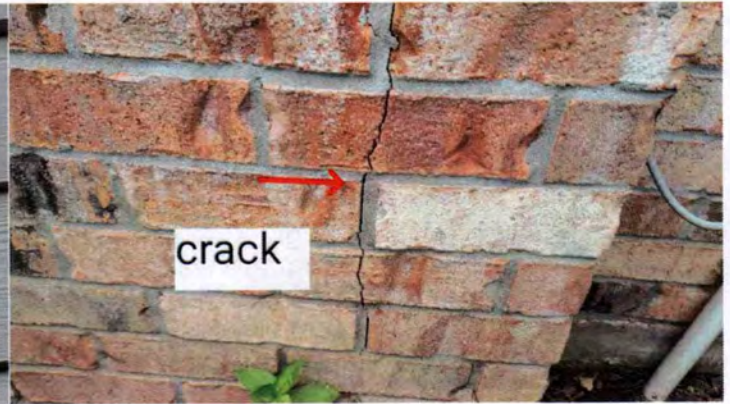
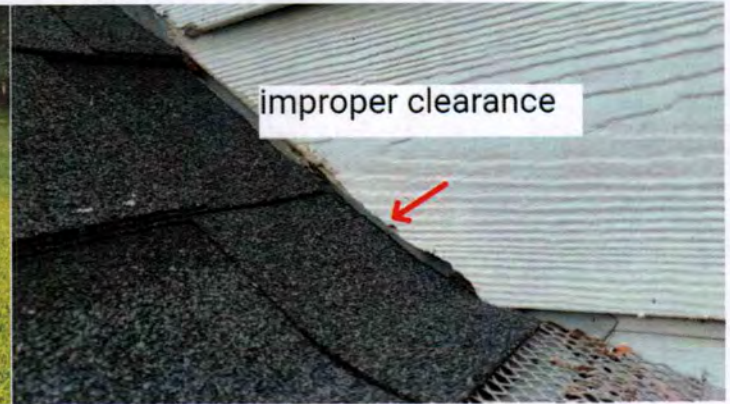
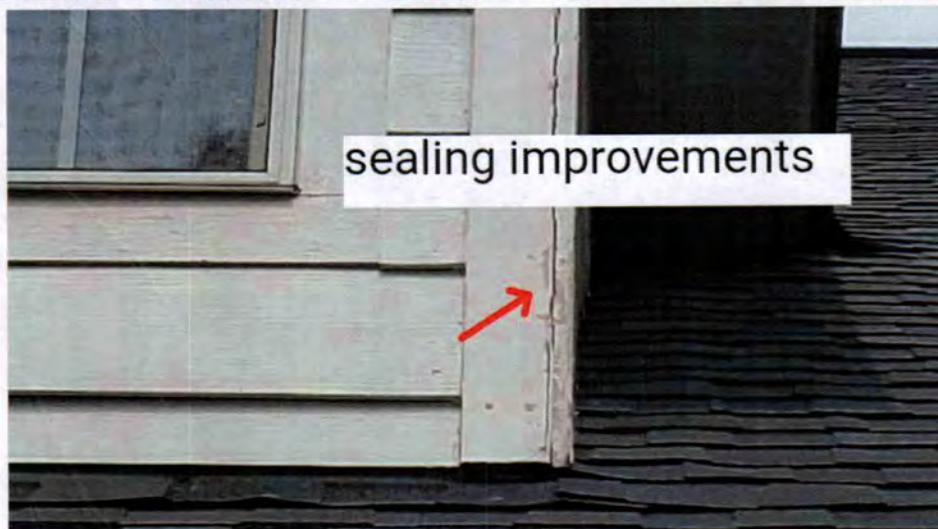
- A minor crack was observed in the brick veneer on the south side of the structure. The crack did not appear to be affecting the performance of the wall at the time of the inspection. Future monitoring is recommended. Consideration should be given to having crack sealed.

- Minor damage was observed on the fiber cement board {hardiboard} in one or more locations. The damage did not appear to be affecting the performance of the wall at the time of the inspection.

- Sealing improvements are recommended where fiber cement trim boards and brick veneer meet.
- Consideration should be given to painting steel lintels above exterior doors and windows to prohibit corrosion.

- The sidewall veneer/cladding was observed with improper spacing from the roofing material in some locations. Under current building standards, a minimum of {2"} clearance is required between the roofing material and the exterior cladding. The spacing did not appear to be affecting the performance of the walls at the time of the inspection. Consideration may be given to having corrected if work is performed in these areas in the future.

Lintels have been painted

Has been painted

Sealed

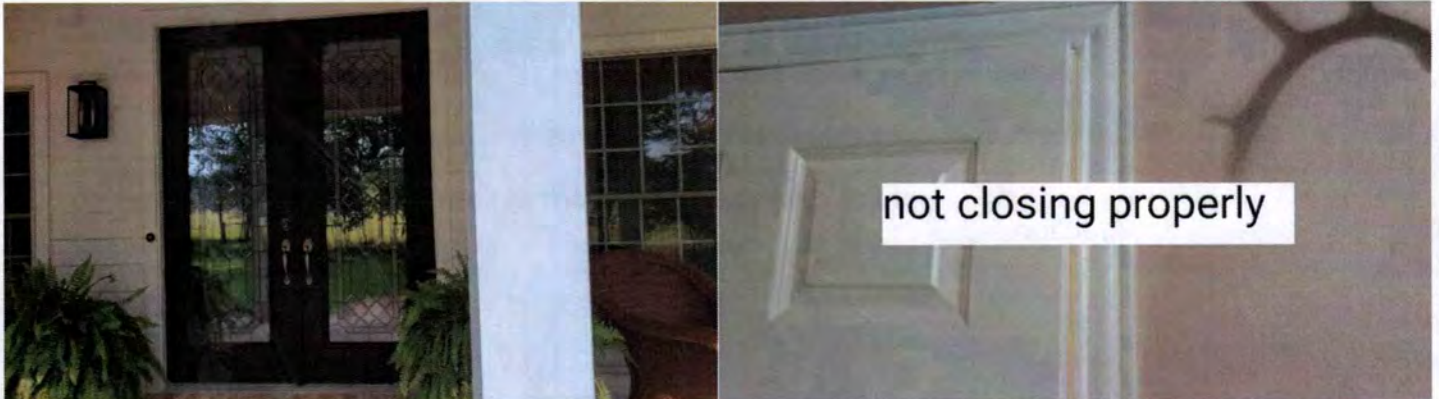
- All doors were functional at the time of the inspection.
- Upstairs bedroom door noted as not closing properly. Appeared that the top hinge was loose and tightening is recommended.

Hinge has been repaired

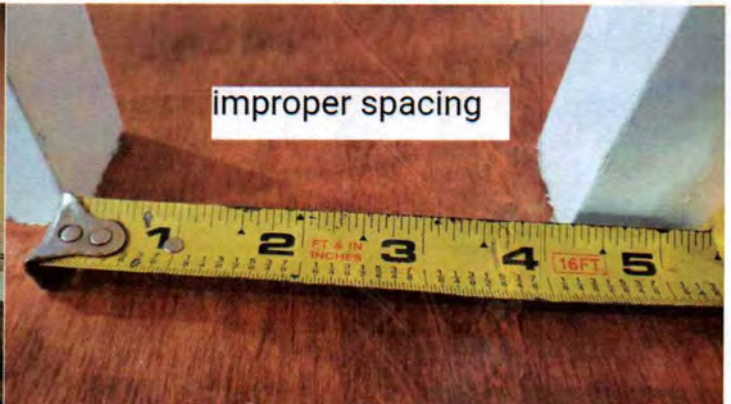
- The stairway and/or landing spindles were observed to be spaced in excess of {4"} apart which is the current standard practice. This may be considered an "As Built" condition when the home was built, however current codes require noting this condition as a deficiency for safety concerns. You may consider corrective measures.

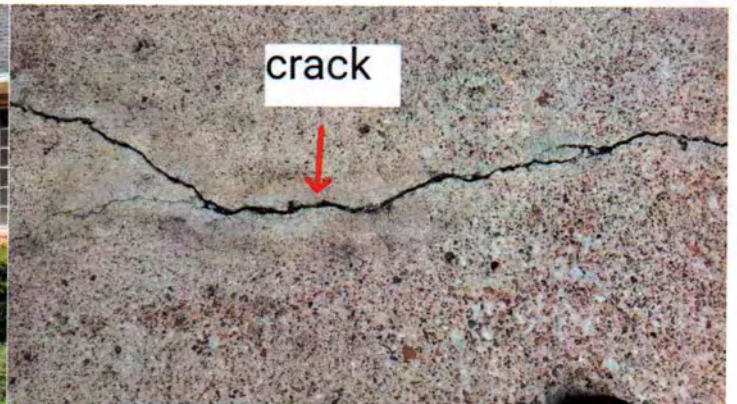
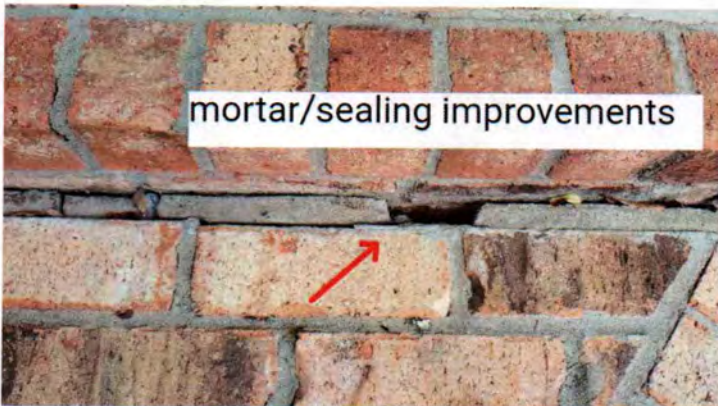
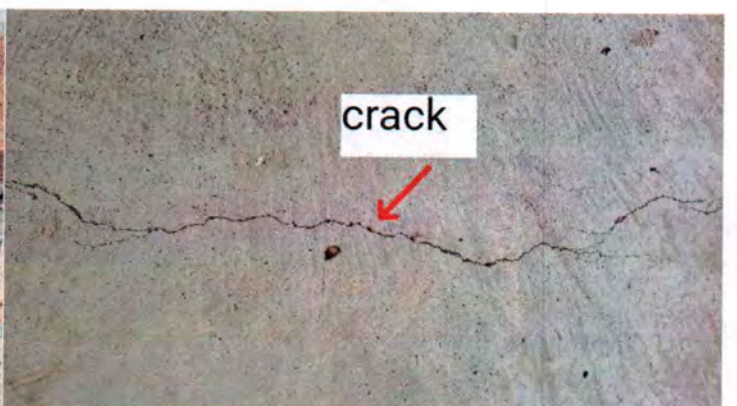
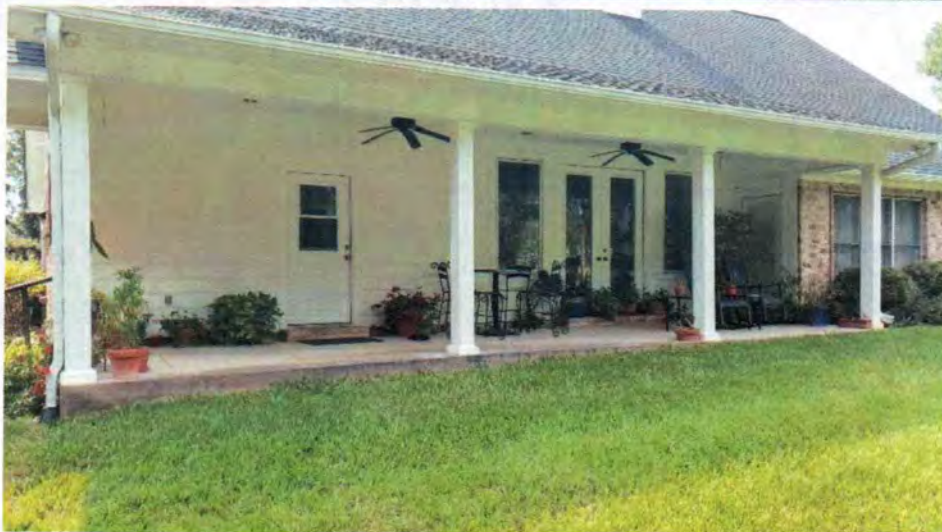
- There was an attached front and rear porch on the residence at the time of the inspection.
- Cracks noted in porches and sidewalk. The cracks appear to be normal shrinkage cracks for a structure this age.
- Gravel driveway noted.
- Concrete sidewalk noted.
- Sealing/mortar improvements should be considered where the front steps meet the front porch, to prevent water intrusion.

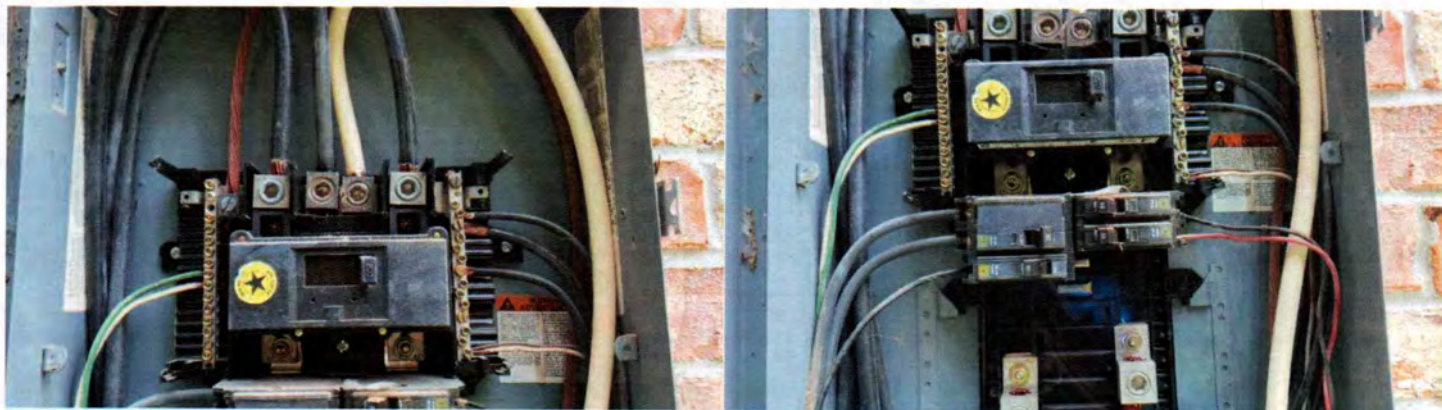
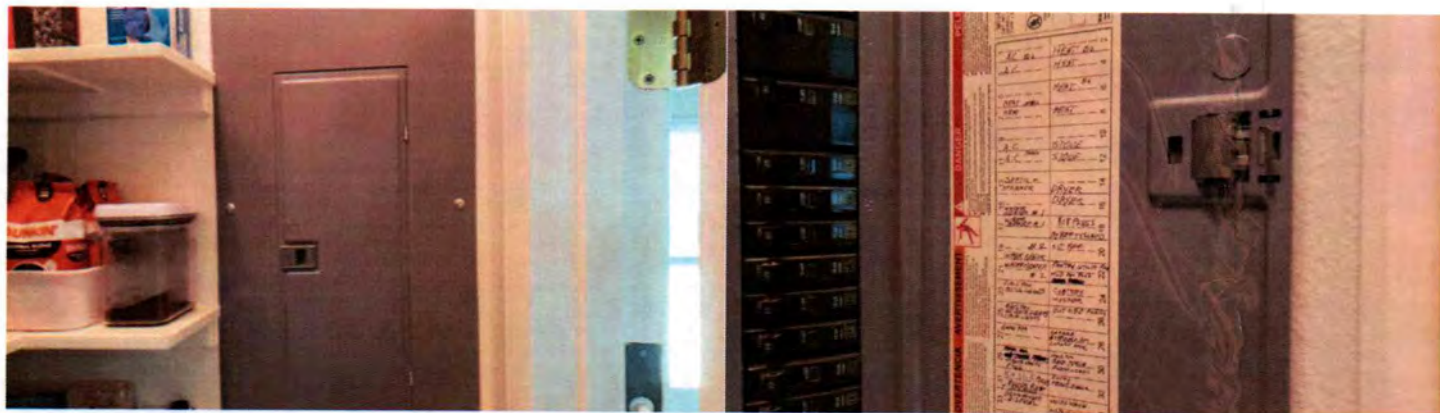
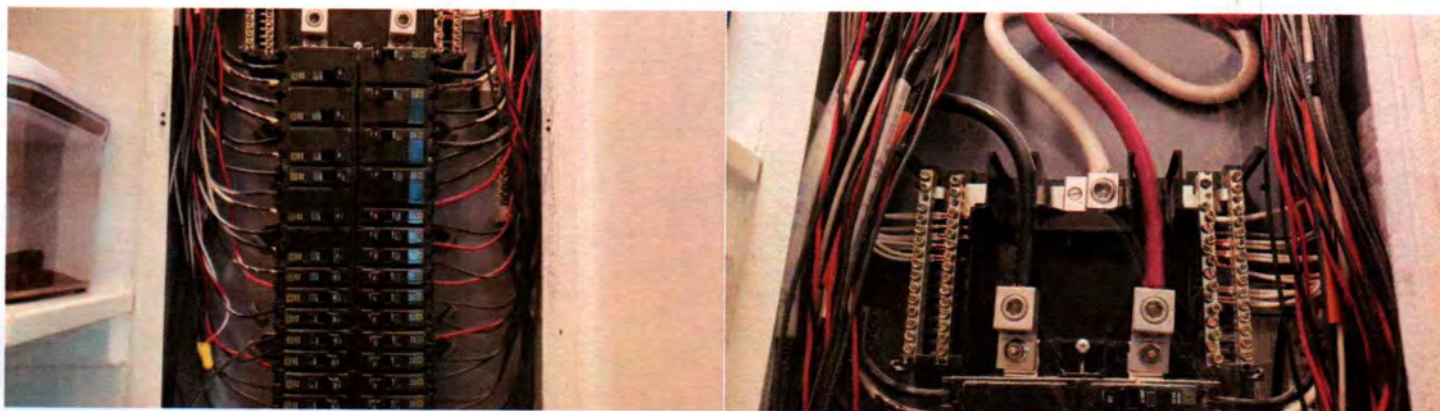
- Underground electrical service noted.
- The ground rod and connector was not visible at the time of the inspection. Recommend having a licensed electrician further evaluate and correct as needed.
- Double tapped neutral wires were observed in the service panel. One neutral wire per screw set is the recommended installation requirement. Consideration may be given to having a licensed electrician further evaluate and correct as needed.

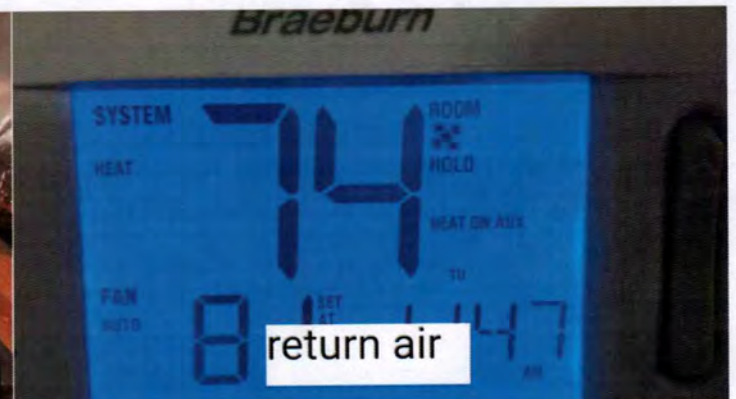
- The units appeared to be functioning as intended at the time of the inspection.
- Some corrosion was observed on the unit enclosure and components on the heating unit on lower level of attic.

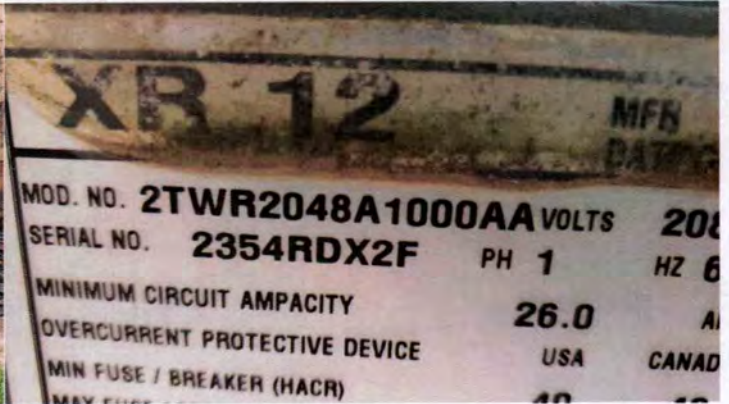
- The units appear to be functioning as intended at the time of the inspection and consistent with accepted industry standards.
- Insulation improvements are recommended on refrigerant lines near condensing unit.
- A safety / float switch was noted in primary drain pan for unit in upper attic space.
- Primary drain termination not determined at the time of the inspection.
- Insulation is recommended on the condensate drain line in lower attic space to prevent condensation drip.
- Some corrosion was observed on unit enclosure on evaporator unit in lower level of attic space.

Insulation has been  
added to the  
drain line

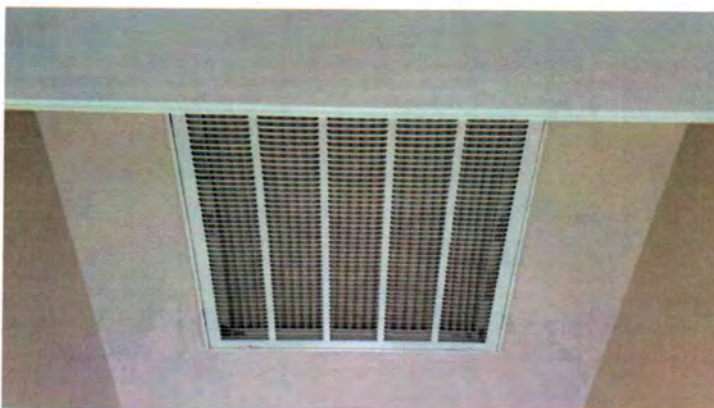
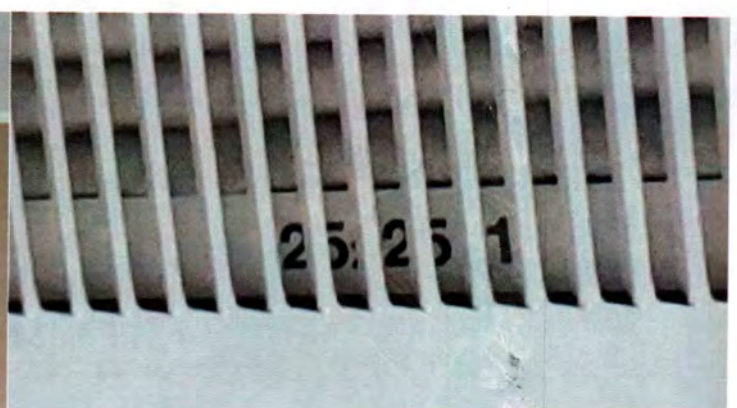
- The return air/filters were located in the ceilings.
- Flexible type ductwork noted.
- Minor corrosion/rust was observed on upstairs bathroom register. Consideration may be given to painting.
- Could not fully inspect ductwork due to accessibility.

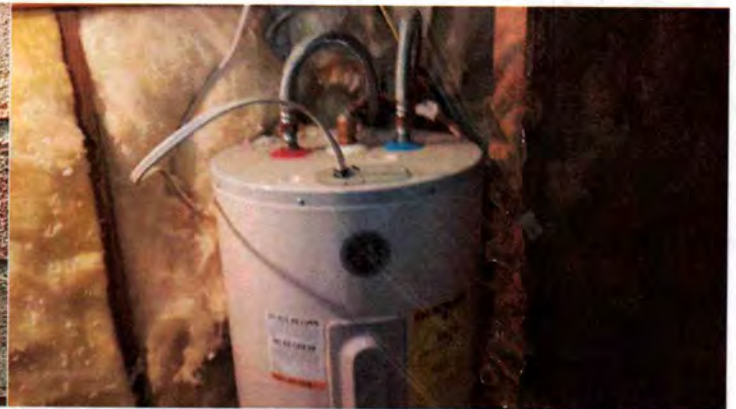
- The water heaters were performing as intended at the time of the inspection.
- The {220V} electrical connection is not properly installed. Recommend having a qualified contractor further evaluate and correct as needed.

Repaired

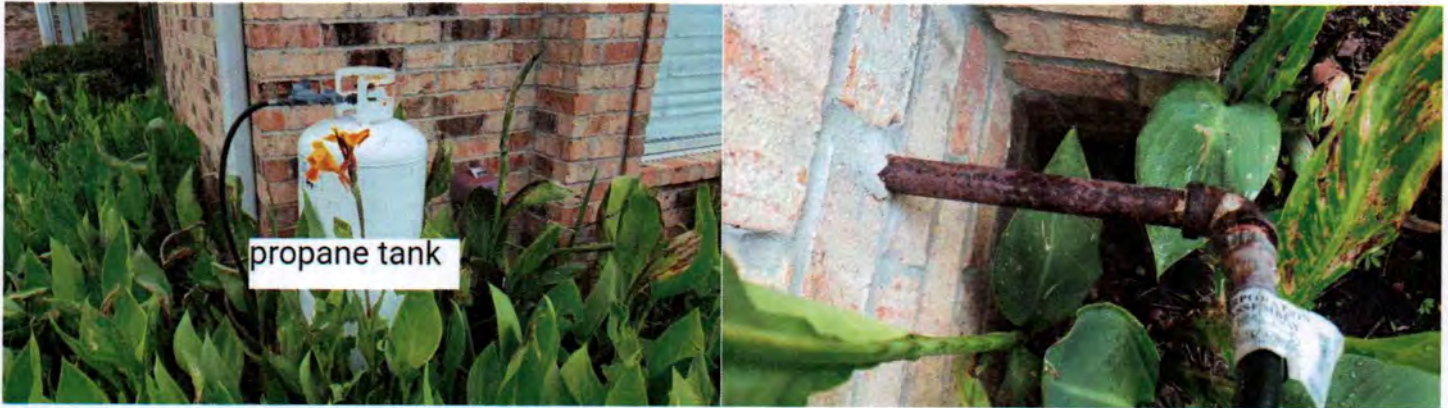
• No visible bonding was observed on the gas system at the time of the inspection. Recommend having a licensed electrician further evaluate and correct as needed.

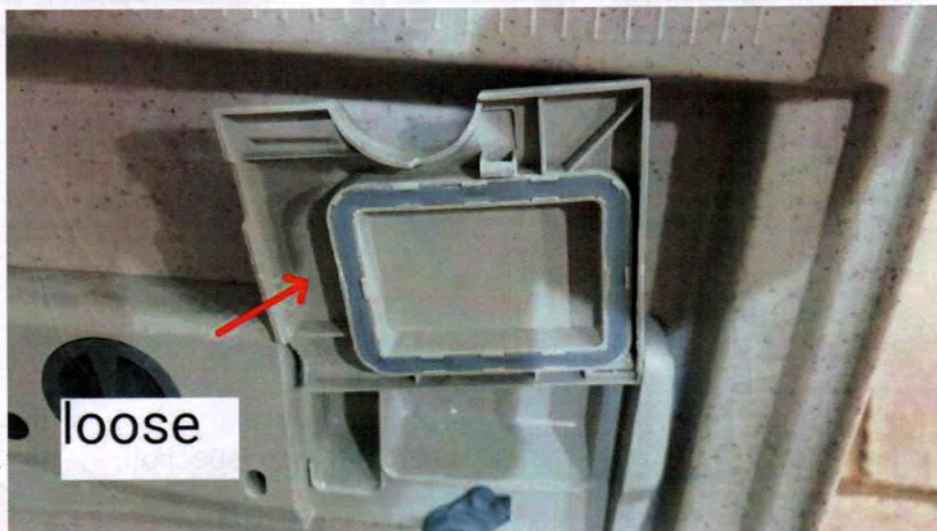
- Dishwasher was functional at the time of the inspection.
- Lack of a proper air gap noted at dishwasher drain line. In the event of a sewer backup this device prevents sewer matter from entering into dishwasher. Recommend having a qualified plumber install an air gap to prevent possible contamination.
- The soap dispenser door was observed to be loose. Consideration may be given to having a qualified technician further evaluate and correct as needed.

Repaired

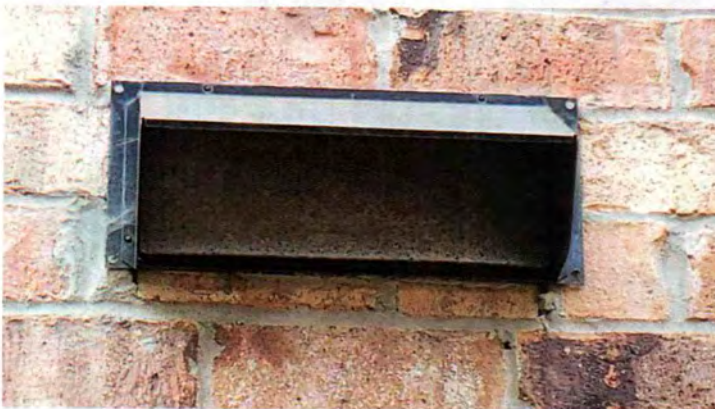
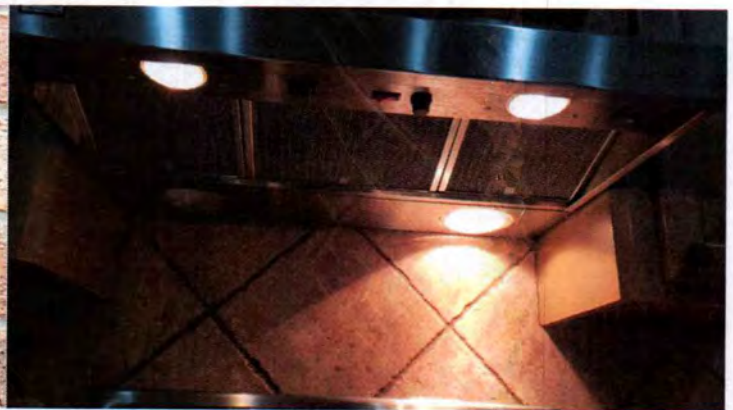
- The range hood was functional at the time of the inspection.
- Self filtering with vent to the exterior.
- One of the vent hood lights were observed to be not functioning. Consideration should be given to having lamp replaced and verifying proper operation.

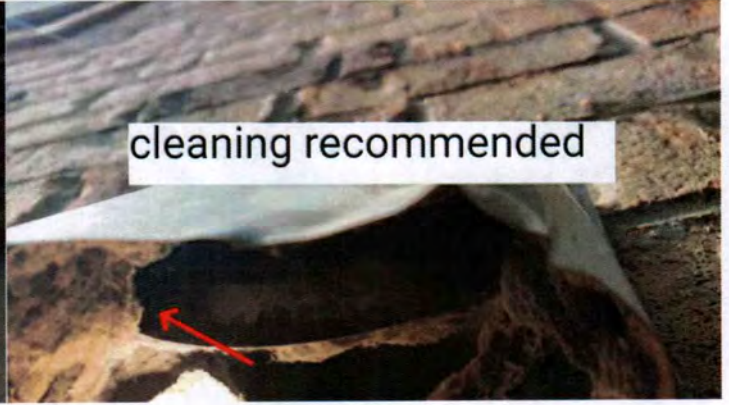
- Dryer vent appeared to be installed properly.
- Lint buildup was observed in the dryer vent and cleaning is recommended.

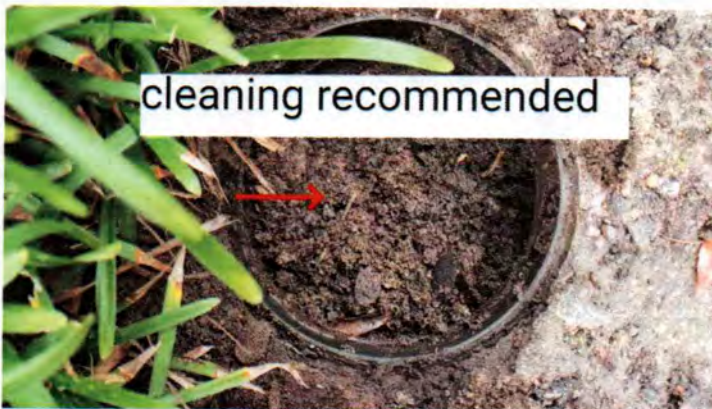
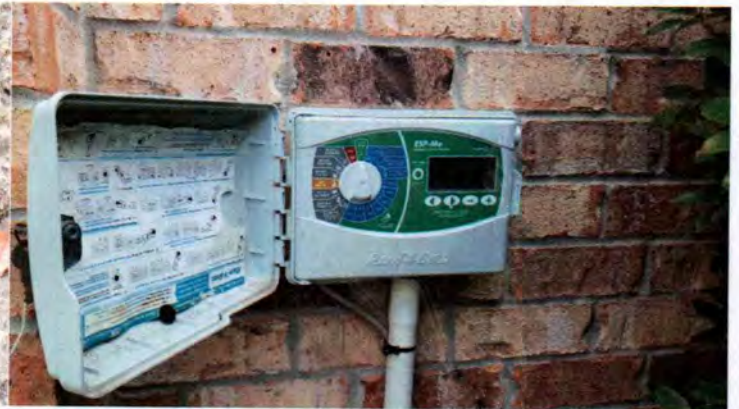
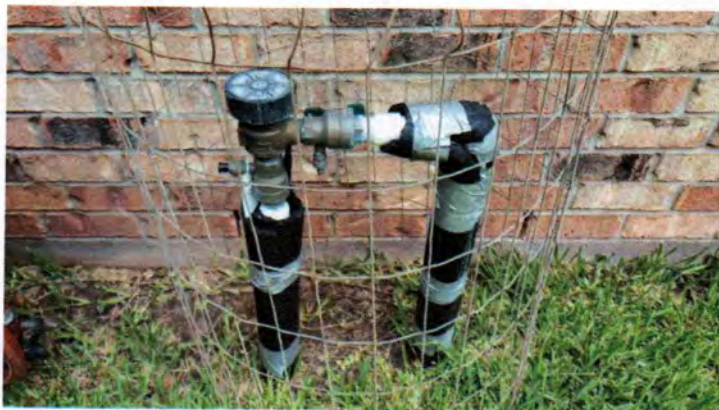
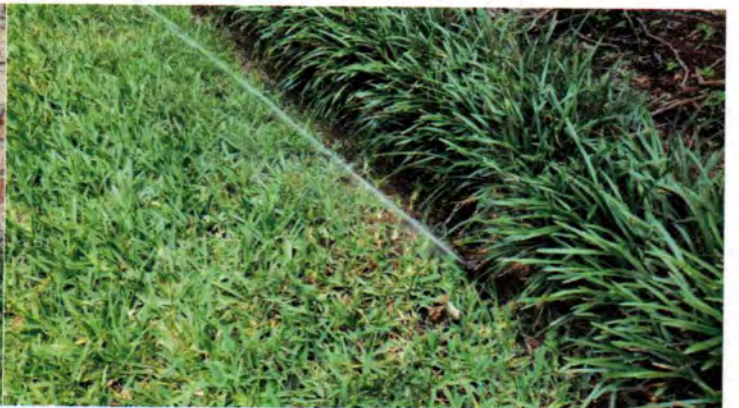
- Sprinkler system appeared to be performing as intended at the time of the inspection.
- Only one valve box was observed at the time of the inspection. Consideration may be given to having other valves located. It is recommended to keep valve boxes clean.
- A rain sensor was not observed at the time of the inspection and may be required. Consideration may be given to having a qualified irrigation contractor further evaluate.

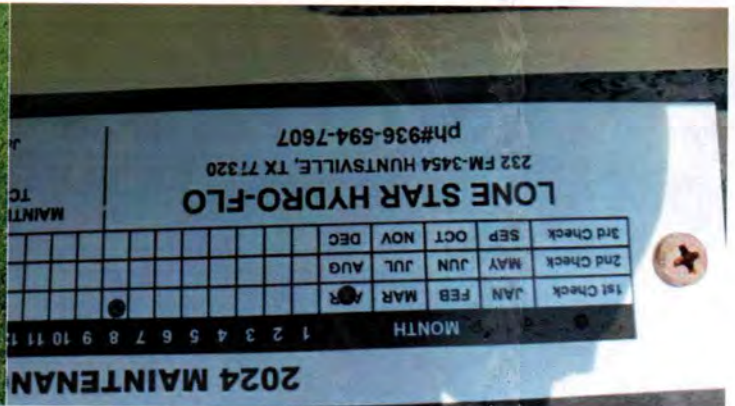
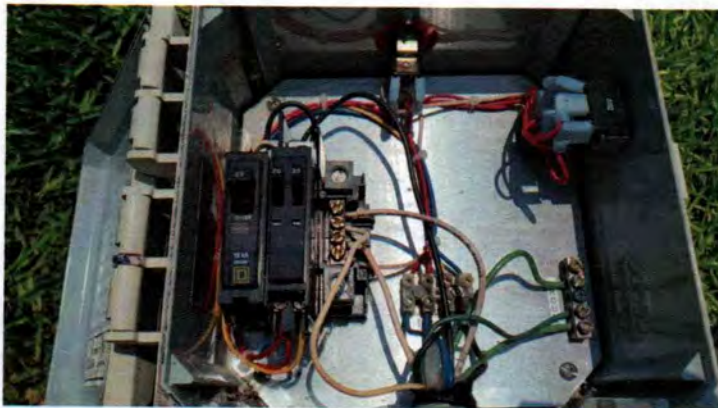
- The aerobic system appeared to be performing as intended at the time of the inspection.
- The chlorinator tube was noted as empty and may require chlorine tablets.
- **No high water float was observed. Recommend having a qualified contractor further evaluate and correct as needed.**

High water float is in place &amp; operational
