Property and Environmental Closeout

**First Student #20218B, 4443 Claude St., Moose Creek, AK
99701**

Inspector	Paul Platillero
Date of Inspection	August 17, 2021

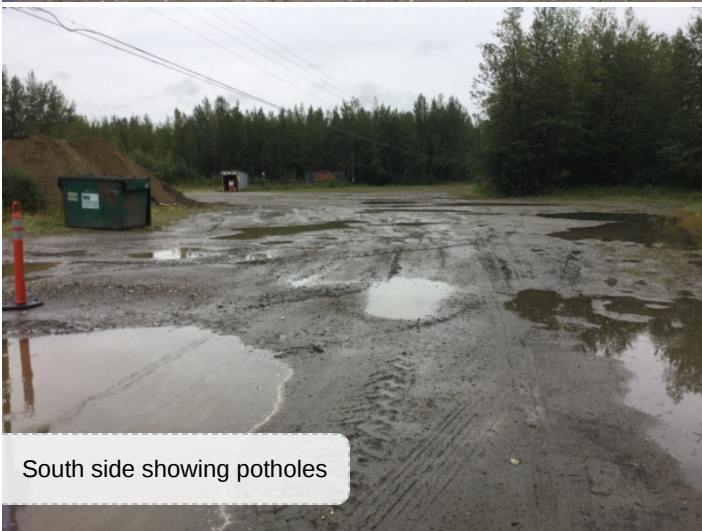
South side showing potholes

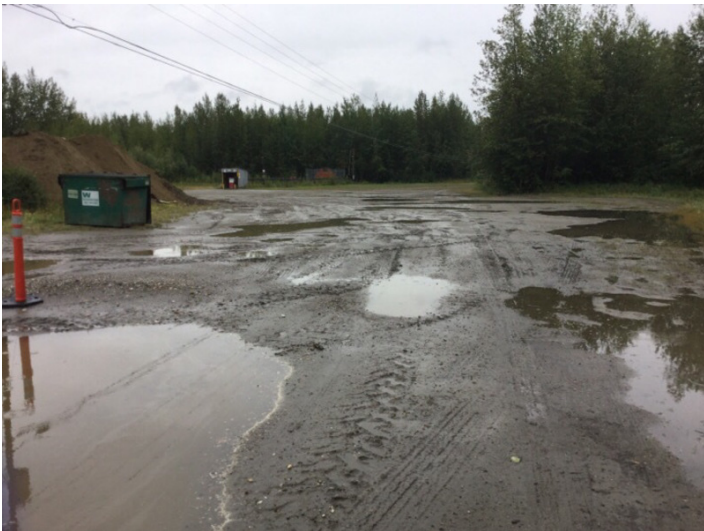
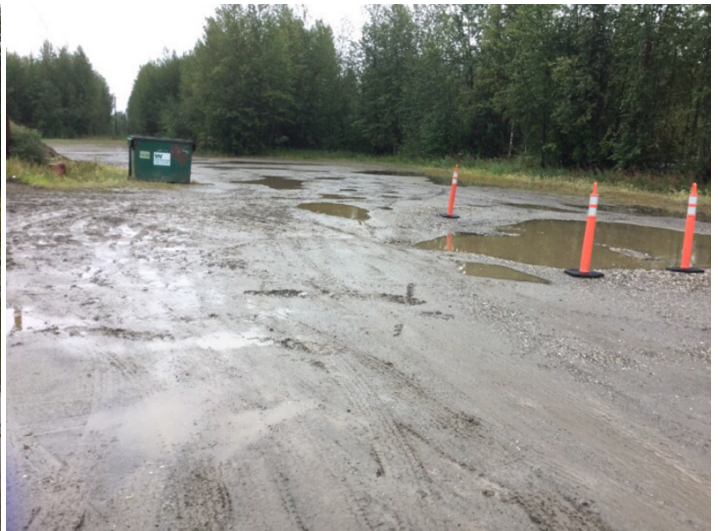
Erosion and Pothole Photos

Parking/Drive Surfacing Material	Gravel and dirt parking areas, including indoors
Significant oil stains in parking or equipment storage areas observed?	No
Tracking of oils outside the maintenance shop onto surrounding paved or gravel surface observed?	No
Significant erosion or potholes in parking or equipment storage areas observed?	Yes

FINDING	RESPONSIBLE PARTY
Lot significantly damaged (i.e., erosion, potholes, etc.)	Minor potholes; no planned activities
Fueling AST(s) may require removal	To be determined
Product drums/containers present require removal or reallocation	Operating company to remove
Wastes present require removal/disposal	Operating company to remove
Outstanding notice(s) of violation, compliance inquiry letter(s), consent order(s), or administrative order(s) related to environmental matters	No further action required; AULs have been instituted at the location

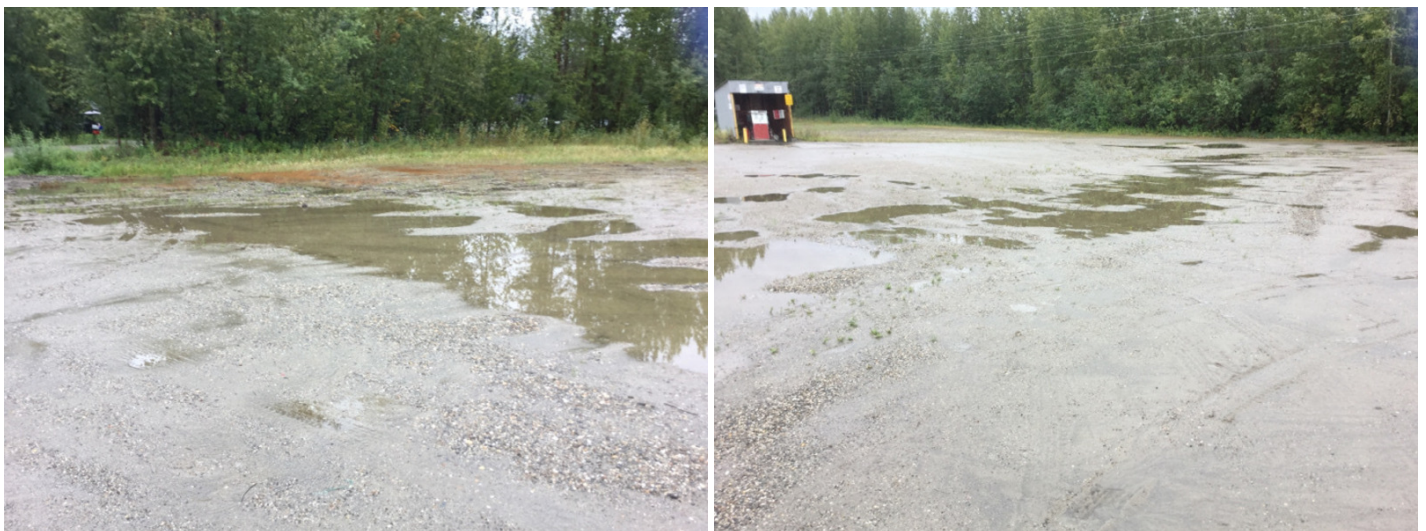
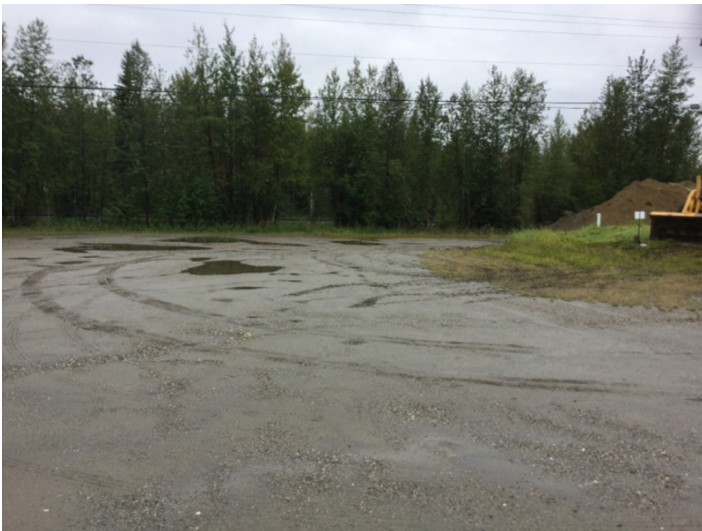
Grading, Drainage, or Flooding Issue Photos

Storm Drains or Dry Well Present?	Neither
Are oil/water separator/clarifier device(s) used to treat storm water (i.e., stormceptor)?	No
Retention/Detention Pond(s) present?	No
Storm Water Outfalls/Point Source Discharges Present?	No
Are drainage ditches or swales free of oil, excessive sediment, and/or debris?	Not present
Poor site grading or drainage, flooding, or related water damage to the building observed or reported by contact(s)?	Yes
Describe grading, drainage, or flooding issues	Potholes outside, roof leaks

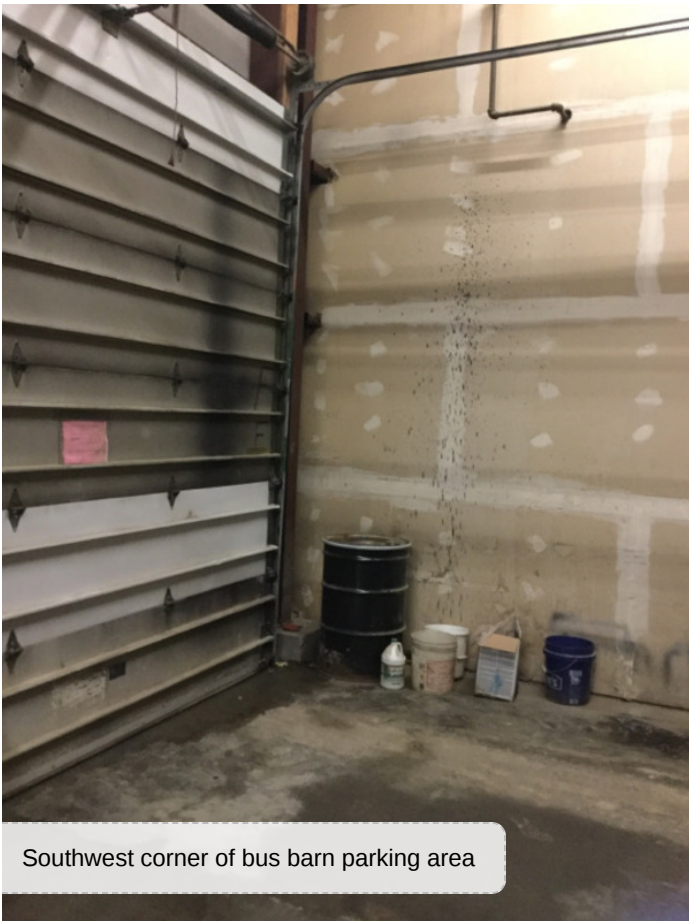
Yes

Southwest corner of bus barn parking area

Old building, dirt floor; no floor drains; some concrete floors inside shop; roof leaks; spill kit

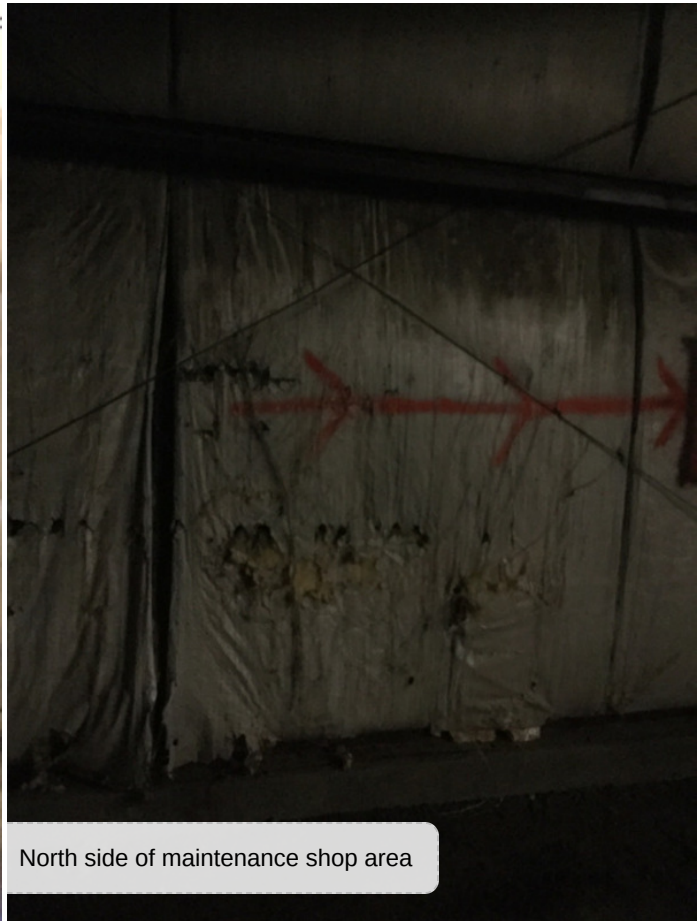
North side of maintenance shop area

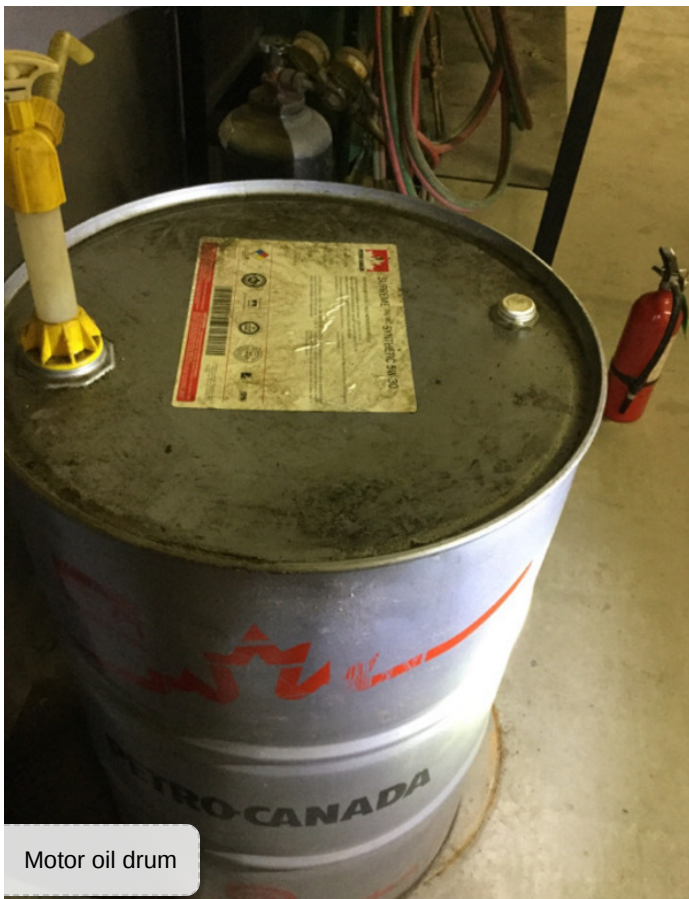
Are product drums/containers (NOT WASTE) present that require removal or reallocation? Yes

Motor oil drum

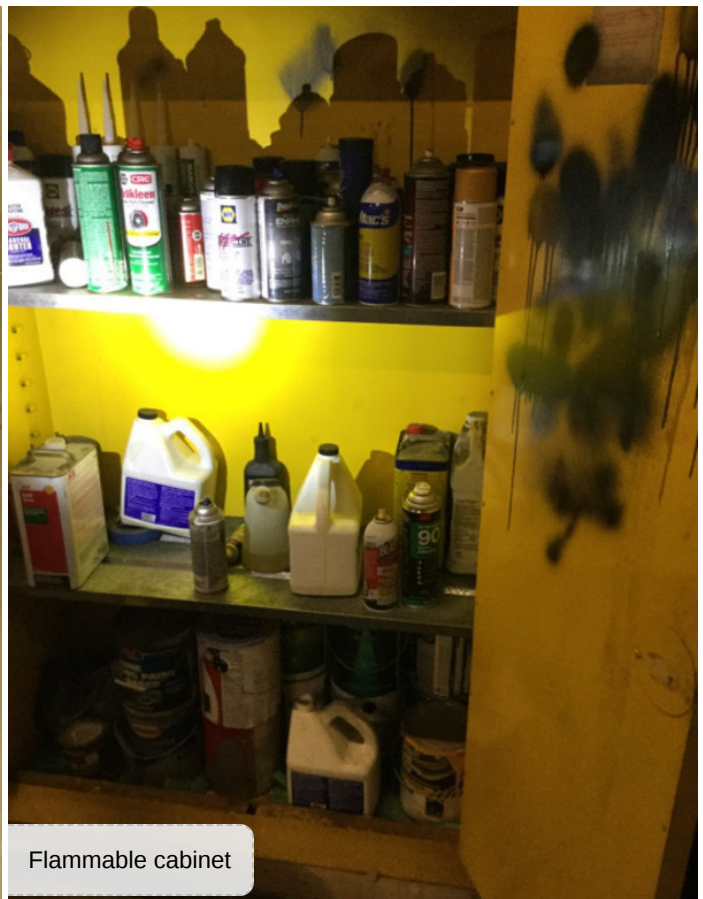
Flammable cabinet

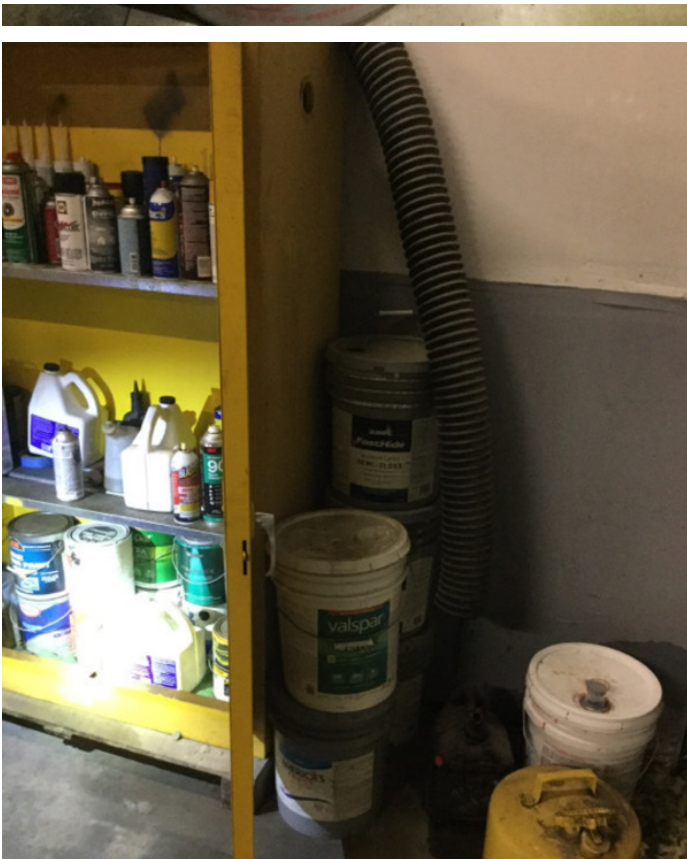
Flam. cabinet and other materials in 5 gal. buckets

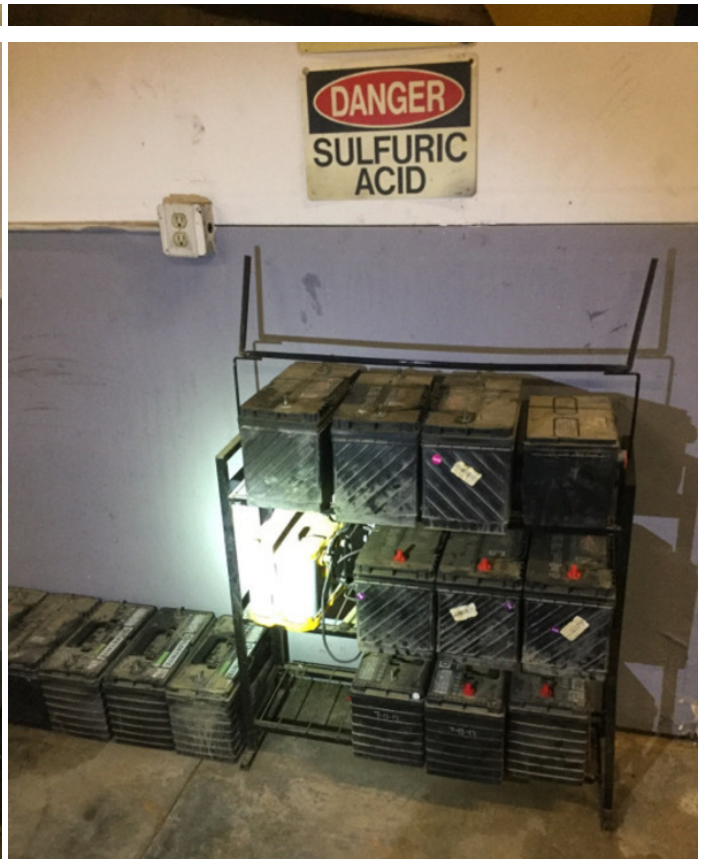
Used battery storage

Product Name	Antifreeze
Container Type	Steel drum
Number of Containers	1
Capacity (gal or lbs)	55
Location	In shop
Remaining product drums/containers are being...	To be determined
Do secondary containment(s) for drums (i.e., spill pallets) contain product that requires removal?	No present
Additional Comment	5W30 5-8 gallons AST, 17 used batteries, 55-gal. drum antifreeze, empty AFT, 2 drums unlabeled

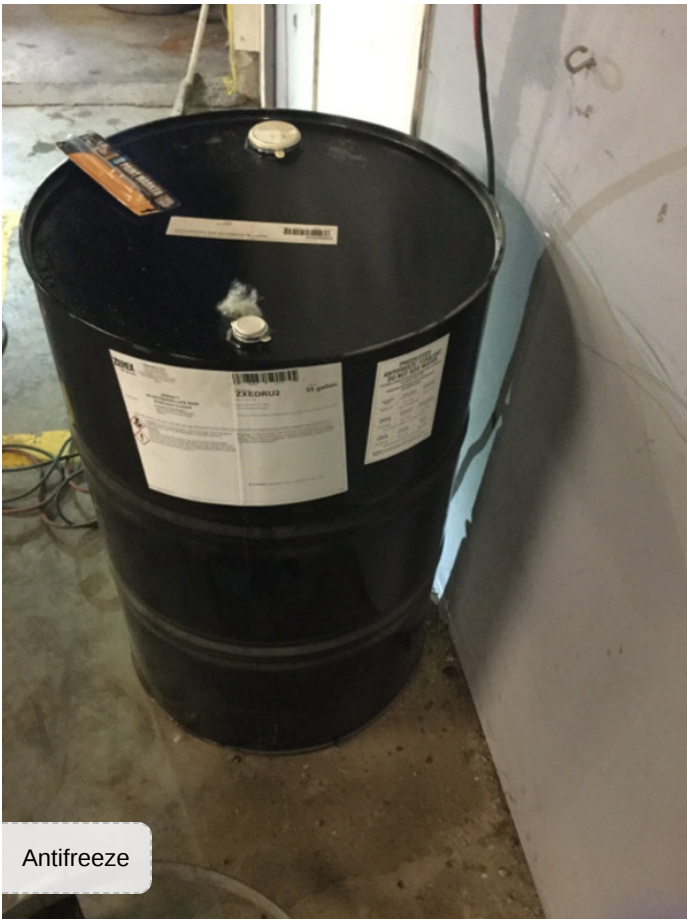
Antifreeze

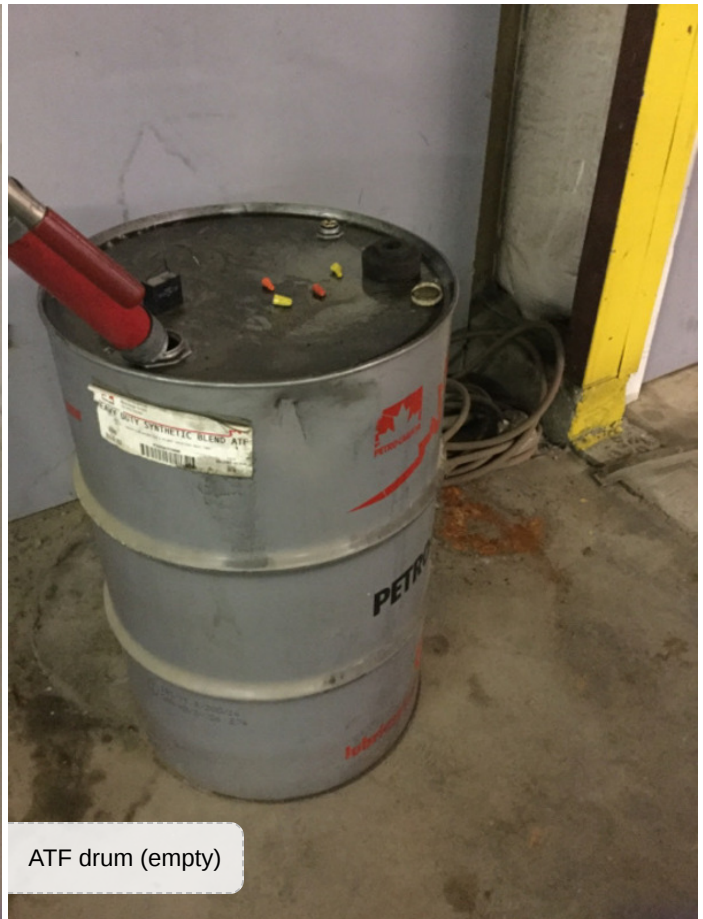
ATF drum (empty)

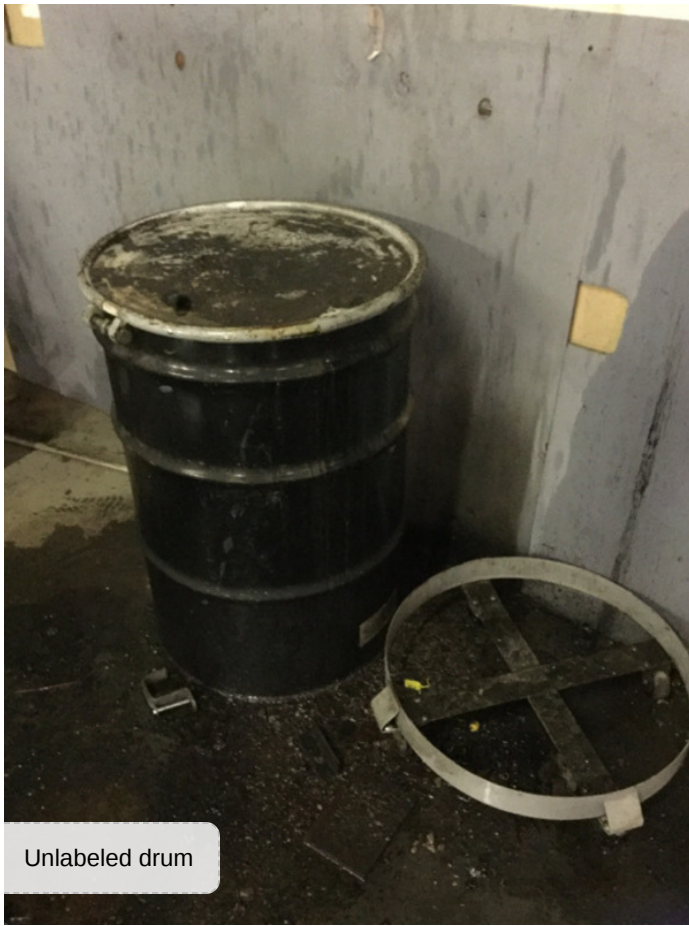
Unlabeled drum

Waste Stream	Unknown waste
Amount Requiring Removal	1-55 gal drum
Designated Vendor to Remove	Waste Management
Approximate Collection/Removal Date	October 29, 2021
Additional Comments	Drum is not labeled

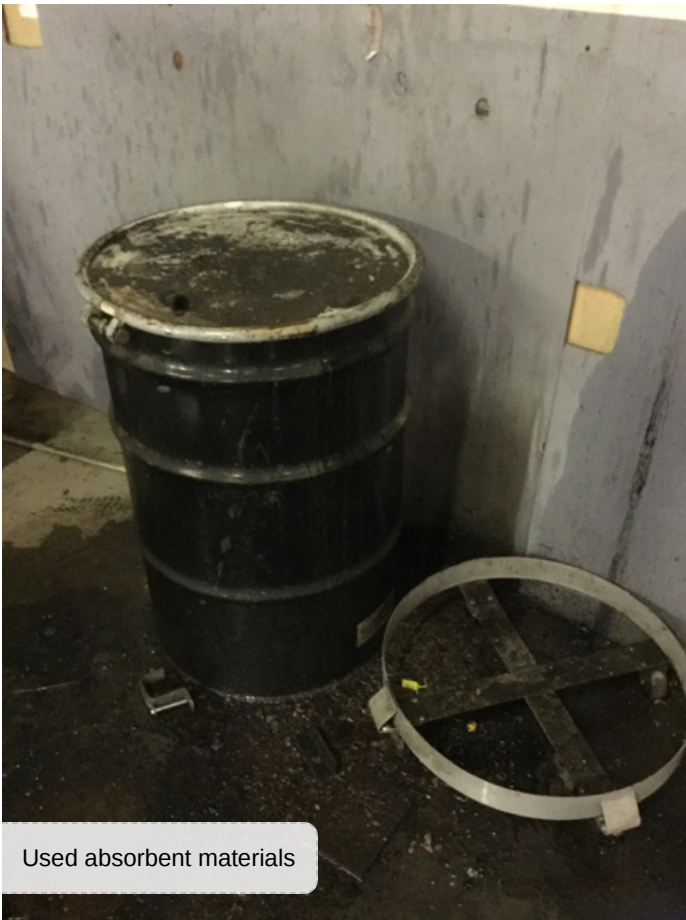
Yes

Used absorbent materials
