COMMERCIAL MULTI-UNIT INSPECTION REPORT

4468 Reinbeau Dr
Columbus, OH 43232

09/09/2024

- This document is a Property Condition Report (PCR) of the property located at: 4468 Reinbeau Dr Columbus OH 43232
- This PCR was prepared by: Russell Allen
- This PCR was prepared for: Gerard Tema
- User's position with the property: Buyer
- The property habitable square footage is: 12390 sq. ft.
- Type of real estate transaction: Commercial Investment, Multi-Family
- Date of site visit: 09/09/2024

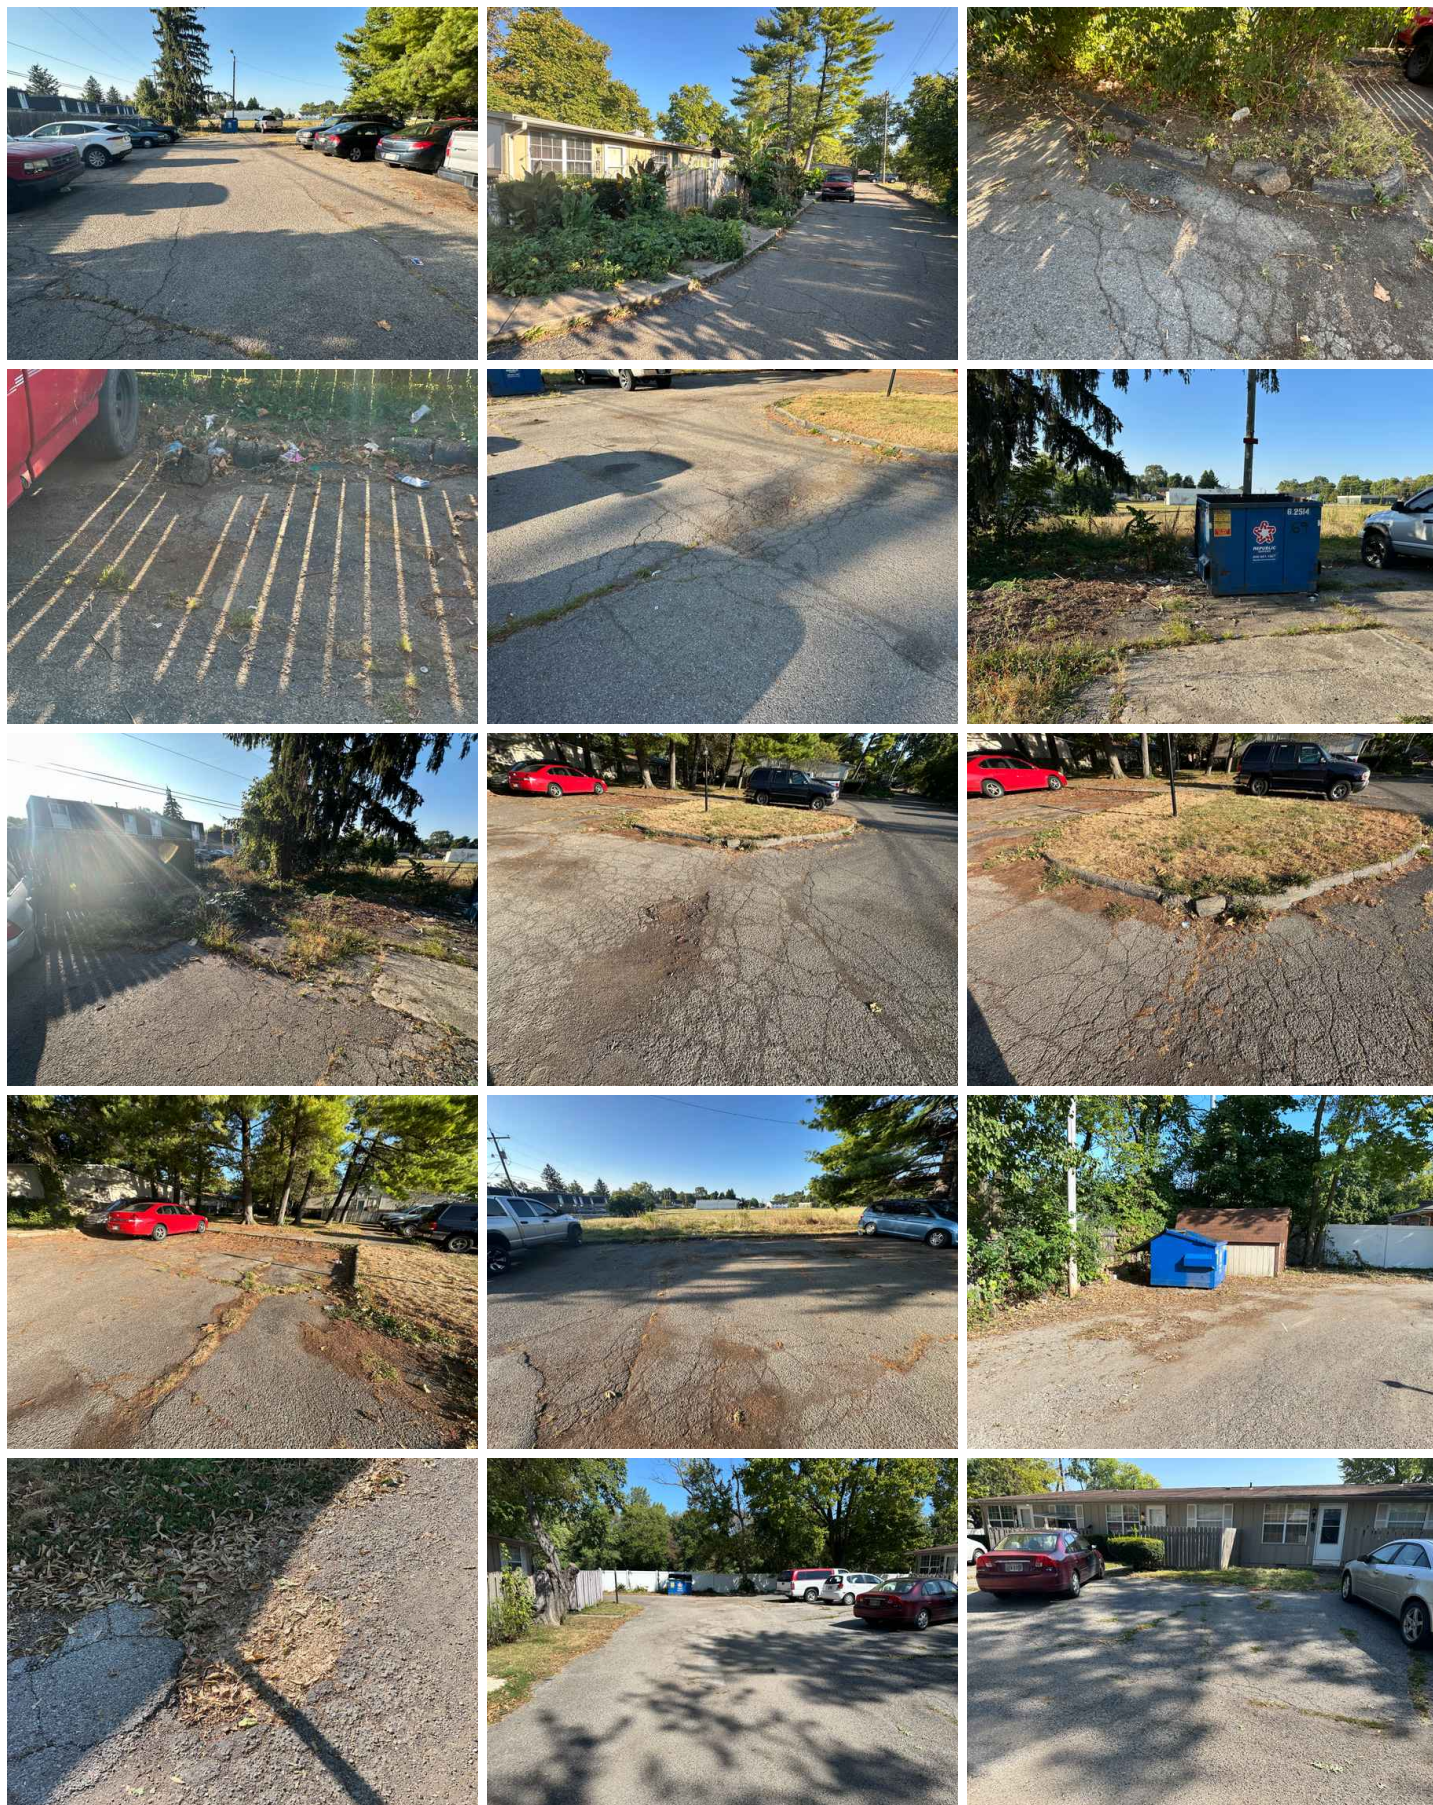
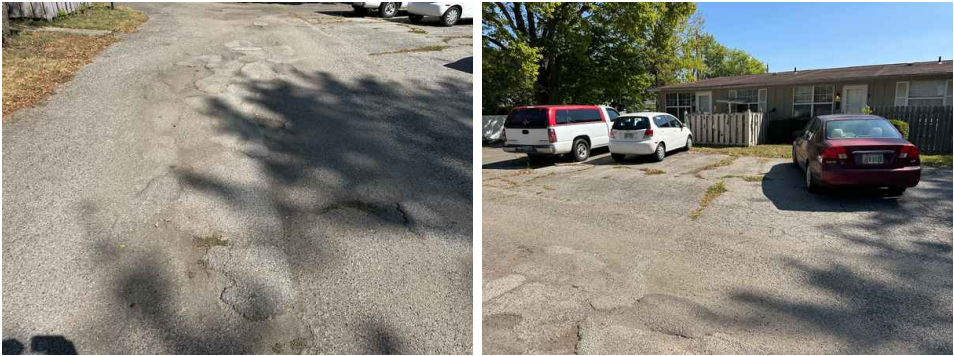
DETERIORATION - GENERALLY SEVERE

The parking lot pavement exhibited general severe disrepair and deterioration, including potholes, cracks, and erosion that will worsen with time. These areas should be repaired as necessary to avoid vehicle damage, pedestrian trip hazard, and to extend the time interval before repaving is necessary.

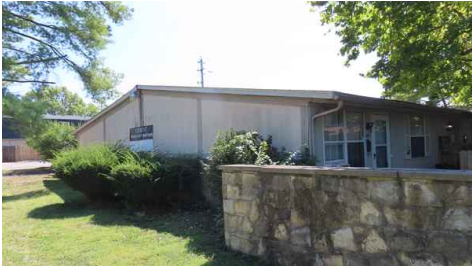
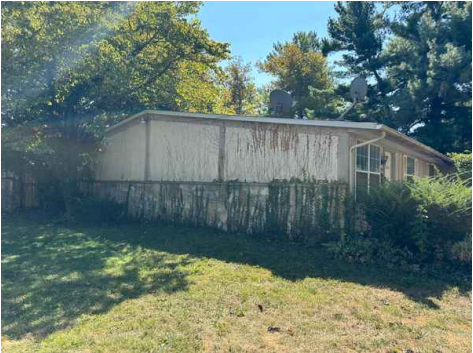
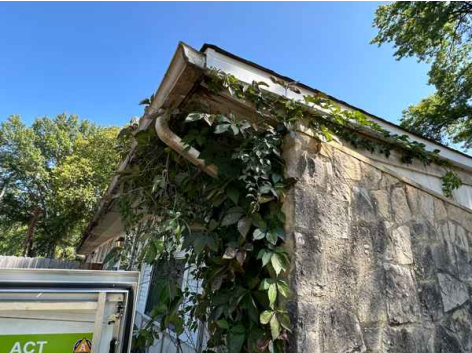
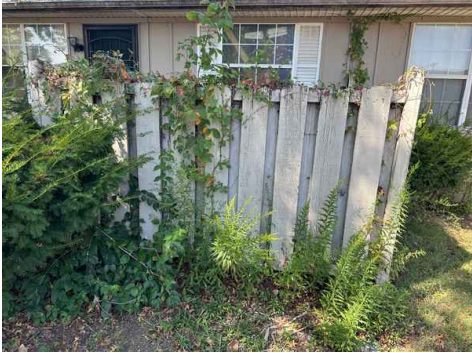
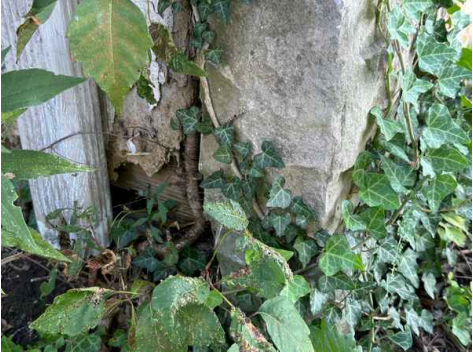
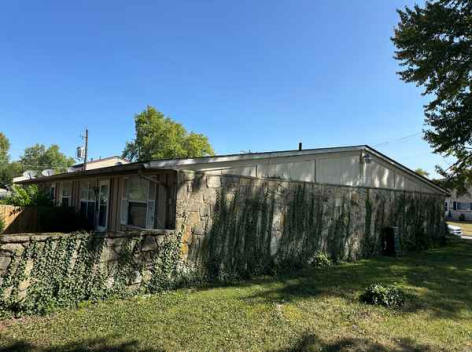
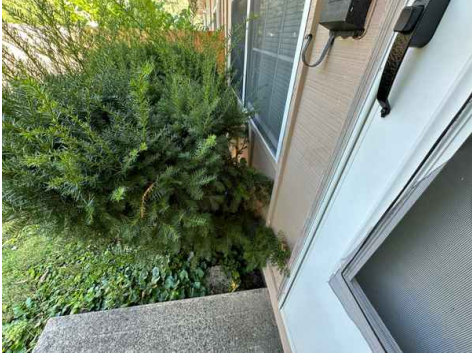
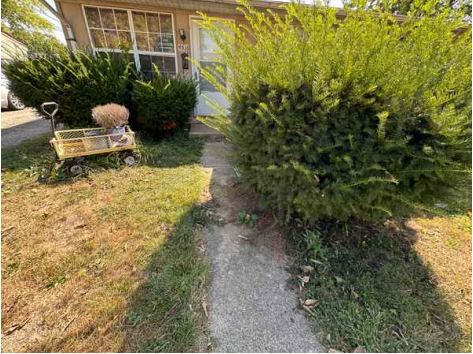
VEGETATION - AGAINST/NEAR THE PROPERTY

There was vegetation in contact with, or in close proximity to the home in areas. Pruning or removal of any plants within 1-2 feet of the home is recommended to be conducted by a qualified person to eliminate pathways of wood-destroying insects and allow moisture to adequately dry behind these areas after rainfall events.

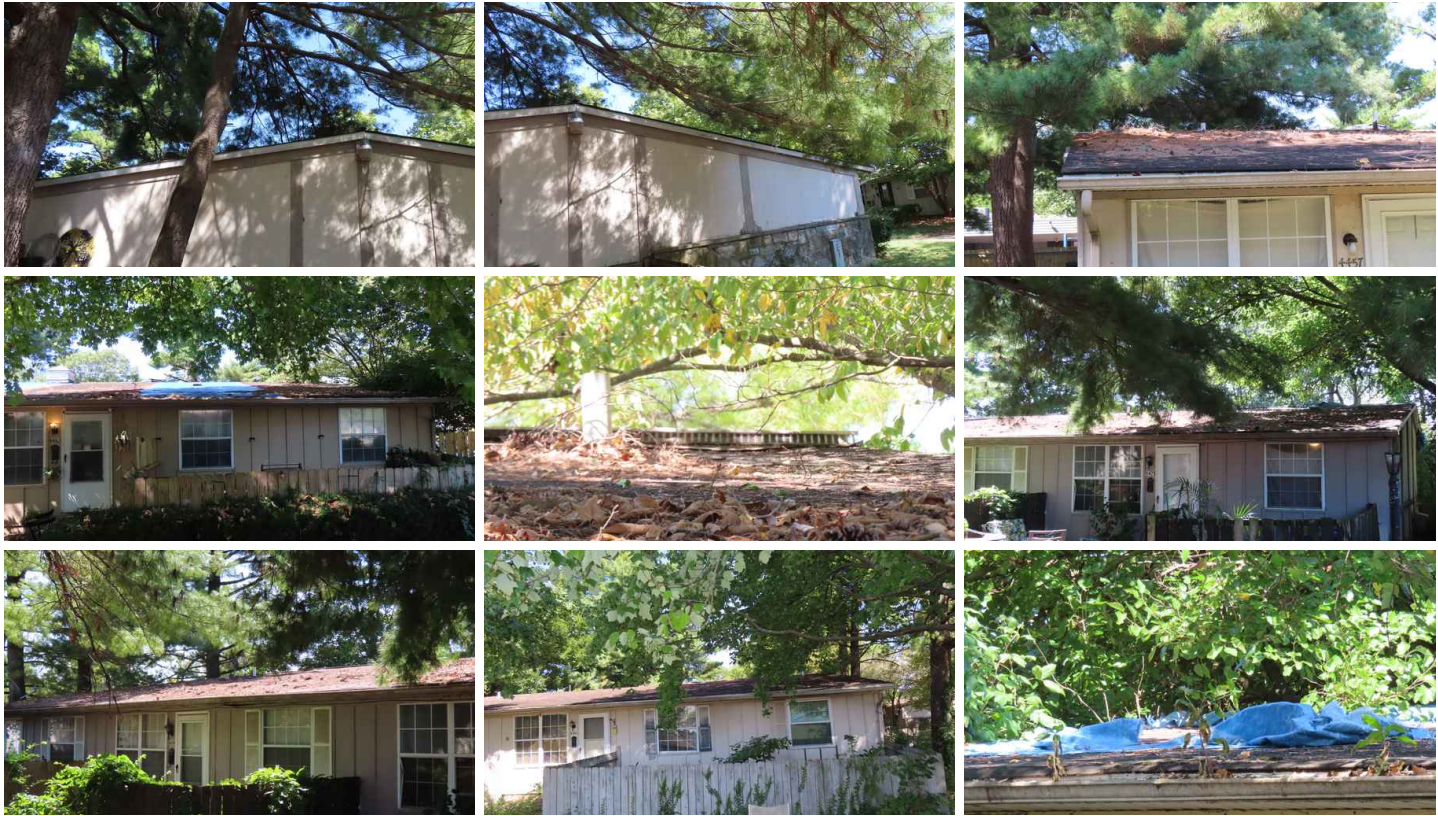
7.3.2 Vegetation

TREE(S) - LIMBS WITHIN 10 FEET OF ROOF

Tree limbs were present that were covering portions of the roof surface or within 10 feet of the roof. Tree limbs within 10 feet of the roof should be trimmed away to provide air and sunlight to the roof, allowing the roof surface to adequately dry after rainfall events. Leaves from trees can also clog downspouts and gutters allowing them to overflow. Trimming or removal of the offending branches as needed is recommended to be conducted by a tree trimming company.

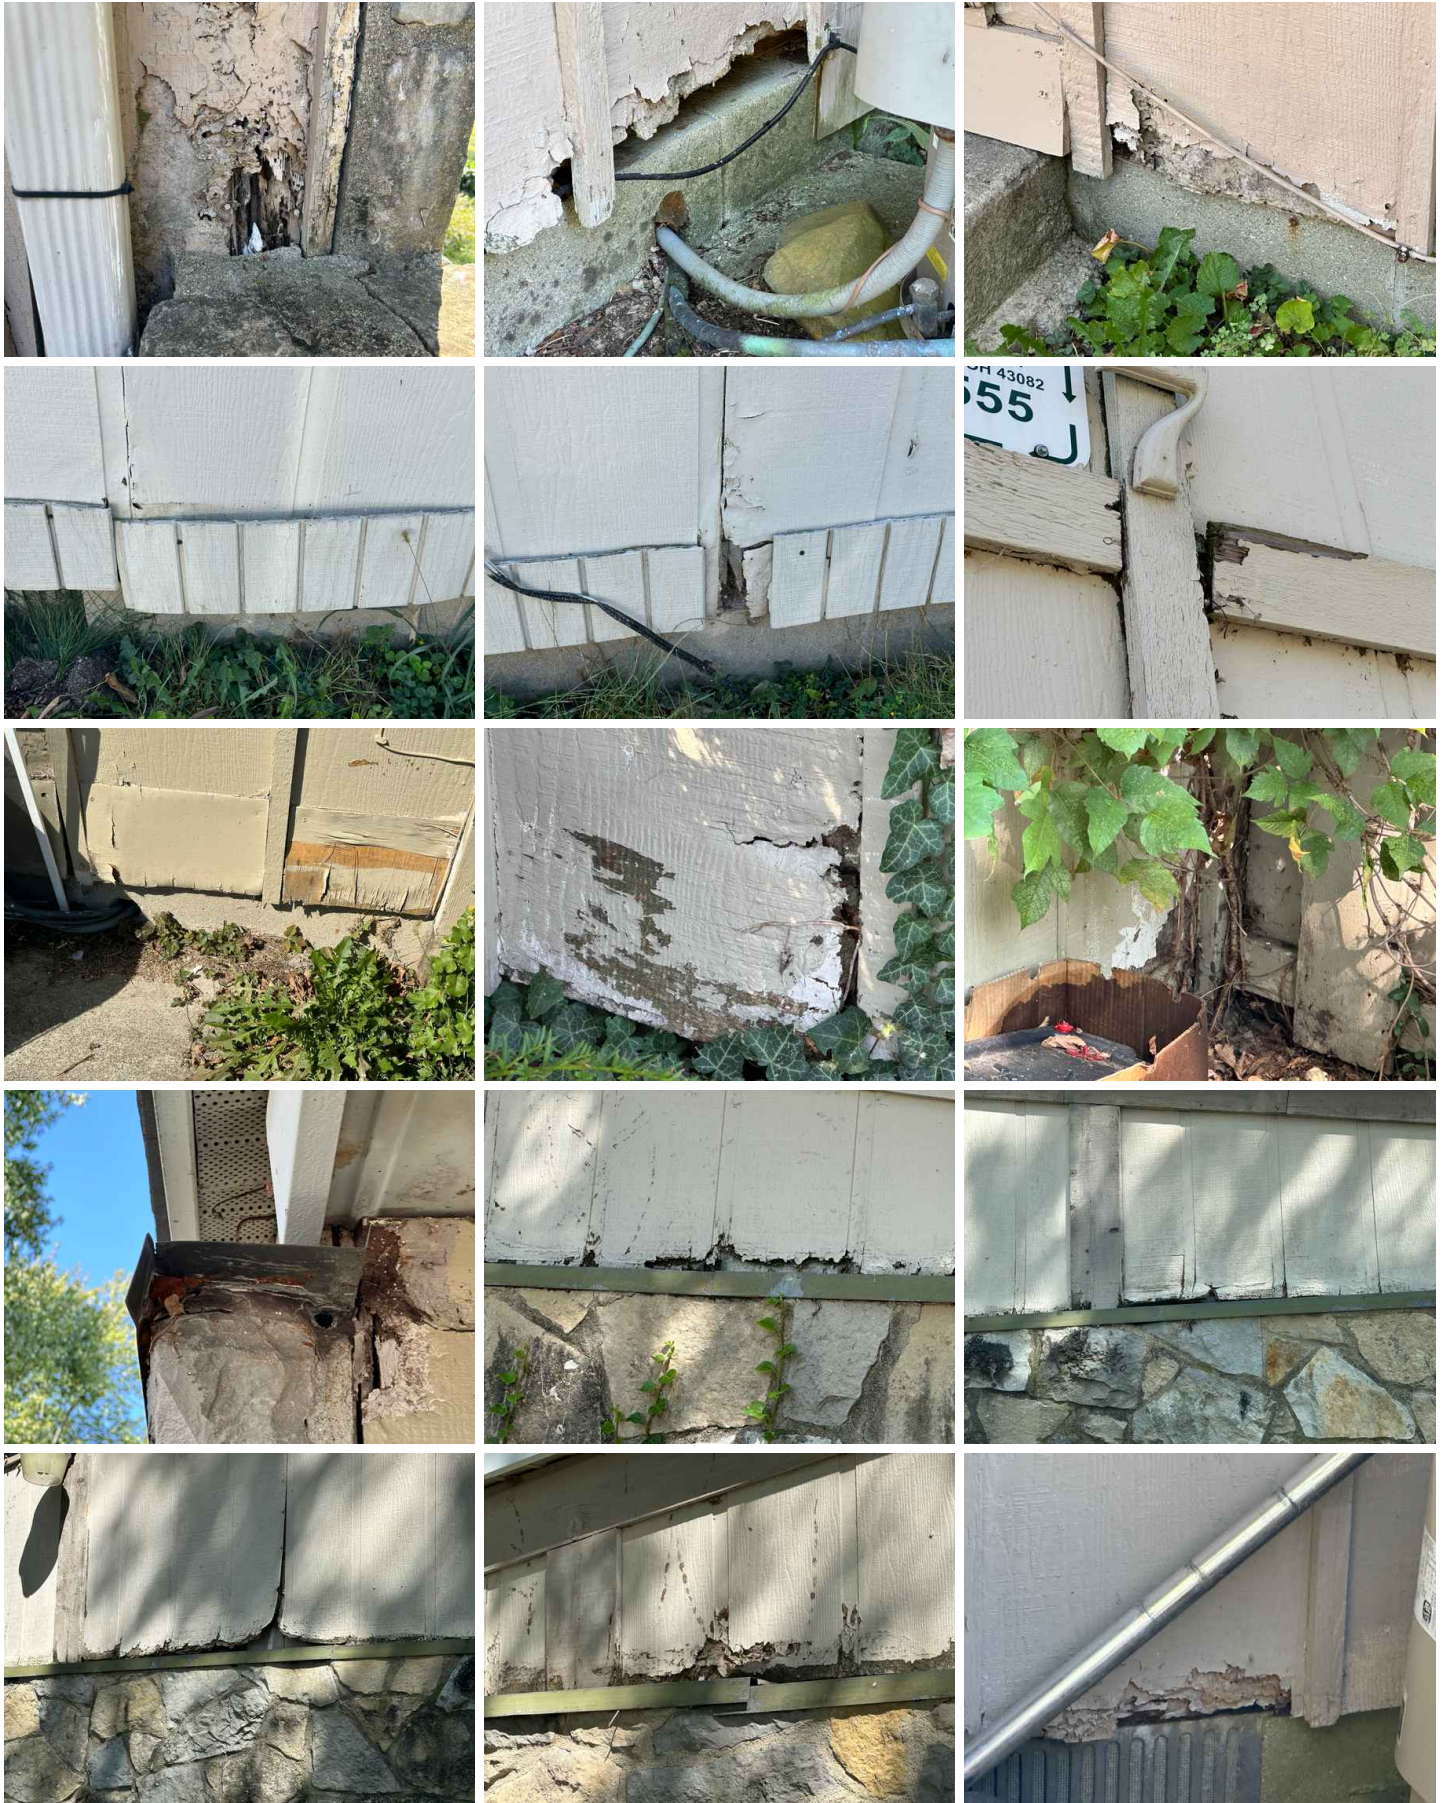
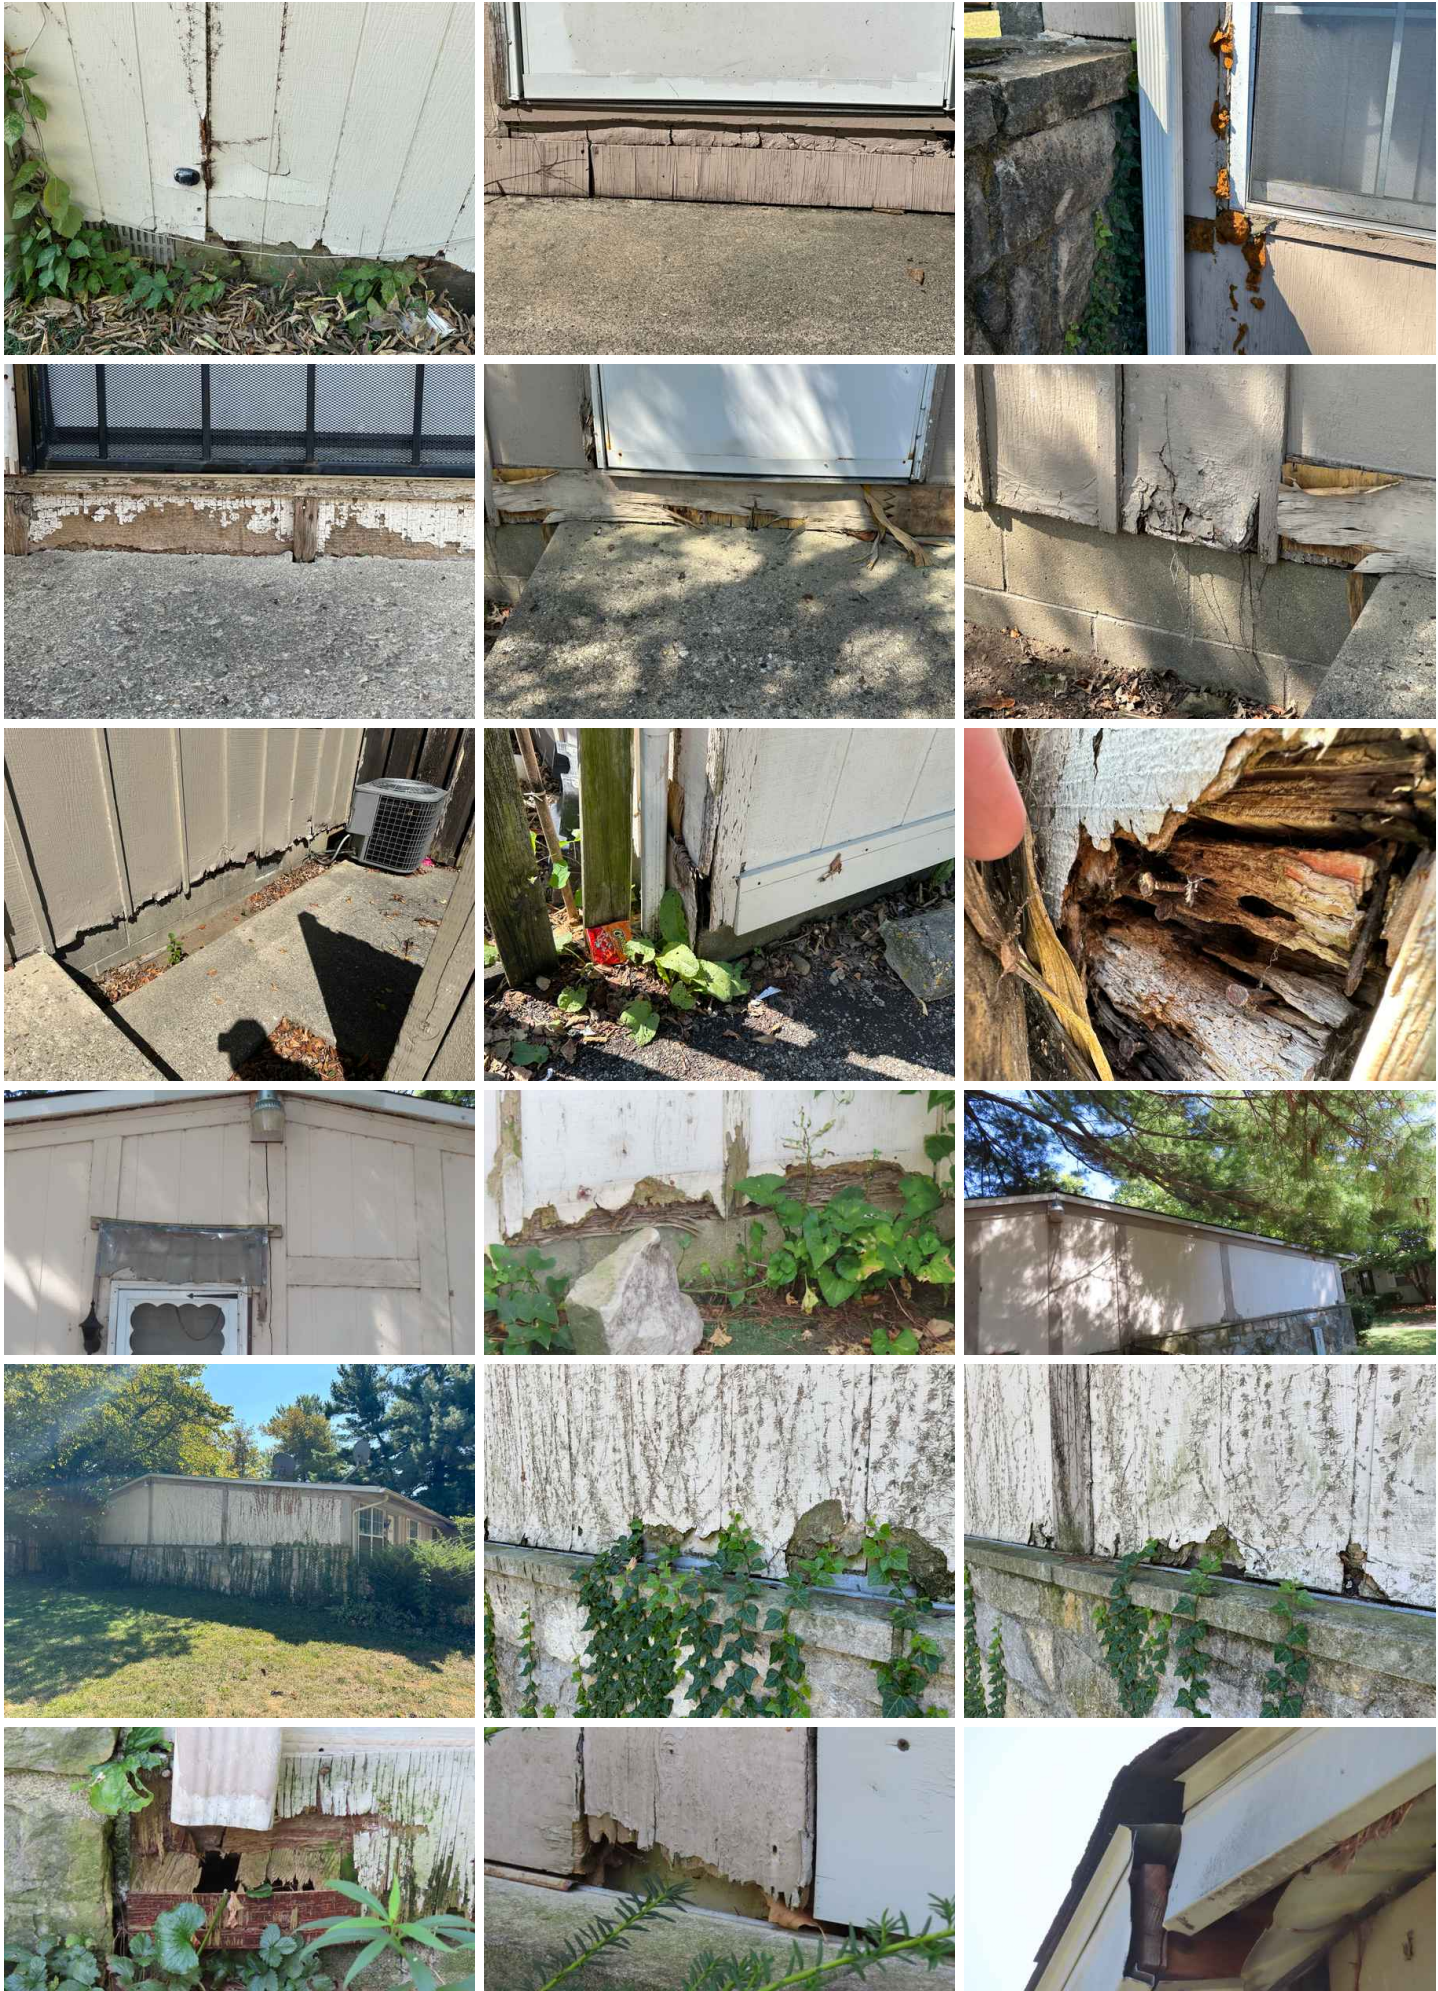
Priority / Safety Issue

The exterior wall cladding was at the end of its useful life. Multiple areas of damage and rot that is beyond a reasonable repair due to likely damage to the framing structure.

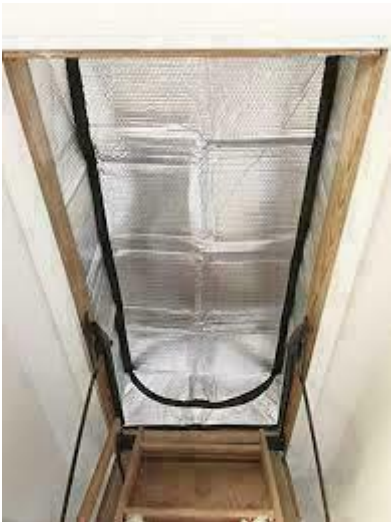
The attic opening over the pull down stairs was not insulated. This can affect the energy efficiency and "comfort" level of the home. I recommend adding an insulated cover over the access. Here's a link that discusses this further:

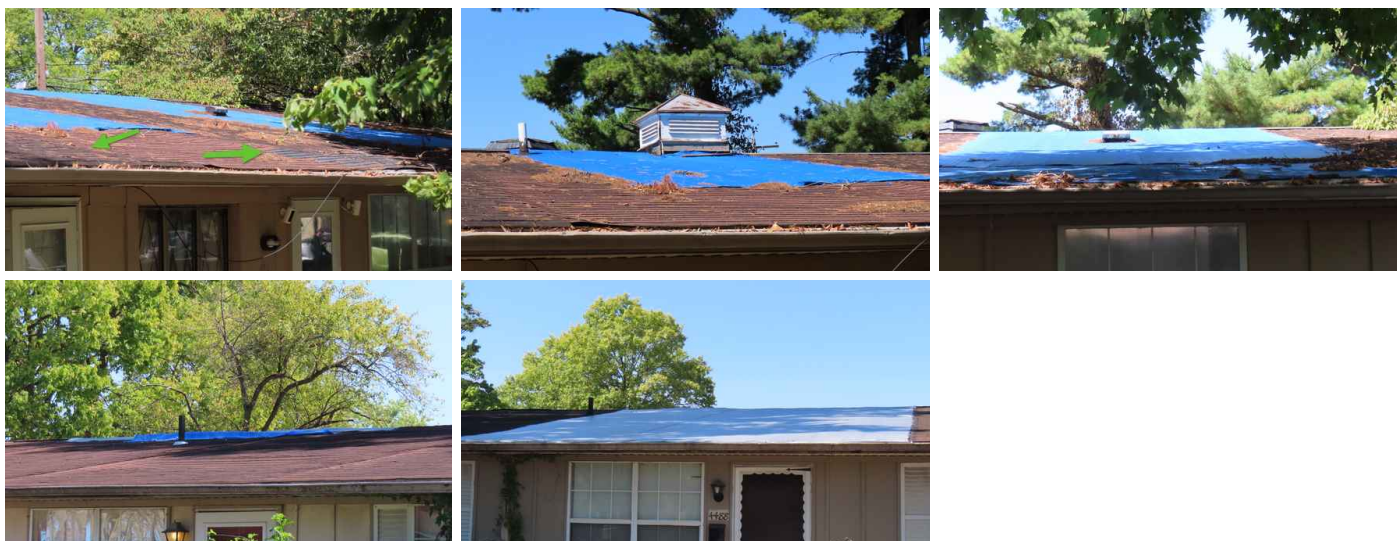
Shingles: Shingles - Prior Repairs Present

FYI - Prior repairs were present on the roof surface. I recommend consulting with the sellers as to why.

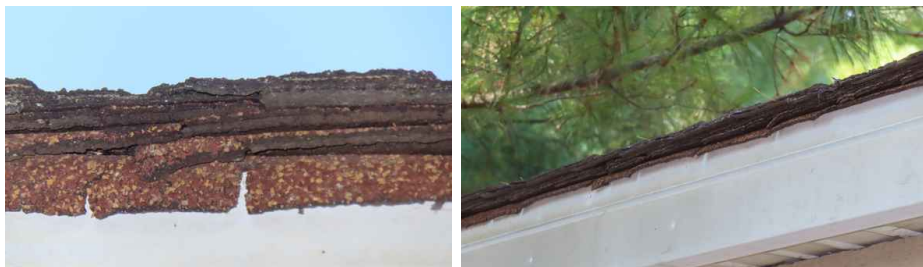
Shingles: Shingles - Multiple Layers Present

Two layers of shingles were present on the roof surface, where the newer shingles were installed over the existing shingles. Although current standards allow for up to two layers, this can create a wavy-like appearance to the shingles and may cause the newer shingles to "wear" faster than expected due to heat. A Google search of "two layers of shingles" will provide additional information.

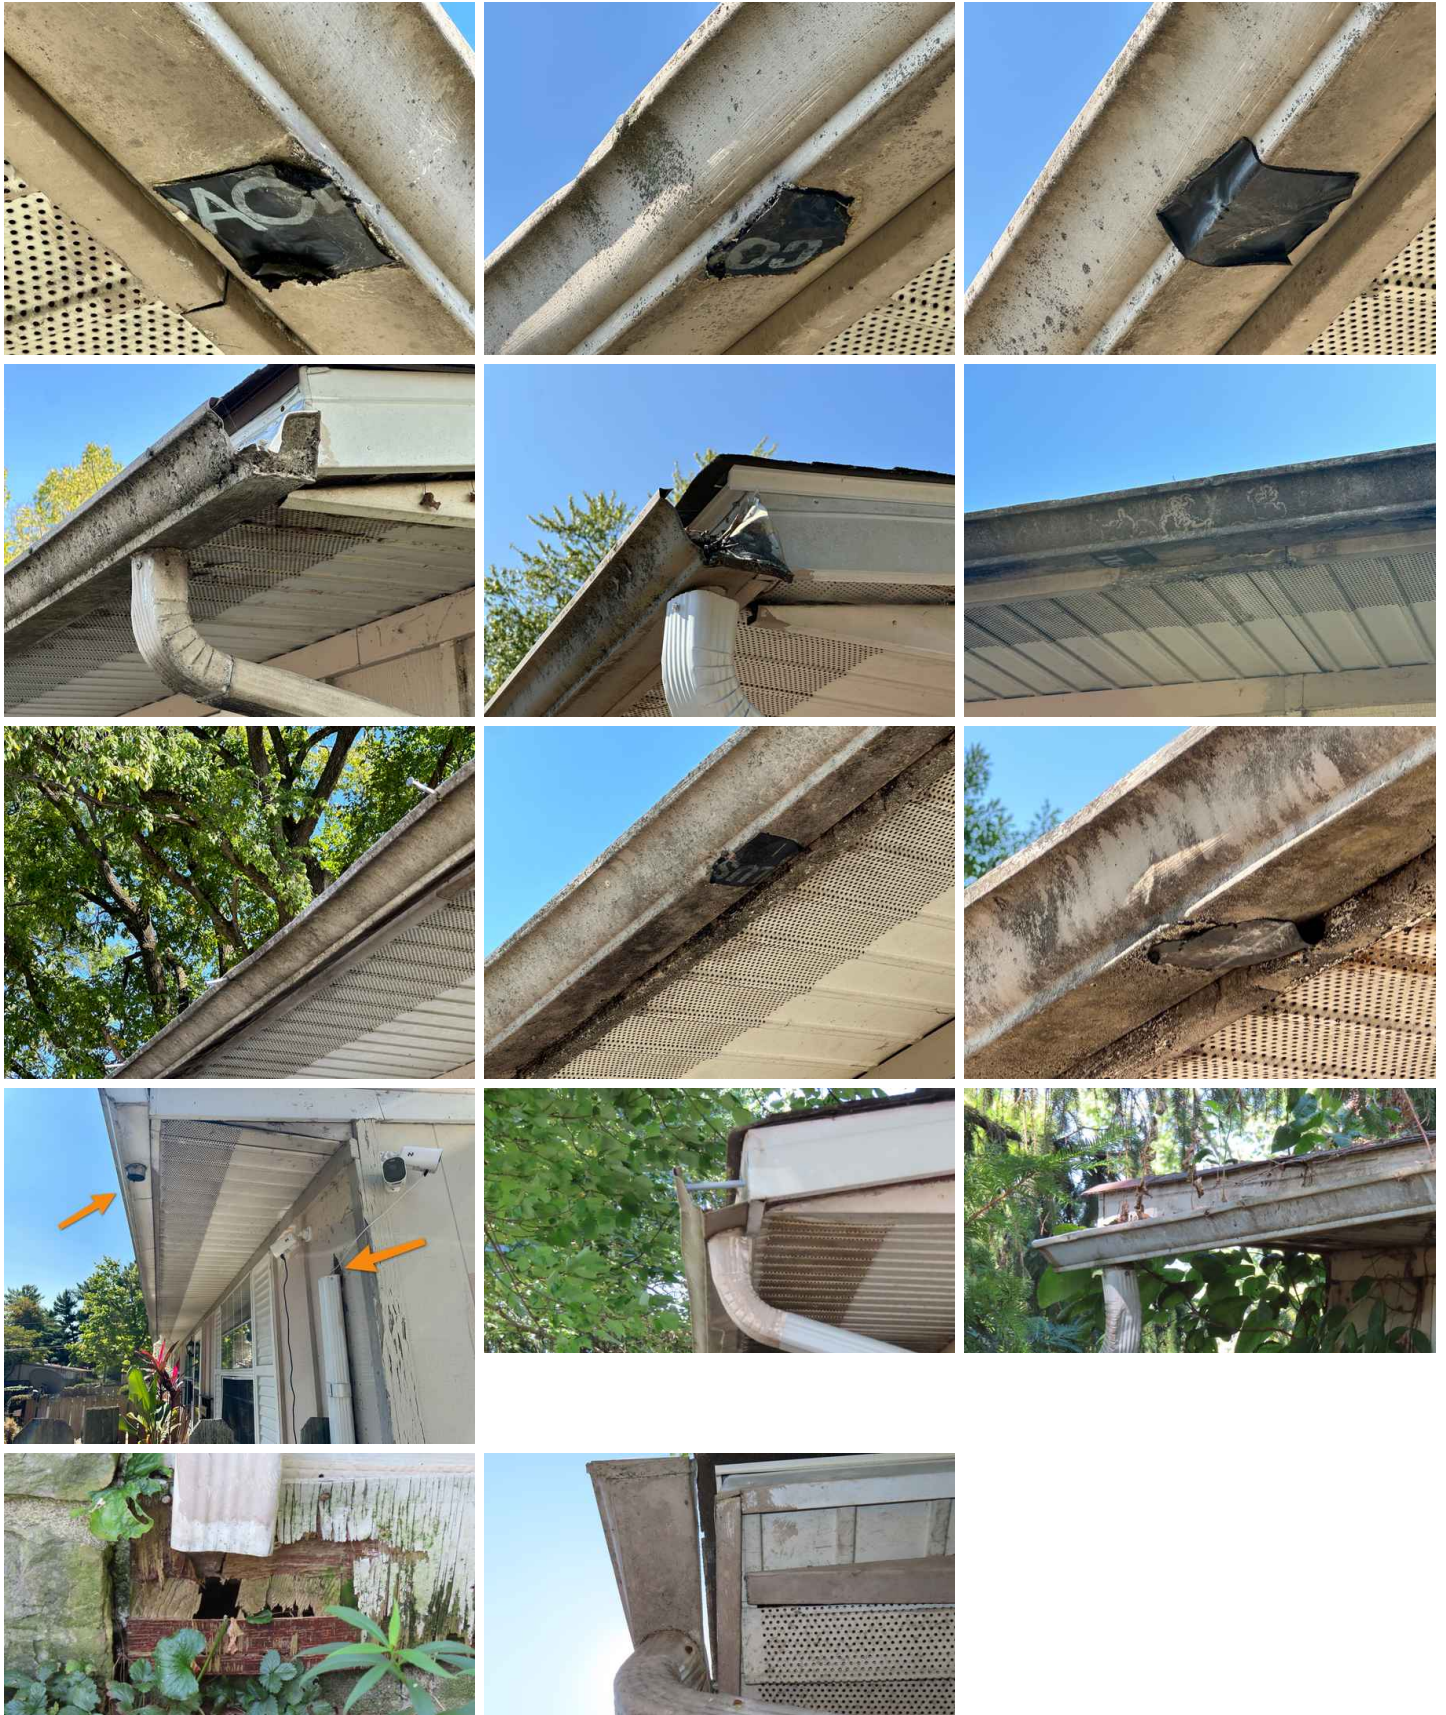
GUTTERS AND DOWNSPOUTS - END OF USEFUL LIFE

Multiple defects found.

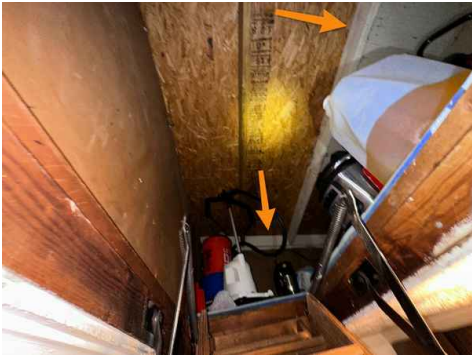
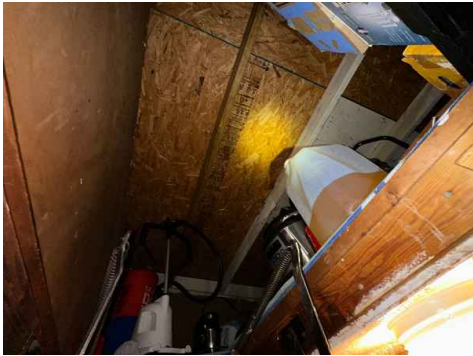
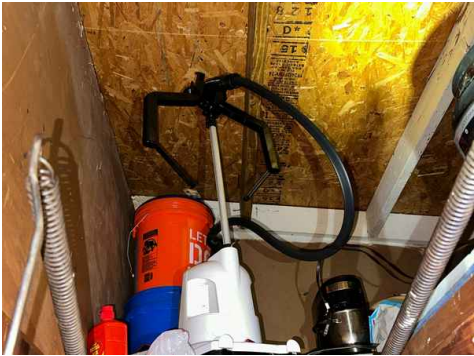
The framing of the roof structure was painted white in area(s). This is typically associated with either smoke restoration or mold remediation. I recommend consulting with the sellers as to why this was done and obtaining any applicable invoices of repairs.

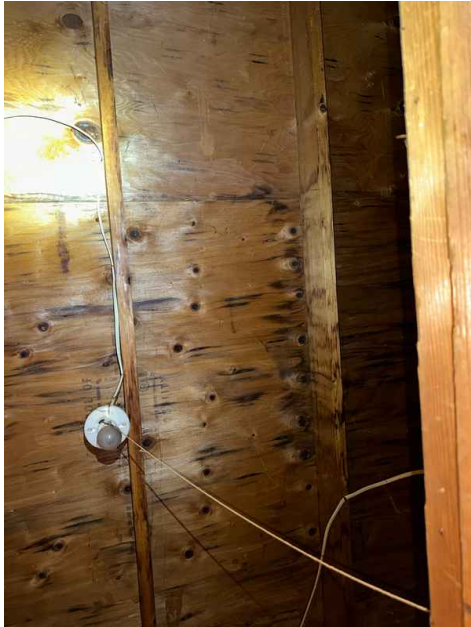
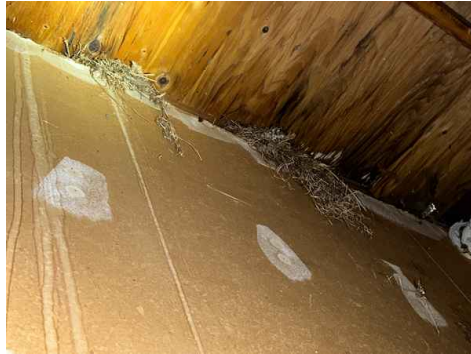
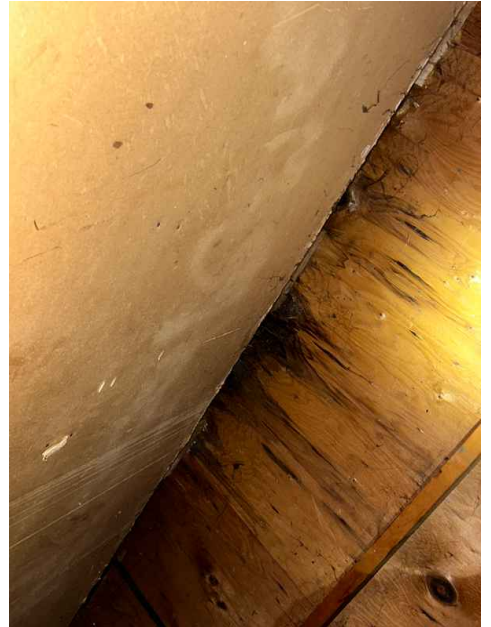
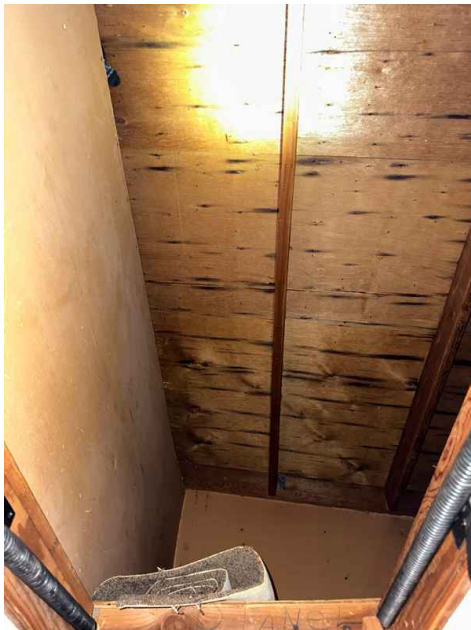
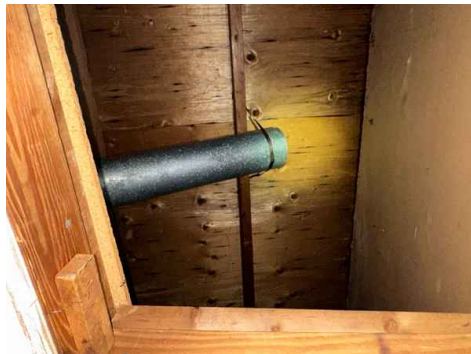
17.6.2 Roof Structure/Framing

**ROOF STRUCTURE - MOISTURE STAINS AT SHINGLE NAIL LOCATIONS
(INDICATION OF CONDENSATION)****MULTIPLE UNITS**

Moisture staining was present on the roof sheathing at shingle nail locations. This is indicative of moisture and/or high humidity allowing condensation to form on the roofing nails due to them having a lower dew point, in the right conditions. This can be the result of improper ventilation of the attic, moisture present in crawl space or basement areas reaching the attic via stack effect, and/or bathroom exhaust fans terminating in the attic. Or some combination of all of these issues.

Appears to be a bathroom fan venting inside the attic

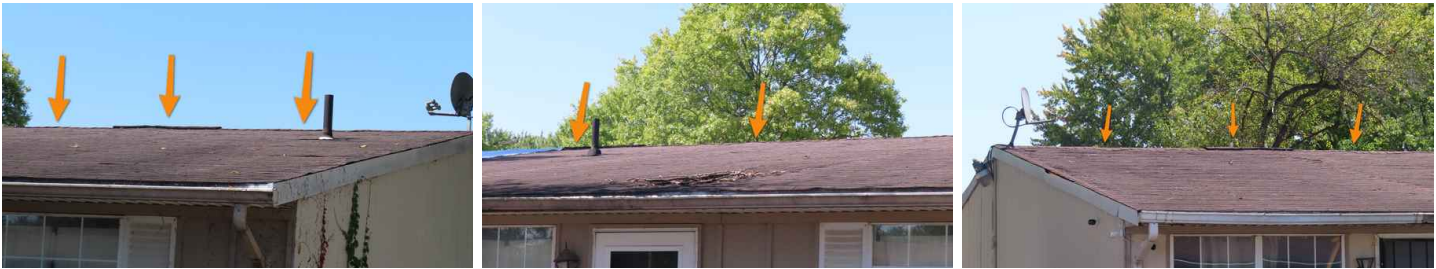
A section of the continuous ridge vent was missing and should be replaced as soon as possible to prevent damage from roof leakage. Overall, some of the roofs seemed to lack adequate ventilation.

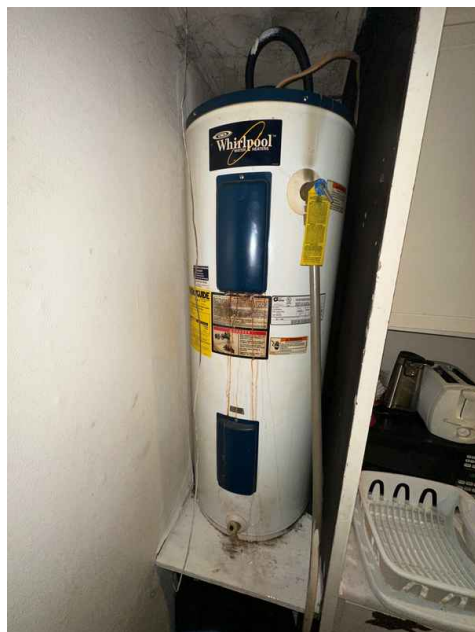
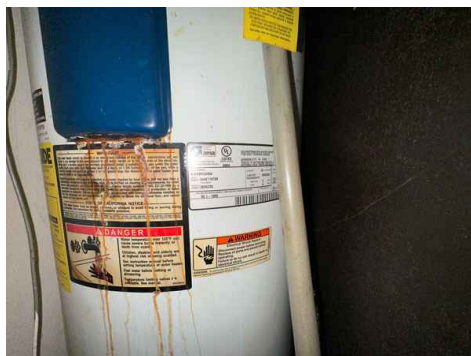
RUST STAINS, PREVIOUS LEAKAGE

Rust stains on side of tank below the burner element access panel of this water heater indicated that it has leaked previously.

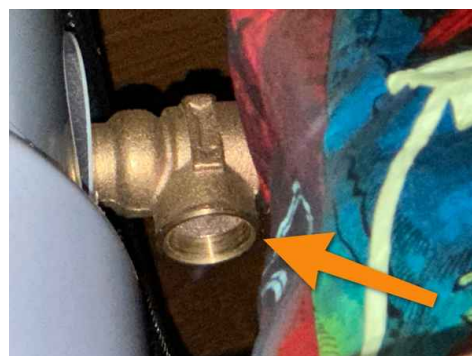
No discharge pipe was installed at the temperature/pressure relief (TPR) valve. The TPR valve is designed to open and release extremely hot water when water temperature or pressure inside the tank exceeds safe levels. With no discharge pipe installed, persons near the tank might be badly burned by hot water released by the TPR valve.

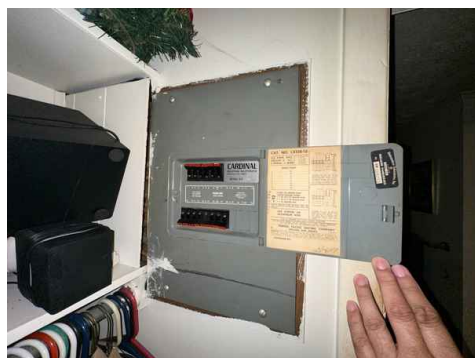
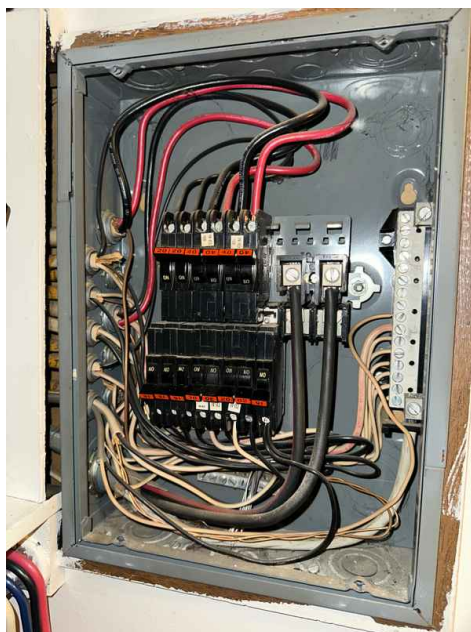
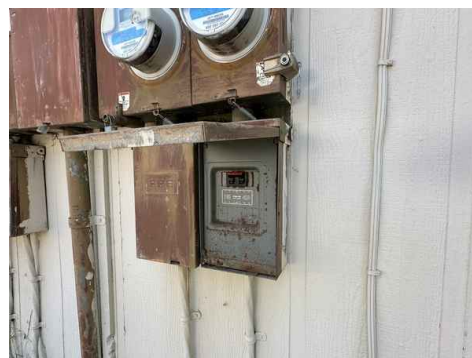
Priority / Safety Issue**BREAKERS - STAB LOK BRAND (DEFECTIVE)**

The property is equipped with a Federal Pacific Electric (FPE) Stab-lok brand electrical panel and breakers. Stab-lok load centers and their components are considered problematic by industry professionals due to their high failure rate as documented by the Consumer Products Safety Commission. Failure of any component within the electrical system may result in fire and/or electrocution. Evaluation of the panel by a qualified electrician is advised to determine its safety, integrity and performance. Replacement is the general recommendation.
