INSPECTION REPORT  
NON-INO

**PROPERTY ADDRESS:**  
84 School Street, Waldoboro, ME 04572

<b>Date:</b> 8/19/2024	<b>Time:</b> 09:00 AM	<b>Report ID:</b> 2024081902
<b>Property:</b> 84 School Street Waldoboro ME 04572	<b>Customer:</b> Alex Rowe	<b>Real Estate Professional:</b> Meriwether Gill Better Homes & Gardens Real Estate/The Masiello Group

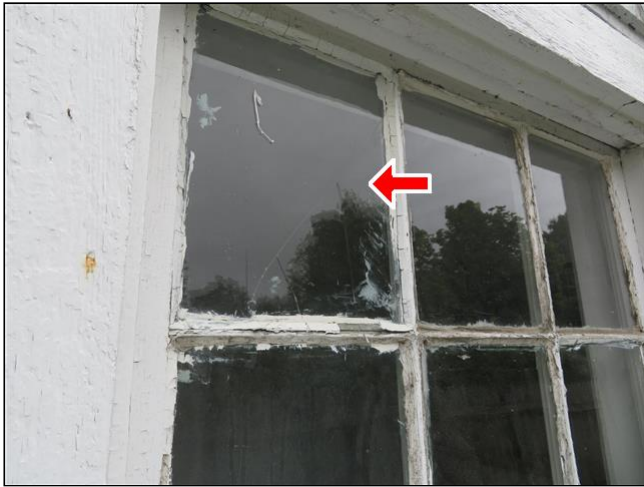
1.3 Item 5(Picture) Rear

(3) There is a crack in one of the rear windows. Cracked or broken windows are considered a potential safety concern as they present the risk of injury. Repairs should be effected to this an all occurrences of cracked glass.

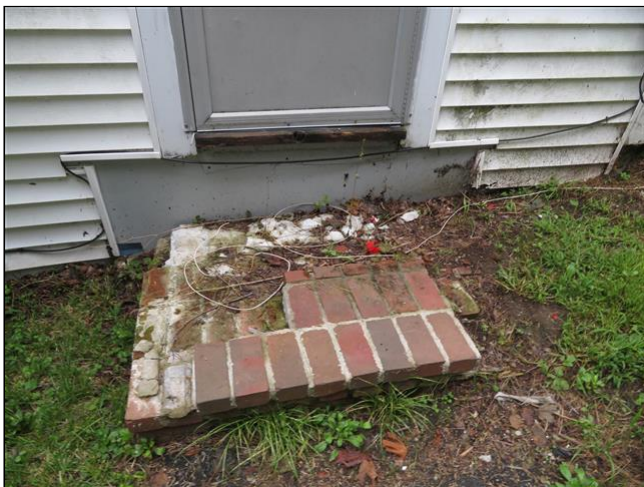
1.5 Item 5(Picture) Right side

(4) The right side steps were noted to be in a state of disrepair. There is a risk that the steps may become unstable and hazardous. It should be expected that the condition will deteriorate over time. It is recommended that the issue be further assessed and repairs effected.

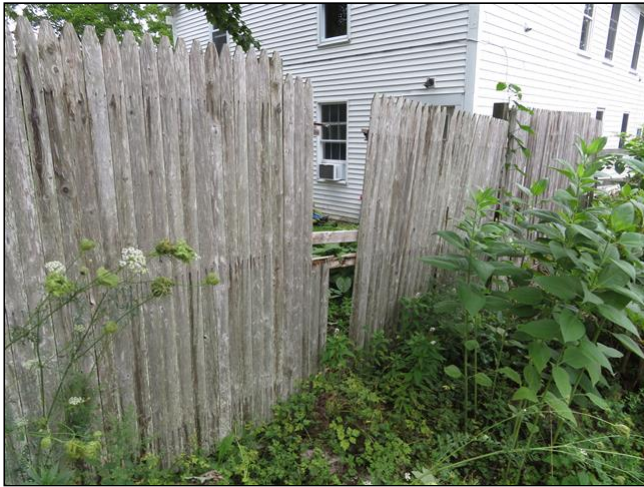
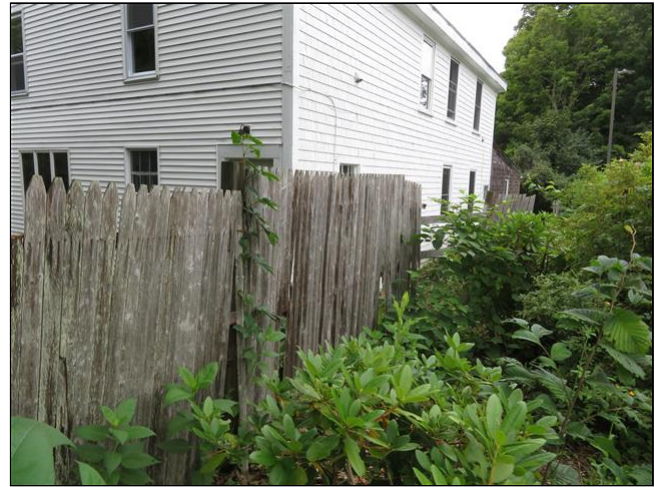
(4) The fence was noted to be in a state of disrepair. It will likely worsen with time and eventually fail. It is recommended that the issue be further assessed and repairs planned.

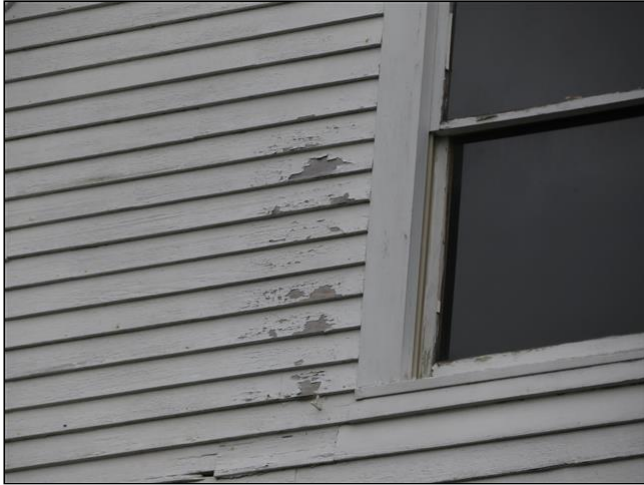
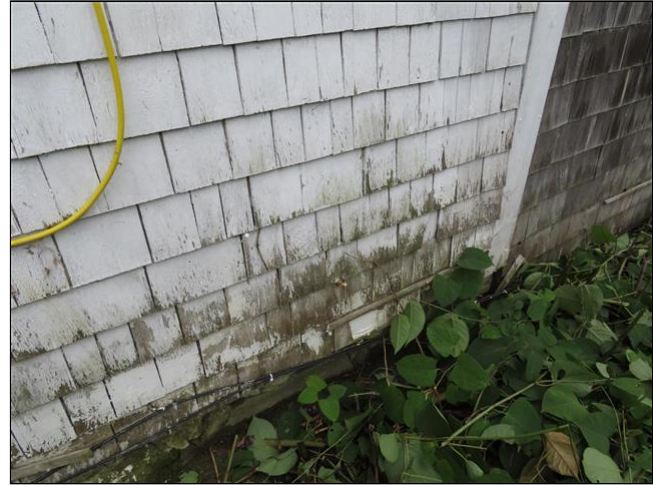
(1) The wood siding and trim generally appeared to be in a condition at least as good as would be expected for a building of this age and in this environment. Small areas require some maintenance, particularly with paint. Nothing of significant concern was noted.

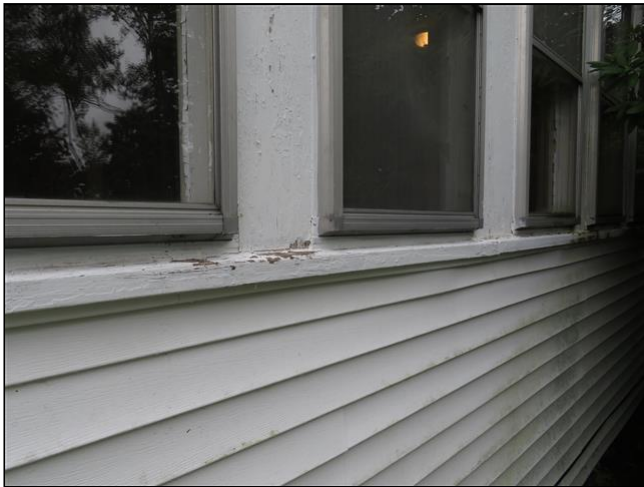
1.2 Item 3(Picture) Front

(2) Several areas of the trim and exterior were checked for rot. While small areas of rot were noted, the trim more generally was in need of new paint. Wood trim left unattended will decay and rot and potentially lead to issues such as water leaks, mold, and potential additional more extensive damage. Trim maintenance should be regarded as an ongoing activity and tended to from time to time.

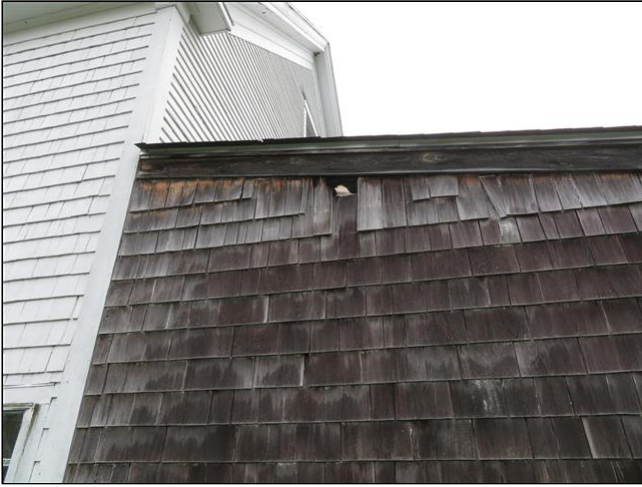
1.2 Item 4(Picture) Rear

(3) The siding on the structure is or includes wood shingles. Areas of the shingles presented in a condition reflecting moderate to advanced age and varying degrees of decay. The decay is in the form of discoloration, some rot, some splitting, and some curling. This is not unusual for older shingles. It is recommended that the most affected areas be repaired, and that repairs be effected to other areas as the decay continues. Some areas require repair now, and others will in the near future. It would also not be unreasonable to expect that ongoing maintenance and repairs will be required unless or until the siding is replaced.

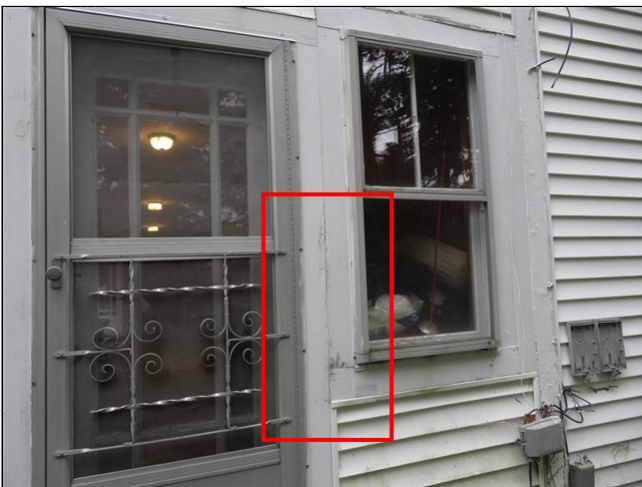
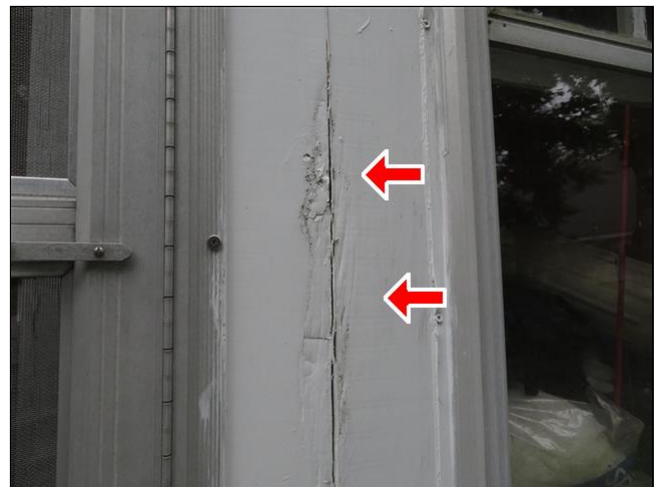
(5) Areas of the trim and exterior were noted to have areas of rot and decay. This is not unusual. Painted or not, wood trim will eventually rot when it is outdoors. Trim maintenance should be regarded as an ongoing activity and tended to from time to time. It is recommended that the issue be further assessed and required repairs effected.

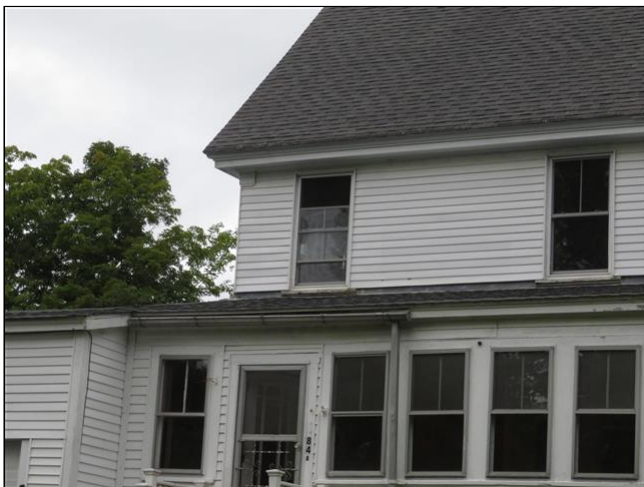
1.3 Item 1(Picture) Front

(2) A degree of decay and rot was noted with the front exterior window trim. While the issue did not appear significant at the time of the inspection, continued decay may lead to issues of water intrusion and damage to adjacent components. It is recommended that repairs be effected and that these components be monitored from time to time for further such issues in the future. (Note: The photos are not an exhaustive list of the affected areas, but a representation.)

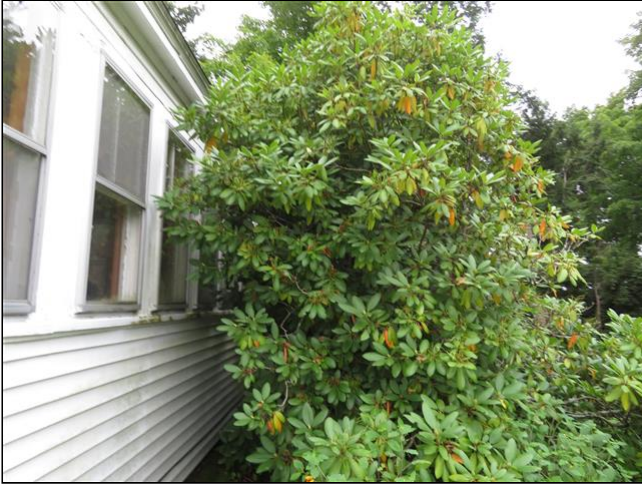
1.6 Item 8(Picture) Front

(5) Vegetation is in contact with the structure or foundation in one or more places. When vegetation is allowed to grow on to or touch a structure it can allow excessive moisture to build up in the area and also facilitate the entry of insects and pests to the structure. Moisture build-up can facilitate the growth of mold, mildew and rot. Vegetation should be kept trimmed and away from contact with buildings. This should be regarded as a normal ongoing maintenance activity.

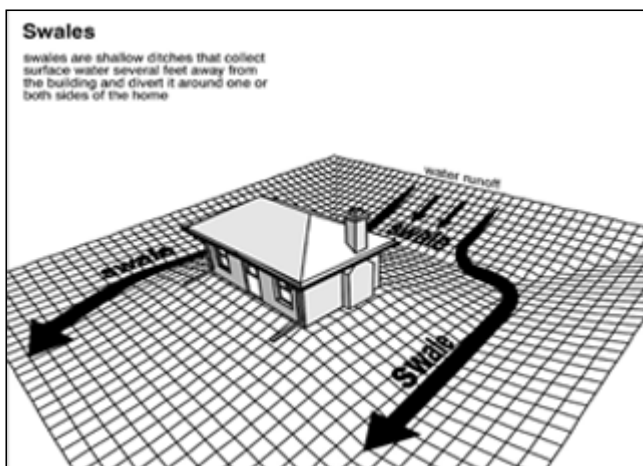
1.6 Item 9(Picture) Illustration

(6) The general grading at the rear of the building was pitched into the building (negative pitch). Ideally grading should be pitched away from the building, or such that the building is higher and the ground drops away (positive pitch). The issue with a negative pitch is that water is guided towards the foundation of the building which can lead to basement moisture issues and potentially foundation erosion issues. Some limited evidence presented in the basement of water intrusion (moisture). The scale and magnitude of the issue suggest that remediation approaches should be considered. Such approaches could include swales, re-grading, and perimeter drainage systems.

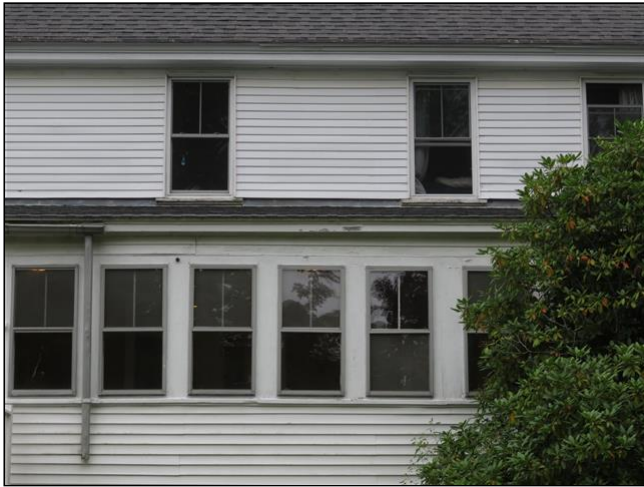
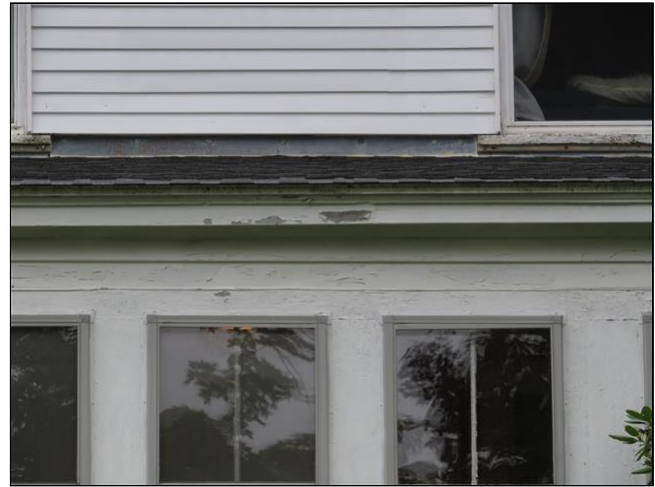
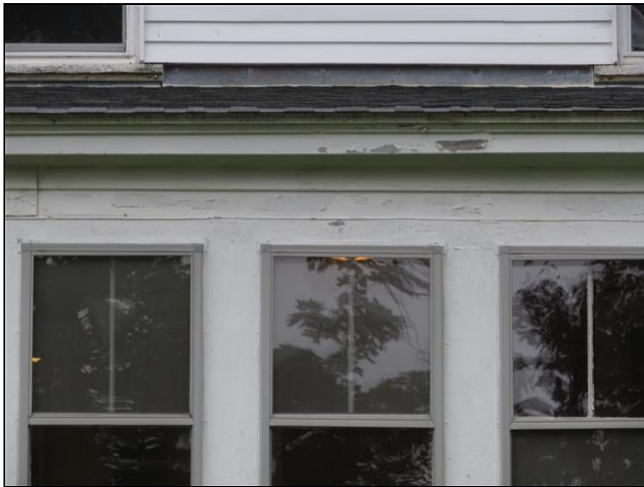
(1) Some minor areas of failing and peeling paint were observed on areas of the fascia and soffit. The extent of the damage that was observed would be regarded as relatively minor. While this type of deterioration of the paint is not unexpected with wood trim, it does require periodic repair and maintenance. When left unattended, the paint will continue to decay exposing the underlying wood which will be at risk for rot and decay. It is suggested that repair and maintenance of the painted wood be considered as a regular ongoing maintenance activity and be attended to. (Note: The photos are not an exhaustive list of the affected areas, but a representation.)

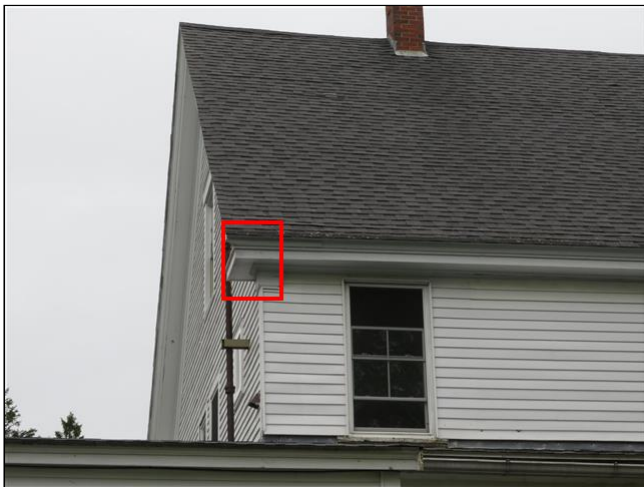
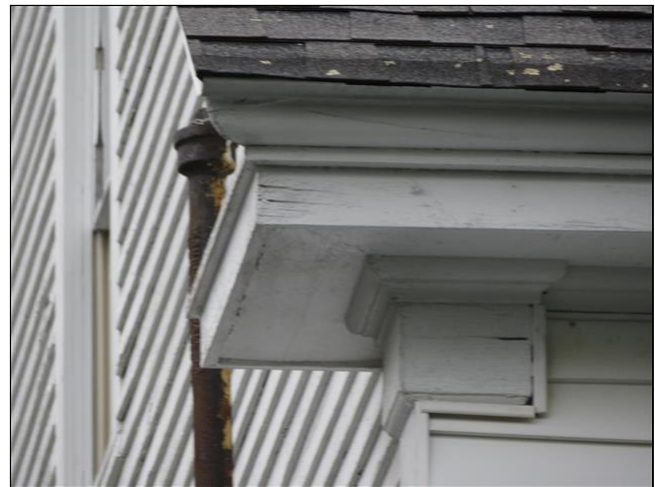
(2) Some minor areas of rot and decay were noted on the fascia in areas around the building. The extent of the damage that was observed would not yet be regarded as significant or large-scale. While this type of deterioration is not unexpected with wood components, it does require periodic maintenance and repair. When left unattended, such areas can develop and require significant repair an reconstruction. It is suggested that repair and maintenance of the wood be considered as a regular ongoing maintenance activity and be attended to. (Note: The photos are not an exhaustive list of the affected areas, but a representation.)

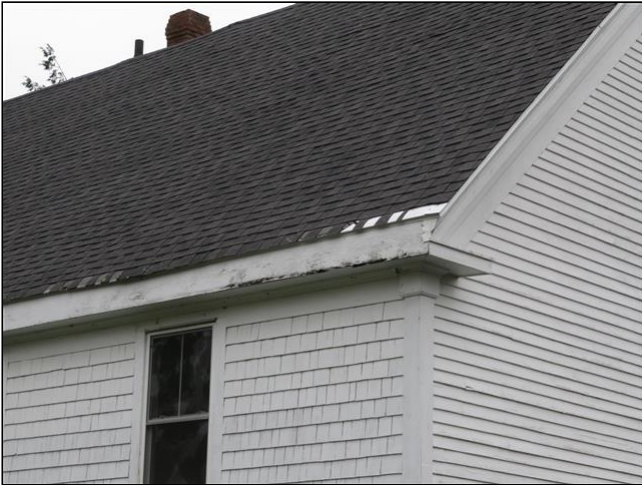
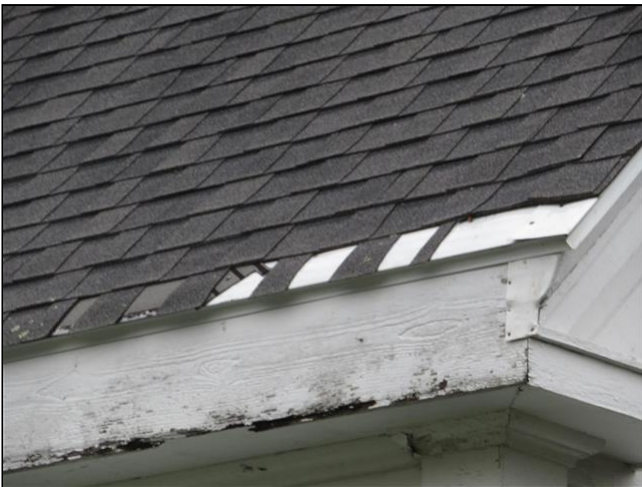
(3) Some areas of rot and decay were noted on the fascia in areas around the building. The extent of the damage that was observed would not yet be regarded as large-scale. While this type of deterioration is not unexpected with wood

components, it does require periodic maintenance and repair. When left unattended, such areas can develop and require significant repair an reconstruction. It is suggested that repairs be effected and maintenance of the wood be considered as a regular ongoing maintenance activity and be attended to. (Note: The photos are not an exhaustive list of the affected areas, but a representation.)

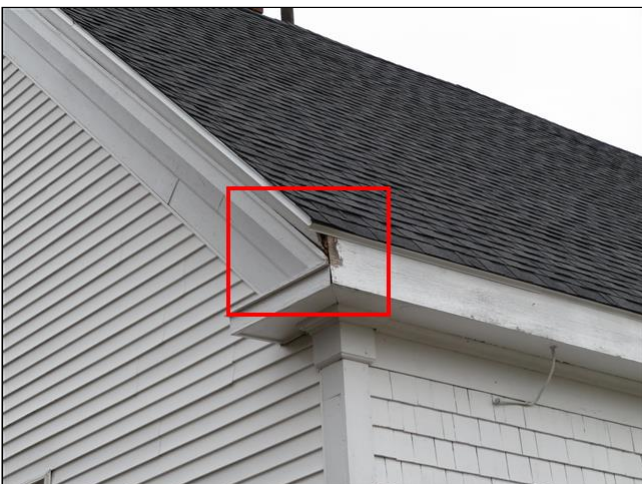
1.7 Item 9(Picture) Rear

(4) Defects (gaps, voids, or opening) were noted in the rear fascia and trim. Such openings can allow pests (insects or rodents) to gain access and nest. There is also a risk of water intrusion that can result in rot or mold issues. It is advisable that repairs be effected.

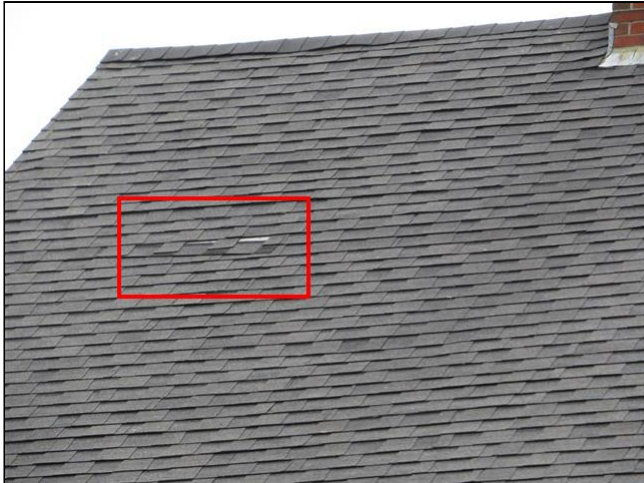
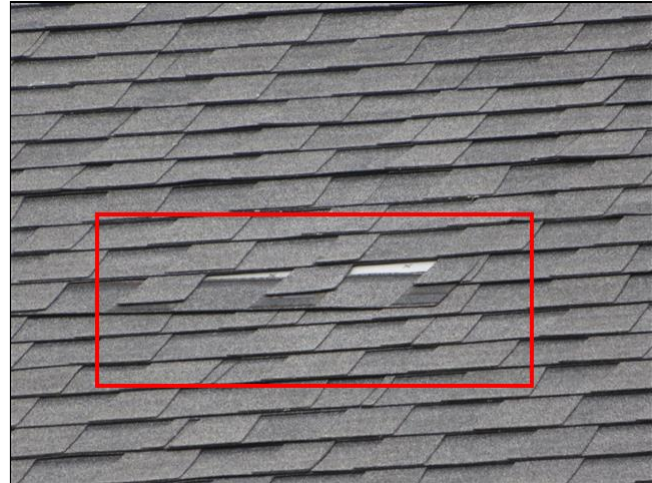
(1) Areas of the front roof displayed damaged or failed shingles. When roof covering material fails, moisture can enter the structure below potentially causing rot, mold, mildew and potential failure of the underlying structure, as well as water damage to any possessions or property that may become exposed. It is advisable that any areas in question be repaired.

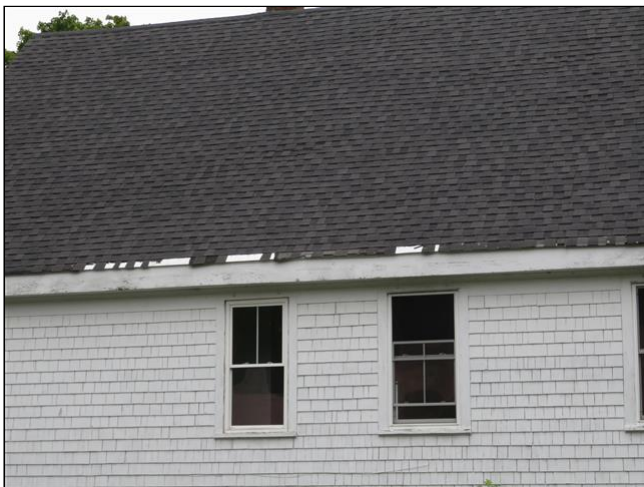
2.1 Item 3(Picture) Rear

(2) Areas of the rear roof displayed damaged or failed shingles. When roof covering material fails, moisture can enter the structure below potentially causing rot, mold, mildew and potential failure of the underlying structure, as well as water damage to any possessions or property that may become exposed. It is advisable that any areas in question be repaired.

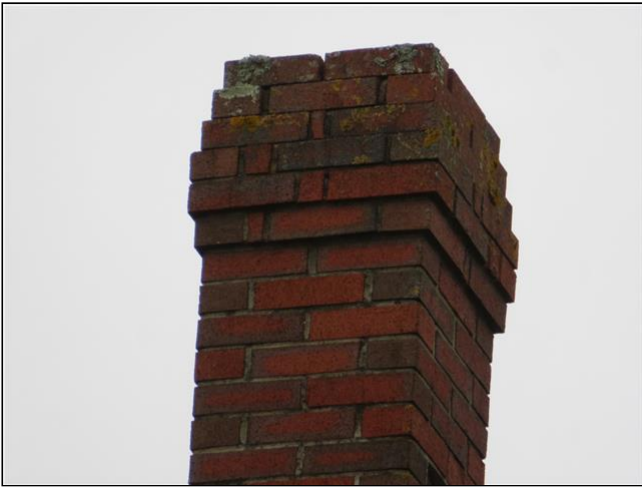
2.3 Item 5(Picture) Left side chimney

(2) The left side chimney was noted to be in a minor state of disrepair. Loose brick(s) were noted. Left unrepaired, there is a risk of the bricks falling and causing damage. Missing bricks can also result in further damage to the chimney. It is recommended that the issue be further assessed and required repairs effected.

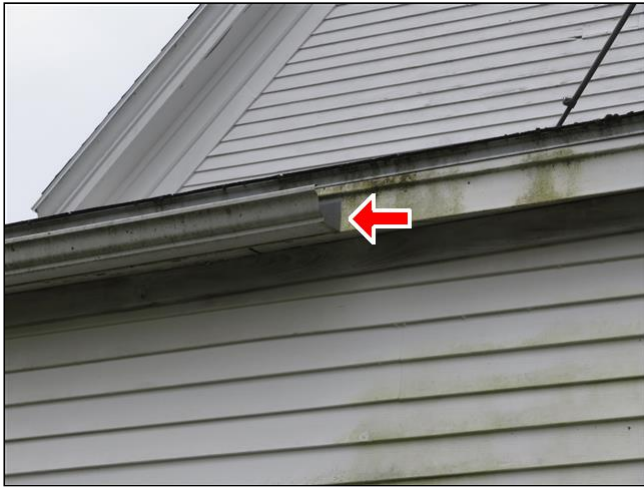
2.4 Item 2(Picture) Left side

(2) The end cap is missing on the left side gutter. Gutters should be in good working order in order to perform their intended function of directing water away the perimeter of the building. It is recommended that repairs be effected (and repairs be effected for all such occurrences).

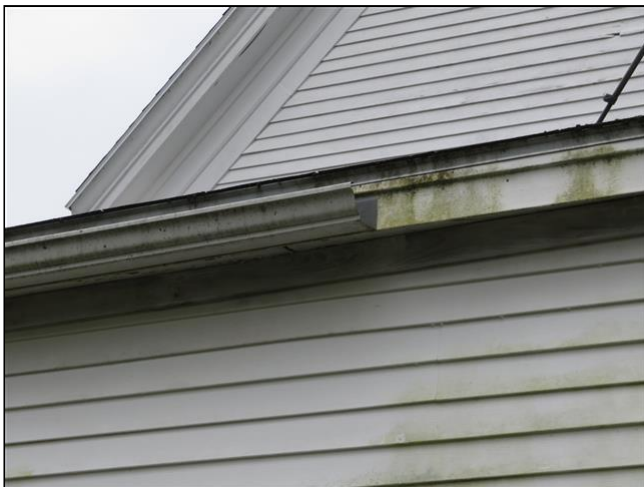
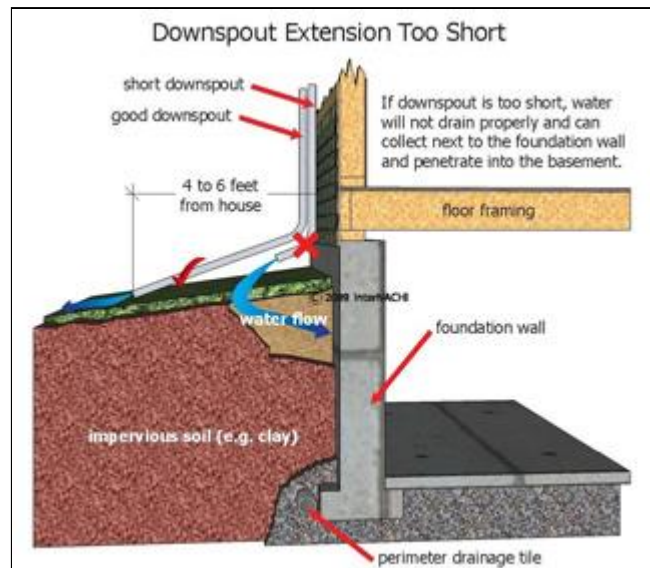
(3) The downspouts were observed to drain at the foundation of the building. Best practices suggest that downspouts should be directed to drain 4 to 6 feet away from foundations. Not doing so can lead to the foundation being exposed to excessive water and moisture and might result in water penetration, leaks, and excessive moisture in the basement. It is recommended that modifications and repairs be effected to all such instances.

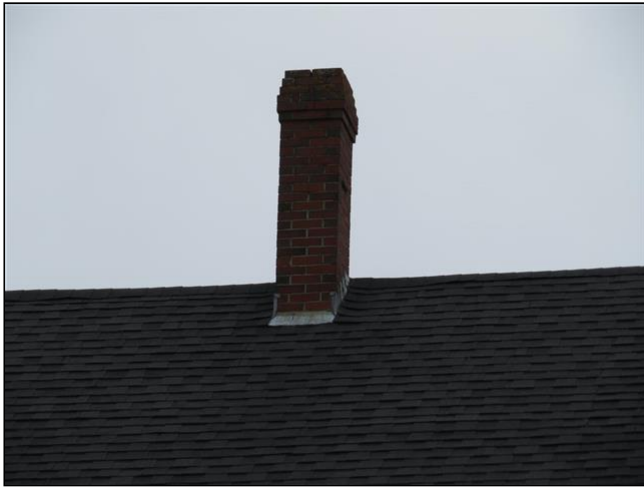
2.3 Item 1(Picture) Left side chimney

(1) It appeared that the chimney cap may be decayed or otherwise deficient. The chimney cap is an important component that helps prevent water (and snow/ice) from accumulating on top of the chimney. Moisture that accumulates on top of the chimney in the winter time can freeze and further damage the chimney materials. In the warmer months, the moisture can seep into the mortar and brick and degrade the structure. It is recommended that repairs be considered.

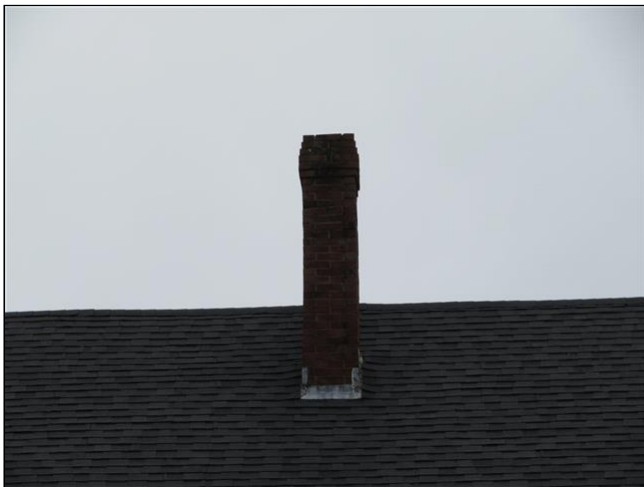
2.3 Item 10(Picture) Right side chimney

(3) It appeared that the chimney cap may be decayed or otherwise deficient. The chimney cap is an important component that helps prevent water (and snow/ice) from accumulating on top of the chimney. Moisture that accumulates on top of the chimney in the winter time can freeze and further damage the chimney materials. In the warmer months, the moisture can seep into the mortar and brick and degrade the structure. It is recommended that repairs be considered.

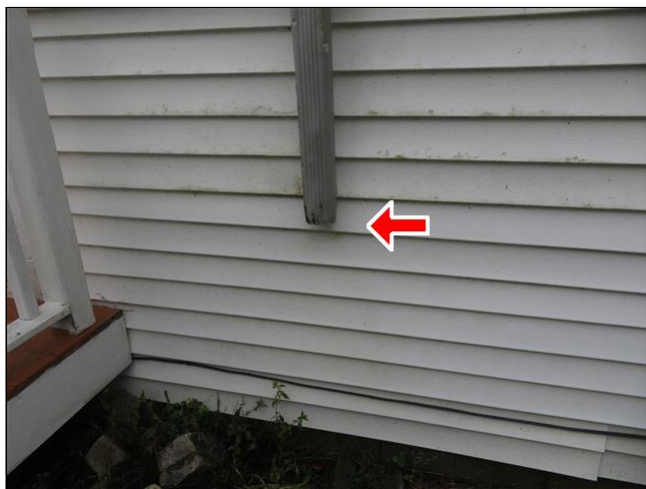
2.4 Item 1(Picture) Front

(1) The downspouts were observed to drain at the foundation of the building. Best practices suggest that downspouts should be directed to drain 4 to 6 feet away from foundations. Not doing so can lead to the foundation being exposed to excessive water and moisture and might result in water penetration, leaks, and excessive moisture in the basement. It is recommended that modifications and repairs be effected.

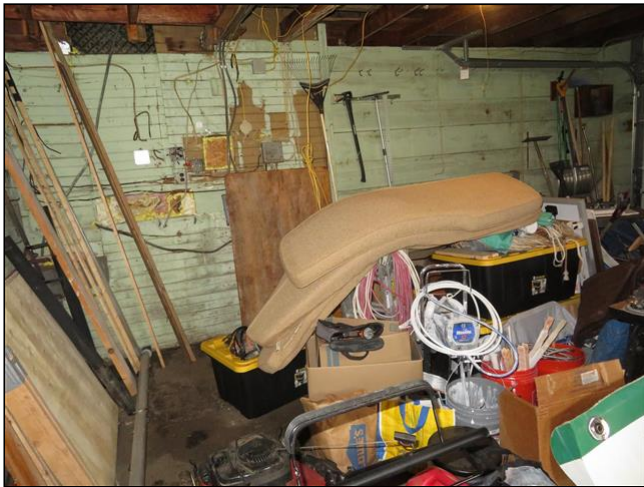
3.1 Item 1(Picture) Attached garage

In all cases it is expected that there is a degree of air sealing to inhibit the seepage of gasses from the garage into the adjacent living spaces. While the specific requirements of areas may vary, it is widely accepted that the above standards are regarded as a life and safety issue, and should be complied with (regardless of the age of the house). It is recommended that the issue be further assessed (e.g. consult the authority having jurisdiction) and any required repairs effected.

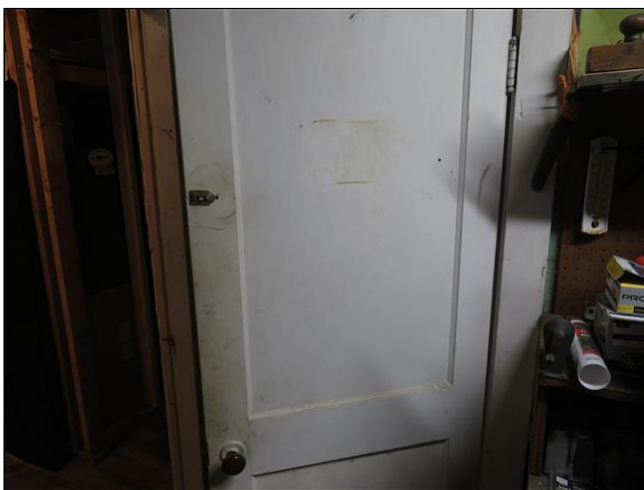
3.7 Item 1(Picture) Attached garage

The occupant door from inside the garage area to inside the living space (including basements and attics) appears potentially not to be a fire rated door. This means that should a fire occur in garage, the occupant door does not afford protection until fireman arrive. By today's standards, and depending upon the area, it is conventionally expected (according to standards) that: *"Openings from a private garage directly into a room used for sleeping purposes shall not be permitted. Other openings between the garage and residence shall be equipped with solid wood doors not less than 1 3/8 inches (35 mm) in thickness, solid or honeycomb core steel doors not less than 1 3/8 inches (35 mm) thick, or 20-minute fire-rated doors."* While the specific requirements of areas may vary, it is recommended that the issue be further assessed (e.g. consult the authority having jurisdiction) and any required repairs effected. Additional discussion of this type of issue can be found in the "General Comments" section of this report in the sub section titled "Life and Safety Issues and Considerations".

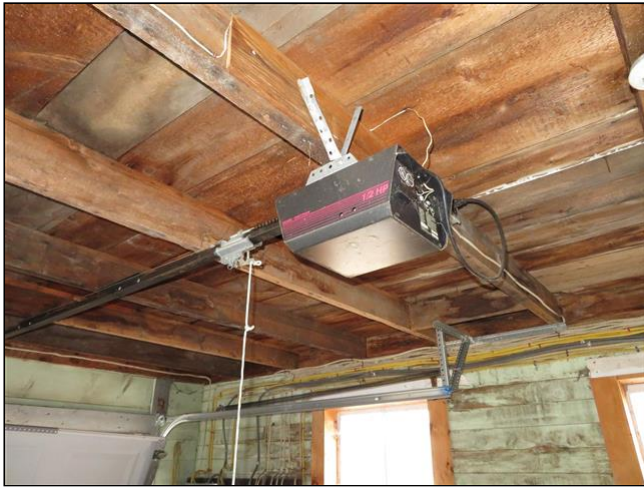
3.8 Item 1(Picture) Attached garage

It was noted that the left garage operator was not working at the time of the inspection. It is recommended that the issue be further assessed and required repairs effected.

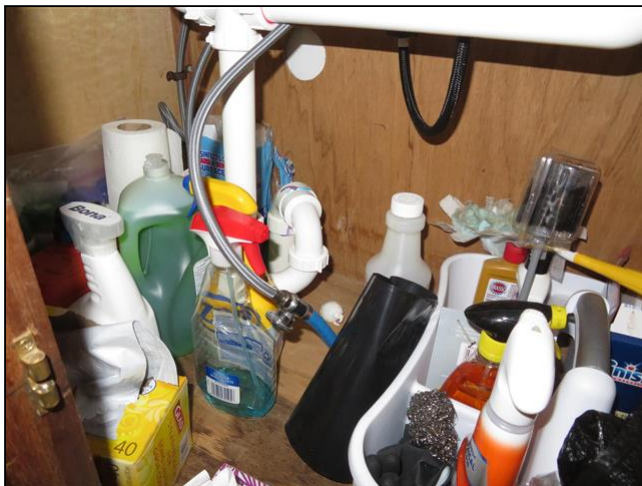
4.7.A Item 1(Picture) Kitchen

(1) The style of drain trap in the kitchen is called an "S-trap". This type of trap is not used as there is a risk of it being evacuated which can result in sewer gasses leaking into the living space. Properly functioning are important components that help prevent sewer gasses from escaping into living spaces from sewer system. It is recommended that the issue be further assessed and required repairs effected. There are two common approaches to resolving the issue. The first is to replace the trap with a "P-trap" and connect it to a vent. This can be a complicated and costly repair. The other common approach is to replace the S-trap with a drum trap (picture in the second illustration) or to use an air admittance valve. Finally, there are instances where the installation of an "air admittance valve" can be an option. It should be noted that there is an argument made that when the drain line is 2" or larger, the issue of an "S-trap" is not as much of a concern as pipe that large is difficult to evacuate.

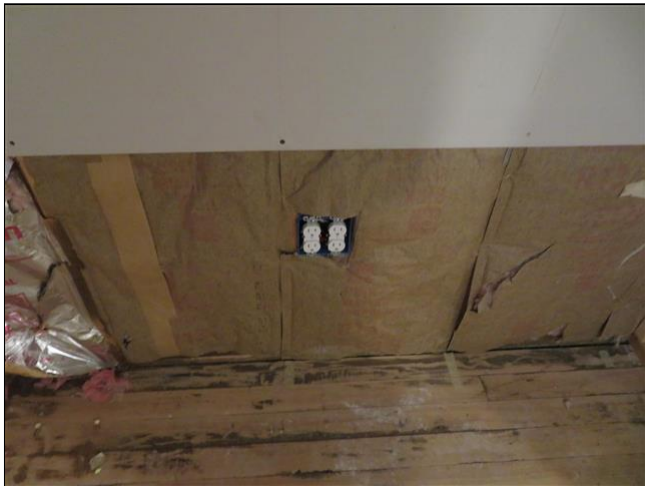
4.15.A Item 2(Picture) Utility room

(3) Electrical boxes without covers were noted in the utility room. Uncovered electrical boxes are safety hazards as they pose a risk of electric shock. It should also be noted that all metal electrical boxes should be grounded. It is advisable that all open/uncovered electrical boxes have an appropriate cover installed and any missing grounding installed.

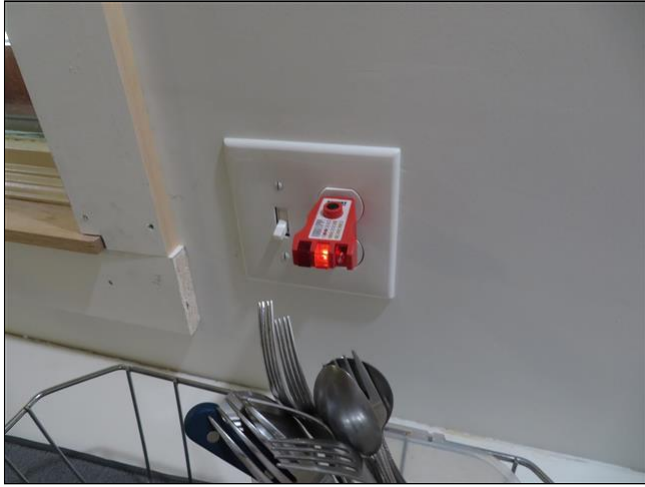
4.16.A Item 1(Picture) Kitchen

The receptacles noted over or near the kitchen counter were not GFCI (Ground Fault Circuit Interruption) protected. Receptacles in wet areas (such as kitchens, bathrooms, garages, outside, and unfinished basements) can pose shock hazards if they are not on GFCI-protected circuits. Additionally, all receptacles over kitchen counters are supposed to be GFCI-protected (regardless of proximity to a water source). It is advisable that repairs or modifications be made by installing GFCI protection to this receptacle (and all other required receptacles).

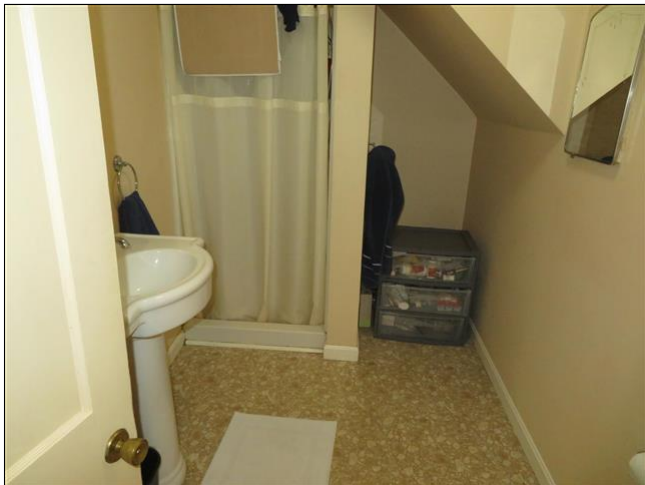
4.18.A Item 1(Picture) Hall bath

(2) The hall bath did not have an exhaust or ventilation fan. They are particularly beneficial when there are no windows, and in fact are required. Bathrooms can introduce a substantial amount of moisture into the air in a home, and excess air moisture can potentially lead to issues relating to mold, mildew and unhealthy indoor air quality. It is recommended that a bathroom exhaust fan be installed.

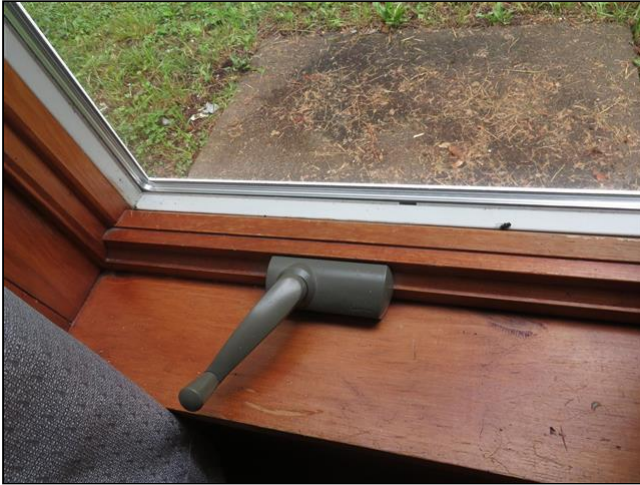
4.5.A Item 1(Picture) Living room

The mechanisms that operate the windows in the living room was in a state of disrepair. It is recommended that the mechanism (and all other inoperable mechanisms) be repaired or replaced.

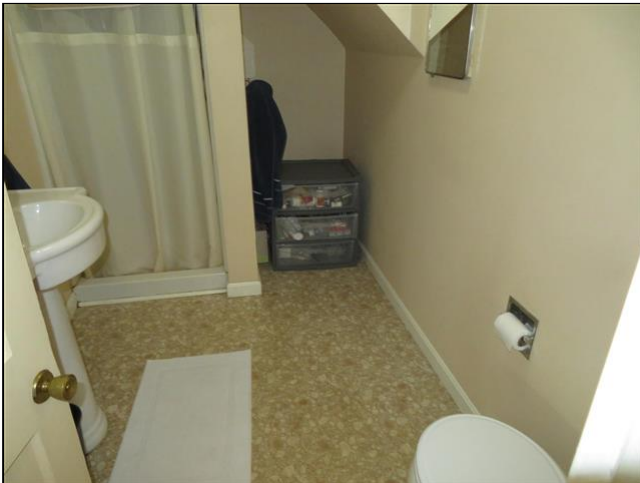
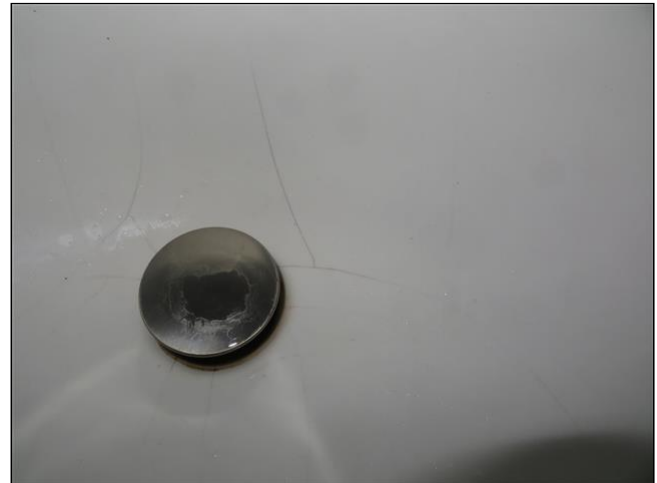
(2) A bathroom sink in the hall bath was noted to be cracked and/or broken. It is recommended that the sink be replaced.

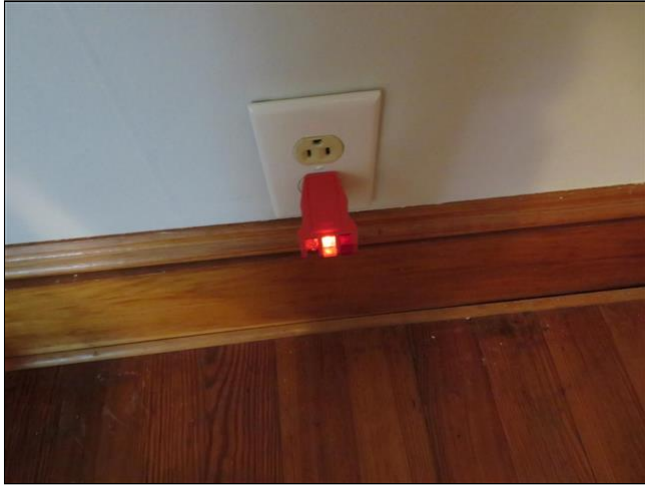
4.15.A Item 1(Picture) Living room

(2) Ungrounded 3-pin receptacles were observed in the living spaces. Such receptacles are regarded as potentially unsafe as it is possible for appliances to malfunction resulting in injury or damage to a person or object. The risks posed can be mitigated to an extent by exercising caution when using such a receptacle and ensuring that electrical appliances are in good working order. While a more significant issue in wet areas, ungrounded outlets should be replaced with grounded ones when possible. It is recommended that the issue be further assessed and any required repairs effected.

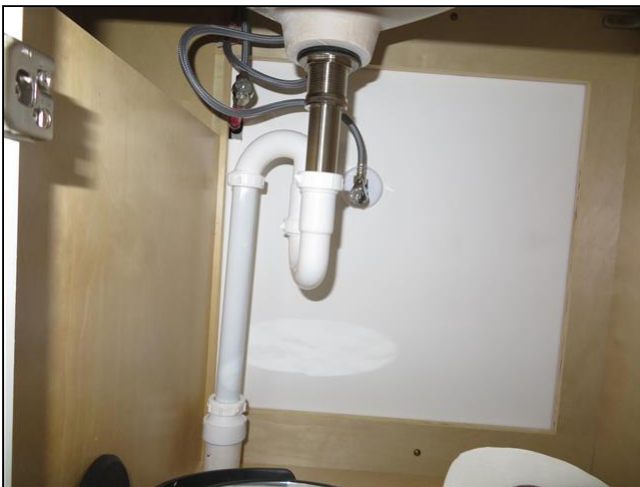
4.8.B Item 1(Picture) Bathroom

(1) The style of drain trap in the hall bath is called an "S-trap". This type of trap is not used as there is a risk of it being evacuated which can result in sewer gasses leaking into the living space. Properly functioning are important components that help prevent sewer gasses from escaping into living spaces from sewer system. It is recommended that the issue be further assessed and required repairs effected. There are two common approaches to resolving the issue. The first is to replace the trap with a "P-trap" and connect it to a vent. This can be a complicated and costly repair. The other common approach is to replace the S-trap with a drum trap (picture in the second illustration) or to use an air admittance valve.

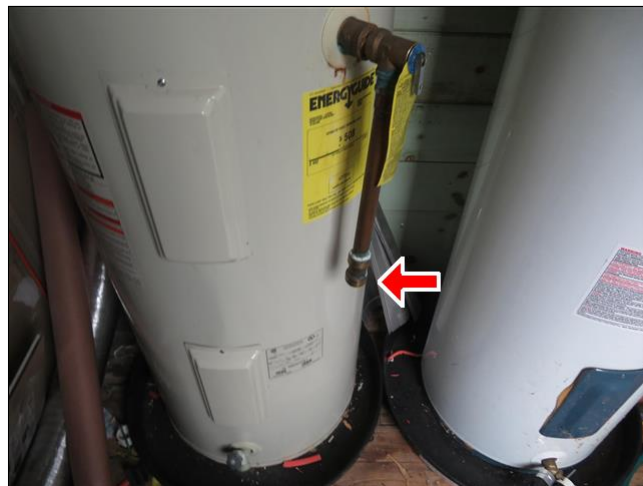
4.10.B Item 2(Picture) Utility room

(5) The drain pipe connected to the temperature pressure relief (TPR) valve on the water heater is not installed appropriately or is missing. Such pipes are supposed to be:

- made of a material that is used for distribution; copper, CPVC, PEX, or other such material;
- made of a material that is not plastic or PVC;
- of a constant diameter;
- free of valves or closing devices;
- drain in such a way as to not pose a flooding risk or potential damage to the interior of the building; and,
- extended to within 6 inches of the ground.

TPR valves and their related plumbing are a safety feature that divert hot water and/or steam out of a water heater and safely to the ground. It is recommended that repairs be effected. Further information may be available from the authority having jurisdiction.

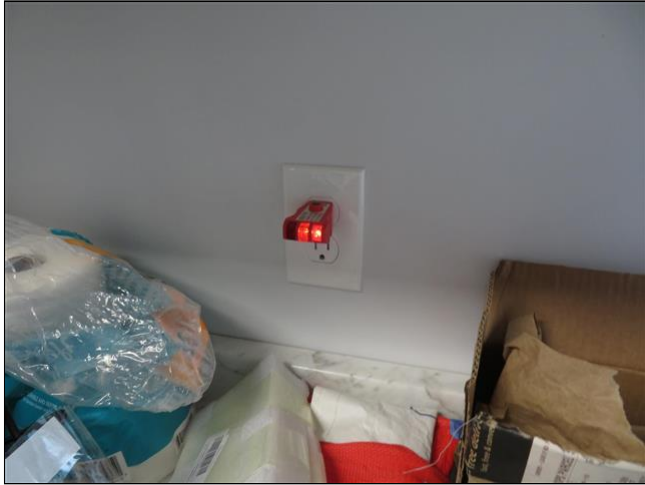
4.17.B Item 1(Picture) Kitchen

(1) The receptacles noted over or near the kitchen counter were not GFCI (Ground Fault Circuit Interruption) protected. Receptacles in wet areas (such as kitchens, bathrooms, garages, outside, and unfinished basements) can pose shock hazards if they are not on GFCI-protected circuits. Additionally, all receptacles over kitchen counters are supposed to be GFCI-protected (regardless of proximity to a water source). It is advisable that repairs or modifications be made by installing GFCI protection to this receptacle (and all other required receptacles).

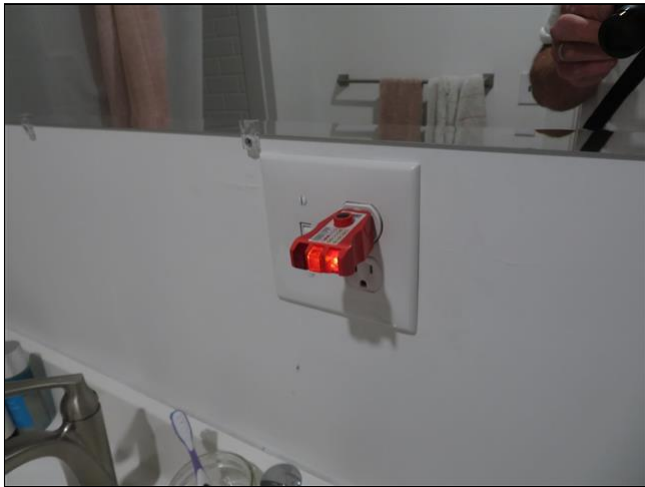
4.17.B Item 2(Picture) Bath

(2) The receptacle noted in the bath was not GFCI (Ground Fault Circuit Interruption) protected. Receptacles in wet areas (such as kitchens, bathrooms, garages, outside, and unfinished basements) can pose shock hazards if they are not on GFCI-protected circuits. It is advisable that repairs or modifications be made by installing GFCI protection to this receptacle (and all other required receptacles).

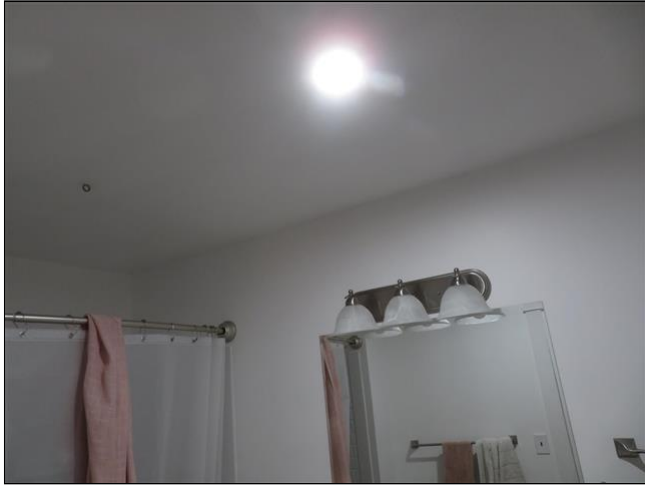
4.19.B Item 1(Picture) Bathroom

(1) The hall bath did not have an exhaust or ventilation fan. They are particularly beneficial when there are no windows, and in fact are required. Bathrooms can introduce a substantial amount of moisture into the air in a home, and excess air moisture can potentially lead to issues relating to mold, mildew and unhealthy indoor air quality. It is recommended that a bathroom exhaust fan be installed.

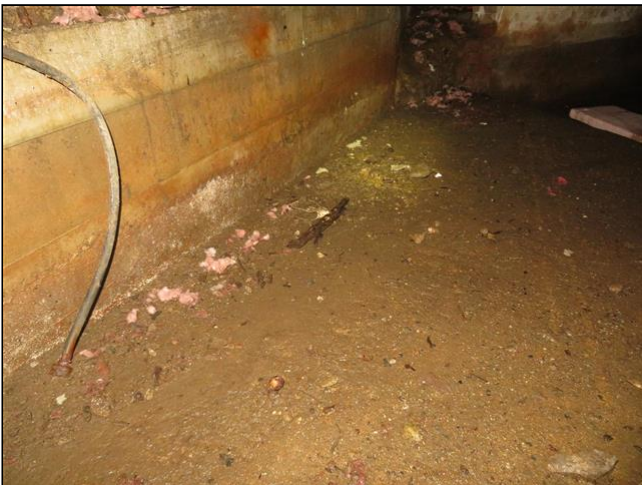
5.1 Item 6(Picture) Basement

(11) Evidence of water intrusion was noted in the basement. While not a large scale issue, it is recommended that means be undertaken to mitigate the issue. Water intrusion into a basement or crawlspace area through the walls can, over time, lead to the degradation of the integrity of the foundation walls. Such measures may include ensuring the proper operation of the gutters in the adjacent exterior area, ensuring that water cannot accumulate around the foundation, and ensuring that exterior perimeter drainage is working.

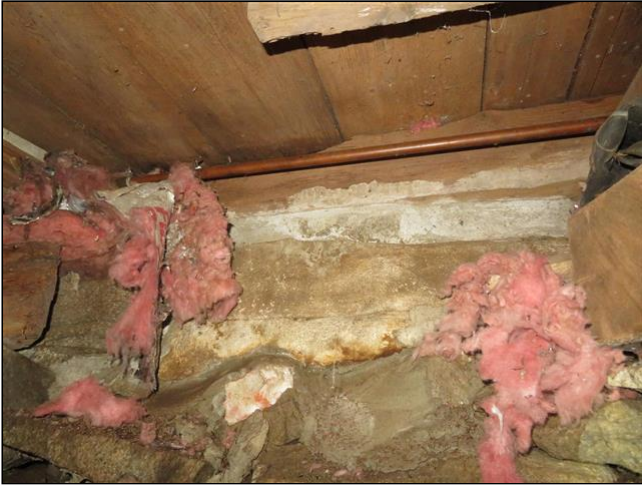
5.1 Item 7(Picture) Basement

(12) Evidence of pests were observed in the basement. Patterns and disturbance in materials (insulation) consistent with nesting or intrusion were noted. Other evidence was also noted in the form of sebum trails or other disturbances. This appearance of nesting materials is similar in appearance to those made by mice. It is recommended that means be undertaken to remove the pests from the building, and that the nesting and other areas be cleaned and removed. Further, it is recommended that the damaged insulation be replaced.

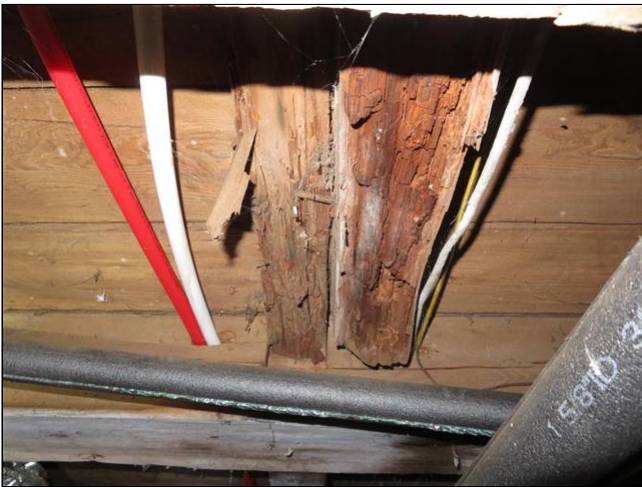
5.5 Item 1(Picture) Crawlspace

(2) Some of the floor joists (basement ceiling structure) presented with some degree of decay. The degree of damage was notable and appeared extensive. There is a risk that the damage may have resulted in structural compromise. It is recommended that the issue be further assessed and required repairs effected.

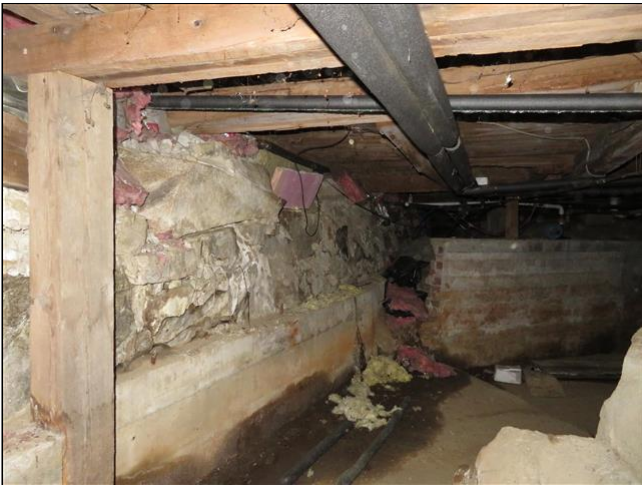
5.1 Item 3(Picture) Crawlspace

(9) Minor evidence of water intrusion was noted in the crawlspace. While not significant, it is recommended that means be undertaken to mitigate the issue. Water intrusion into a basement or crawlspace area through the walls can, over time, lead to the degradation of the integrity of the foundation walls. Such measures may include ensuring the proper operation of the gutters in the adjacent exterior area, ensuring that water cannot accumulate around the foundation, and ensuring the that exterior perimeter drainage is working.

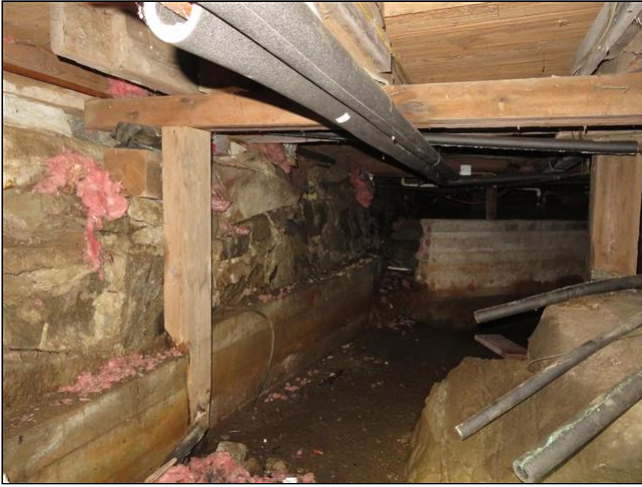
5.4 Item 1(Picture) Crawlspace

Some degree of water damage was noted at the bottom of the columns in the crawlspace. This damage likely occurred from moisture or water on the floor. Measures should be taken to minimize the exposure of the columns to moisture. There are situations where sump pumps can be helpful. Managing the potential intrusion of water into the area is also recommended. This can mean exterior perimeter drainage. Additionally, replacing the columns with the worst damage should be considered.

It is important that wood not come in contact with concrete or soil/dirt, as the wood will absorb moisture. To that end, it would be an idea to install a plastic barrier under the columns to separate them from direct contact with the floor.

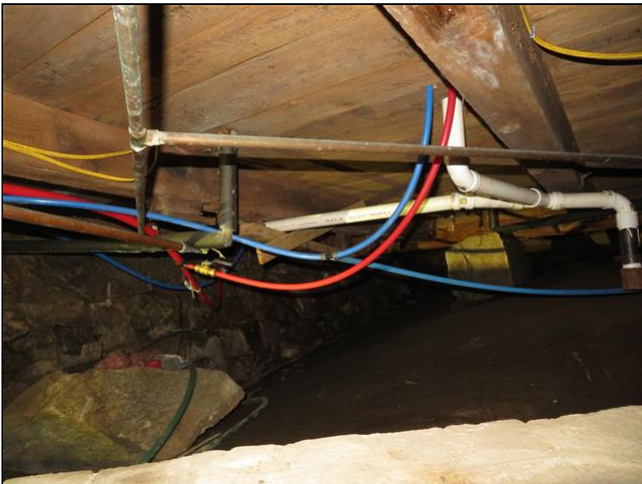
6.1 Item 1(Picture) Crawlspace

The drain system in the basement/crawlspace is not installed and secured in a way that is consistent with best practices or plumbing standards. There is a risk that the drain system could shift and the a leak could occur. It is recommended that repairs be effected.
