INSPECTION REPORT  
NON-INO

**PROPERTY ADDRESS:**  
84 School Street, Waldoboro, ME 04572

<b>Date:</b> 8/19/2024	<b>Time:</b> 09:00 AM	<b>Report ID:</b> 2024081902
<b>Property:</b> 84 School Street Waldoboro ME 04572	<b>Customer:</b> Alex Rowe	<b>Real Estate Professional:</b> Meriwether Gill Better Homes & Gardens Real Estate/The Masiello Group

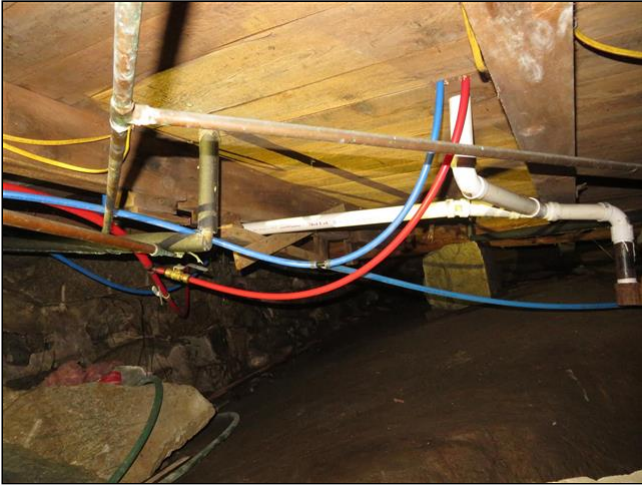
6.2 Item 1(Picture)

A plumbing supply line was noted that was not adequately secured or secured in a way that is consistent with best practices and accepted standards. Pipes that are not adequately installed or secured are at risk for damage or leaking from excessive stress, movement, or mechanical damage (jarring). It is recommended that the lines be appropriately secured.

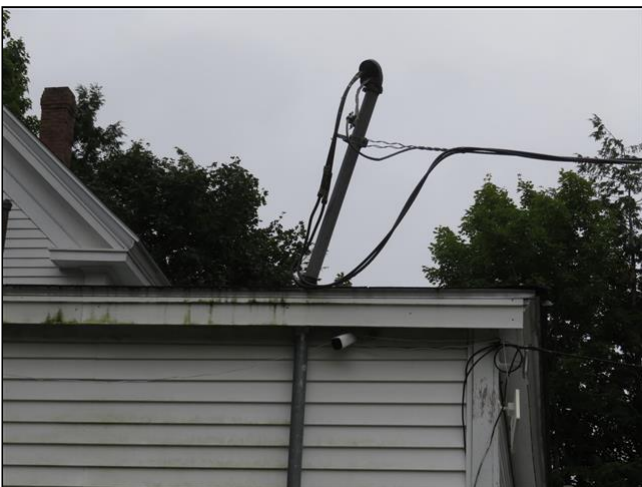
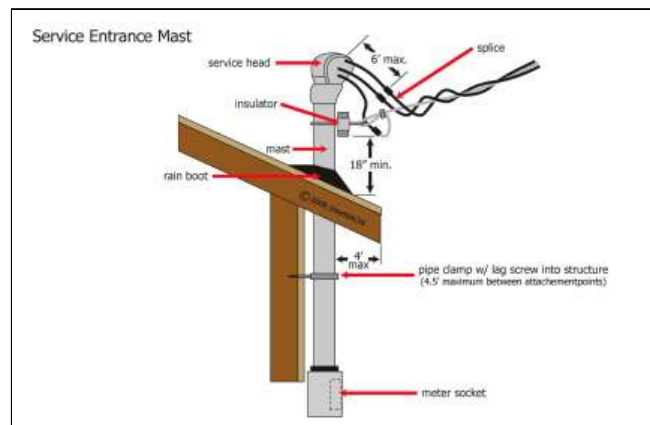
The service drop is connected to the property by means of mast. While a common and acceptable approach, the mast is required to be sufficiently strong to support the weight (tension) of the service drop wire the connects to the utility pole. In this case, the mast was noted to be leaning and not adequately supported. The common approach to this issue is to secure the mast with a guy wire. It is advisable that the issue be further assessed and repairs effected as required.
