WOOD DESTROYING PESTS AND ORGANISMS INSPECTION REPORT

Building No. 360	Street 362 and 364 Hathway	City San Luis Obispo	Zip 93401	Date of Inspection 10/14/25	Page 1 of 7
<div style="display: flex; justify-content: space-between; align-items: center;"> <div> Mojoe Termite INC 1445 Grand Ave., Suite H Grover Beach, CA 93433 Phone: 805-574-1990 Fax: 805-574-1991 Mojoetermite.com Registration # PR5493 </div> <div style="text-align: right;"> Report # 18609 </div> </div>					
Ordered by: Triad Real Estate Group Jenna Lee 2436 Broad Street Sn Luis Obispo, CA 93401 H: 805-530-0572		Property Owner and/or Party of Interest:		Report sent to: Triad Real Estate Group Jenna Lee 2436 Broad Street, Sn Luis Obispo, CA 93401	
COMPLETE REPORT <input checked="" type="checkbox"/> LIMITED REPORT <input type="checkbox"/> SUPPLEMENTAL REPORT <input type="checkbox"/> REINSPECTION REPORT <input type="checkbox"/>					
General Description: #360, #362, #364 One story residence; Wood and hardie siding; Composition roof; Furnished and occupied; With a detached garage				Inspection Tag Posted: Other Tags Posted:

Building No.	Street	City	Zip	Date of Inspection	Report #	Page
360	362 and 364 Hathway	San Luis Obispo

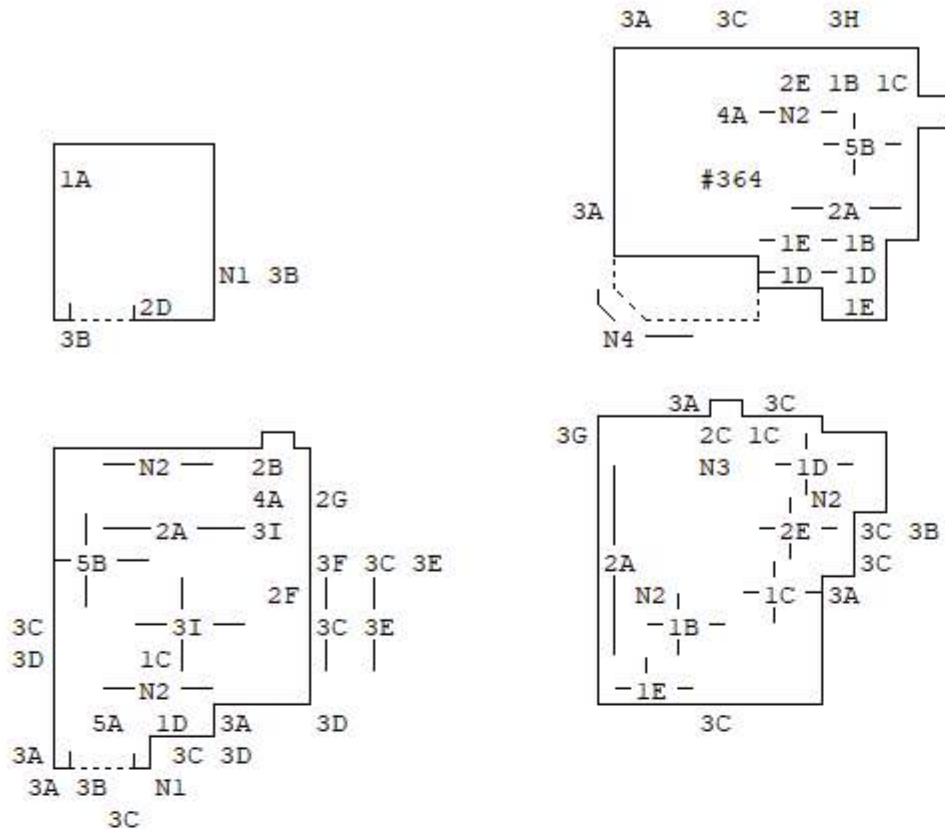
FINDING: Subterranean termite infestation was noted at the garage slab.

FINDING: Subterranean termite infestation was noted at the substructure framing.

FINDING: Subterranean termite damage was found at the cripple wall framing.

FINDING: Subterranean termite damage was found at the subfloor.

FINDING: Subterranean termite damage was found at the joists in the subarea.

FINDING: Evidence of drywood termites was noted at the attic framing.

FINDING: Drywood termite damage was noted at the trim in the water heater closet.

FINDING: Evidence of Drywood termite infestation was found at the water heater closet.

FINDING: Evidence of Drywood termite infestation was found at the garage framing.

FINDING: Minor Drywood termite damage was noted at the joist in the subarea.

FINDING: Evidence of Drywood termite infestation was found at the substructure framing.

FINDING: Drywood termite damage was noted at the substructure access framing.

FINDING: Fungus damage was found at the siding.

FINDING: Fungus damage was noted at the base of the exterior door frame.

FINDING: Fungus damage was found at the trim.

FINDING: Fungus damage was found at the fascia of the eaves.

FINDING: Fungus damage was found at the window sill.

FINDING: Fungus damage was found at the window frame.

FINDING: Fungus damage was noted at the boxed eaves.

FINDING: Fungus damage was found at the exterior door.

FINDING: Fungus damage was found at the subfloor.

FINDING: Earth to wood contact was noted at the substructure framing.

RECOMMENDATION: Chemically treat the soil in areas of infestation with Taurus SC (Fipronil). Holes may be drilled through concrete, paving or masonry adjacent to the foundation in areas such as, but not limited to; patios, sidewalks, porches and driveways, to allow for chemical treatment of the soil below. We will exercise reasonable caution when drilling but assume no liability for damage to hidden plumbing, electrical, or other utilities below these areas. The location of such utilities should be identified prior to our arrival.

RECOMMENDATION: Replace the termite damaged wood members as necessary.

RECOMMENDATION: Remove and reinforce the termite damaged wood members as necessary.

RECOMMENDATION: Seal and fumigate the entire structure with a registered fumigant sulfuryl fluoride in accordance with the manufacturer's label. This company will exercise all due caution, but cannot be held responsible for damage to plants, TV antennas, or roofing due to the fumigation.

RECOMMENDATION: Remove the damaged portions of the trim.

RECOMMENDATION: Repair the damage with wood filler and reinforce as well.

RECOMMENDATION: Replace the damaged portions of the access framing.

RECOMMENDATION: Replace the damaged portions of the siding.

RECOMMENDATION: Replace the damaged portion of the door frame.

RECOMMENDATION: Replace the damaged portions of the trim.

RECOMMENDATION: Replace the damaged portions of the fascia.

RECOMMENDATION: Replace the damaged window sill.

RECOMMENDATION: Replace the damaged portion of the window frame, if the window is broken during the course of repair the owner will need to contact a licensed glass contractor for replacement of the window.

RECOMMENDATION: Replace the damaged portions of the boxed eaves. If upon opening the eaves damage is found to extend into the eave framing, such findings and additional costs will be submitted on a supplemental report.

RECOMMENDATION: Replace the damaged door with the same or similar type. Existing door hardware (Locks; hinges; sweep, etc.) will be reused. Additional costs will apply if the hardware is not functional. Exterior doors are limited to the manufacturers warranty of one year.

RECOMMENDATION: Remove and reinforce the damaged portions of the subfloor.

RECOMMENDATION: Lower the soil grade to eliminate earth to wood contact.
