LV2 Levenson Palm Villa II
4585 Felton St., San Diego, CA 92116

SB721 Inspection Report

Jon Silva, Torrey Pines Property Management
September 12th, 2024

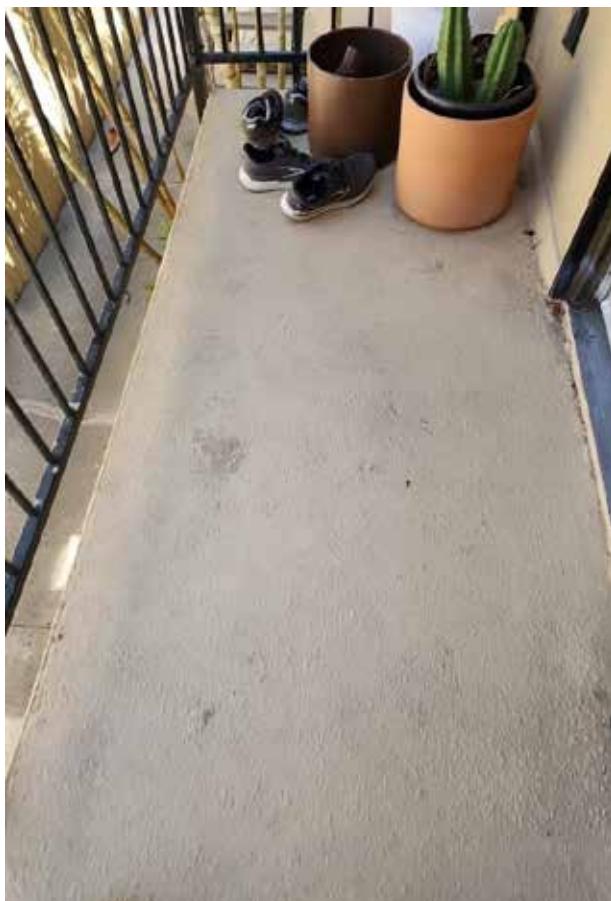
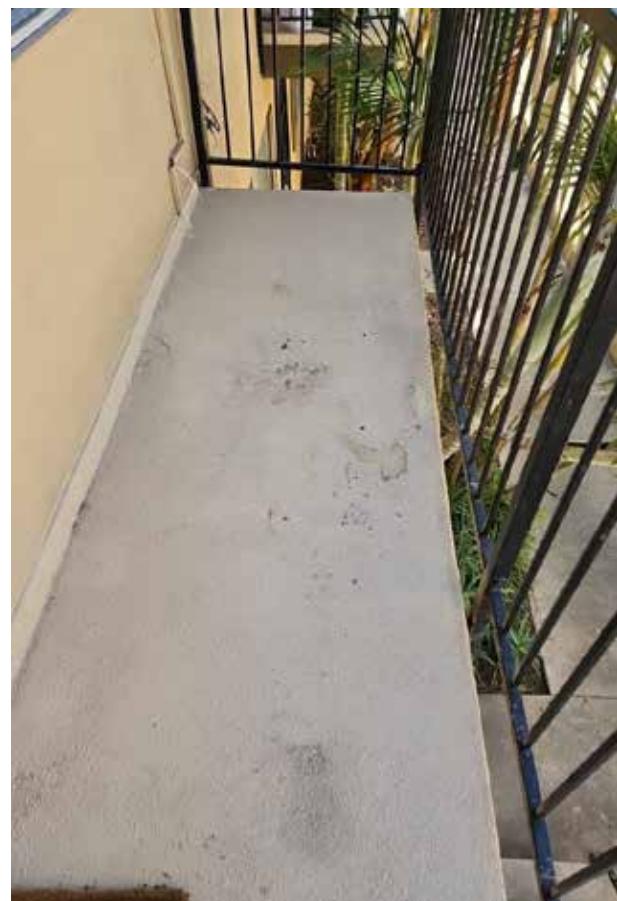
- Southern Cross Property Consultants did not observe issues with the waterproofing/traffic topping layer at the time of inspection.
- The residents should be aware of potential water damage to deck surfaces caused by planters without collections trays and any other instance of prolonged water logging.

3. Continue regular maintenance of the waterproofing system at landings and walkways. An entire cleaning and resealing of the waterproof coating system should be completed in the next 6 – 9 months and then every five years and conducted as per the manufacturer's recommendations.

5. Encourage residents to utilize collection trays under their potted plants to reduce the constant source of moisture on the decking surface; and prohibit the placement of rugs or carpeting on the deck surfaces.

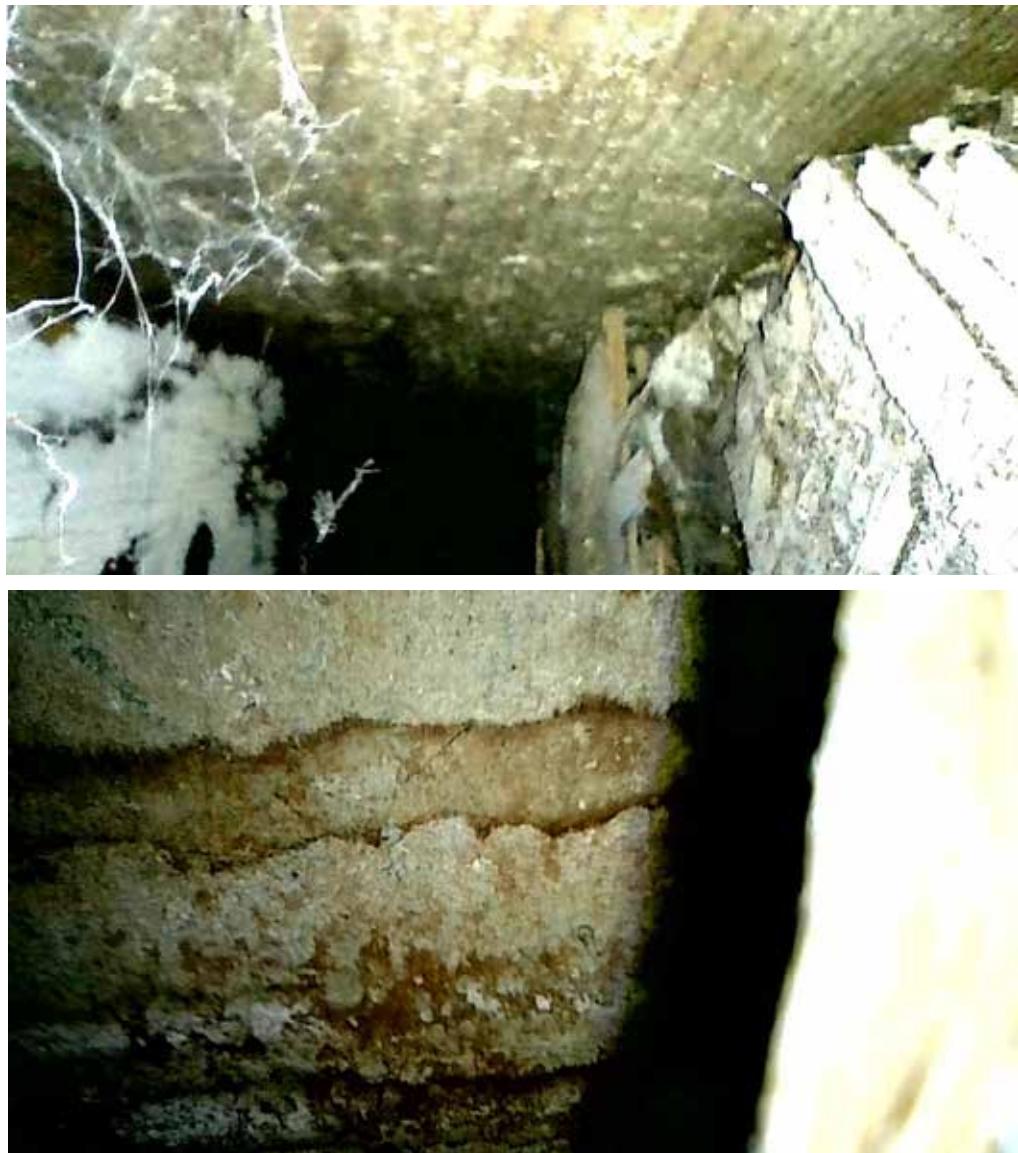
- Southern Cross Property Consultants observed water damage, rust, bio-growth, within the landing structures.

1. Because of the plywood deterioration within the Unit 5 landing waterproofing assembly, it is our recommendation to remove and replace the entire topping system to mitigate further damage and avoid a safety threat. Inspect the ledgers, joists, and framing members for any further rot/water damage and repair or replace as necessary. This should be done in the next 6 - 9 months.

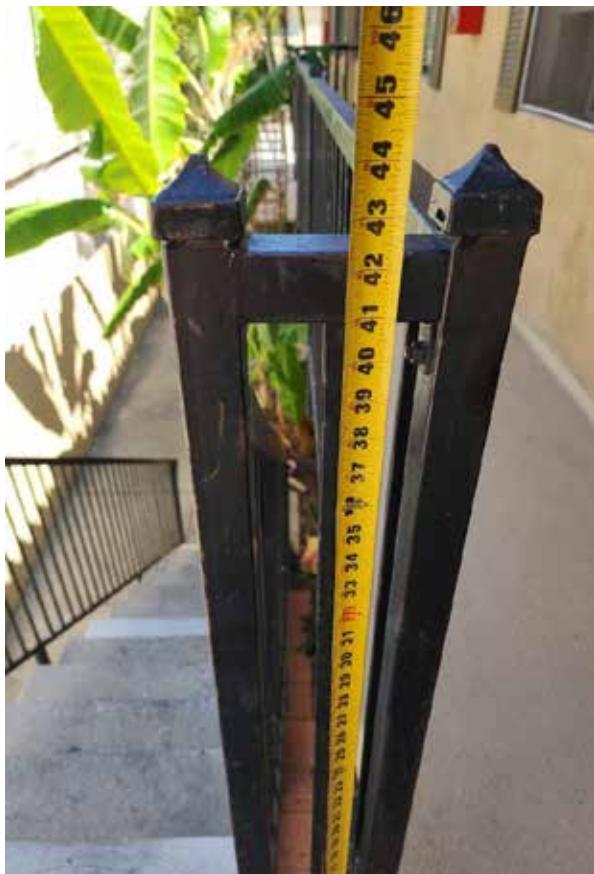
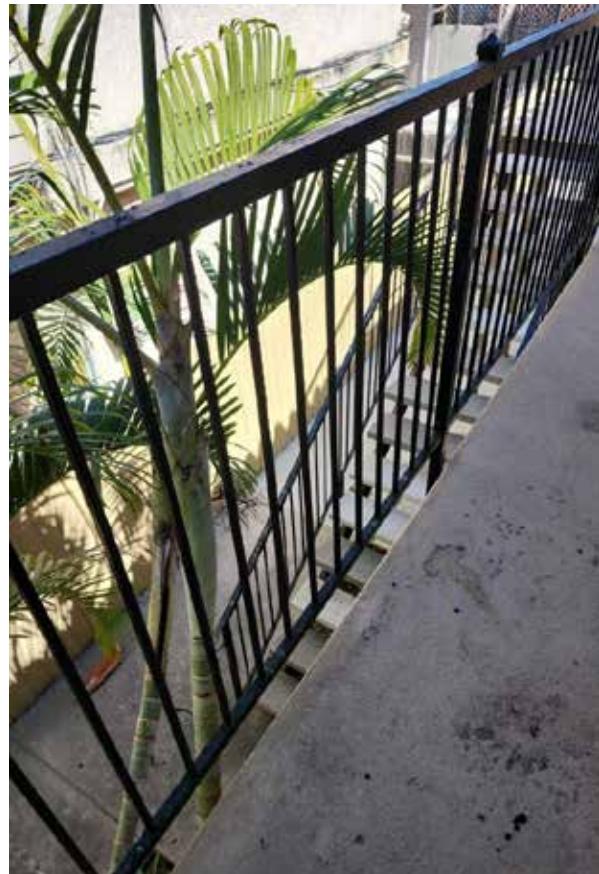
- The guardrails were observed to follow current code requirements.

4. Continue regular maintenance at the railings – removing minor rust and repainting all guardrails. An entire repainting should be completed every five (5) years.

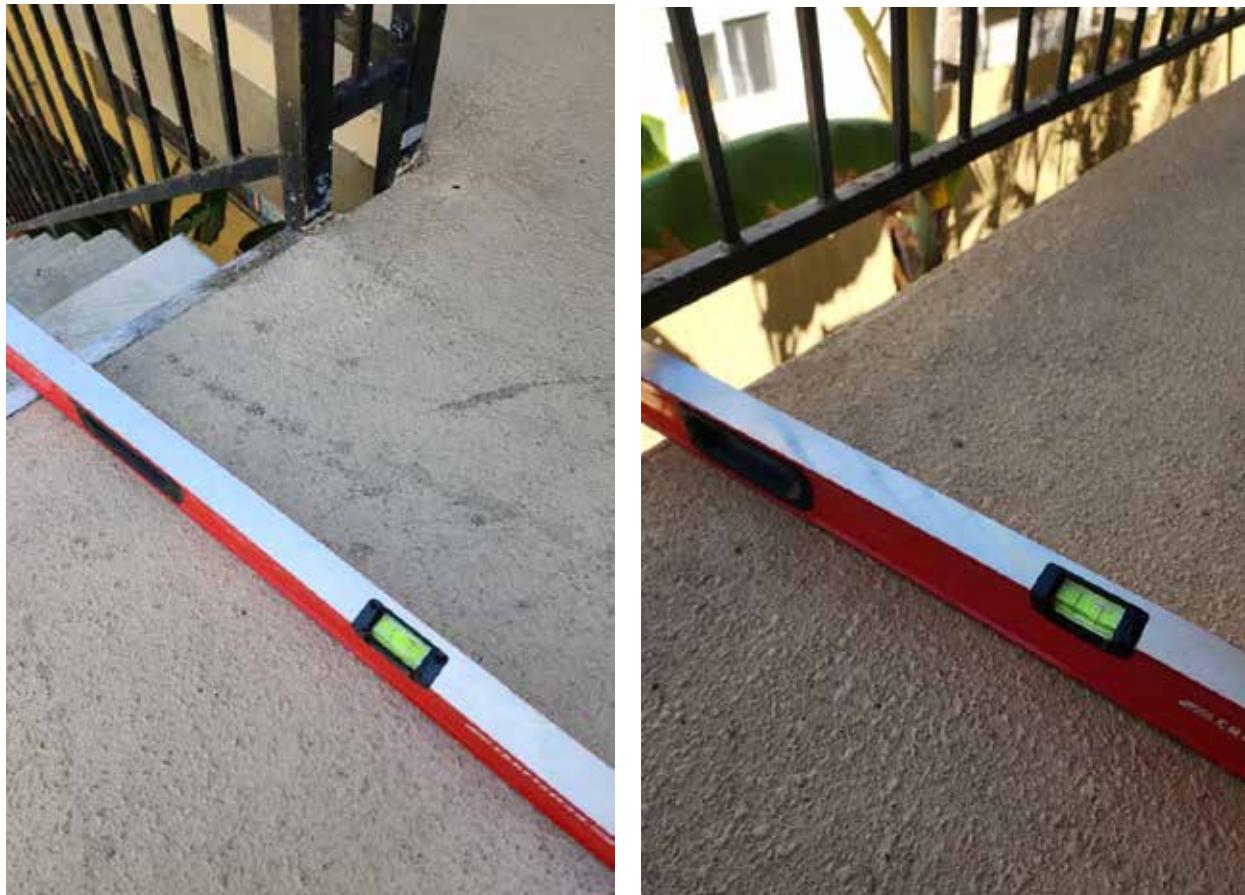
- Southern Cross Property Consultants observed adequate slope allowing excess moisture to flow off traffic surfaces.

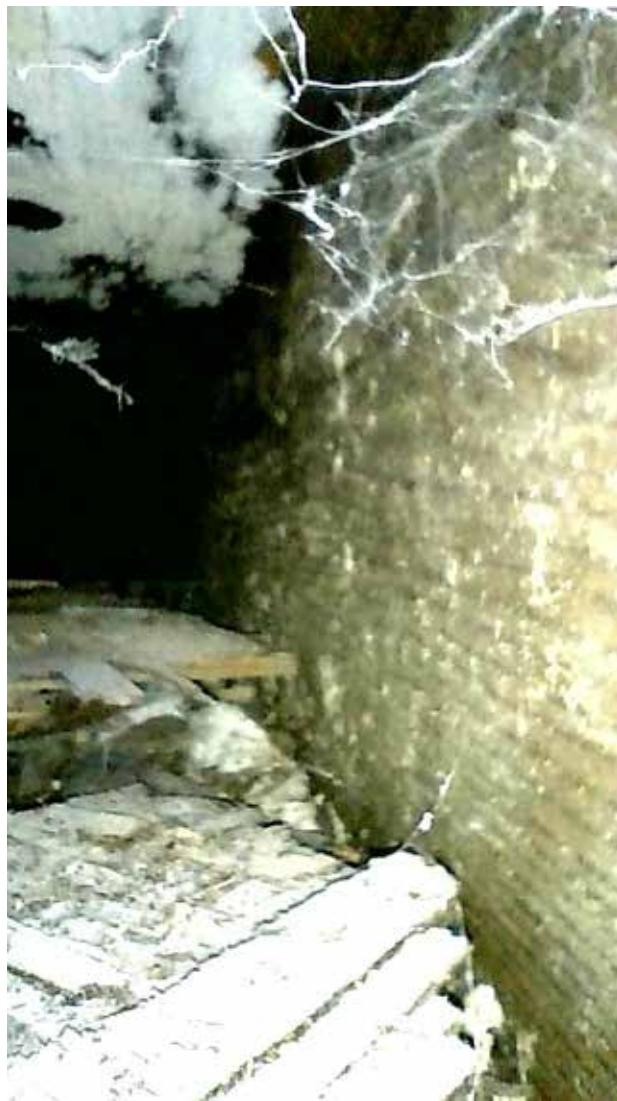
- Southern Cross Property Consultants observed termite droppings in the soffit of the landing to Unit 5. Any severely damaged wood components identified by the pest control contractor should be replaced.

2. Southern Cross Property Consultants recommends the ownership and management should have an inspection performed by a state licensed pest control contractor and proceed with any suggested treatments. This should take place within the next 3 – 6 months due to evidence of termites found at the time of inspection. Routine inspections should then follow every 18-24 months.

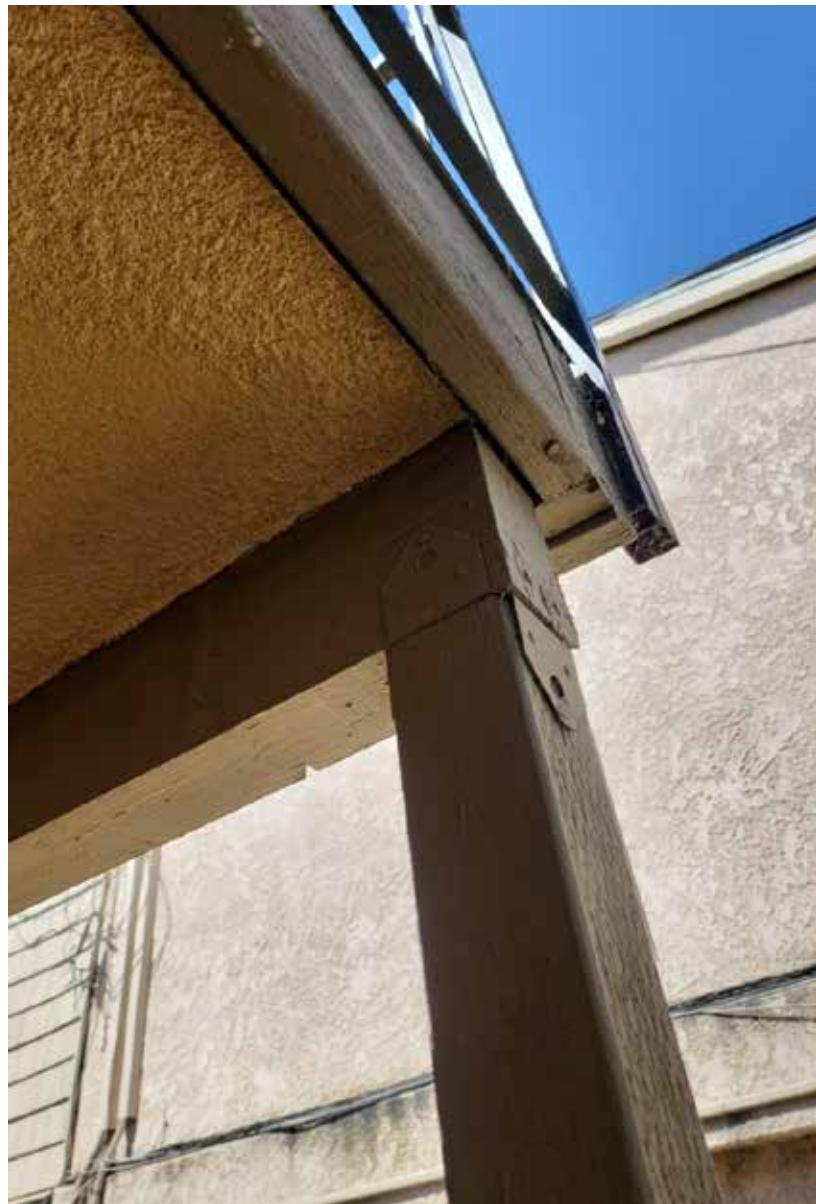
- Southern Cross Property Consultants did not observe dry rot at the stair landings.

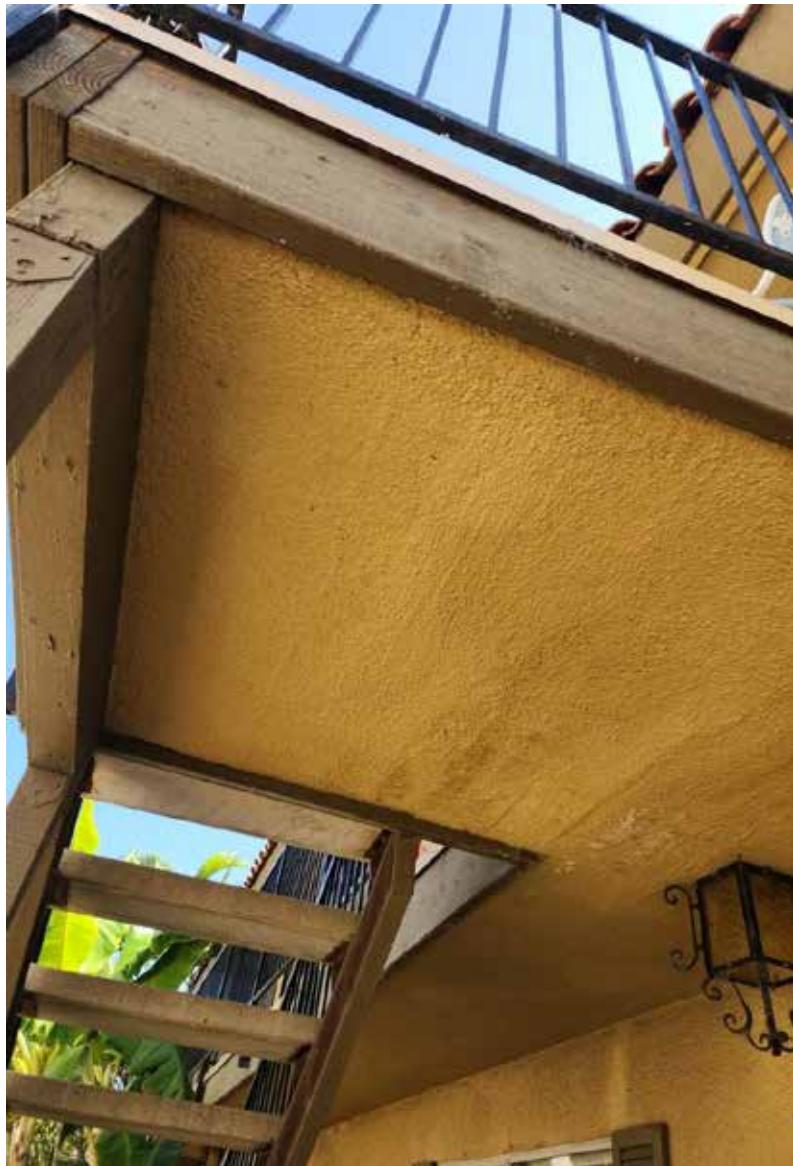
- Southern Cross Property Consultants observed the edge flashings to be in good condition. No rust or corrosion were observed at the flashings at the time of inspection.
