PHASE I
ENVIRONMENTAL
SITE ASSESSMENT

64 Union Way
Vacaville
California

May 21, 2019
19-ENV5425

Subject: Phase I Environmental Site Assessment Report
64 Union Way
Vacaville, California 95687

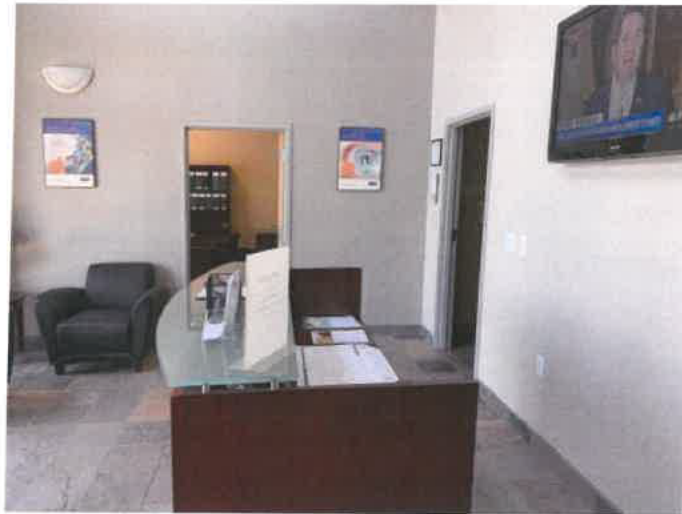
Office Area – The office area is located in the center northeast portion of the building and consists of individual offices, a conference room, break room and copy room. Located within the office area are typical office furnishings (See Photos 5-6). Visual observations of the office area did not reveal any obvious evidence of hazardous materials, stains or spills. Visual observations of the floor within the office area did not reveal any obvious evidence of drains, sumps, cracks or other conduits to the subsurface.

Photo 5: Subject Site (Facing Southeast)
First Floor
Office Area

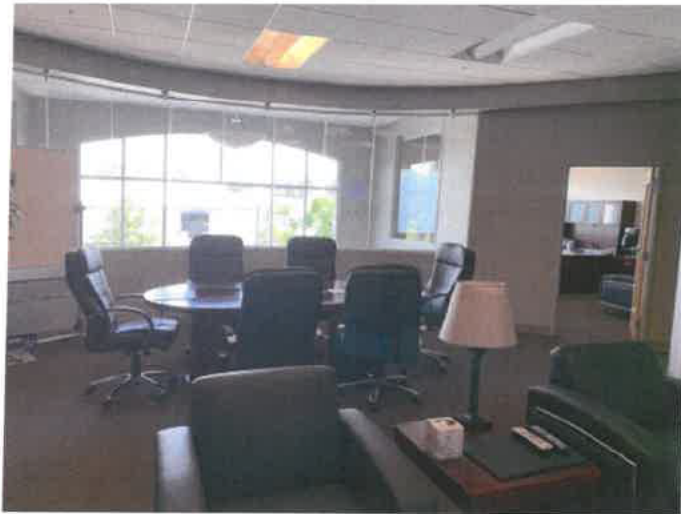
Second Floor – The second floor is composed of an office area and is only located above the first floor office area (See Photo 7). Located in the office area are individual offices, a conference area and a server room. Located in the area are typical office furnishings. A restroom and small kitchenette is located in the southeast corner of the area. Located in the restroom are typical restroom furnishings. Located in the kitchenette are typical kitchenette furnishings. Visual observations of the office area did not reveal any obvious evidence of hazardous materials, stains or spills. Visual observations of the floor within the office area did not reveal any obvious evidence of drains, sumps, cracks or other conduits to the subsurface.

Photo 7: Subject Site (Facing Northeast)
Second Floor
Office Area

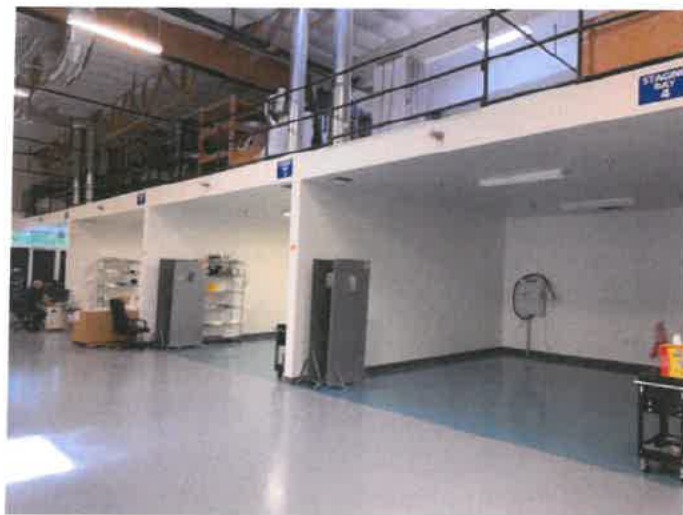
Staging Area – The staging area is located on the southeast side of the building and consists of four 'service bays' that are utilized to repair/refurbish CT machines (See Photos 10-12). Discussions with Mr. Bringolf indicated the walls and ceilings of the service bays are lead-lined to protect employees when the CT machines are tested. Portable lead-lined wall units are utilized to block off the openings in the service bays when CT machines are tested. Discussions with Mr. Bringolf indicated that only digital x-rays are produced as part of testing activities and no photochemicals are utilized on the subject site. Located across from the service bays are shelving units of tools, a small office desk, and a dry-type electrical transformer. Visual observations of the staging area did not reveal any obvious evidence of hazardous materials, stains or spills. Visual observations of the painted concrete floor within the staging area did not reveal any obvious evidence of drains, sumps, cracks or other conduits to the subsurface.

Photo 10: Subject Site (Facing East)
First Floor
Staging Area

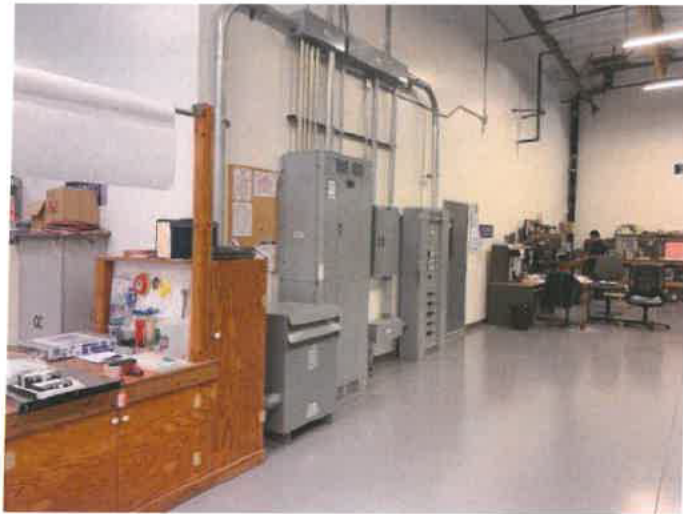
Photo 11: Subject Site (Facing North)
First Floor
Staging Area

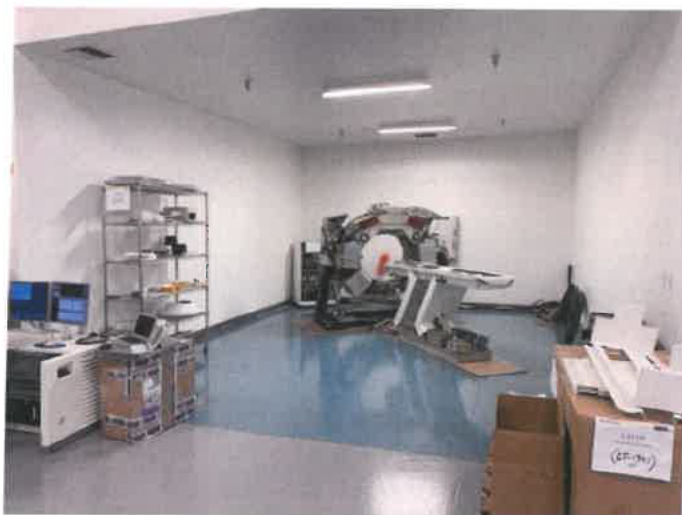
Photo 12: Subject Site (Facing Southeast)
First Floor
Staging Area

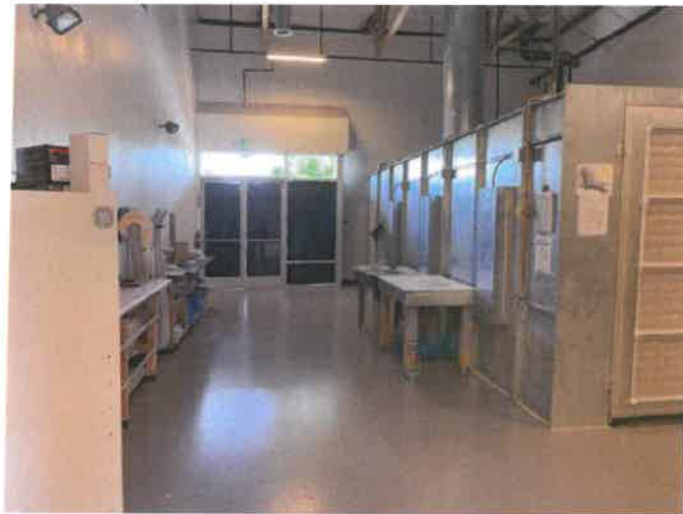
Paint Booth Area – The paint booth area occupies a portion to the northwest of the office area. Located in the paint booth area is a spray paint booth and small work area for fiberglass, plastics and metal working (See Photos 13-18). Discussions with Mr. Neufeld indicated that the work area is just for minor repairs of CT aesthetic coverings. Within the spray paint booth, the floor is covered with brown paper. Located adjacent to the spray paint booth are two empty 5-gallon cans and one half used 5-gallon can of Shop-Line VOC General Purpose Solvent (JT571). According to the manufacturer's website and MSDS sheet, the general purpose solvent is composed of toluene, methanol, acetone and Ligroine. Discussions with Mr. Neufeld indicated

Photo 13: Subject Site (Facing Northeast)
First Floor
Paint Booth Area

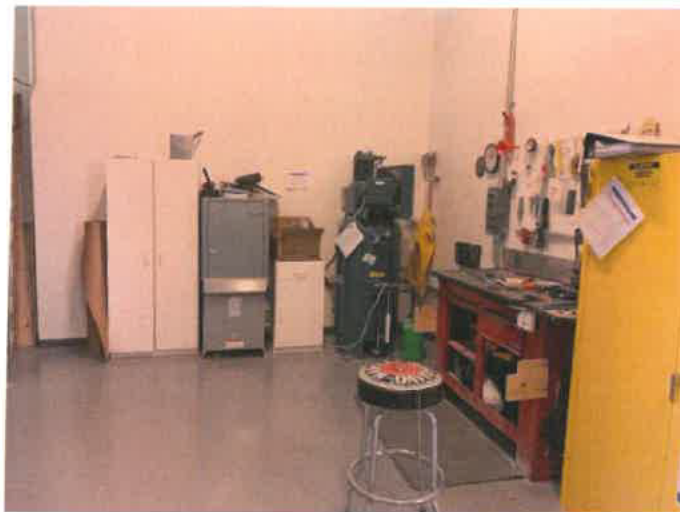
Photo 14: Subject Site (Facing Southeast)
First Floor
Paint Booth Area

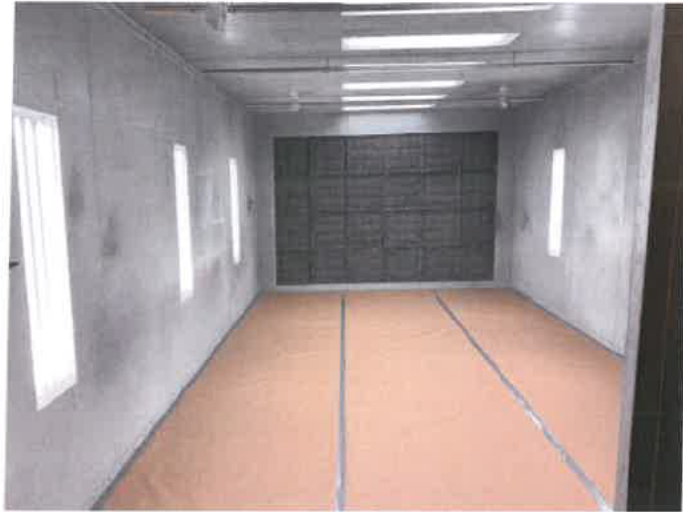
Photo 15: Subject Site (Facing Northeast)
First Floor
Paint Booth Interior

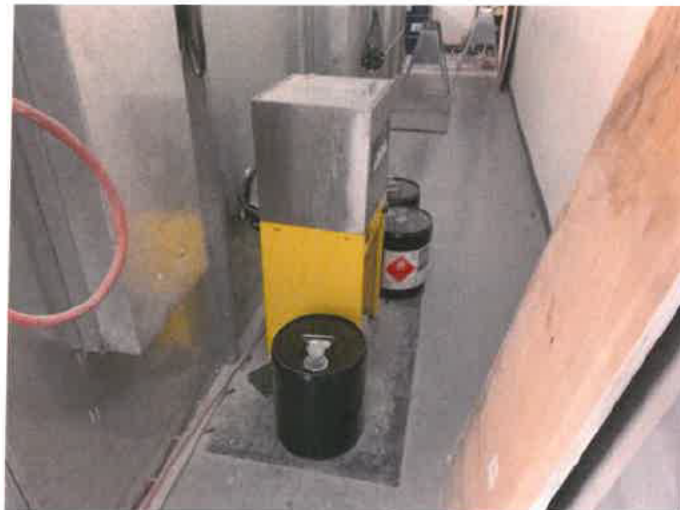
Photo 16: Subject Site (Facing Northeast)
First Floor
Paint Booth Area

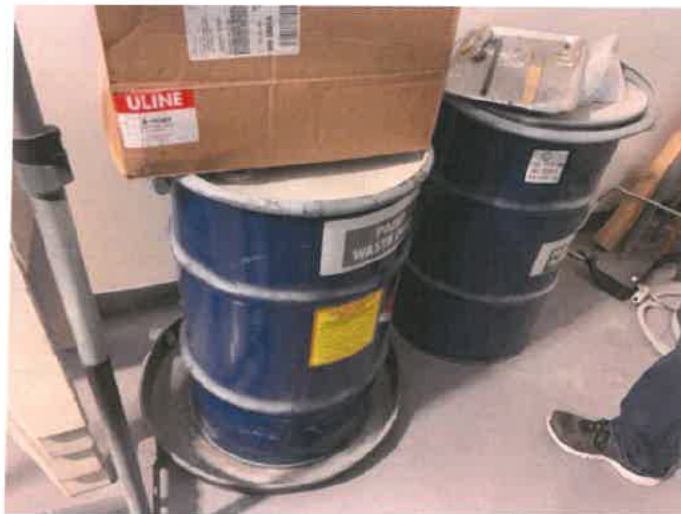
Photo 17: Subject Site (Facing Northeast)
First Floor
Paint Booth Area

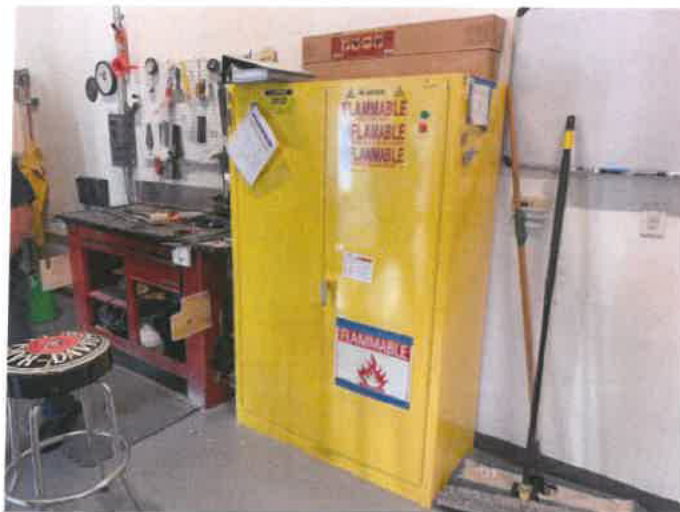
Photo 18: Subject Site (Facing Southwest)
First Floor
Paint Booth Area

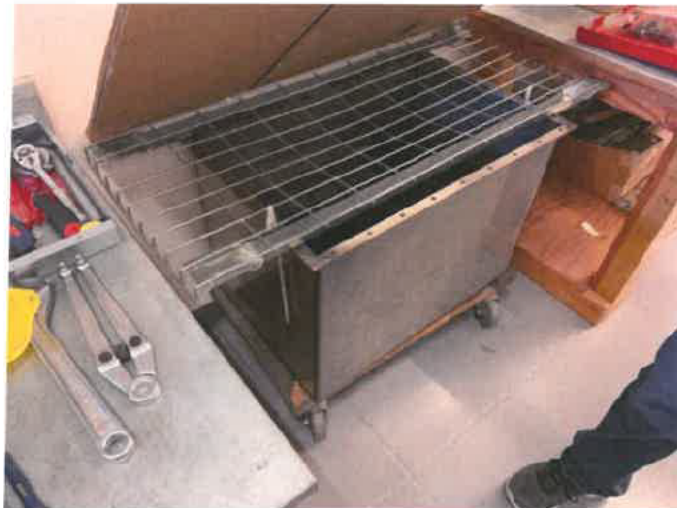
mineral based oil is stored next to the machine. Discussions with Mr. Neufeld indicated that the mineral based oil is constantly reused and is not considered 'hazardous waste.' Visual observations of the warehouse area did not reveal any other obvious evidence of hazardous materials, stains or spills. Visual observations of the painted concrete floors within the warehouse area did not reveal any obvious evidence of drains, sumps, cracks or other conduits to the subsurface.

Photo 20: Subject Site (Facing Southeast)
First Floor
Warehouse Area- Bin for Reused Mineral Based Oil

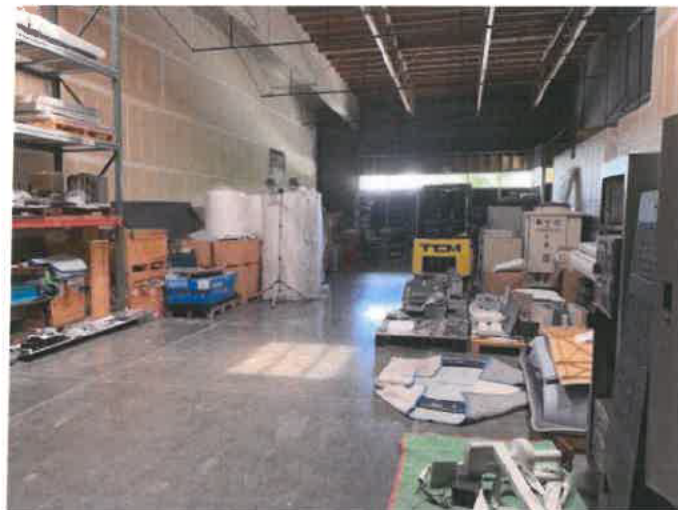
Located within the southeast storage area are several shelving units of CT parts and tools (See Photo 22). The second forklift is stored in the area. What appears to be a sewer cleanout is located in the south corner. Visual observations of the southeast storage area did not reveal appreciable amounts of hazardous materials, stains or spills. Visual observations of the concrete floor within the southeast storage area did not reveal any obvious evidence of drains, sumps, cracks or other conduits to the subsurface.

Photo 22: Subject Site (Facing Northeast)
First Floor
Southeast Storage Area

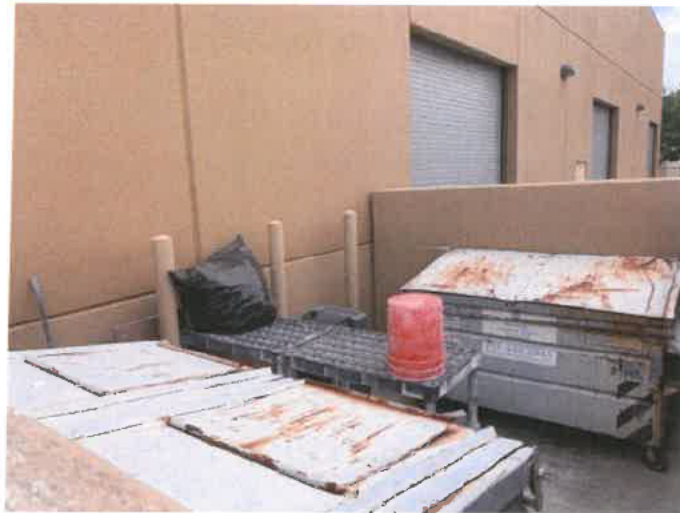
Located along the southwest side is a dumpster enclosure (See Photo 23). Located in the enclosure are two dumpsters and two carts. General observations of the enclosure did not reveal any obvious evidence of hazardous materials, stains or spills.

Photo 23: Subject Site (Facing Northeast)
Associated Paved Area
Trash Enclosure
