PHASE II ENVIRONMENTAL SITE ASSESSMENT REPORT

Commercial Property
Located At 1240 Northwest 29th Street
Miami, Miami-Dade County, Florida

Project Number HA18-4786

March 1, 2018

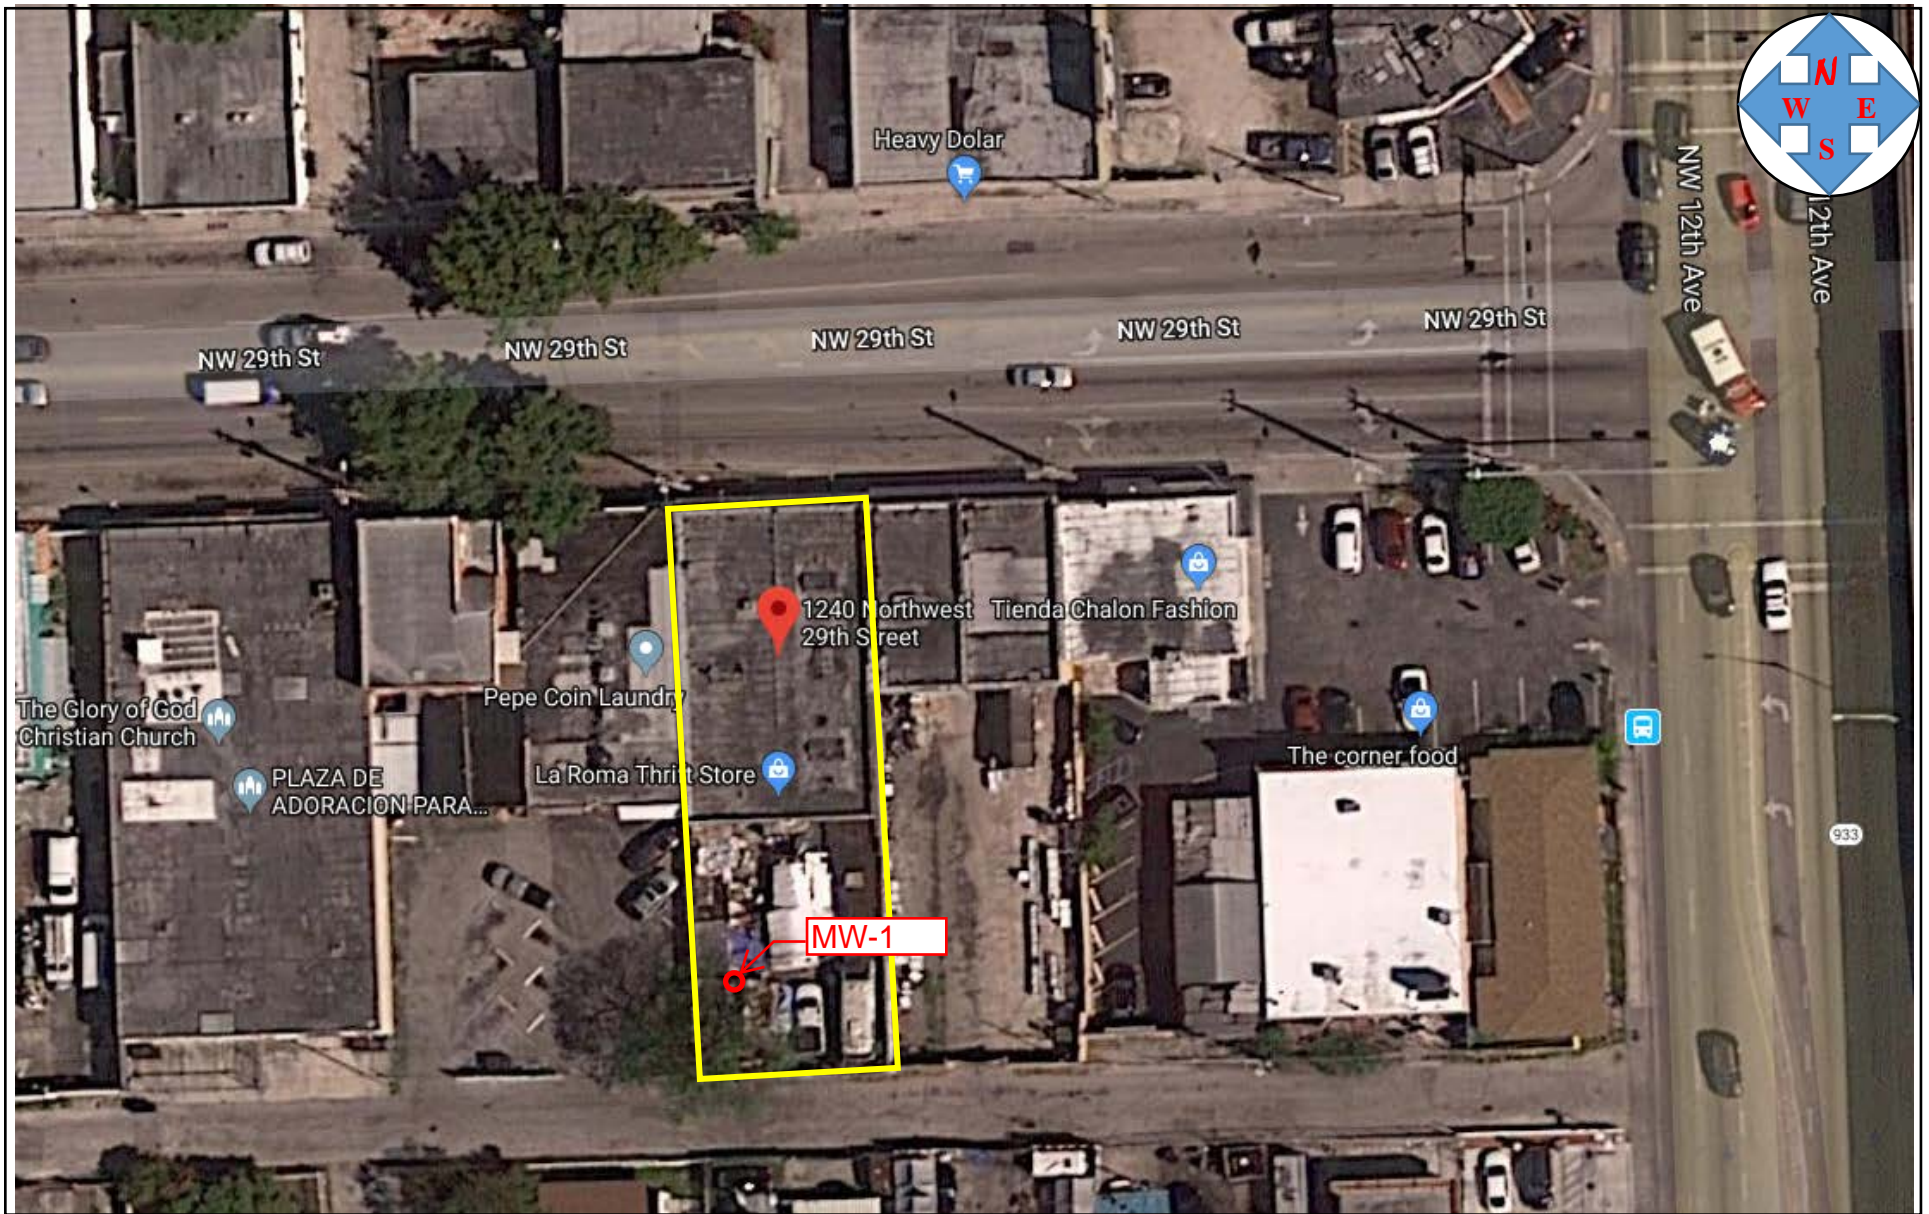
FIGURE 2: Monitoring Well Location Map

On February 23, 2018, a representative of HAI supervised the placement of one monitor well, MW-1, in the southwestern portion of the subject site. The approximate location of the monitor well is shown in Appendix 7.1, Figure 2.
