RE: Storage Tank Closure
Moran Residence
3062 Main Street
Green Lane, Montgomery County, Pennsylvania

Table 1
Laboratory Analytical Data (No. 2 Fuel Oil Target Analytes)
May 20, 2013

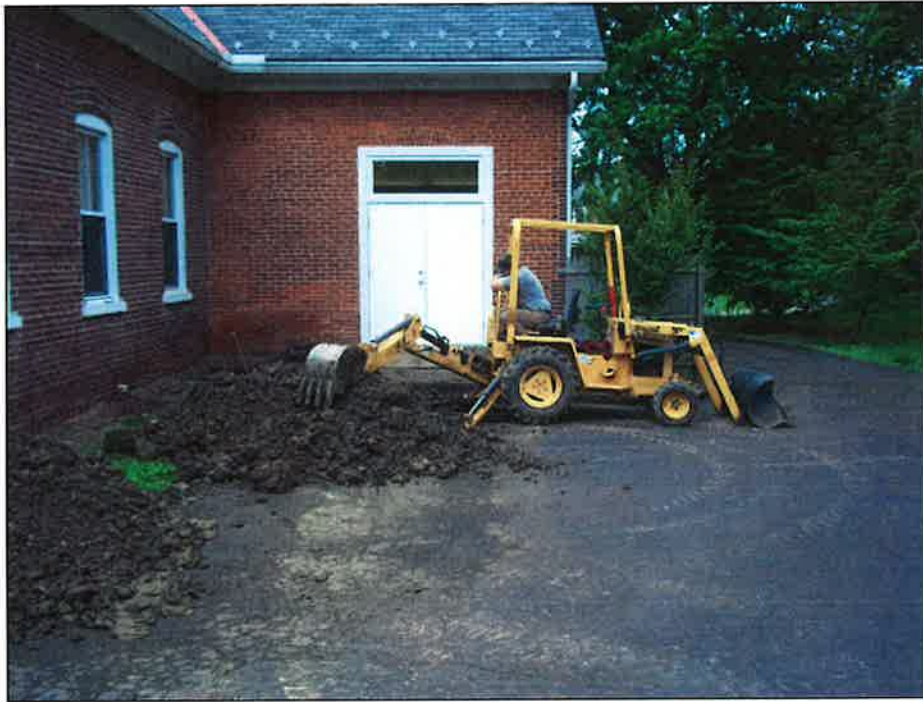
Photograph 1: Area where the UST was located.

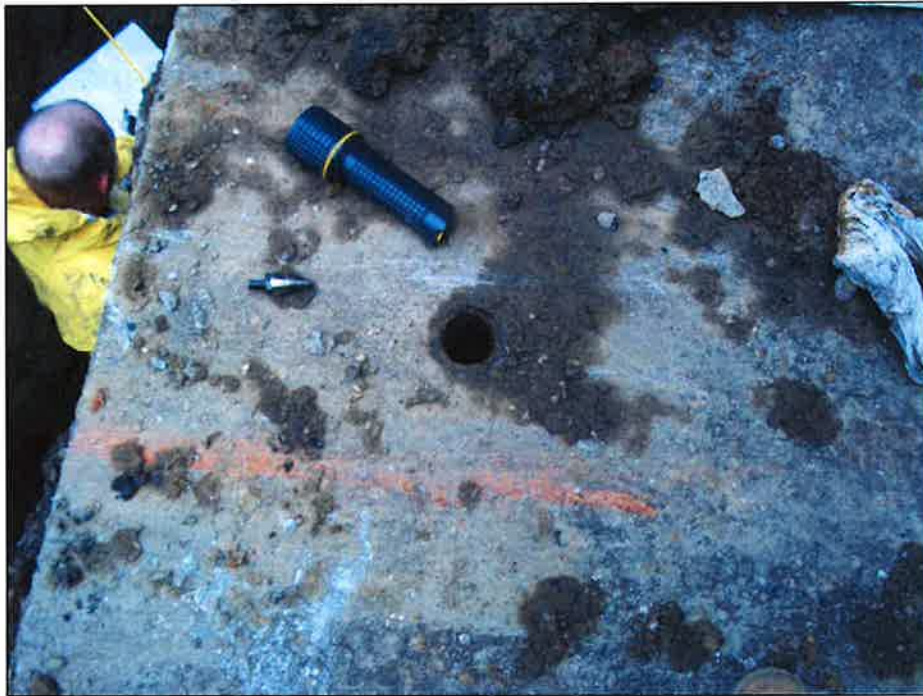
Photograph 2: View of the fill pipe of the former tank.

The tank was subsequently filled with flowable fill, which is a mixture of water, sand, and cement. The fill pipe was filled with concrete and blended with the concrete porch. Lastly, the excavation was backfilled to the original grade with the previously removed material.

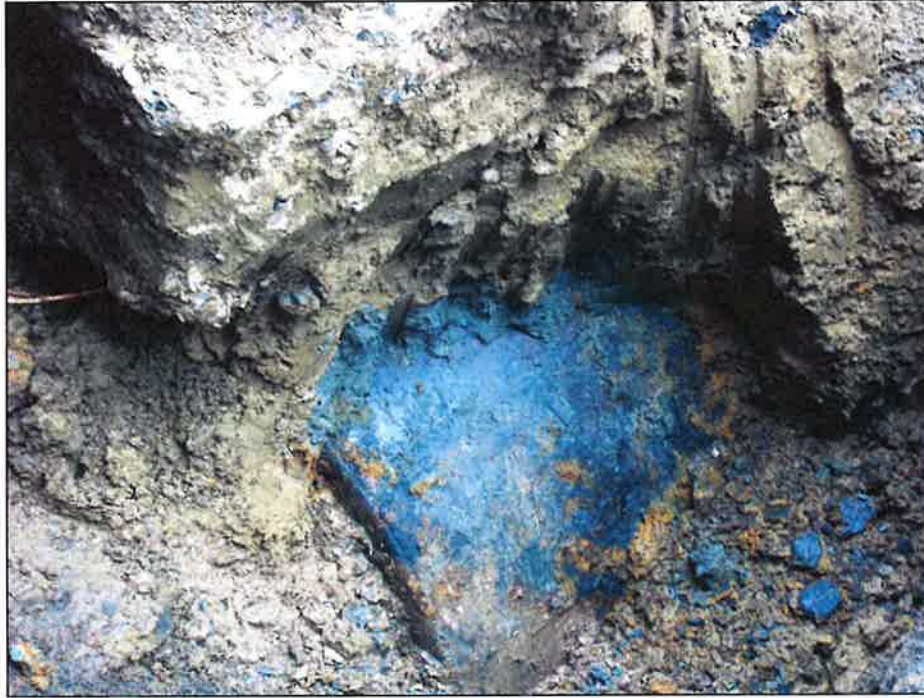
On May 20, 2013, Patriot personnel completed the abandonment of the UST. Due to the location of the UST beneath the existing concrete porch, the tank could not be removed and was abandoned in-place. Soil was excavated alongside the concrete porch in order to expose the side of the tank. The excavated soil was screened with a photoionization detector (PID) to assess the presence or absence of volatile organic compounds indicative of No. 2 fuel oil. No PID readings were recorded.

Photograph 3: View of the side of the tank after excavating alongside the concrete porch.

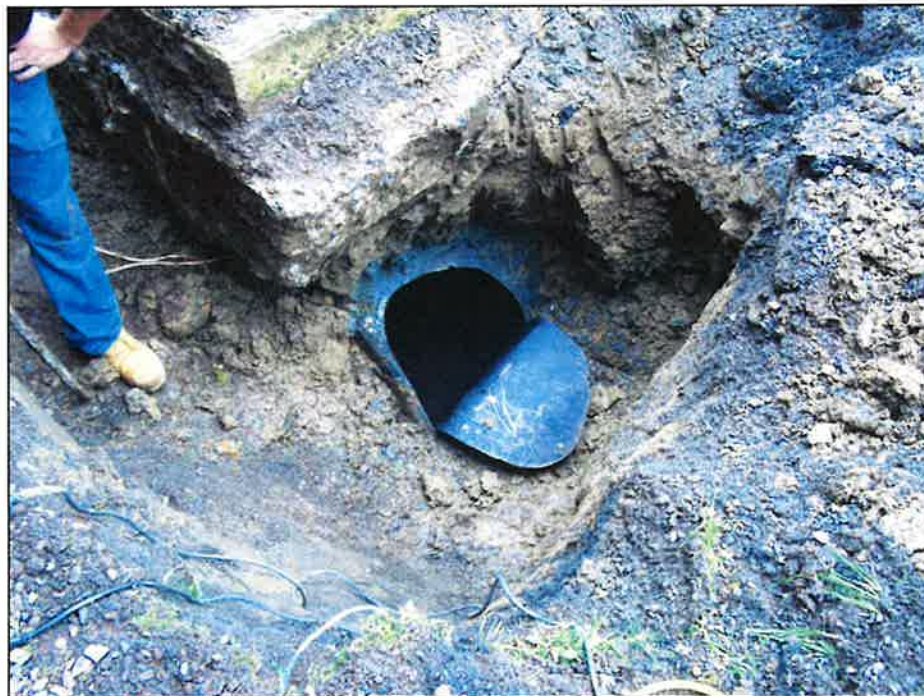
removed from the tank and transferred to a 55-gallon steel drum for disposal. The integrity of the tank was visually inspected for corrosion or other potential signs of a release. The tank was observed to be in good condition, with only minimal surficial corrosion inside the tank. Photodocumentation of these activities is presented as **Attachment 1**.

Photograph 4: View of the access hole cut into the side of the tank.

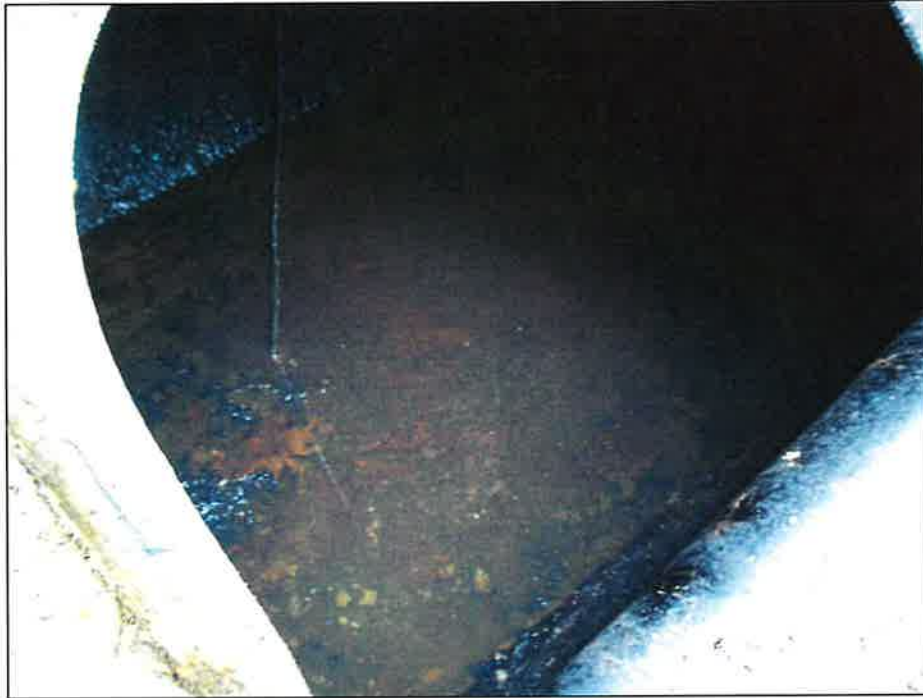
Photograph 5: View of residual material in the bottom of the tank.

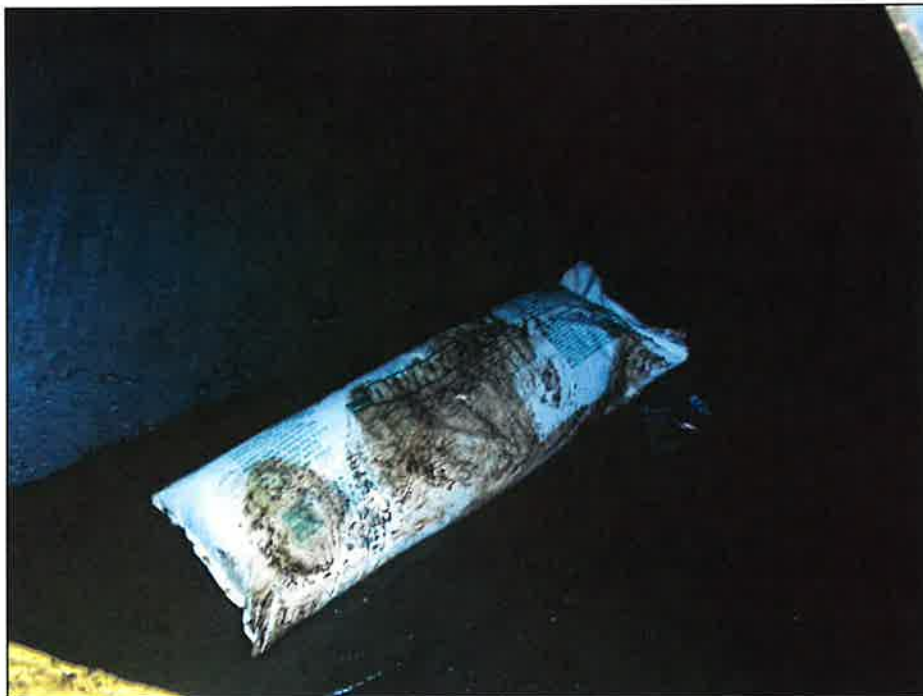
Patriot personnel attempted to drill a hole in the bottom of the tank in order to assess the soil beneath the tank. However, upon completion of the hole, groundwater began to enter the tank. Therefore, Patriot advanced a soil boring alongside the tank to a depth that coincided with the bottom of the tank utilizing a hand auger. The soil was screened with a PID and visual and olfactory observations were also made.

Photograph 6: View of water in the bottom of the tank after the hole was drilled through the tank.
