Report Date: March 23, 2022  
Field Assessment Date: March 11, 2022

## Property Condition Report

1612 Frazier St  
Conroe, Montgomery County, Texas 77301

AEI Project No. 458021  
Client Reference No. NA  
Client Reference Name: Frazier

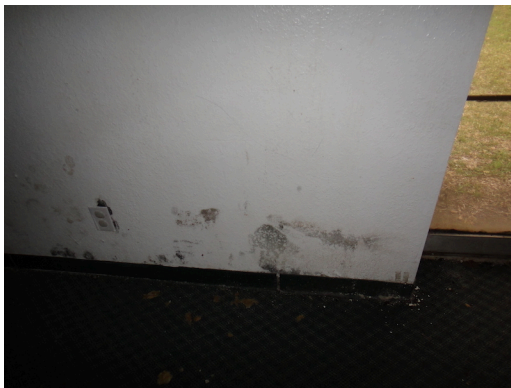
Evidence of significant or unusual ponding of storm water was reported along the southeast elevation of building two. Water does not drain away from the foundation in this area and is entering the building. Damaged floor and wall finishes were observed due to the water intrusion and suspect mold growth was observed. Approximately 200 SF of moisture damaged floor and wall finishes were observed. The ponding appears to be related to poor drainage patterns in the topography.

Moisture damage bldg 2

AEI recommends that the overall site drainage system be reviewed by a Professional Engineer to determine the best course of action to prevent continued chronic ponding and determine estimated costs to resolve the observed problems. An opinion of cost for this work is included in the Tables.

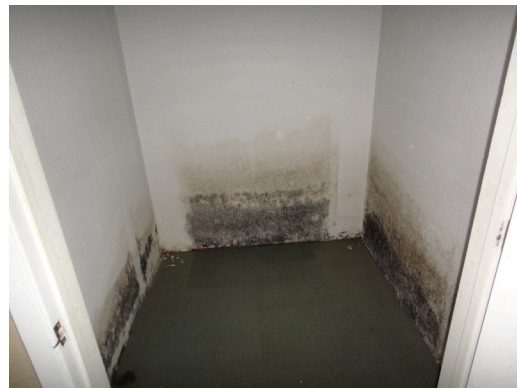
Mold damage bldg 2

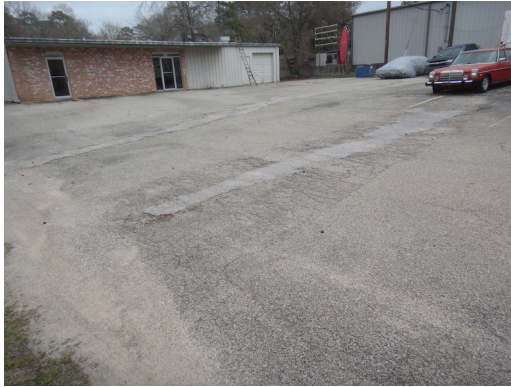
AEI observed widespread asphalt pavement deficiencies including alligator cracking, cracks supporting weed growth, edge crumbling, and loose aggregate. Due to the severity of the deficiencies it appears that full-depth replacement is warranted. An opinion of cost for this work is included in the Tables.

Fair asphalt paving

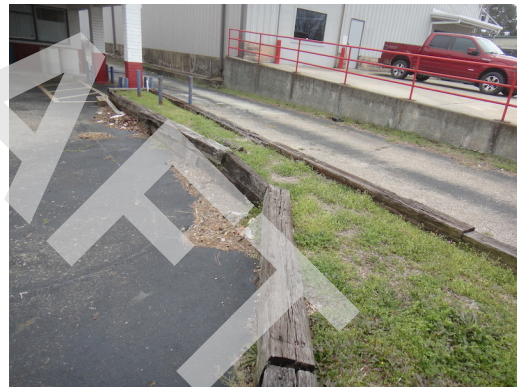
Fair landscape borders

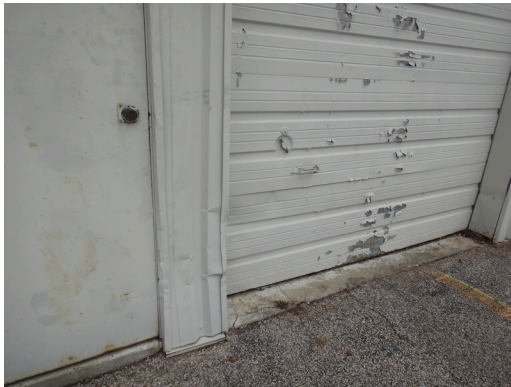
Fair to poor finishes

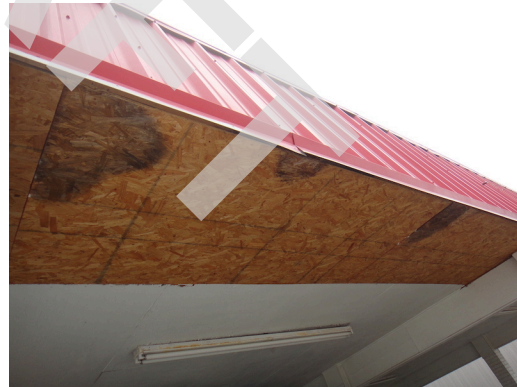
Damaged soffits

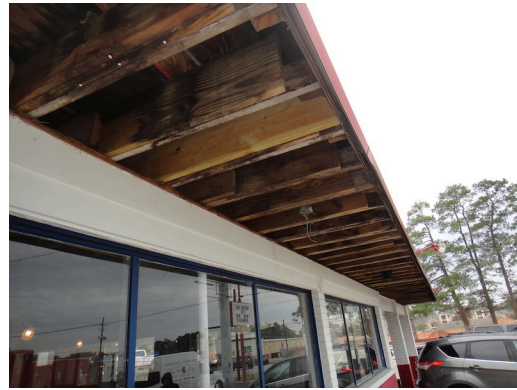
Soffits exposed

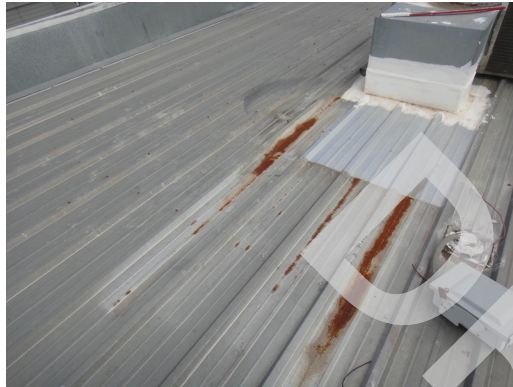
Roof surface rust bldg 1

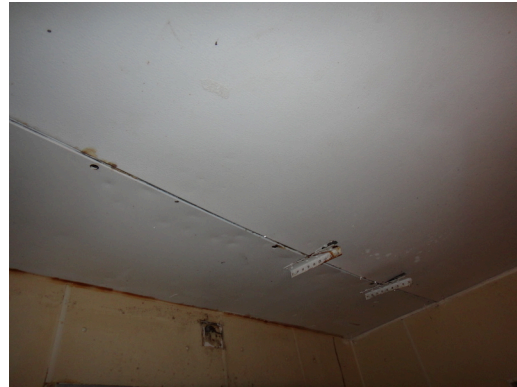
Roof leak bldg 1

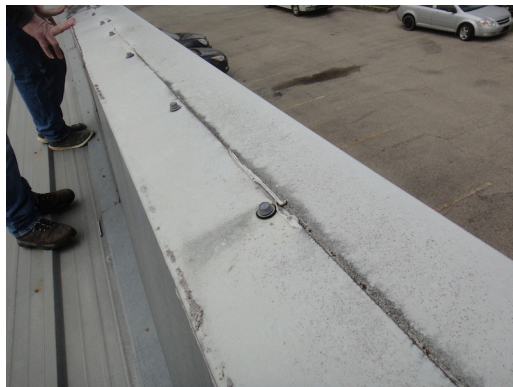
Roof coping poor

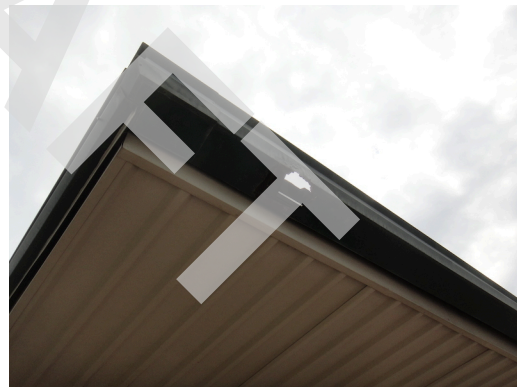
Damaged gutter areas

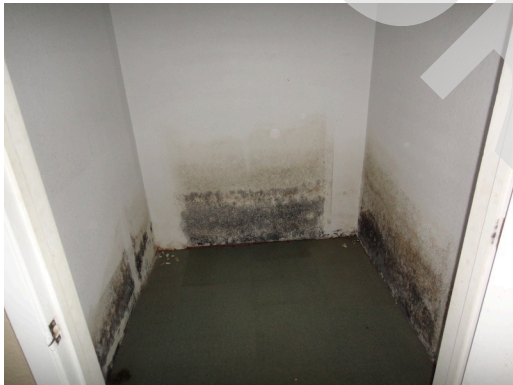
Mold damage bldg 2

Refer to Section 3.1.1, 3.2.4 and 4.1 for additional discussion and recommendations regarding the water infiltration.

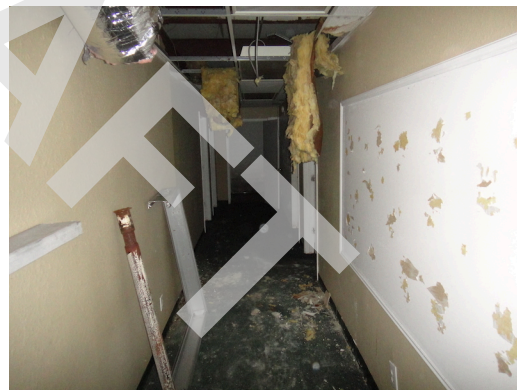
Bldg 2 interior poor

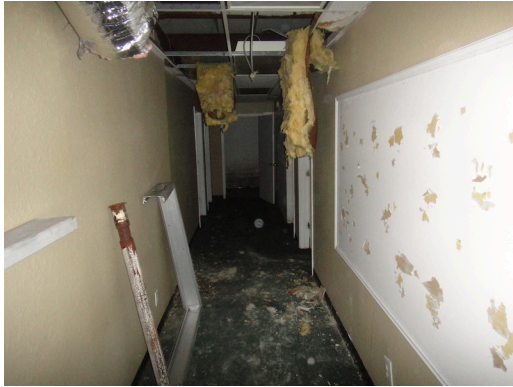
Bldg 2 interior poor

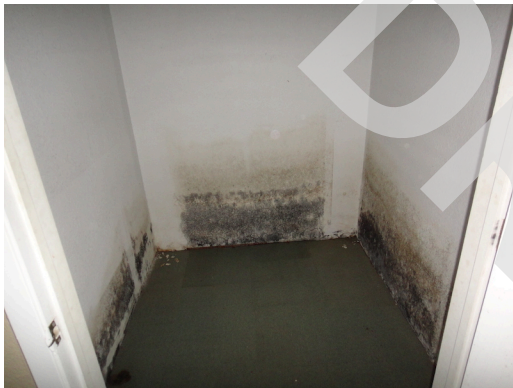
Mold damage bldg 2

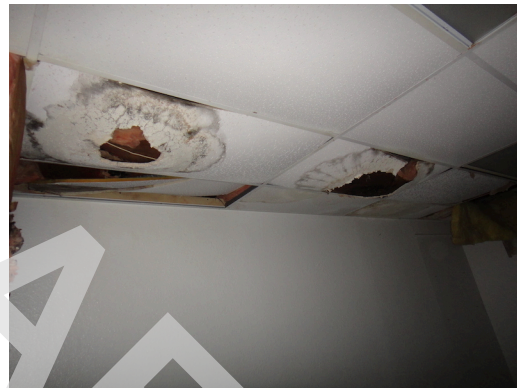
Past roof leaks bldg2
