# **Farm Bureau** **Building Structural Assessment**

**201 West Fourth Street  
Walnut Cove, North Carolina**

Re: Building Structural Assessment  
Farm Bureau Insurance  
Walnut Cove, NC  
MEPC No: 105-24

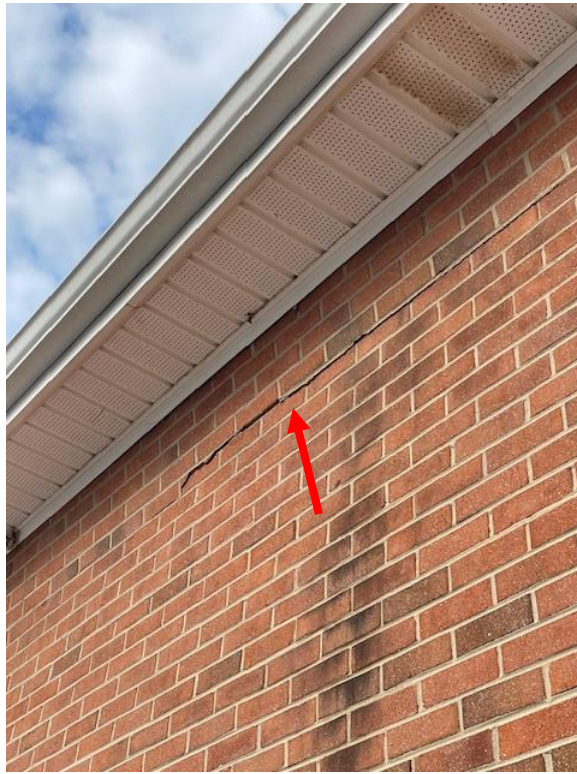
Based on our review of the attic access condition, it appears the framed roof condition, with no ceiling joist, has allowed the roof to flex and push outward on the brick parapet walls. It appeared the original parapet coping was removed and a 2x4 nailer added to the existing nailer to create a bearing point for the new rafter framing. Collar ties were added along the ridge, but the building roof has flexed enough that several of those were observed to be broken free from the rafters. Without ceiling joists to hold the bearing conditions together, the flexing has led to the rotation of the top of the parapet condition and led to the brick cracking observed at the top of the east and west walls. This parapet condition will require modification.

Parapet shift on east wall

- Remove existing wood framed roof and the existing roofing and insulation material down to the metal deck for new roof installation. A new roof installation would utilize tapered insulation to enhance the slope and require rework of the damaged brick parapet and new coping with the addition of a TPO or EPDM type roof with a new rear gutter system to be incorporated.

- Provide temporary bearing walls that will remain permanent approximately 12” away from the parapet condition supported by a 4x8 runner and a 2x4 framed wall to the rafter for support. This condition would occur continuously along the rafter bearing conditions at the east and west walls. This would transfer the rafter loads to the steel bar joist roof structure and allow for modification of the existing brick and bearing condition where the damage has occurred. In addition to the new support conditions and new rework of the existing bearing conditions with the brick work, there would also be the requirement to add 2x8 cross ceiling joists at every 3<sup>rd</sup> rafter location to create a tension tie between the plates to prevent push-out after repairs are made.

- The same approach as outlined above could be considered with a new support approximately 12” in from each rafter bearing condition to transfer the vertical load with the addition of the ceiling tie joist at every 3<sup>rd</sup> rafter location. Once the bearing condition was established with the new runner walls and the ceiling joist installed to prevent the kick-out, we could frame a boxed-out soffit condition approximately 16” deep to cover the damaged brick condition which would no longer provide support for the rafters with the new runner system in place.

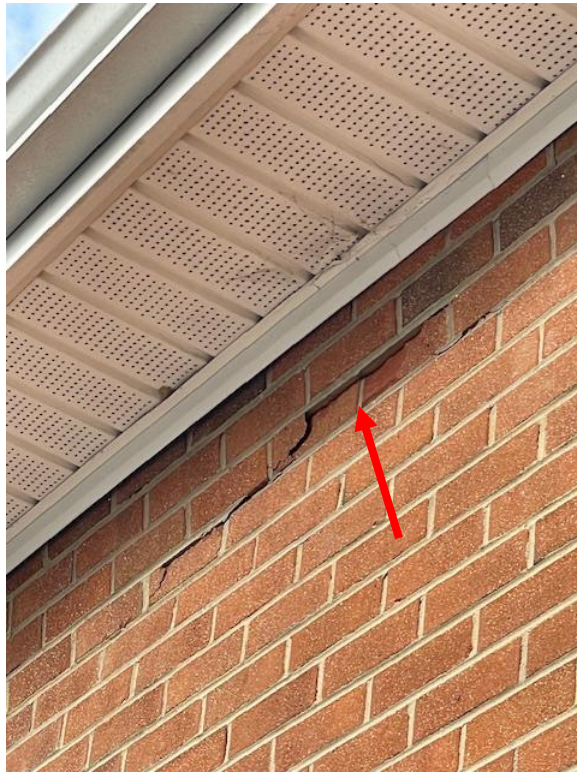
Parapet shift on east wall

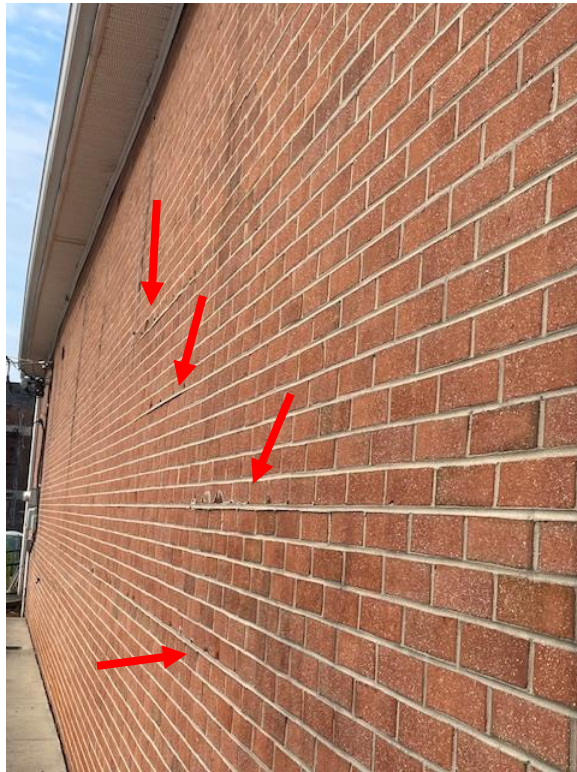
The east wall showed signs of mortar joint deterioration and mortar joint spauling in multiple locations. In regard to the primary issue to be addressed in the assessment, we observed cracking along the top of the east wall approximately 12"- 16" below the soffit. On the west wall, vegetation growth prevented good visual observation of this wall, but we did observe some similar conditions that are outlined above on the east wall.

Joint spauling on east wall

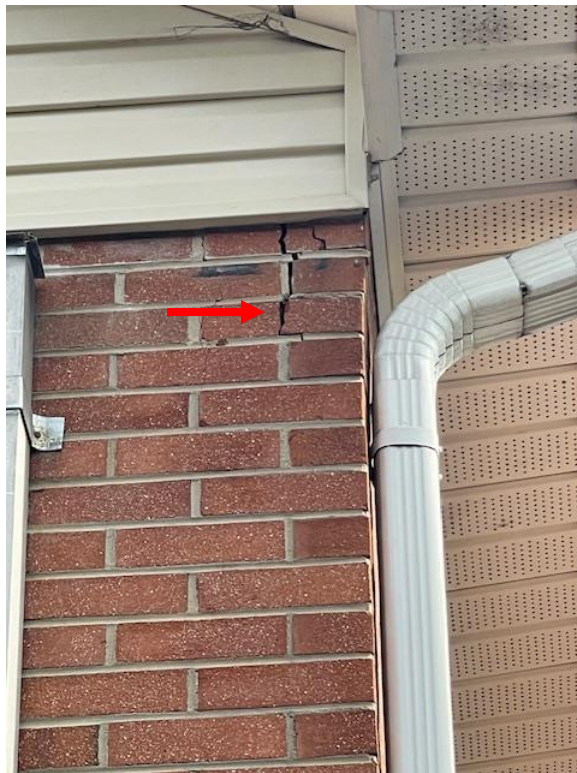
Parapet shift on east wall

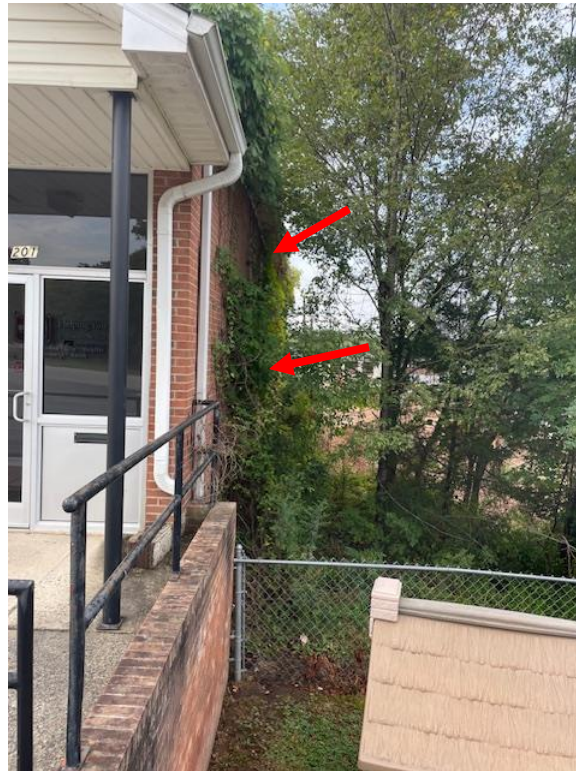
Vegetation growth on west wall

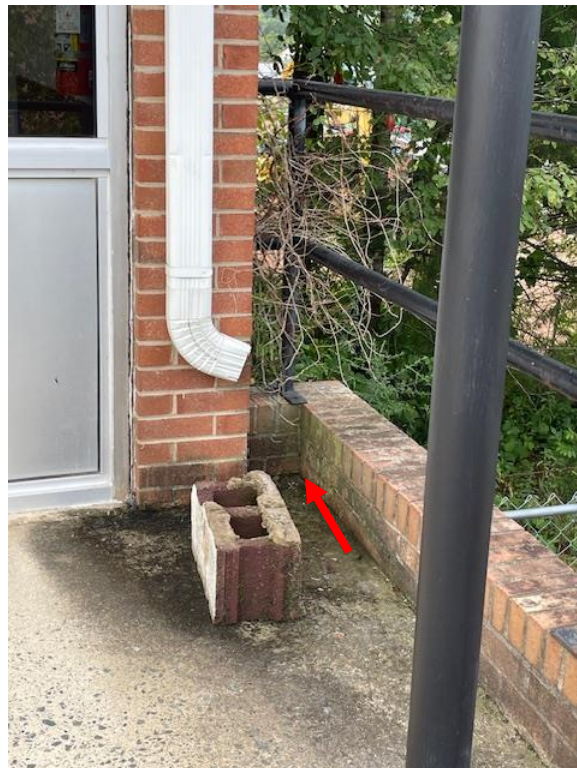
In regard to the exterior walk around, we noted numerous items in regard to downspout gutter discharge conditions. The gutter downspouts are dumping water adjacent to the foundation and should be modified to divert water from the foundation walls. We also observed the water meter has settled within the sidewalk condition on the east wall and has created a trip hazard.

Downspout discharge issue on west wall

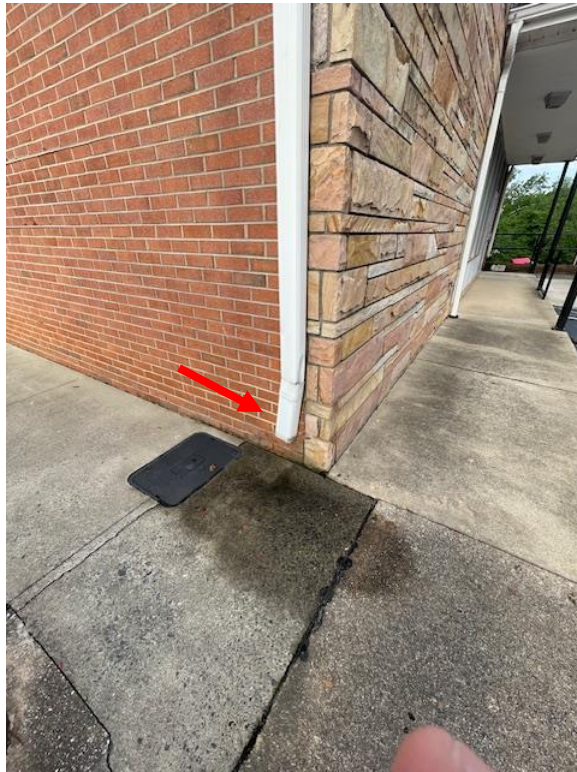
Downspout discharge issue on east wall

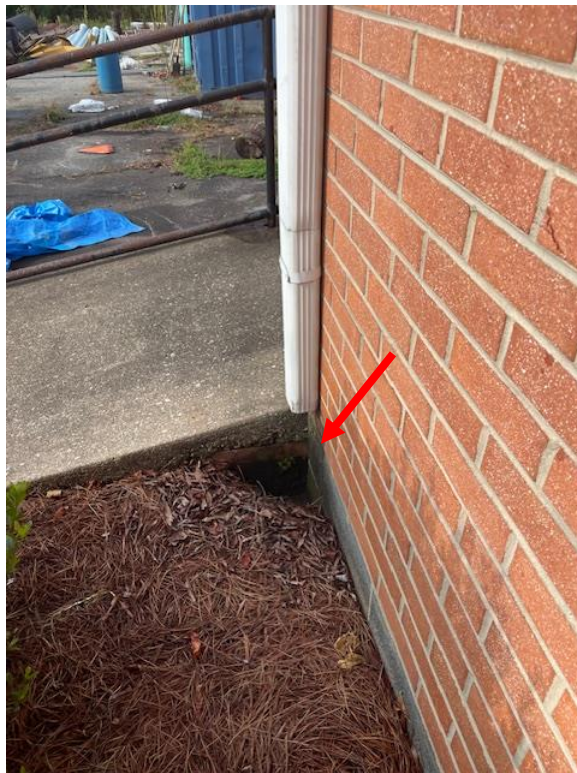
Downspout discharge issue on east wall – trip hazard

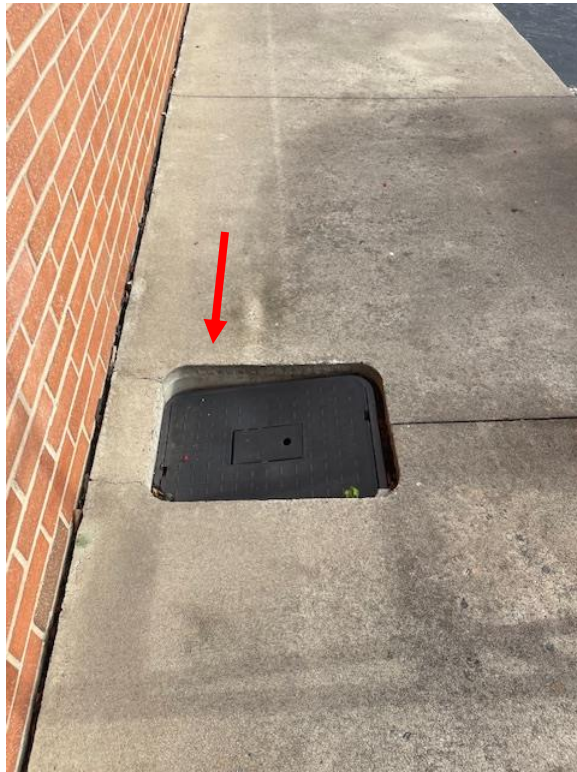
Water meter settlement on east wall

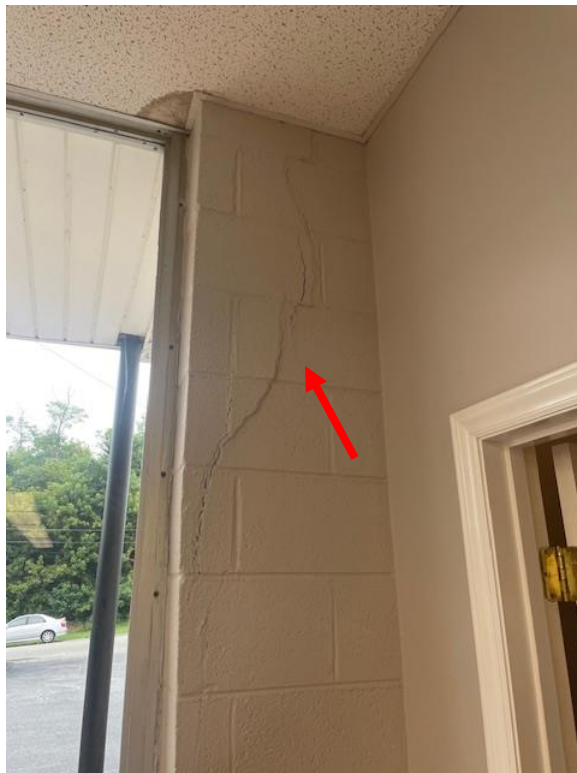
Wall settlement crack on north wall

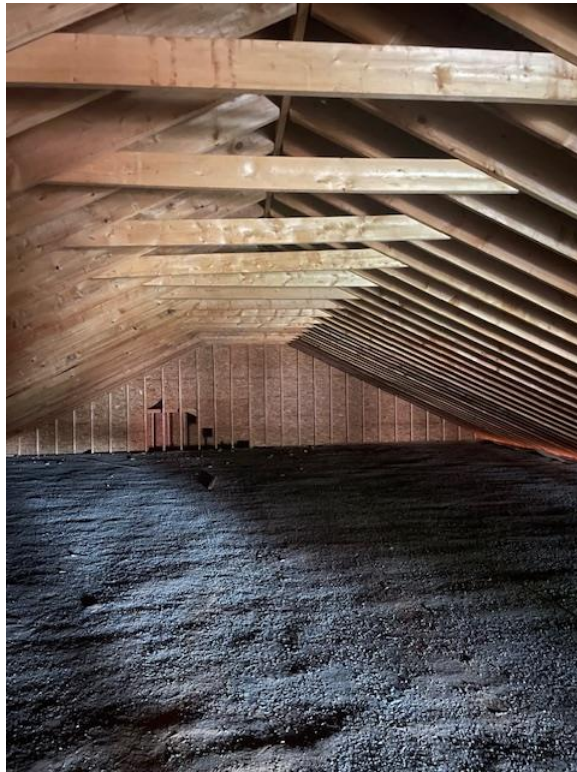
View of over framed wood roof

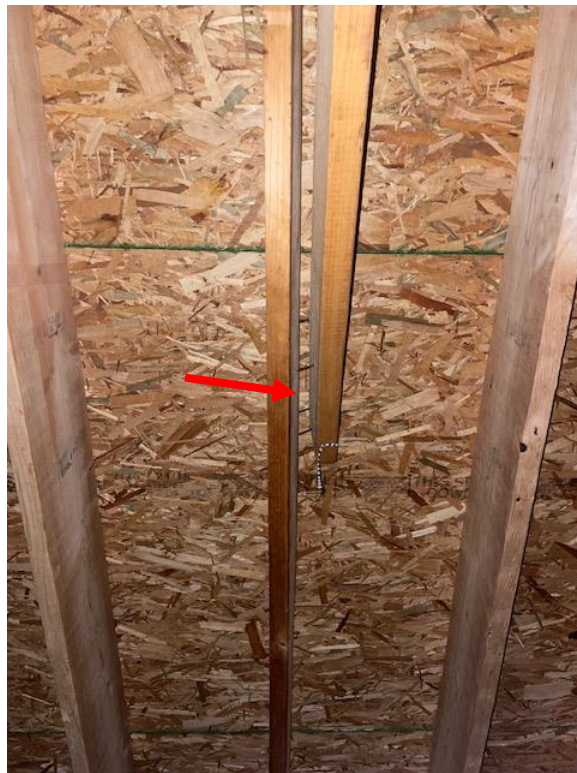
Collar ties with nail failure

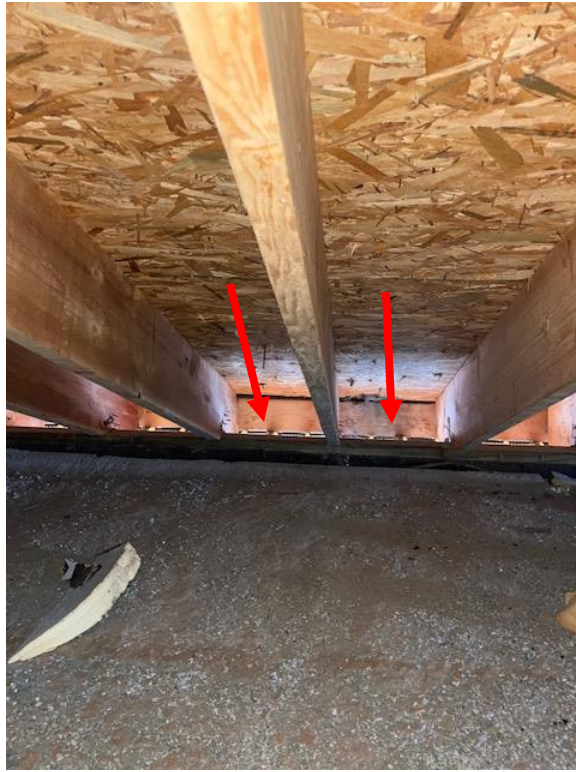
Pushed out rafter bearing plate on east wall

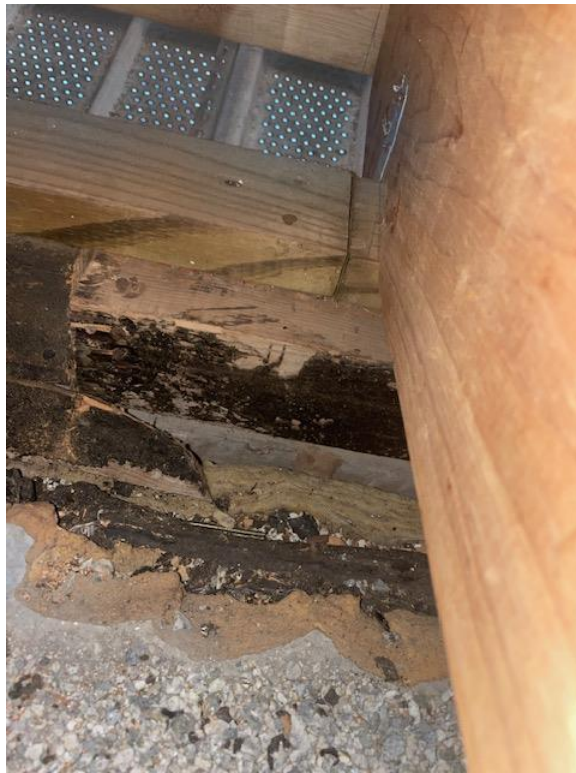
Pushed out rafter bearing plate on east wall
