The Nanni Corporation DBA
National Property Inspections

AMI INC, 6678 River Road, Fuquay Varina, NC, 27526

Wednesday, December 13, 2023

Property Location : **6678 RIVER ROAD
FUQUAY VARINA NC 27526**

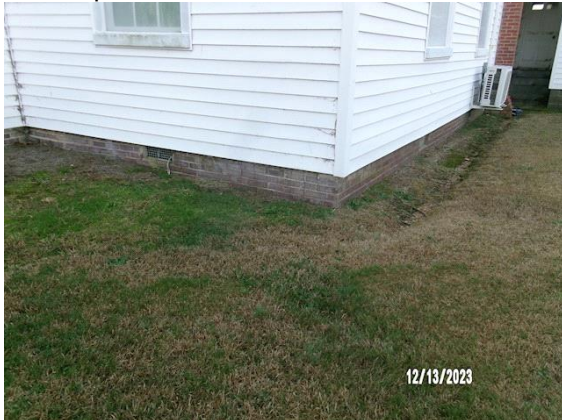
1. Near level to level grading present along the front of the building(s). Area is conducive to water draining toward the home, for water ponding near the perimeter of the home which can lead to ground saturation and water intrusion problems that may effect the foundation system of the structure and increase moisture inside the crawl spaces which is suspected here as indicated by damp foundation walls / ground conditions, visible erosion in the crawl space earthen floor and condition of the floor framing as observed during the crawl space inspections. Further evaluation and repair by a qualified contractor is needed to correct grade and or install drainage collection to ensure water drainage is away from the foundation.

GRADING / DRAINAGE: typical negative grade along foundation

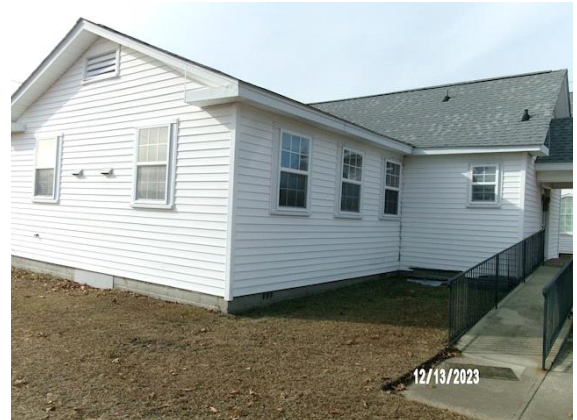
GRADING / DRAINAGE: typical near level to level grade along foundation

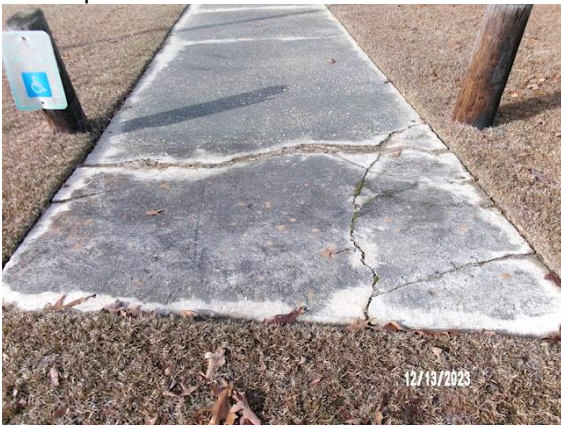
1. Noted cracks / broken concrete with vertical offset in the front sidewalk, typically indicating sidewalk settlement and/or heave. Vertical offset is a trip hazard.

FLATWORK / SIDEWALKS: typical cracked/broken concrete w/vertical offset

Repairs by a qualified contractor are needed as people safety and function of these components is compromised.

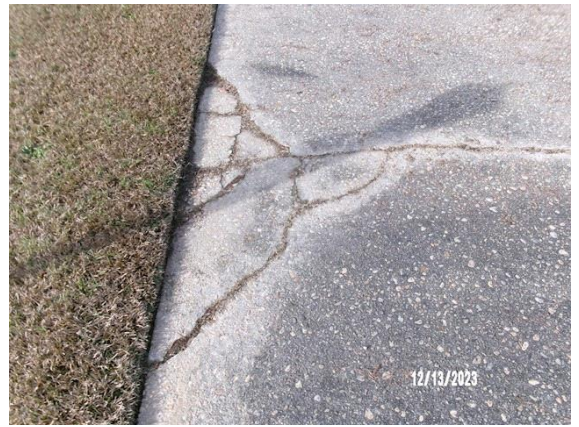
FLATWORK / SIDEWALKS: typical cracked/broken concrete

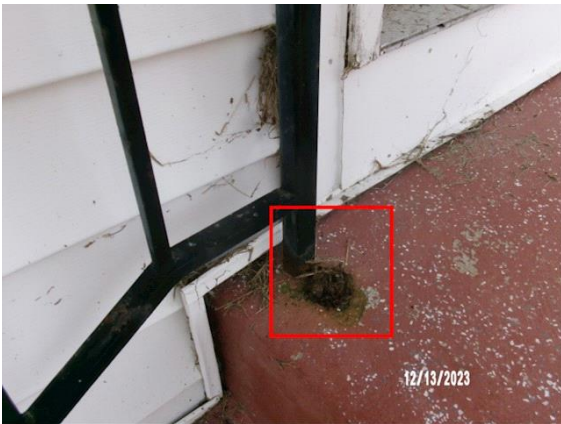
2. The left metal handrail at the main, front steps is loose, post has "rusted" through at point it was embedded in the front masonry porch type structure. Handrail provides minimal support.

FLATWORK / SIDEWALKS: left handrail post at front entry rusted thru

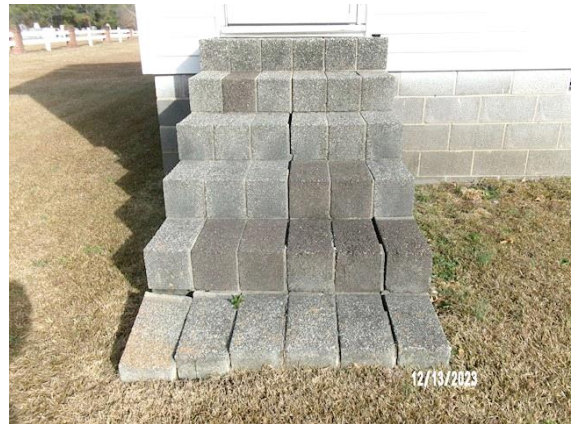
3. Noted separation / settlement at the back right masonry block steps which can cause someone to trip and fall. A handrail is not installed which compromises safety for anyone using the steps.

FLATWORK / SIDEWALKS: separation / settlement at back right steps, no handrail

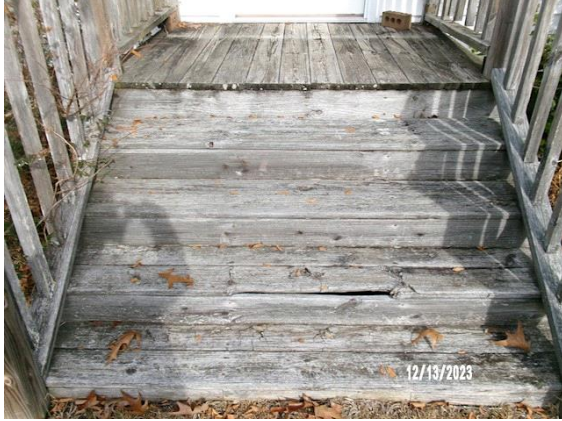
4. Noted general decay / deterioration at back left wood platform and steps, Handrail is loose, the nail connection which attaches the handrails to the support post have and or are failing. Condition can lead to handrail failing to support loads placed on/against them.

FLATWORK / SIDEWALKS: general decay / deterioration at back wood steps

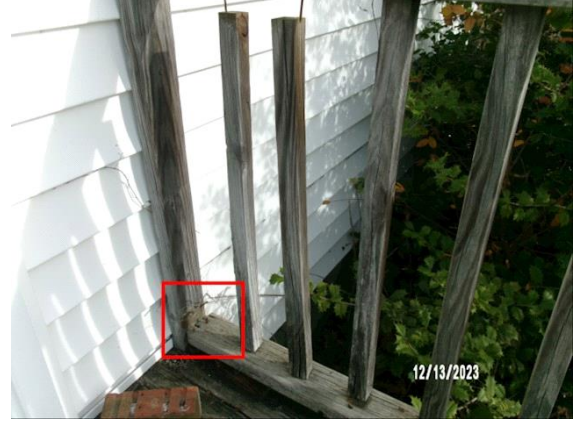
FLATWORK / SIDEWALKS: failed nail connection at back wood steps handrail

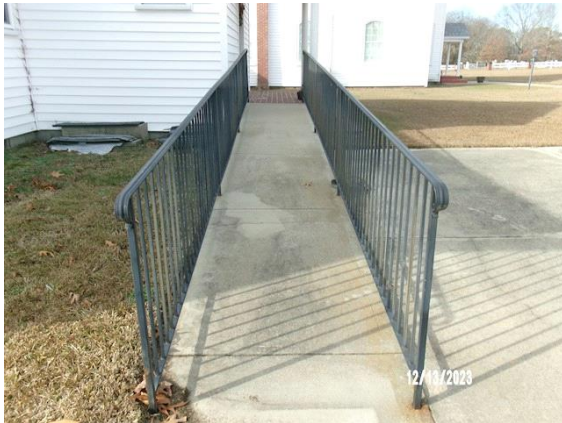
5. Metal handrails along the handicap ramp are loose. Condition will typically loosen until handrails fail to support loads placed on/against them.

FLATWORK / SIDEWALKS: loose handicap railings

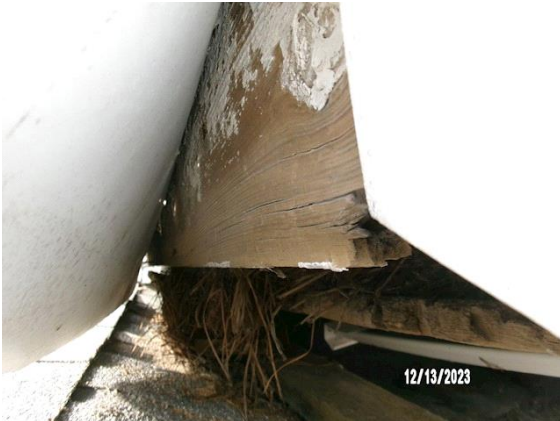
EXTERIOR SURFACE: loose aluminum trim at water table

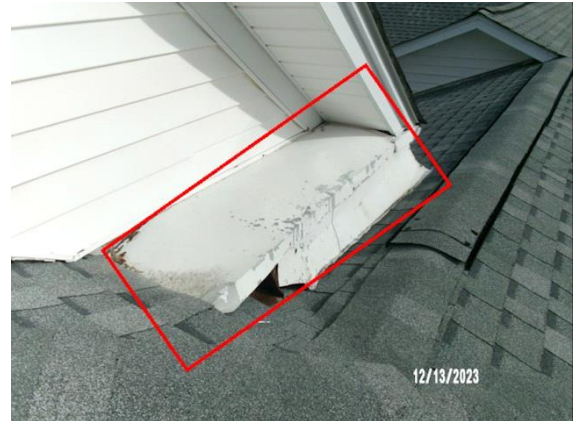
EXTERIOR SURFACE: back left water table / return

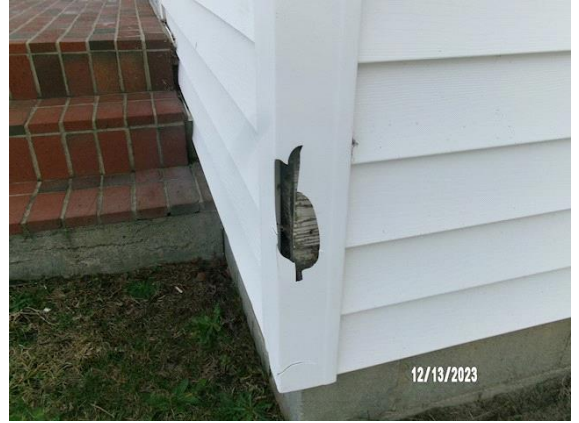
EXTERIOR SURFACE: hole in siding corner post

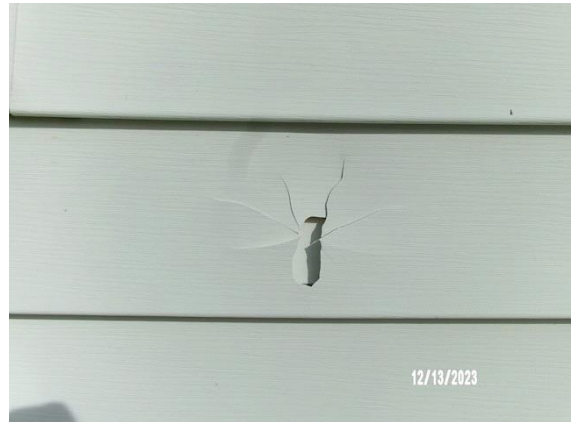
EXTERIOR SURFACE: hole in siding

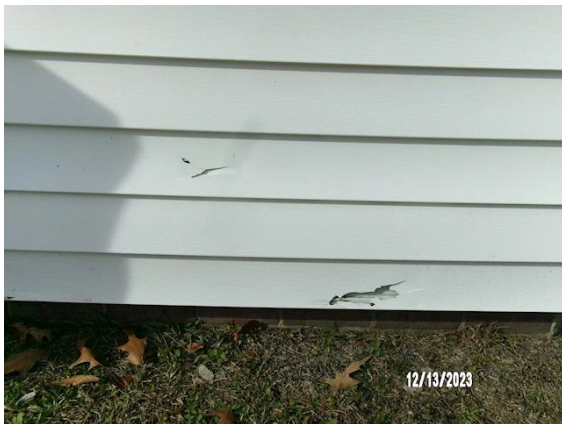
EXTERIOR SURFACE: holes in siding

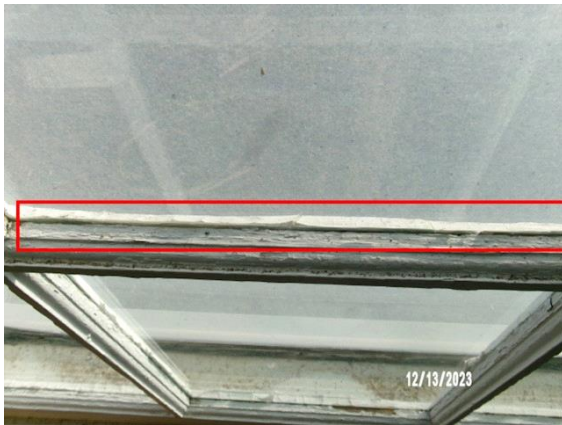
1. Noted brittle, cracked and or missing window glazing putty at multiple wood windows. Glazing putty is needed to secure the glass in the window and also to help prevent the transfer of air/moisture between the interior and the exterior of the home. Repairs by a qualified contractor are needed.

FENESTRATION SYSTEMS: brittle / cracked glazing putty

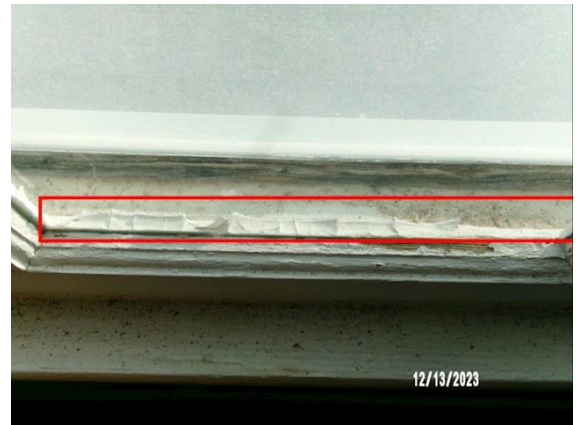
FENESTRATION SYSTEMS: brittle / cracked glazing putty

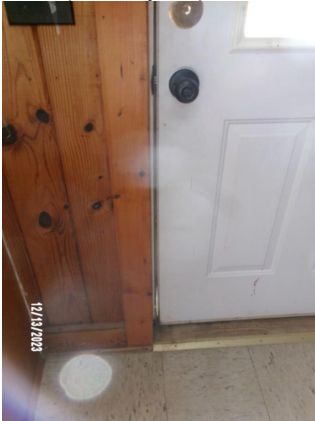
DOORS - EAST WING: kitchen door does not seal

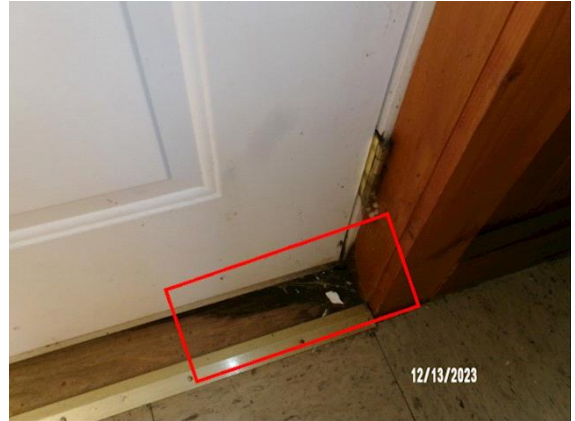
3. Noted decay in the jamb/trim of the exterior kitchen door below the bottom hinge. Also noted evidence of water intrusion as indicated by discoloration of the threshold. Condition can allow water penetration below the threshold and into the flooring /framing.

DOORS - EAST WING: water intrusion along kitchen door

Repairs by a qualified contractor are needed.

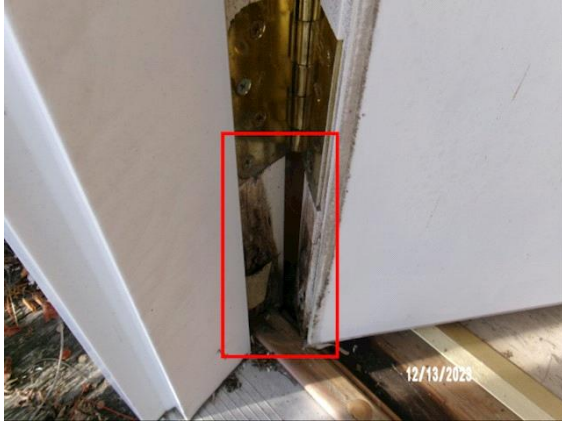
DOORS - EAST WING: decay in kitchen door & jamb

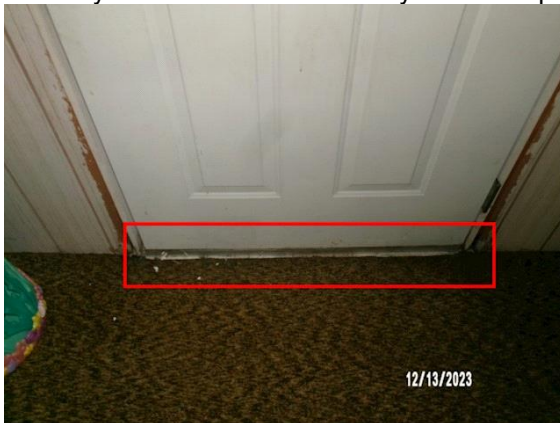
1. Noted evidence of water intrusion along the bottom of the "class room" exterior door as indicated by soft floor along the threshold, floor will deflect when weight is applied. Decay and previous repairs were visible during the crawl space inspection. Further evaluation by a qualified contractor is needed to determine if the water intrusion causing the decay is active and to make any needed repairs.

DOORS - WEST WING: soft sub

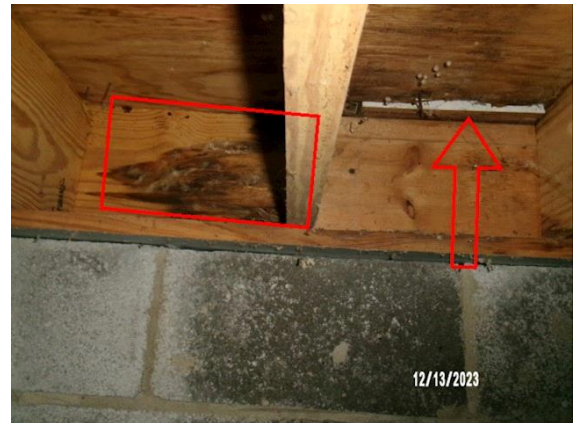
DOORS - WEST WING: decayed sub floor & band joist under door

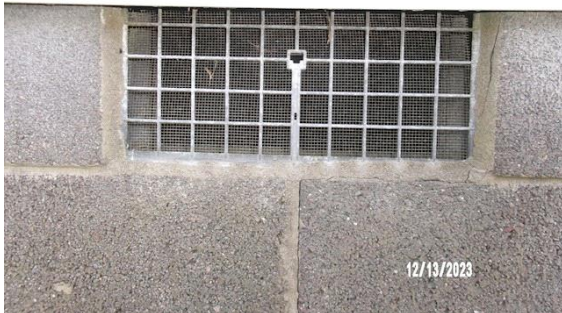
1. Multiple foundation vents are inoperable, broken, missing vent door handles, vent door and or the pest screen is missing/damaged. Control of the crawl space ventilation is compromised. Vent replacement / repair by a is needed as all vents should open/close and have pest screens which helps prevent pest intrusion into the crawl space.

EXTERIOR FOUNDATION: typical vent missing a vent door/handle

Repairs by a qualified contractor are needed.

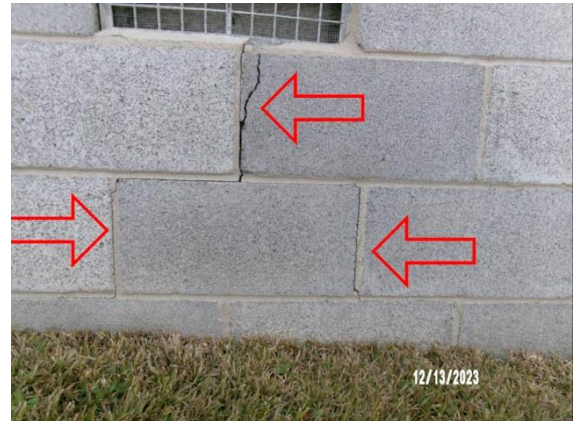
2. Noted a generally vertical crack in the right wall of the west wing. Due to the width at the top of the crack below the foundation vents and crack steps both towards the front and back corners recommend further evaluation by a qualified contractor are structural engineer if deemed necessary by the general contractor.

EXTERIOR FOUNDATION: step crack

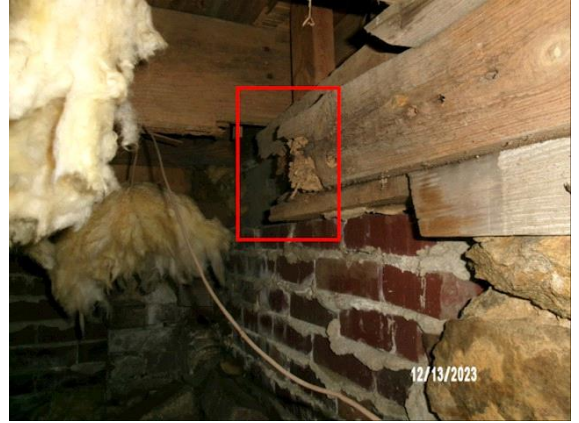
1. Wood destroying insect (WDI) activity and elevated moisture levels/fungal growths inside chapel crawl space has lead to significant damage of the framed floor structure including to the girders, floor joist and turned timber floor joist. Multiple WDI tubes were visible as is damage caused by the WDI activity. Probing various round timber floor joist and dimensional floor joist especially those with a suspected fungal growth found significant decay. Amount of damage can compromise the structural integrity of the framing component which can lead to floor sag, deflection and or collapse.

STRUCTURAL FRAME AND BUILDING ENVELOPE:
decayed/WDI damage joist

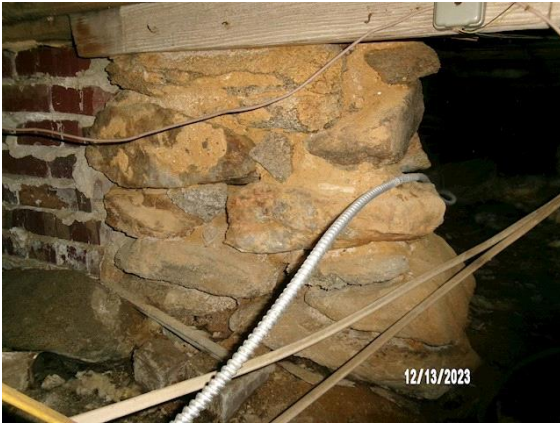
3. Although an acceptable practice when the chapel section was built noted multiple dry stacked stone piers. Over time settlement and stones shifting can allow floor framing to move. Also noted deteriorated mortar in some of the aged piers which do have mortar.
Due to the visible current conditions of the floor framing and framing support, mainly under the chapel, the floor structure and support requires further evaluation by a structural engineer is needed.

STRUCTURAL FRAME AND BUILDING ENVELOPE:
typical stone pier with deteriorated mortar

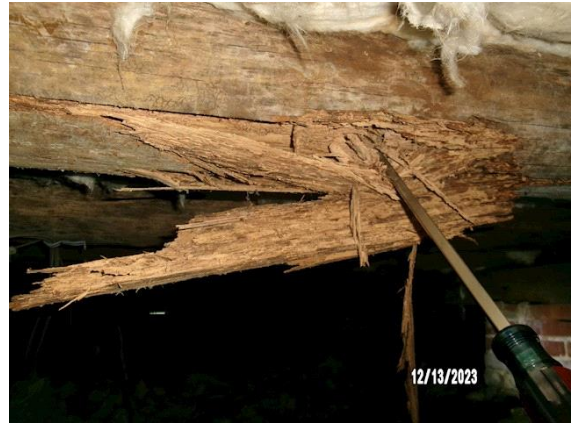
STRUCTURAL FRAME AND BUILDING ENVELOPE:
probing a typical round timber floor joist

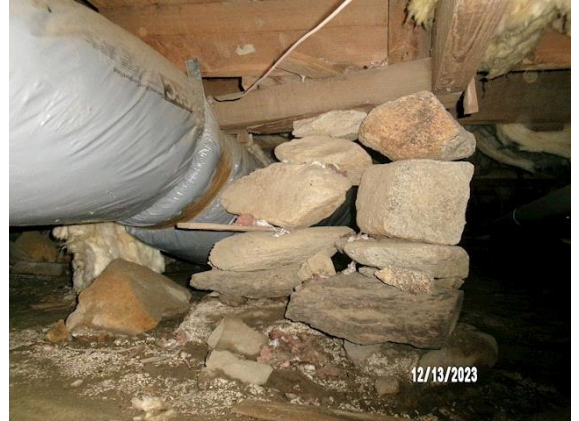
STRUCTURAL FRAME AND BUILDING ENVELOPE:
typical stacked stone pier

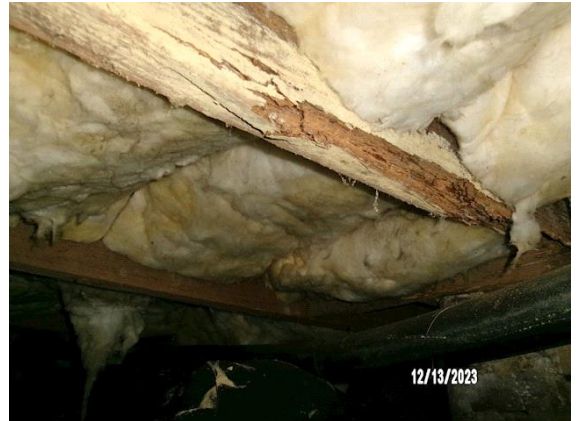
STRUCTURAL FRAME AND BUILDING ENVELOPE:
probing a mold covered floor joist

4. A suspected fungal / organic growth noted on the floor framing member inside the crawl spaces which can indicate elevated and/or previously elevated moisture levels inside the crawl space. Further evaluation by a contractor(s) who specializes in crawl space moisture control and fungal / organic growth identification and removal is needed to develop and implement a course of action to control moisture levels, remove and prevent future growths. Elevated moisture levels, growth can damage the framing, insulation and can compromise the health of the occupants.

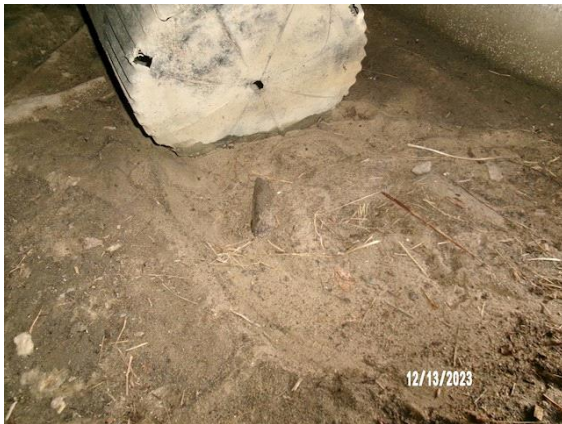
1. Missing a vapor barrier in the crawl spaces. A vapor barrier is needed to help reduce moisture from seeping up into the crawl space from the ground (moisture intrusion) and to reduce condensation in the crawl space due to elevated moisture. Repair by a qualified contractor is needed to remove all debris from the crawl spaces, prepare ground and install a vapor barrier.

3. Noted evidence of active water intrusion into the crawl space as indicated by damp foundation walls, damp to wet earthen crawl space floor and erosion in the crawl space earthen floor. Water intrusion can elevate moisture levels inside the crawl space leading to damaged insulation, floor framing and/or an environment conducive to fungal growth which was observed inside the crawl spaces. Further evaluation and repair by a water proofing contractor is needed.

CRAWL SPACE: missing vapor barrier, wet crawl space earthen floor

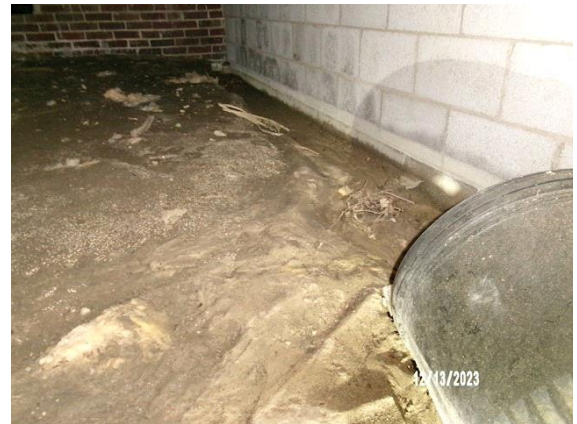
CRAWL SPACE: erosion in wet crawl space earthen floor, also missing vapor barrier

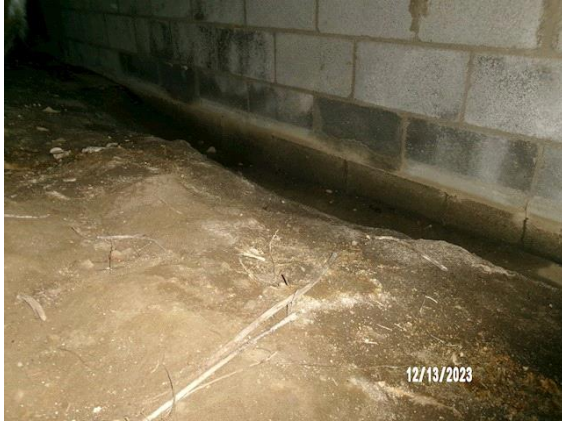
CRAWL SPACE: missing vapor barrier, damp foundation walls.

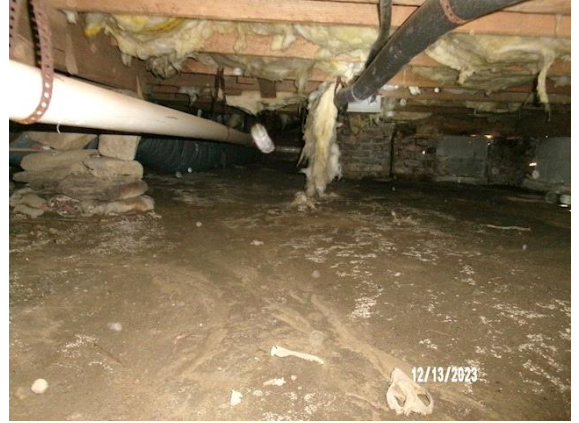
CRAWL SPACE: erosion in wet crawl space earthen floor, also missing vapor barrier

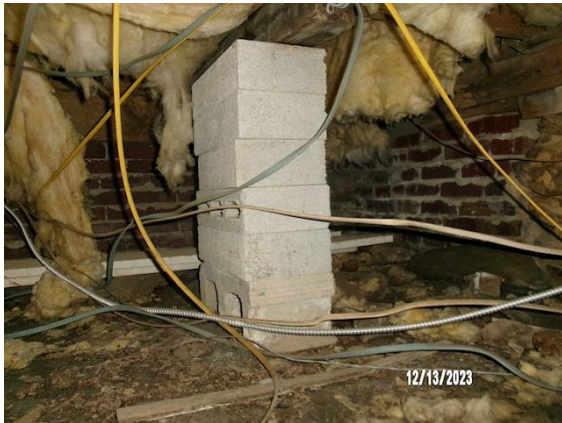
2. Noted multiple places where the floor insulation has fallen from or is falling from the joist cavities exposing sub floor to unconditioned air. This can cause cold floors and condensation on the sub floor due to temperature differential between the conditioned living areas and the unconditioned crawl space. Repairs by a qualified contractor are needed to replace any missing / damaged insulation and to re install fallen insulation which is still functional.

CRAWL SPACE: typical fallen floor insulation

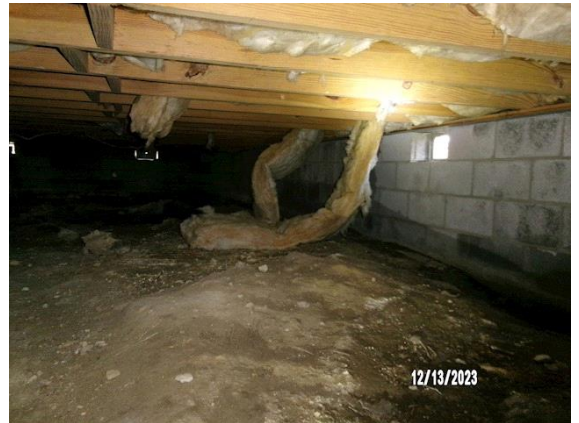
CRAWL SPACE: typical fallen floor insulation, missing vapor barrier

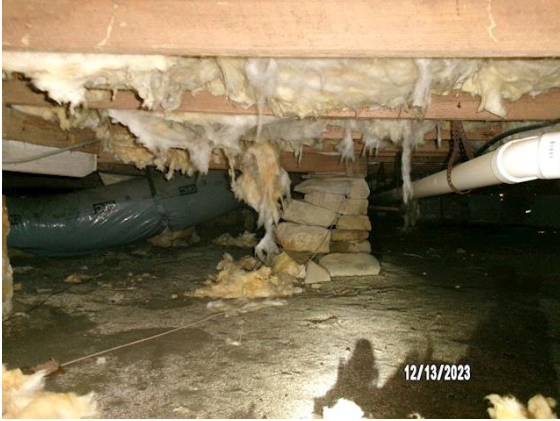
CRAWL SPACE: fallen , stringy insulation (moisture caused) missing vapor barrier

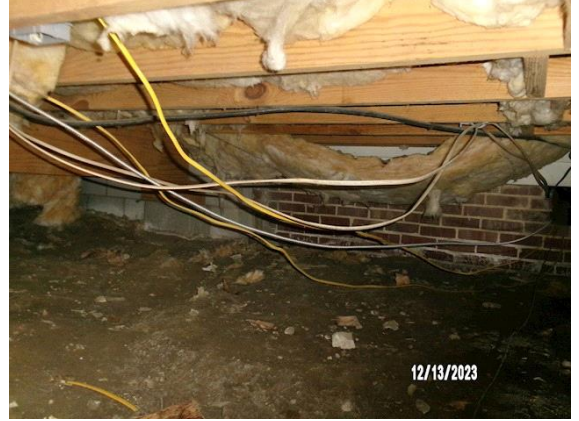
CRAWL SPACE: fallen insulation, damp earthen floor

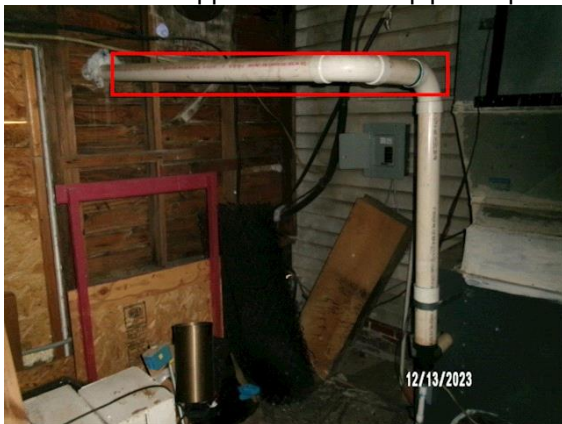
1. The PVC exhaust pipe is not supported. Typically metal strapping rated for this application are installed to support the exhaust pipe. Repair by a qualified contractor is needed.

DRAFT CONTROL / VENT GOODMAN FURNACE: no support strapping

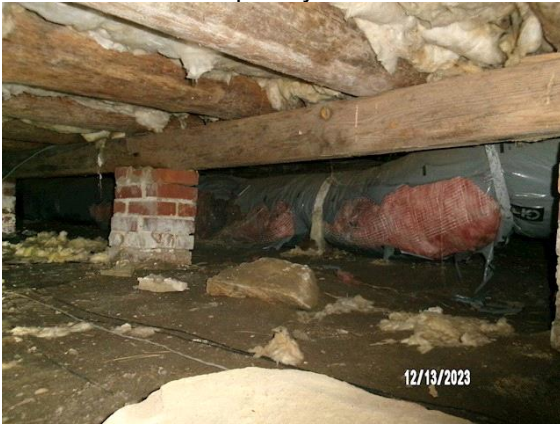
1. Noted deteriorated vapor barrier on multiple supply ducts in the crawl space under the chapel, one main duct in crawl space has a hole torn in it causing conditioned air to be released into the chapel crawl space. Multiple ducts are sagging and or are in contact with the crawl space earthen floor. Also noted torn vapor barrier / insulation in a duct above the class room ceiling in the west wind. Further evaluation and repair by a mechanical contractor is needed to repair or replace the damaged ducts.

HVAC DISTRIBUTION: Typical torn duct vapor barrier, hole torn in duct, duct on ground

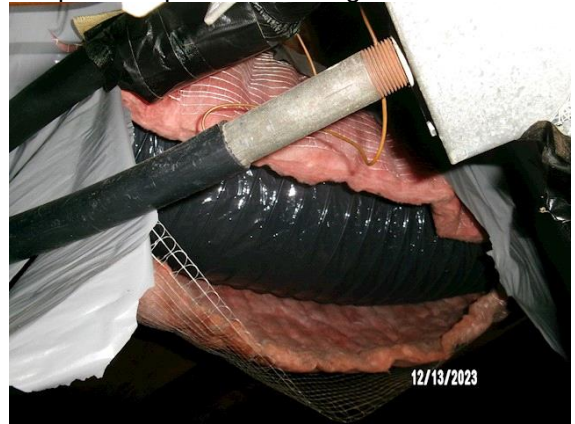
HVAC DISTRIBUTION: typical torn vapor barrier, missing duct insulation

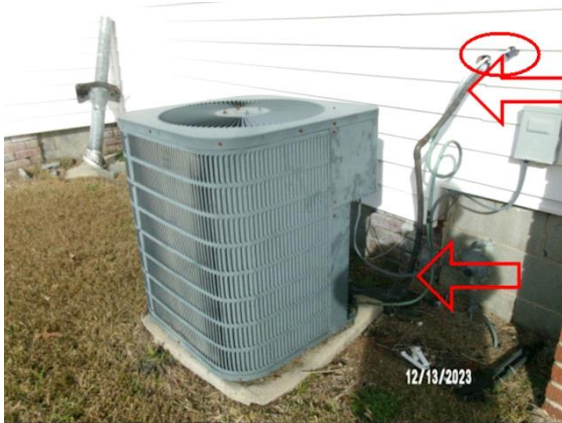
1. Noted deteriorated insulation on the exterior section of the Goodman heat pump , exposed suction line which can lead to decreased efficiency. Insulation should be replaced/repared by a mechanical contractor. Also recommend sealing lines at pint they penetrate the siding.
- 2, Noted the evaporator coil cabinet located below the ceiling in the chapel office is rusted/deterioarted which can indicate a condensate leak. Further evaluation by a mechanical contractor is needed.

COOLING - HEAT PUMPS: exposed suction line, missing sealant at siding

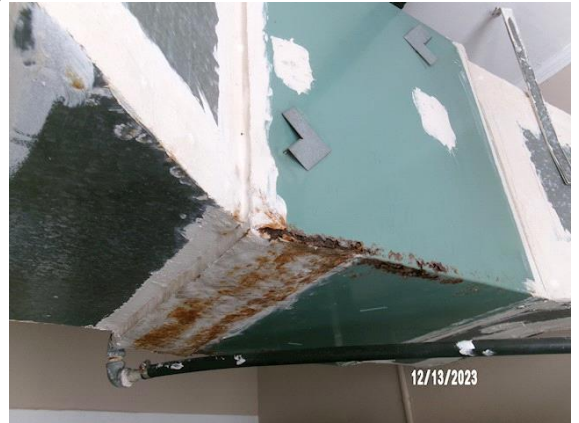
COOLING - HEAT PUMPS: rust/deteriorated evaporator coil cabinet

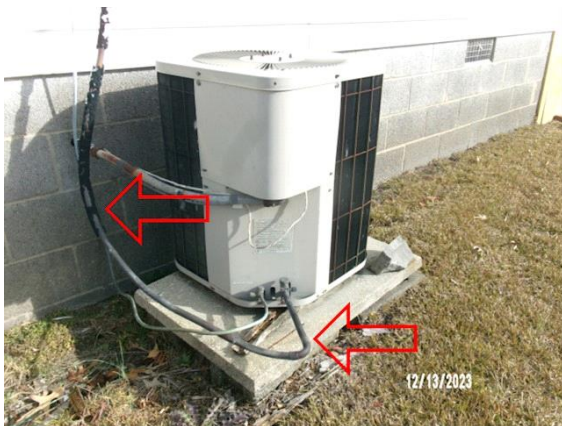
1. Noted deteriorated insulation on the exterior section of the suction line, exposed suction line which can lead to decreased efficiency. Insulation should be replaced/repared by a mechanical contractor. FYI: S/N not legible, Suspect unit is equal to or greater than 18 years of age which places it beyond normal life expectancy. The air handler is located above the west wing class room ceiling, data plate not found. Suspect unit is > 18years of age and reaching its useful life expectancy.

COOLING - GOODMAN: exposed suction

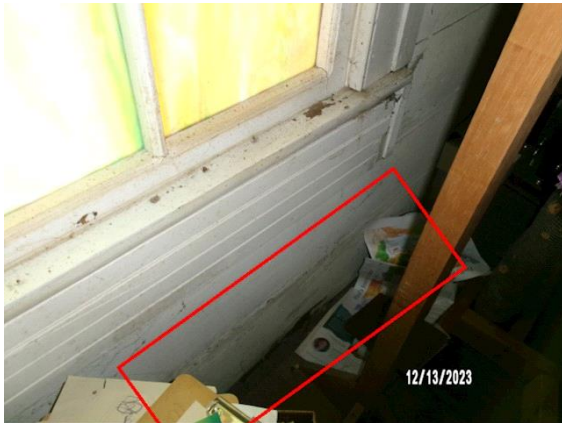
1. A suspected wood destroying insect activity / damage was observed below the front left window in both the siding and band joist 1st left facing window, at the 1st left facing window in the window/trim. Due to the visible damage walls and floors should be opened for additional inspection for hidden damages which may require repairs including structural repairs. Further evaluation by a qualified contractor is needed.

CHAPEL: WDI damage under front window

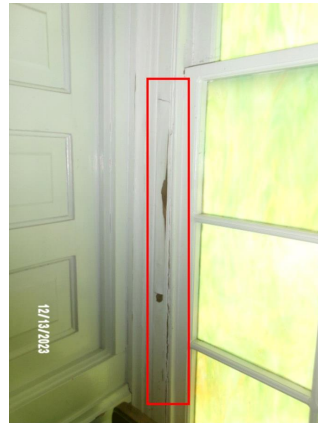
CHAPEL: WDI damage left facing window

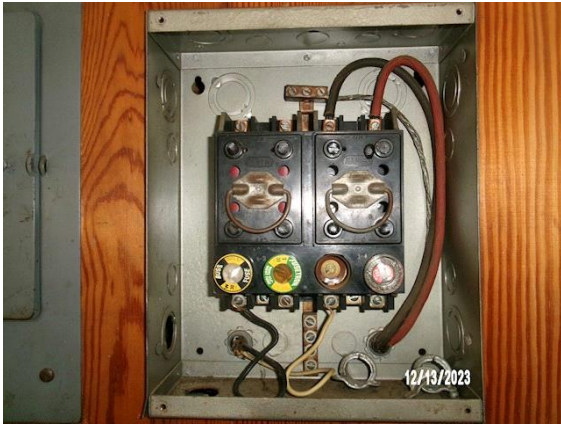
The main electrical panel located on the back exterior wall was not accessible as the front cover was pad locked. Interior of this panel could not be inspected.
 Sub panel amperage could not be determined. A sub panel is located in the west wind hallway (breakers) and in the dining hall (fused)
 Missing one fuse and a second appears to be blown.

Electrical: fused sub panel

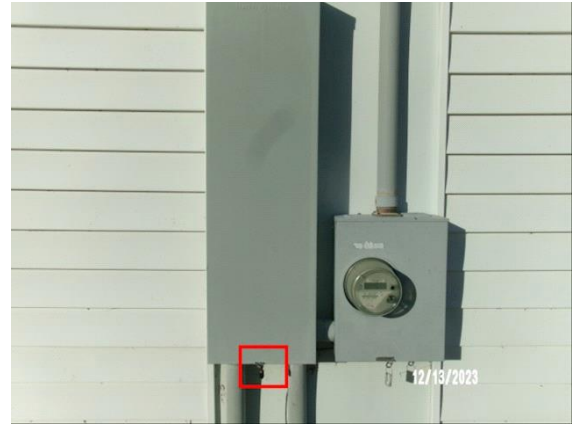
Electrical: main electrical panel - pad locked

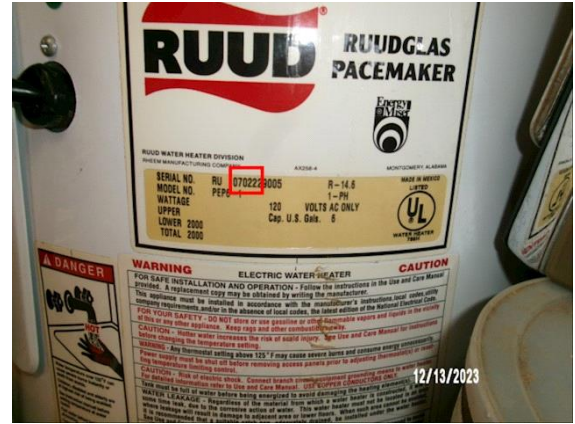
Based on the date code in the s/n the approximate age of this water heater is 21 years. Recommend budgeting for a new water heater in the new future as age indicates water is past normal life expectancy

Water Heater: data plate

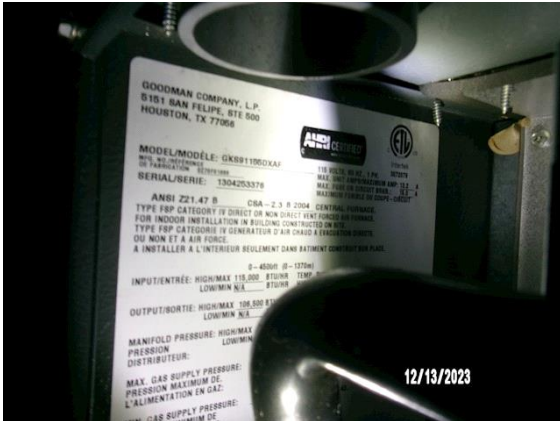
1. Based on the data plate on the exterior unit a Goodman heat pump is packaged with this LP gas furnace. Goodman model CPLE481, S/N 0506780972, Est. age = 18 years which places it beyond normal life expectancy. Using the installed thermostat located inside the chapel the heat pump failed to turn on in the heating mode. It is unknown if the heat pump has been defeated as not to operate in the heating mode. Using the thermostat the fan/blower did turn on.

HVAC 2: Goodman furnace data plate

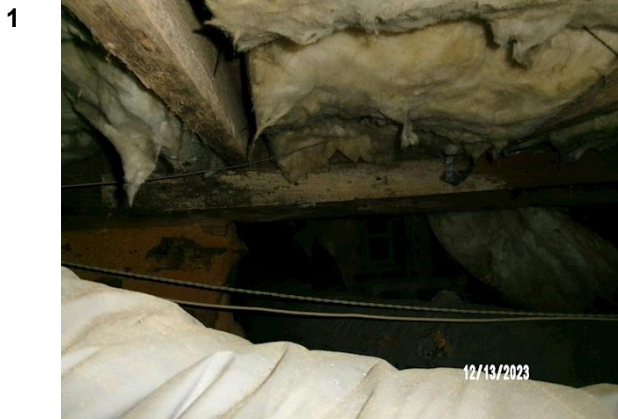
mold covered floor framing - crawl space

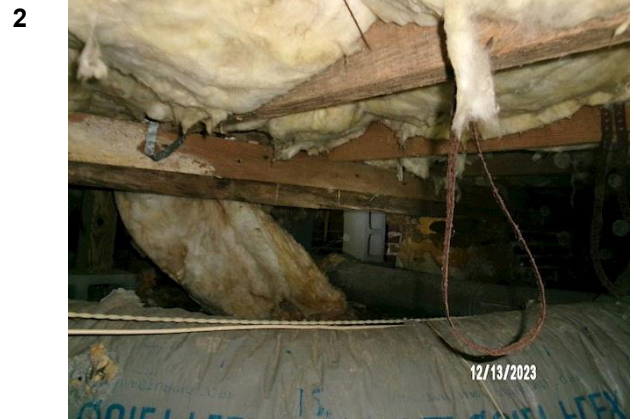
mold covered floor framing - crawl space

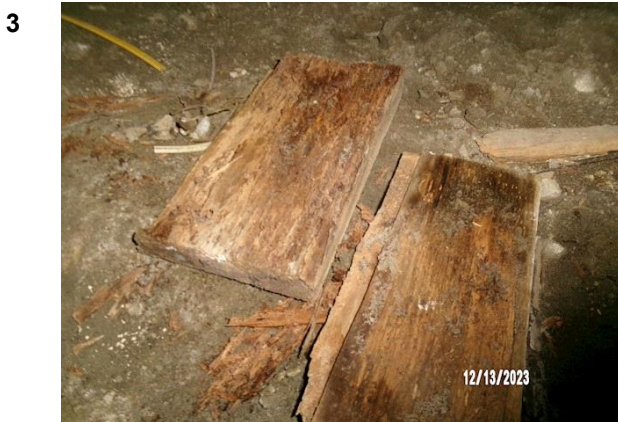
WDI activity in wood

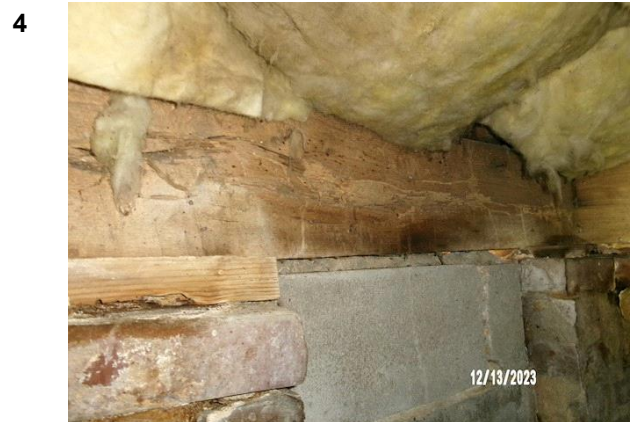
WDI activity in girder

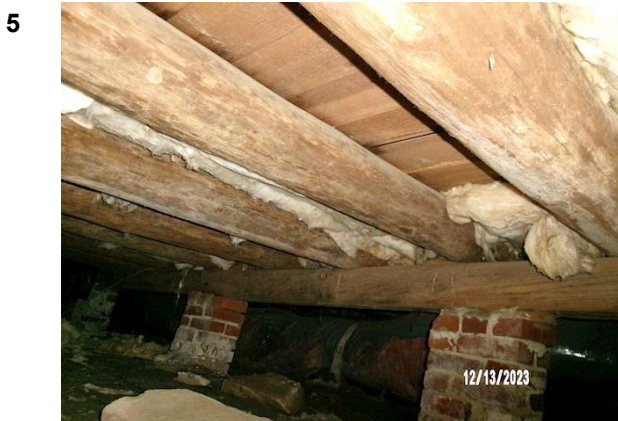
decayed round floor joist, note mold on joist under chapel

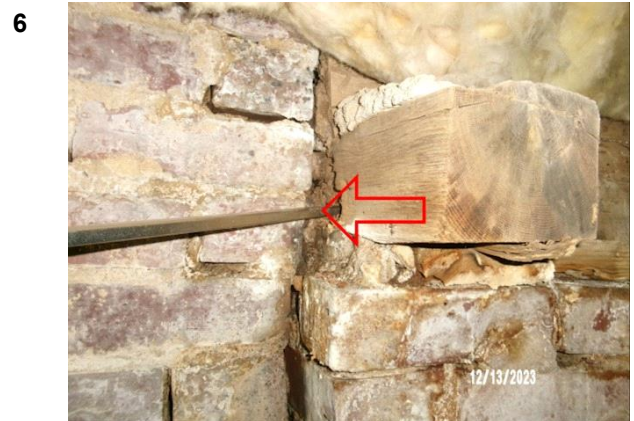
probe pushed through outer floor support - crawl space

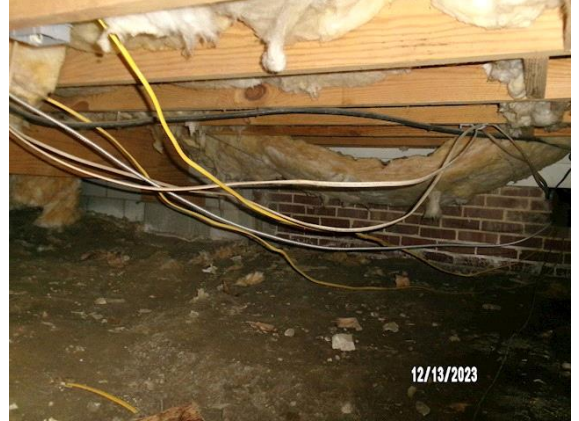
6. Noted multiple electrical wires "dangling" inside the crawl spaces. Wires should be neatly attached to the bottom side of the floor framing using straps rated for this application. Repair by an electrical contractor is needed.

typical wires dangling thru crawl spaces
