Roof Inspection Report

2710 Kollmar Drive #1-24, San Jose

Ernest Rodriguez
May 17, 2025
Reg No. HIS-80151-SP

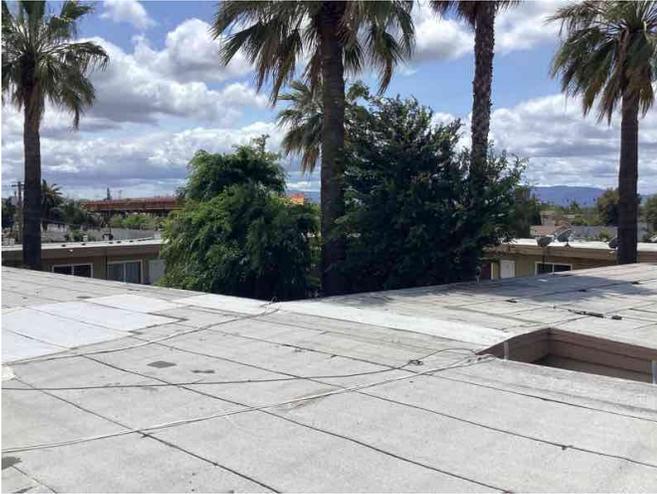
Photo 01

1. Main roof, pictured. (See Photo 1)
2. Previous repairs have been performed to the roofing system at several areas, these repairs appear vulnerable to leakage. (See Photo 2) (See Photo 3) (See Photo 6)

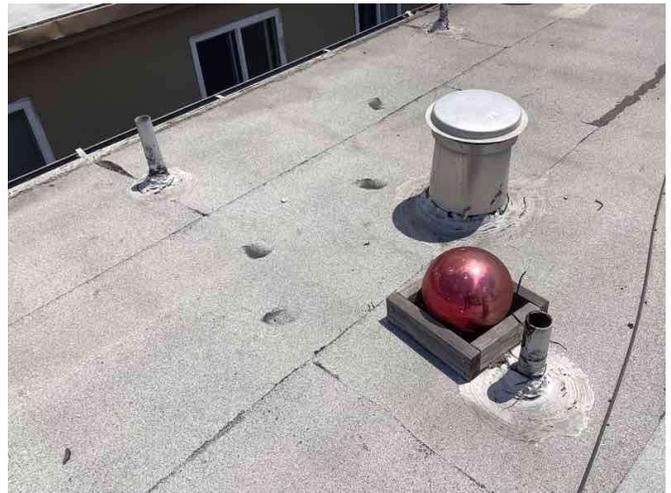
Photo 04

3. The plumbing, heater, and gas vents have been sealed with mastic at the roofline. The mastic has cracked and is beginning to peel away from the surfaces it was intended to seal, exposing these areas to subsequent leakage. (See Photo 4) (See Photo 5) (See Photo 15)

The roof appears to be vulnerable to leakage and is beyond practical repair. If a bid for a new roof is desired please contact HomeGuard Incorporated for re-roofing options.

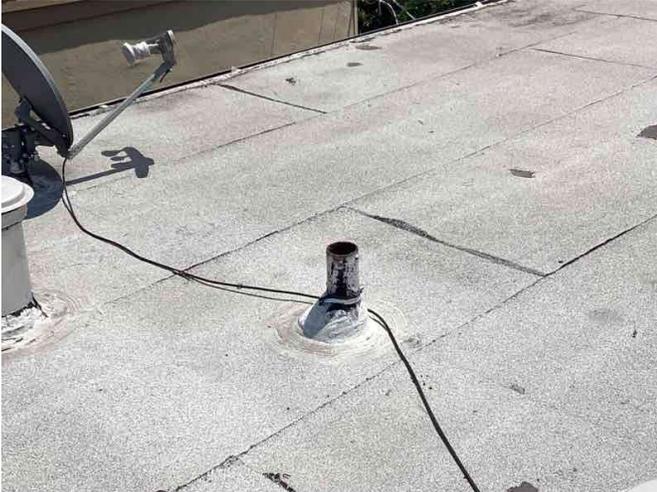
Photo 07

4. The plumbing flashing(s) are not adequately sealed at the collars. (See Photo 7)
5. The roof has lost areas of the protective granules, this condition has weakened the integrity of the membrane at these areas. (See Photo 8) (See Photo 19)

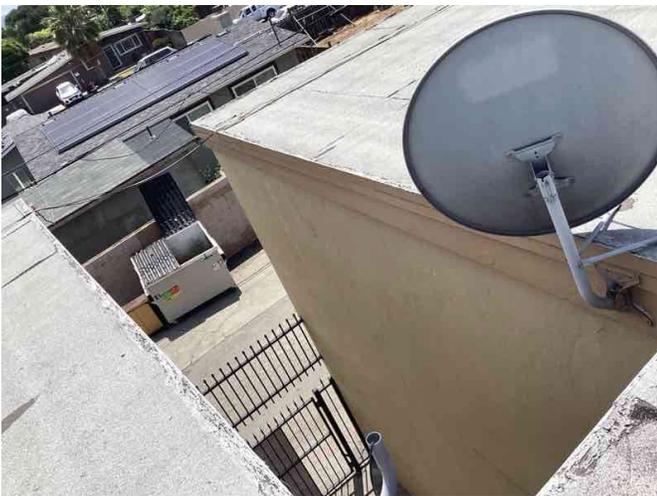
Photo 09

6. The perimeter curb is beginning to deteriorate, due to age, at most all areas. (See Photo 9) (See Photo 12) (See Photo 14)
7. There is debris on the roof that impedes water travel. (See Photo 10) (See Photo 11)

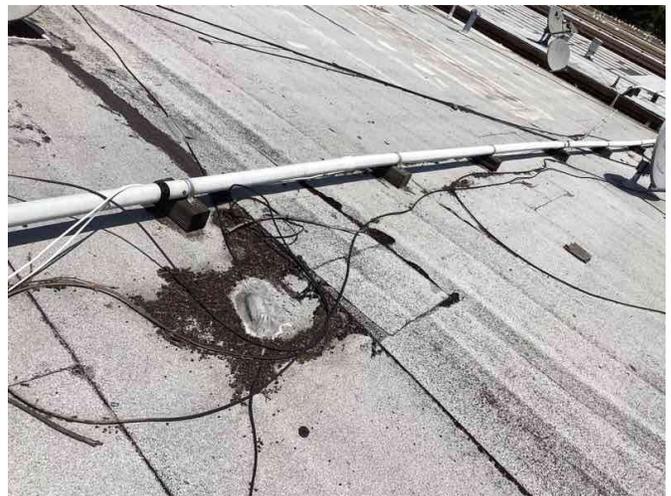
Photo 10

8. There are areas of the roof surface that have been sealed with mastic. The mastic is showing signs of wear and tear and must be resealed. Mastic is usually used around skylights, pipe vents, corner seams and other penetrations to help ensure a watertight seal. The typical serviceable life of mastic before it begins to crack is 3 to 5 years. (See Photo 10) (See Photo 13) (See Photo 16)

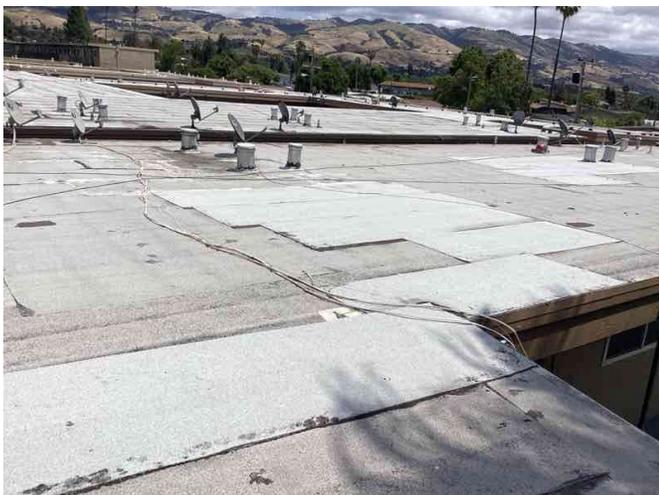
Photo 17

9. This roof has been previously serviced; the performance of these repairs were not verified. (See Photo 17) (See Photo 18)
