#4 (RIGHT BUILDING)

835 Minnie St
Jacksonville, FL 32204

NOVEMBER 7, 2024

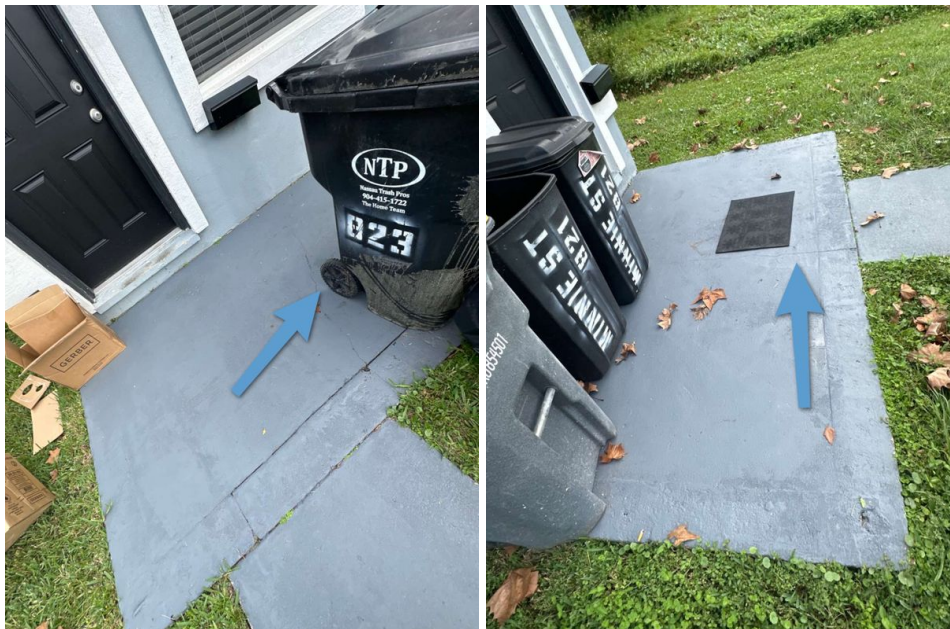
TYPICAL CONCRETE CRACKS

Cracks noted at the exterior concrete slabs in the areas pictured below. These type of cracks are typical and not a concern unless they have dropped or settled creating large uneven surfaces. Recommend monitoring the cracks periodically for growth. These cracks can be sealed with approved sealants as a typical repair, but is found on most concrete slabs we inspect.

Recommend monitoring.

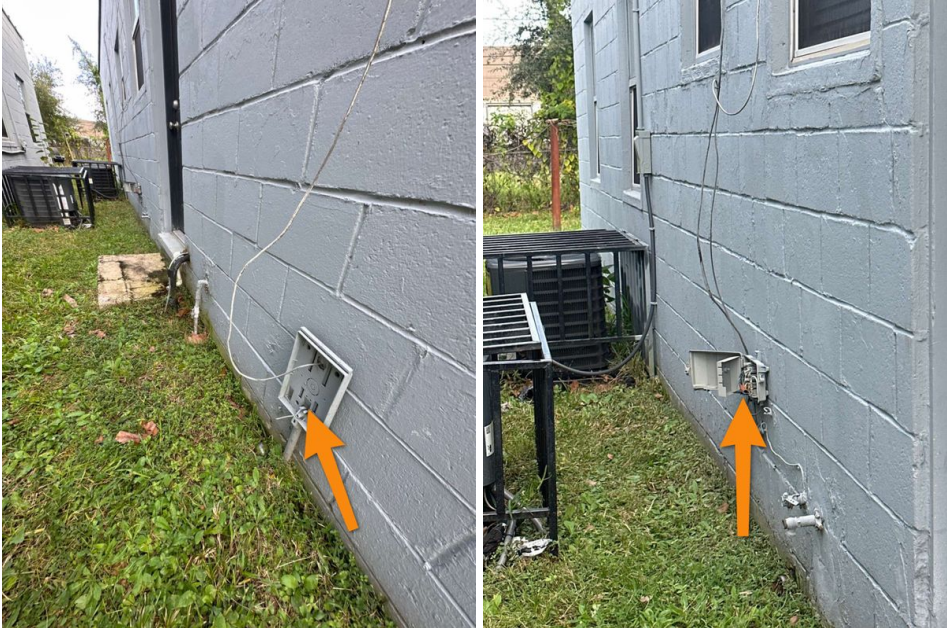
2.3.1 Siding, Flashing & Trim

**MISSING COVERS AT CABLE BOXES**

Some of the cable boxes are missing their covers. These are low voltage wires, so not a shock hazard and okay to have the wires exposed, but a cover does help protect the cable wiring from potential damage.

Contact a qualified professional.

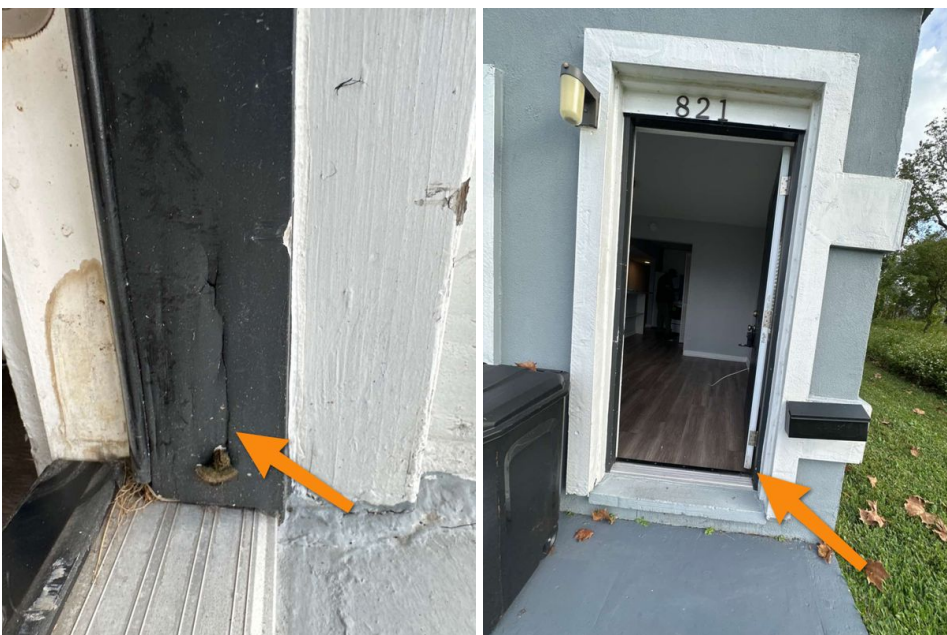
2.5.1 Exterior Doors

**WOOD DECAY - LOWER DOOR TRIM**

Wood decay noted at the unit 821s exterior door's lower door jamb. Recommend repair to allow for normal wear and tear.

Wood decay is common for exterior doors with only a small roof overhang above it or where wind driven rain can enter. This can allow water to run down the seams during wind driven rain. This is a exterior rated door, so this is okay, but wood decay is commonly found at these doors after enough time. Adding storm doors or extending the roof overhang can help reduce this.

Contact a qualified professional.

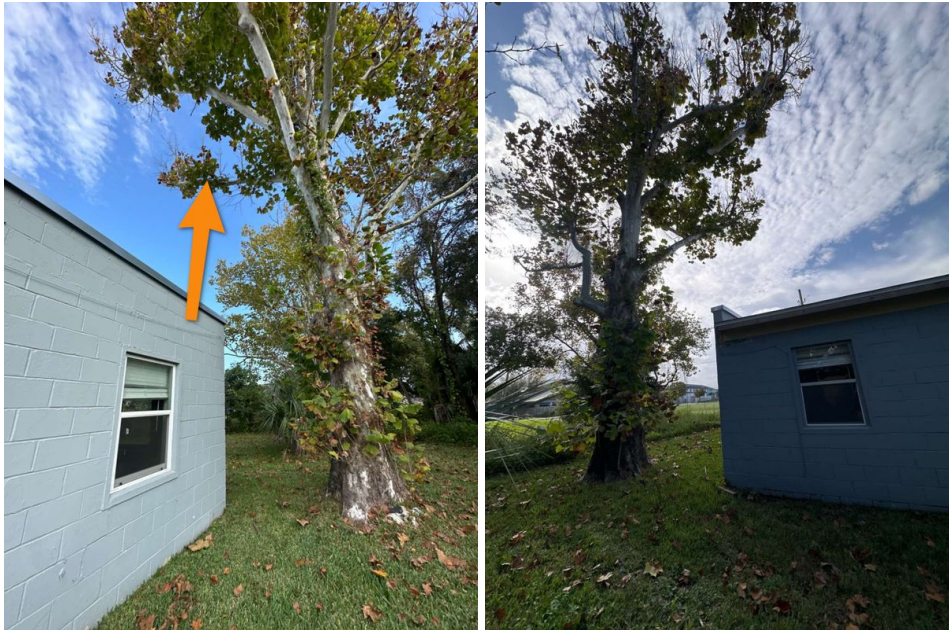
2.9.1 Vegetation, Grading, Drainage & Retaining Walls

Recommend removing the tree branches that are over the roof covering to reduce excessive vegetation and debris contact with the roof covering and to reduce potential damage during strong winds if one of the branches break and fall onto the roof.

Contact a qualified tree service company.

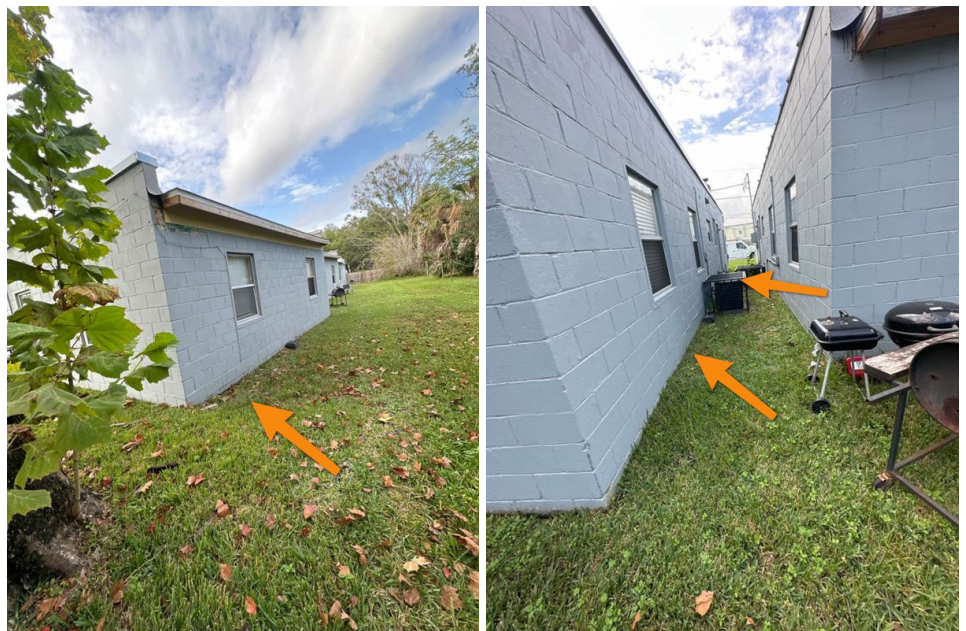
2.9.2 Vegetation, Grading, Drainage & Retaining Walls

There are a few negative slopes that does not appear to drain water away from the home. Recommend correcting the grading or drainage so water is diverted away from the structure. Typically dirt needs to be added, compacted and sloped away from the home to allow for better drainage or underground drains can be added.

Contact a qualified handyman.

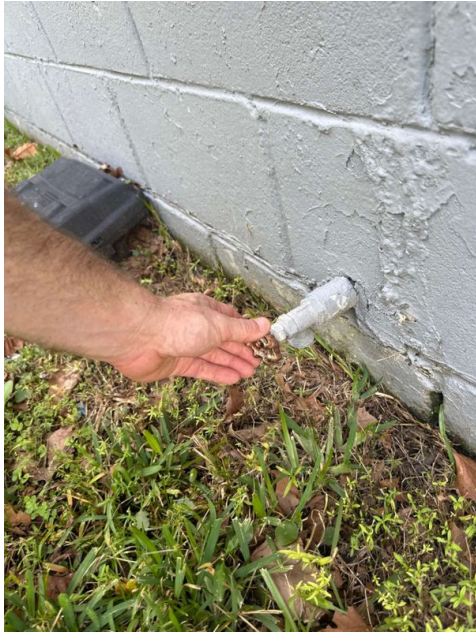
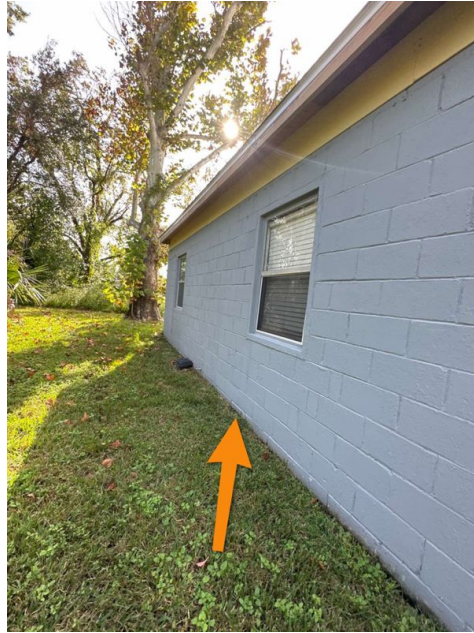
2.11.1 Hose Bibbs

The hose bibbs pictured below were inoperable, likely due to the repiping of some of the plumbing components (the original pipes are disconnected, so the new pipes can be installed). This is typically okay, as it is assumed this is due to the supply pipe replacement. Recommend asking the seller for additional info.

Contact the seller for more info

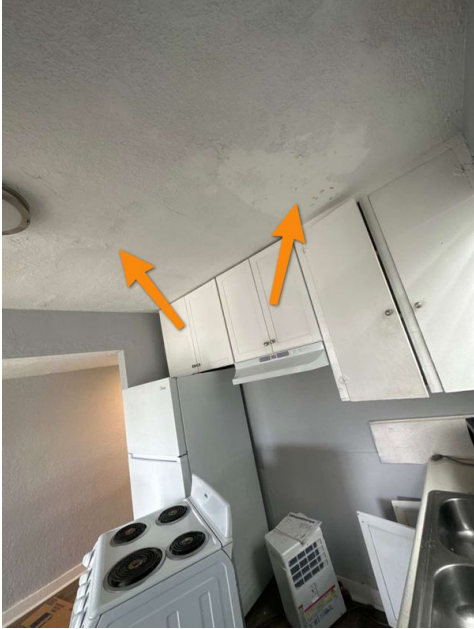
Water stains noted on the ceiling. The stains had low moisture levels according to the moisture meter, but the roof shows standing water in multiple areas. While some pooling water is considered normal, this appeared more than what is typical. A typical rule for pooling water on these types of roofs is that the water should be gone by 48 hours after rain. The roof covering is loose at the rear of roof and not adhered fully. Recommend further evaluation by a qualified roofing contractor.

Contact a qualified roofing professional.

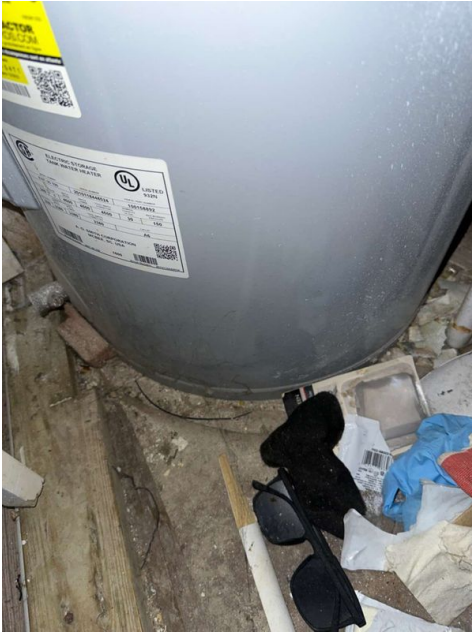
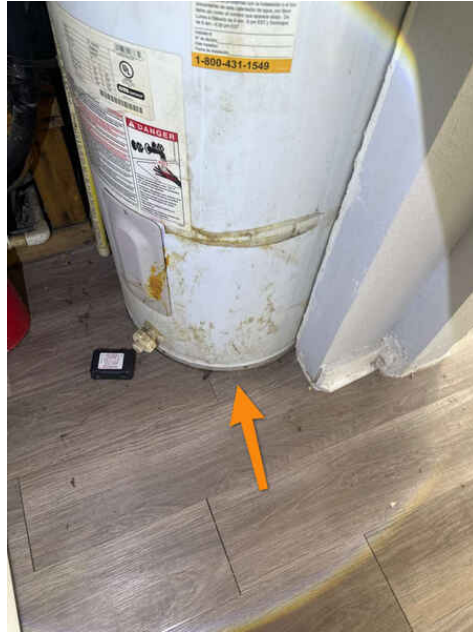
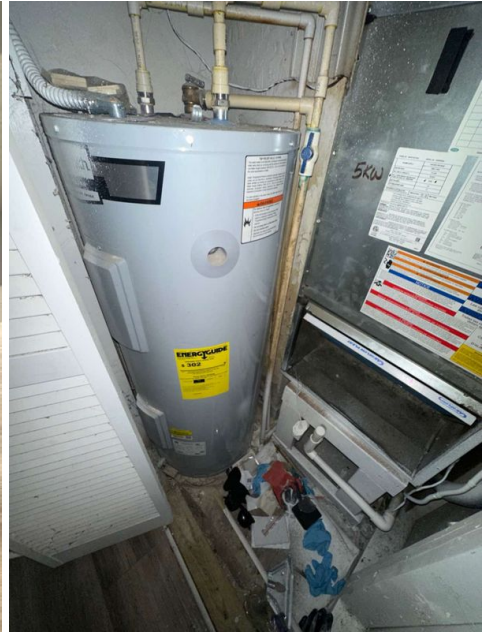
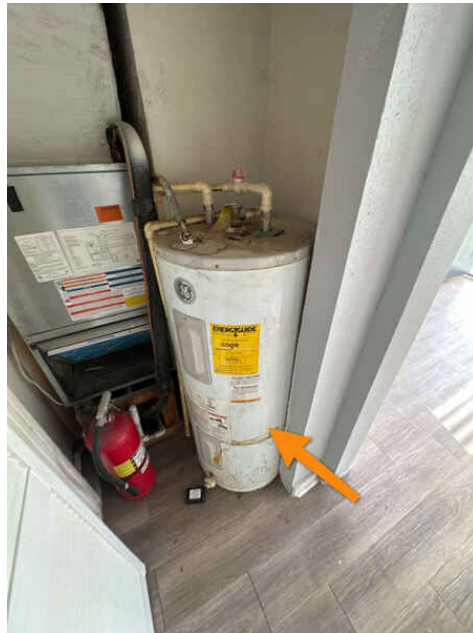
4.2.1 Water Heater Condition

The water heaters are located inside the home or is near components that could be effected if the water heater leaks overtime. Recommend installing a drain pan underneath the unit as a precautionary measure in case of leaks (no drain pan present). One of the units is older and has a manufacture date of 2012, but was operable.

Contact a qualified professional.

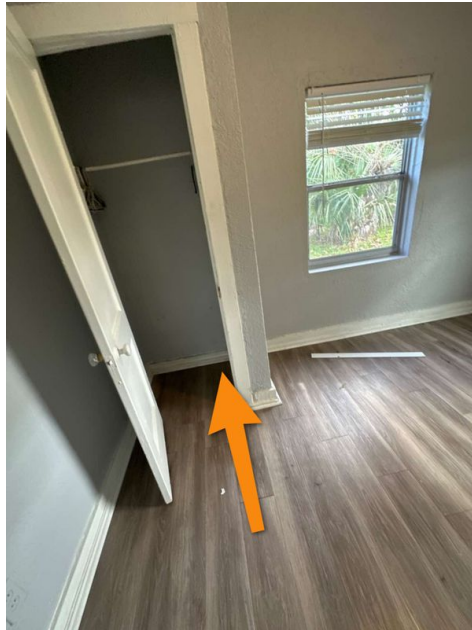
WATER STAINS AT BASEBOARDS

Water stains noted at the baseboard in unit 821s rear bedroom closet. The moisture readings were dry, so unclear what this was from. Recommend asking the seller for any additional info and monitoring periodically.

Contact the seller for more info

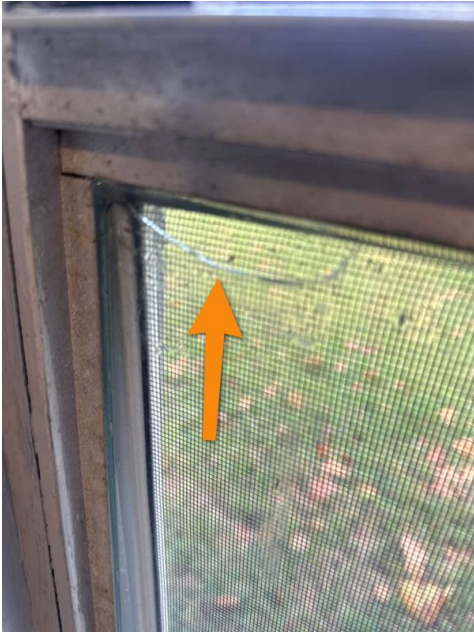
CRACKED WINDOW PANE

A cracked window pane noted in unit 821. Recommend replacement by a qualified window contractor.

Contact a qualified professional.

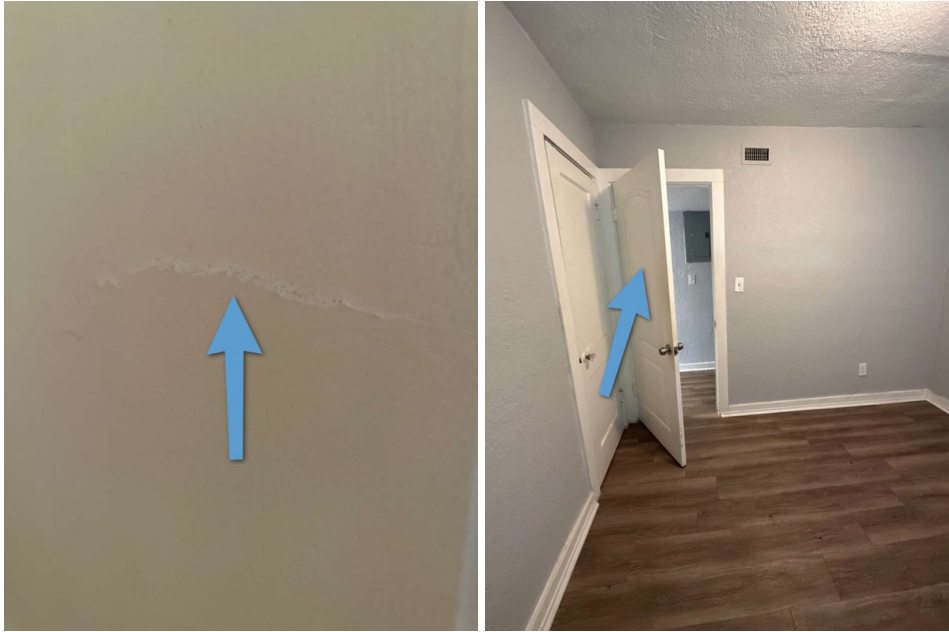
DAMAGE AT DOOR PANELING

The door paneling is damaged in unit 821s bedroom. Recommend replacing the door if desired or just monitoring.

Contact a qualified door repair/installation contractor.

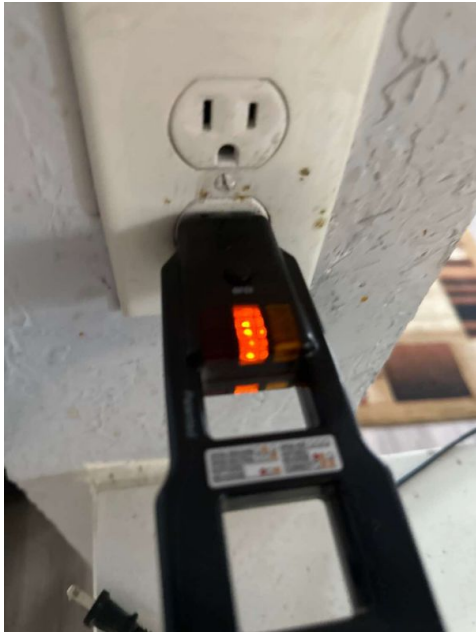
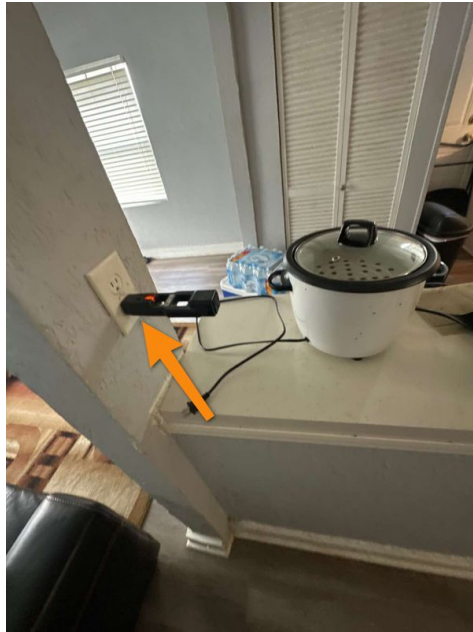
The electrical outlets pictured below (in unit 823) showed an improper ground according to the receptacle tester. An open ground outlet can cause an electrical surge to the connected device resulting in damage or electrical shock. Recommend further evaluation and repair by a qualified electrical contractor.

Contact a qualified professional.

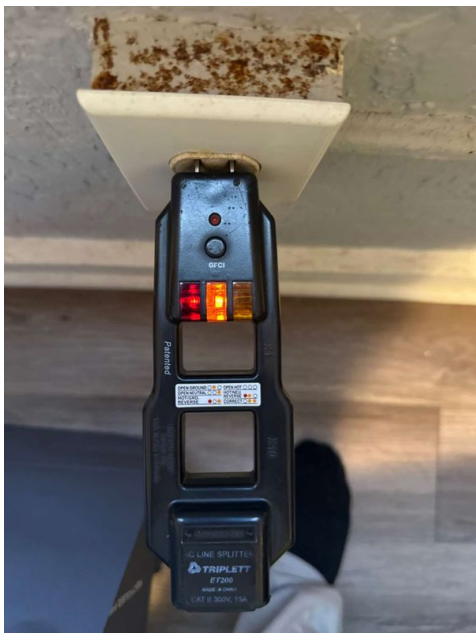
6.11.2 Electrical Outlets

The electrical outlets shows reverse polarity in unit 823s bedroom (pictured below). The hot and neutral appeared reversed according to the receptacle tester. Improper wiring can cause a potential electrical shock hazard in rare occurrences, but is typically a easy repair. Recommend further evaluation and repair by a qualified electrical contractor.

Contact a qualified electrical contractor.

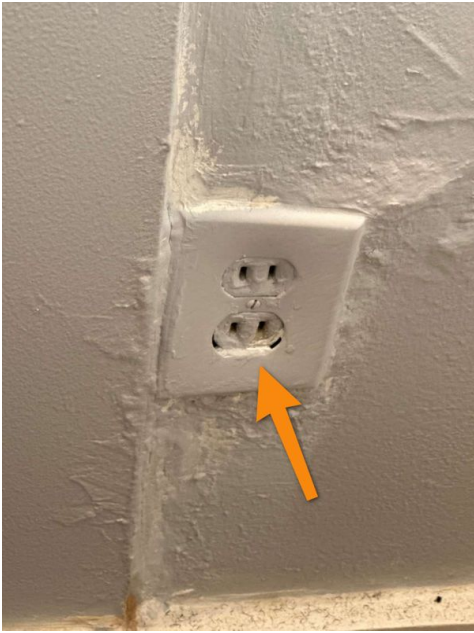
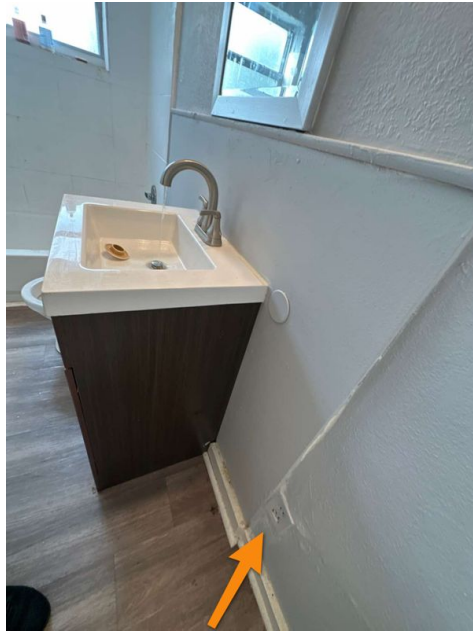
6.11.3 Electrical Outlets

Some of the outlets are 2 prong receptacles. This type of outlets do not have a ground, which can be common for older homes (lack of grounds in the wiring). Recommend upgrading for safety.

Contact a qualified electrical contractor.

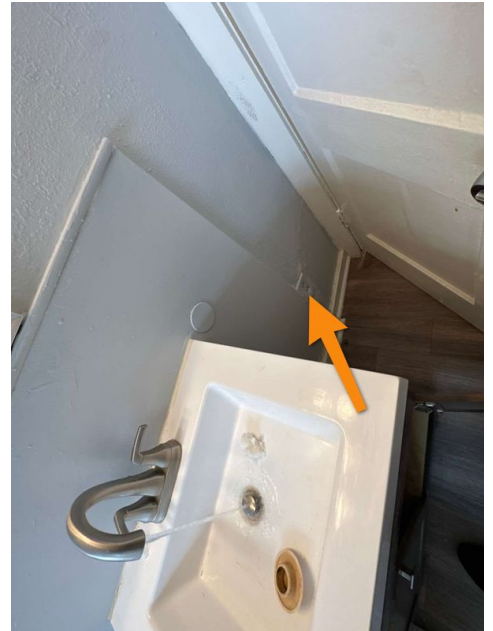
Recommend installing ground fault circuit interrupter (GFCI) protection to the electrical outlet in unit 821s bathroom. While this may have not been required when the home was built, upgrading is recommended for safety.

Contact a qualified professional.

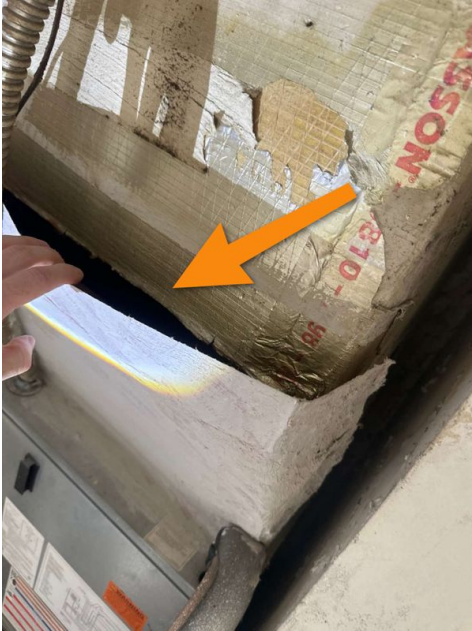
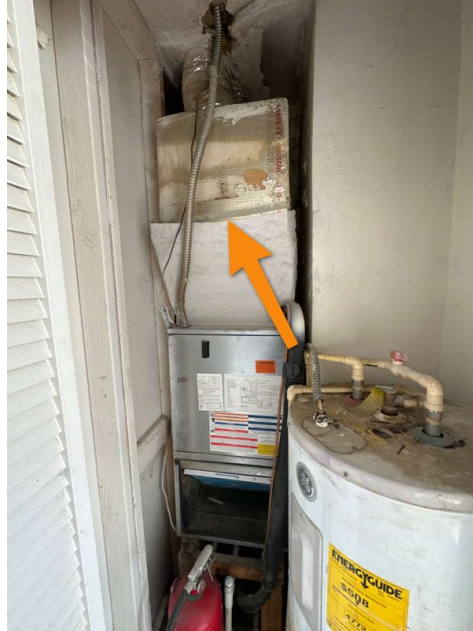
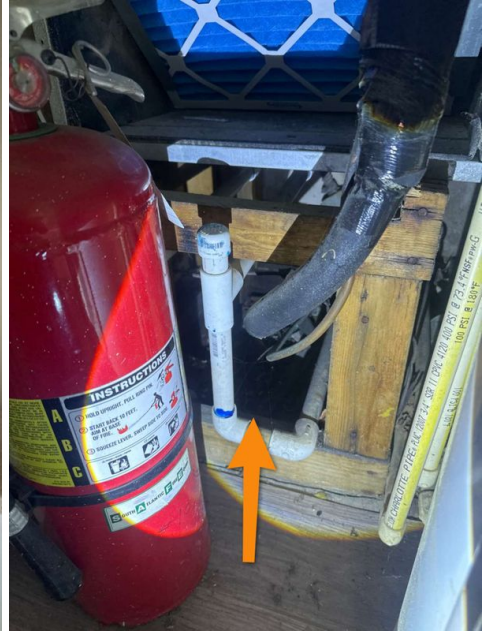
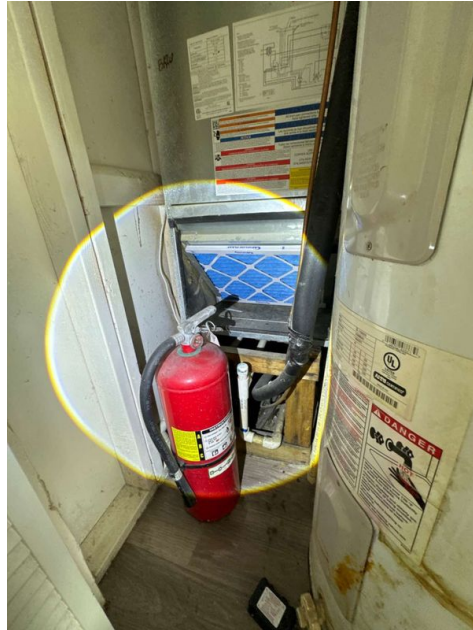
LEAKING AIR AT AIR HANDLER UNIT

The air handler unit is leaking conditioned air at the supply duct connections at unit 823s air handler. The foil tape has failed. Recommend re-sealing the supply ducting to reduce energy loss and potential condensation concerns (a common cause for mold evaluation). There is also no overflow safety switch or drain pan at the air handler and signs of previous leaks. Recommend further evaluation, servicing and repair as needed.

Contact a qualified professional.

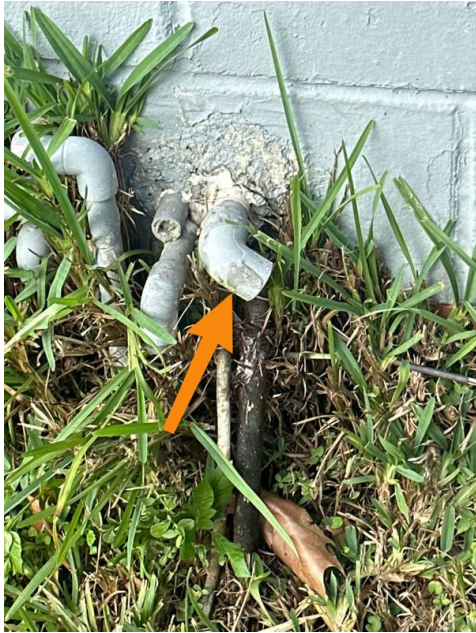
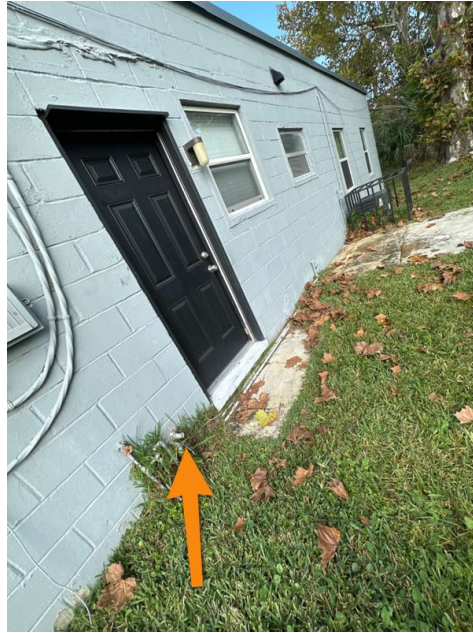
7.9.1 Condensate Drain Pipe

CONDENSATE DRAIN PIPE TERMINATED NEAR FOUNDATION

The condensate drain pipe terminated at or near the foundation of the home. This can allow water to saturate the soil in this area, possibly entering back into or under the structure. Extending the drain pipe, away from the foundation, is recommended to be conducted by a qualified person as needed.

Contact a qualified professional.

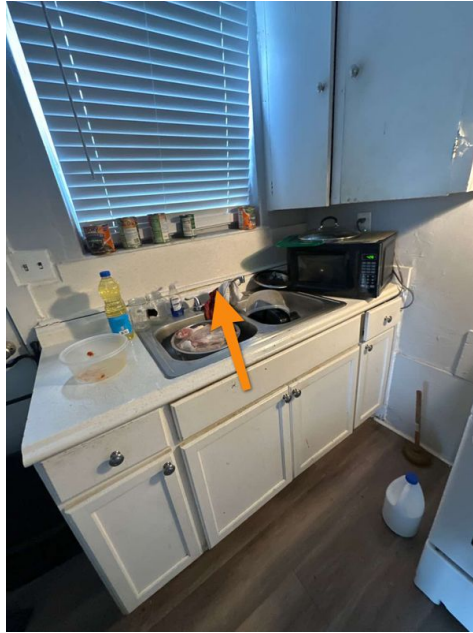
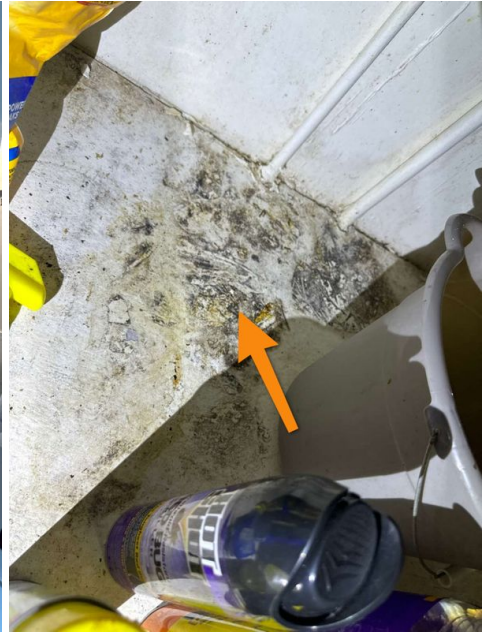
Unit 823s kitchen counter sunk downwards, so needs more support, so the counter is level as intended. There is also fungi growth at the cabinet shelving under the sink due to the leak. Recommend repair as needed and removing or repairing the fungi growth.

Contact a qualified professional.

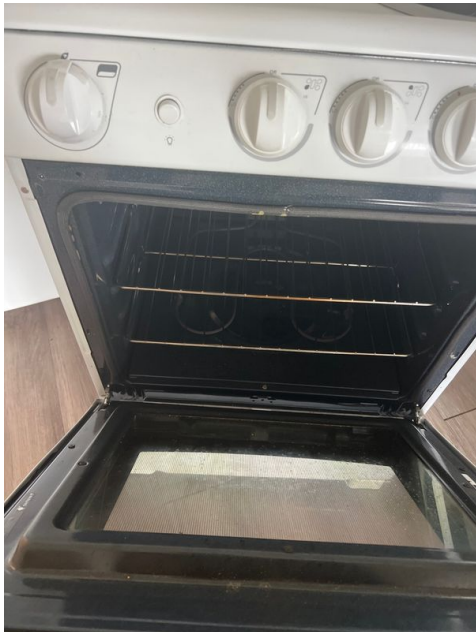
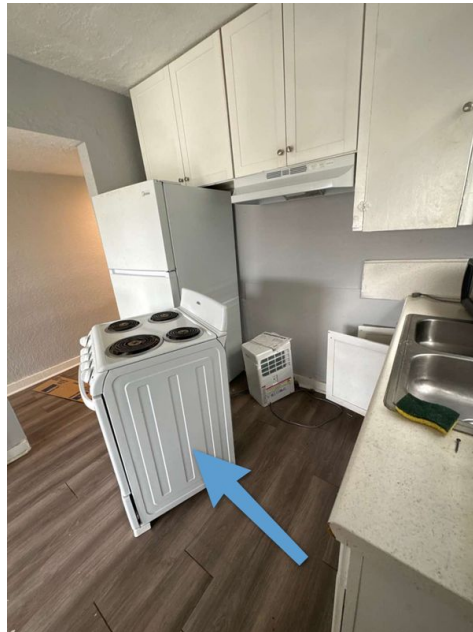
The oven/stove was pulled out and not installed in unit 821. Recommend further evaluation and re-installation.

Contact the seller for more info
