LIMITED ELECTRICAL THERMOGRAPHY INSPECTION REPORT

Building: 1362 SW 2nd St Bldg. No.: 2 Miami FL 33135

James Hanskat, P.E.
Florida Licensed Professional Engineer #49801
Level II Thermographer

Date: December 6, 2024

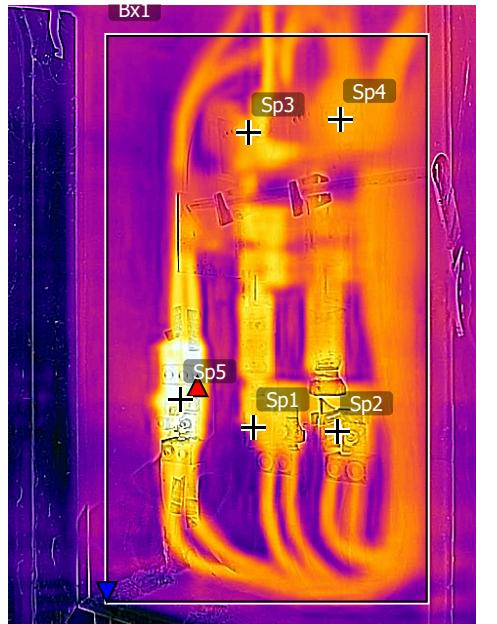
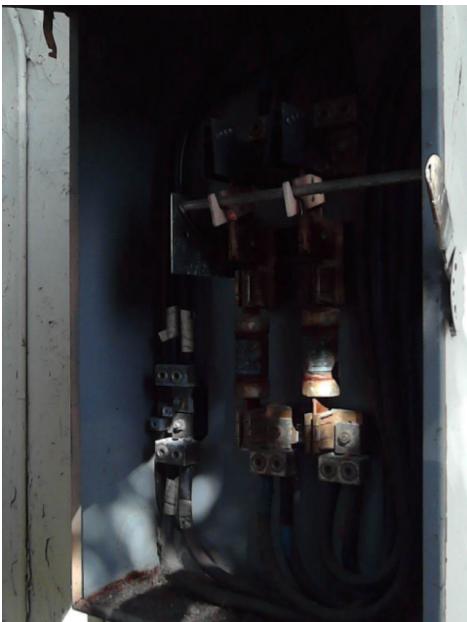
Bx1	Max	100.3 °F
	Min	86.2 °F
	Average	90.7 °F
Sp1		91.8 °F
Sp2		93.0 °F
Sp3		93.5 °F
Sp4		92.5 °F
Sp5		97.2 °F

3. Electrical ServiceS
400 Amp Main Disconnect
Location: West Exterior Wall

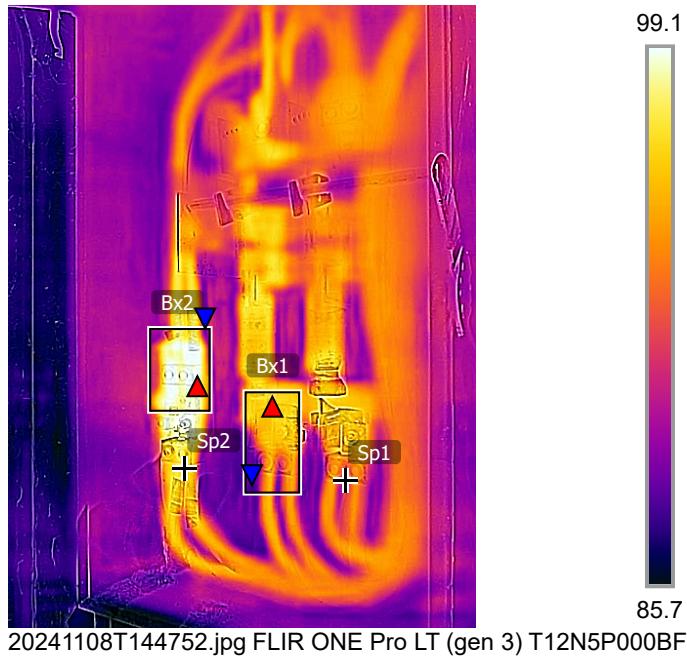
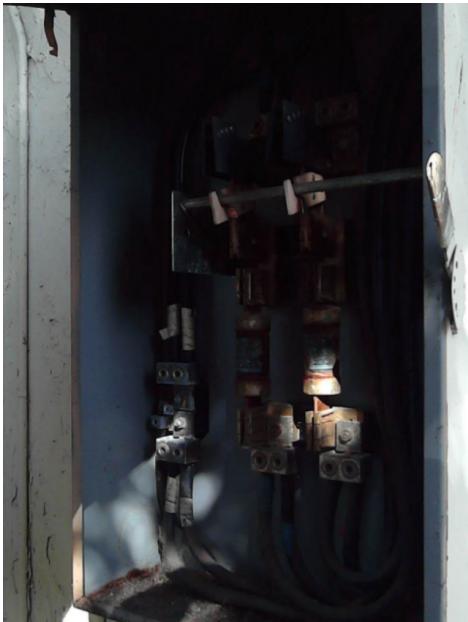
Bx1	Max	95.2 °F
	Min	87.2 °F
	Average	92.0 °F
Bx2	Max	100.3 °F
	Min	88.1 °F
	Average	95.5 °F
Sp1		90.1 °F
Sp2		93.1 °F
Dt1	Bx1.Max - Sp1	5.1 °F
Dt2	Bx2.Max - Sp2	7.1 °F

3. Electrical Services
400 Amp Main Disconnect
Location: West Exterior Wall

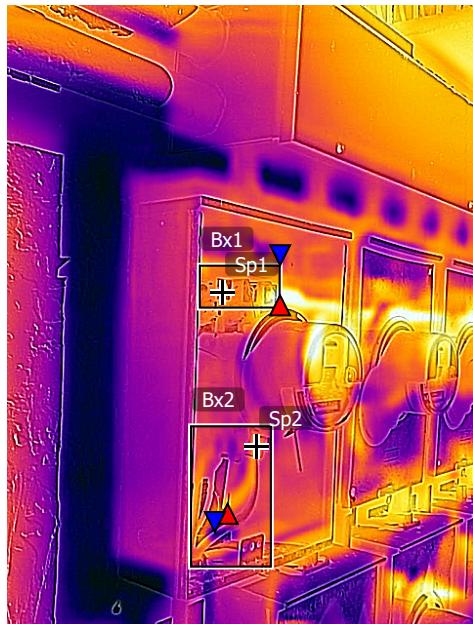
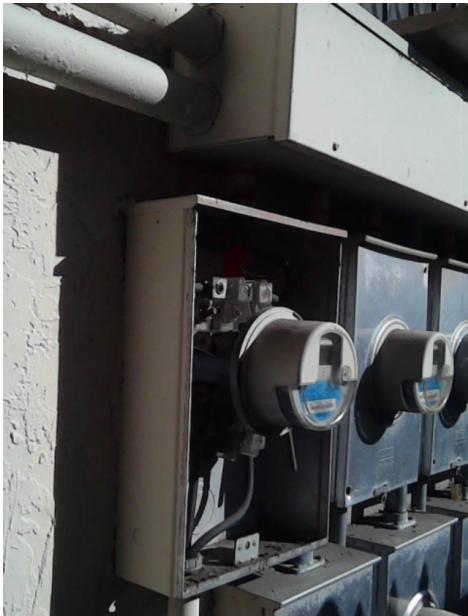
Bx1	Max	122.0 °F
	Min	97.1 °F
	Average	102.3 °F
Bx2	Max	103.0 °F
	Min	89.3 °F
	Average	97.8 °F
Sp1		99.7 °F
Sp2		101.2 °F

4. View of Metering Equipment
Location: West Exterior Wall

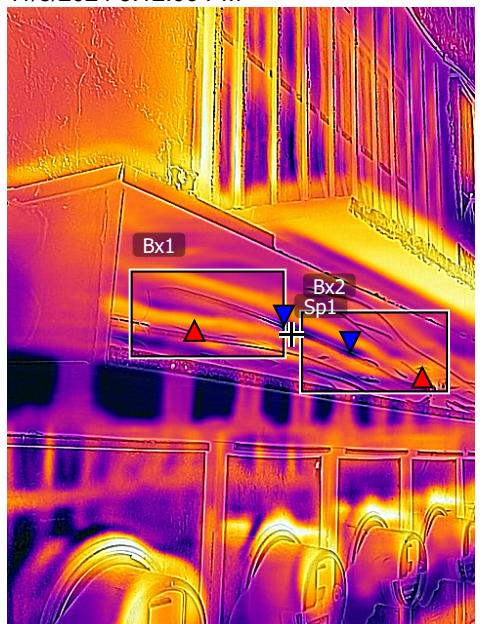
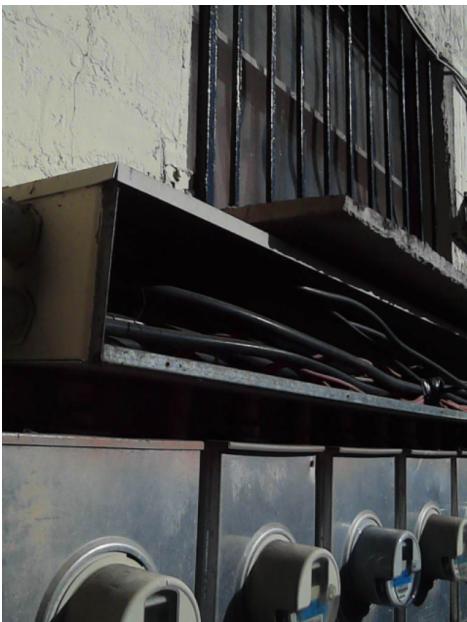
Bx1	Max	108.7 °F
	Min	88.2 °F
	Average	100.9 °F
Bx2	Max	107.0 °F
	Min	88.8 °F
	Average	100.0 °F
Sp1		101.2 °F
Dt1	Bx1.Max - Sp1	7.5 °F
Dt2	Bx2.Max - Sp1	5.8 °F

6. View of Electrical Gutters, Wireways
Location: West Exterior Wall

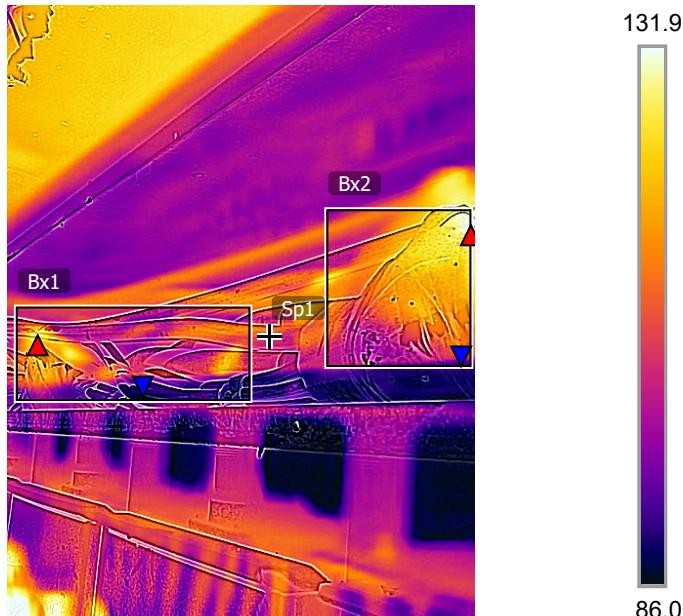
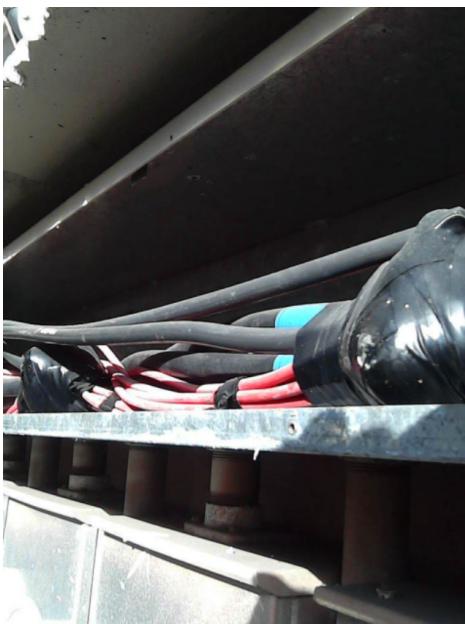
Bx1	Max	126.1 °F
	Min	86.2 °F
	Average	100.7 °F
Bx2	Max	132.7 °F
	Min	89.9 °F
	Average	107.5 °F
Sp1		101.7 °F
Dt1	Bx1.Max - Sp1	24.4 °F
Dt2	Bx2.Max - Sp1	31.0 °F

6. View of Electrical Gutters, Wireways
Location: West Exterior Wall

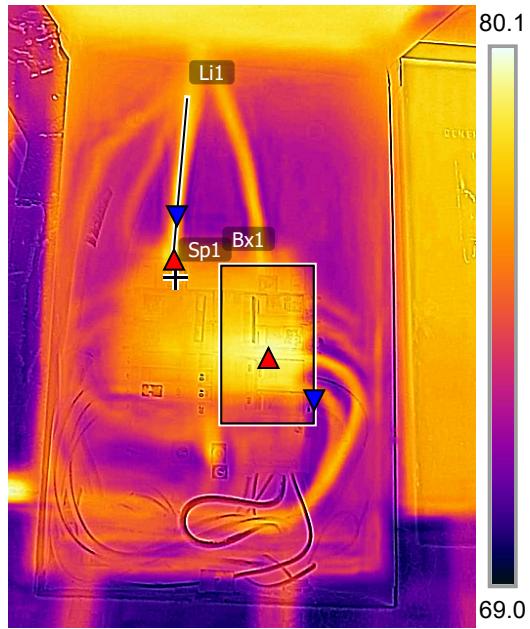
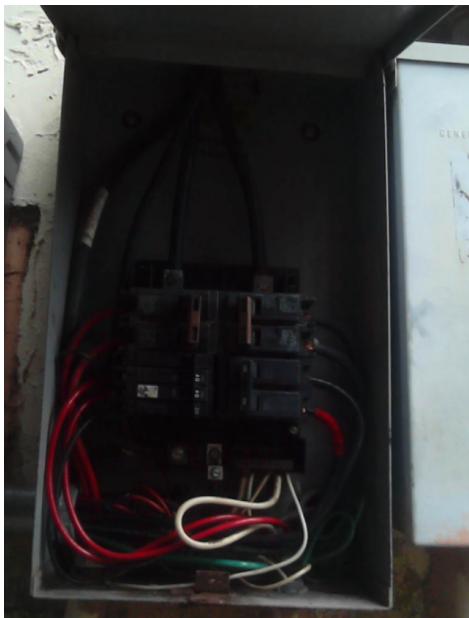
Bx1	Max	78.2 °F
	Min	73.0 °F
	Average	75.8 °F
Sp1		75.7 °F
Li1	Max	76.9 °F
	Min	76.0 °F
	Average	76.5 °F
Dt1	Bx1.Max - Sp1	2.5 °F

7.1. View of Electrical Panel
125 Amp House Panel
Location: West Exterior Wall

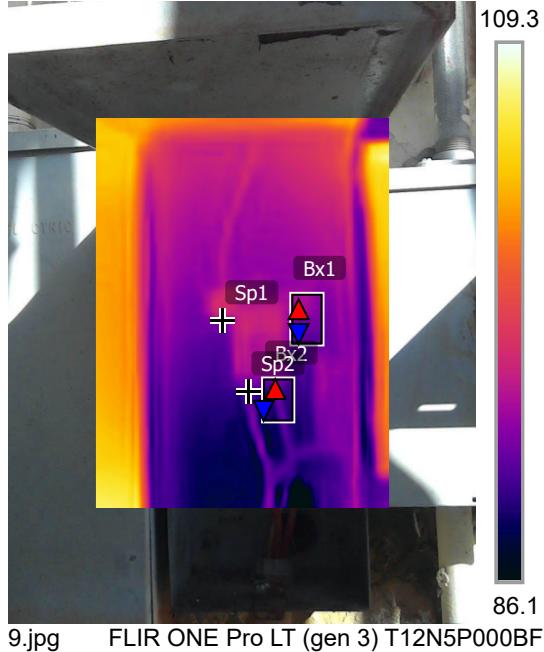
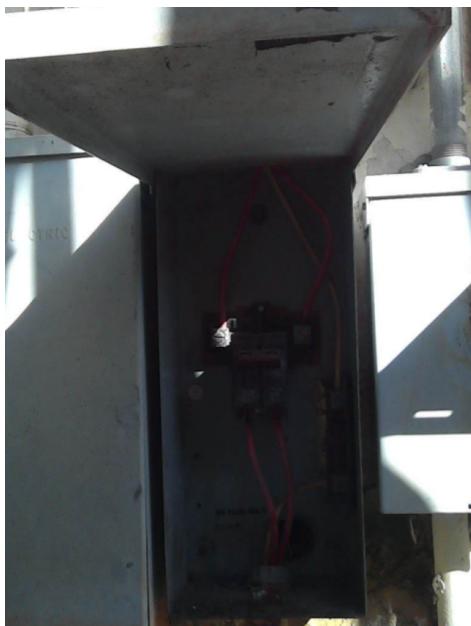
Bx1	Max	94.2 °F
	Min	91.0 °F
	Average	92.5 °F
Bx2	Max	92.7 °F
	Min	88.4 °F
	Average	90.3 °F
Sp1		93.0 °F
Sp2		91.4 °F
Dt1	Bx1.Max - Sp1	1.2 °F
Dt2	Bx2.Max - Sp2	1.3 °F

7.2. View of Electrical Panel
60 Amp Tenant Main Disconnect
Location: West Exterior Wall

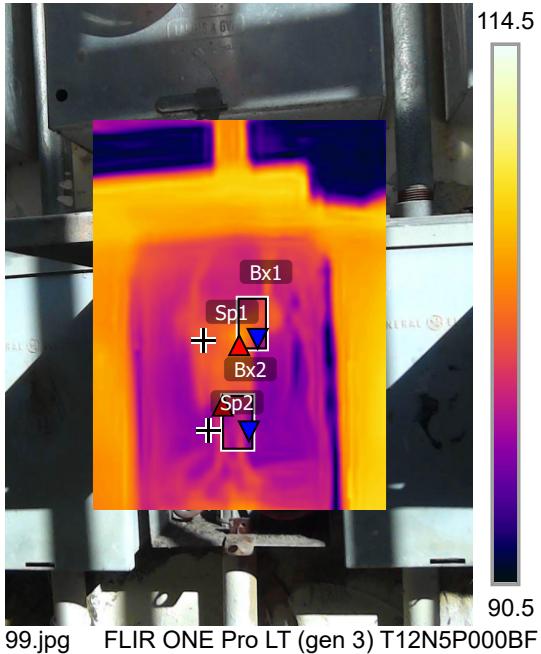
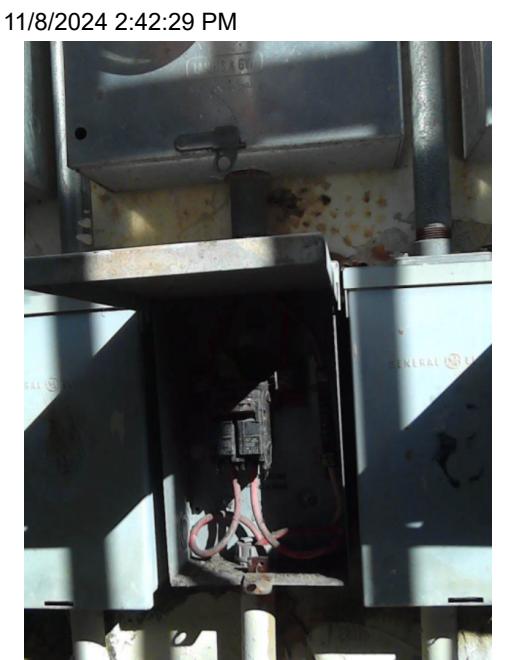
Bx1	Max	105.0 °F
	Min	97.6 °F
	Average	101.2 °F
Bx2	Max	101.5 °F
	Min	95.9 °F
	Average	98.4 °F
Sp1		101.9 °F
Sp2		96.7 °F
Dt1	Bx1.Max - Sp1	3.1 °F
Dt2	Bx2.Max - Sp2	4.8 °F

7.3. View of Electrical Panel
 60 Amp Tenant Main Disconnect
 Location: West Exterior Wall

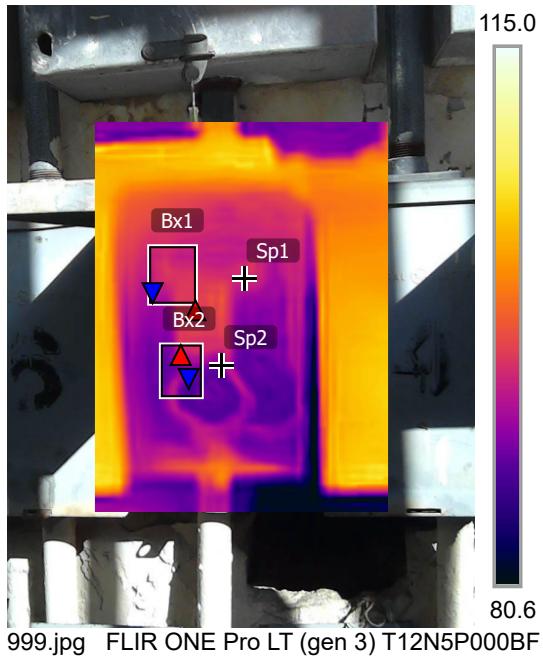
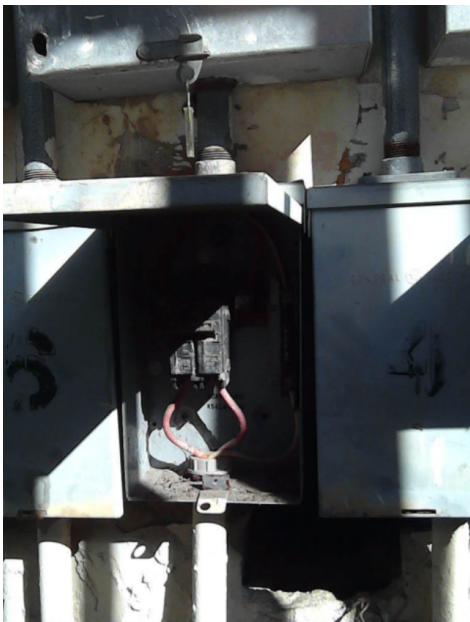
Bx1	Max	96.6 °F
	Min	91.7 °F
	Average	94.7 °F
Bx2	Max	95.7 °F
	Min	87.4 °F
	Average	90.9 °F
Sp1		94.6 °F
Sp2		90.5 °F
Dt1	Bx1.Max - Sp1	1.9 °F
Dt2	Bx2.Max - Sp2	5.2 °F

7.4. View of Electrical Panel
60 Amp Tenant Main Disconnect
Location: West Exterior Wall

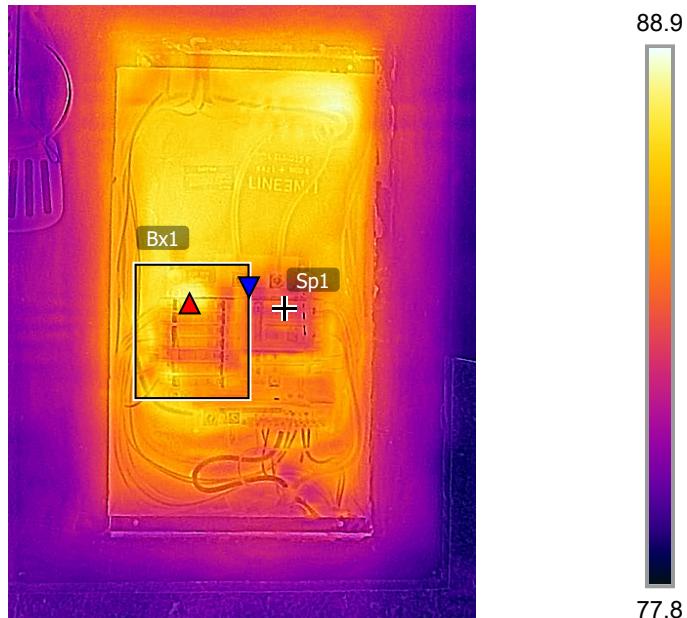
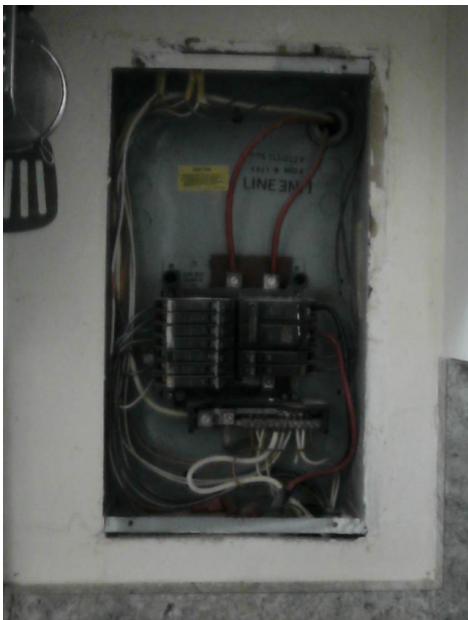
Bx1	Max	86.8 °F
	Min	82.7 °F
	Average	84.4 °F
Sp1		82.9 °F
Dt1	Bx1.Max - Sp1	3.9 °F

7.5. View of Electrical Panel 100 Amp Tenant Sub-Panel
Location: Interior of Tenant Space

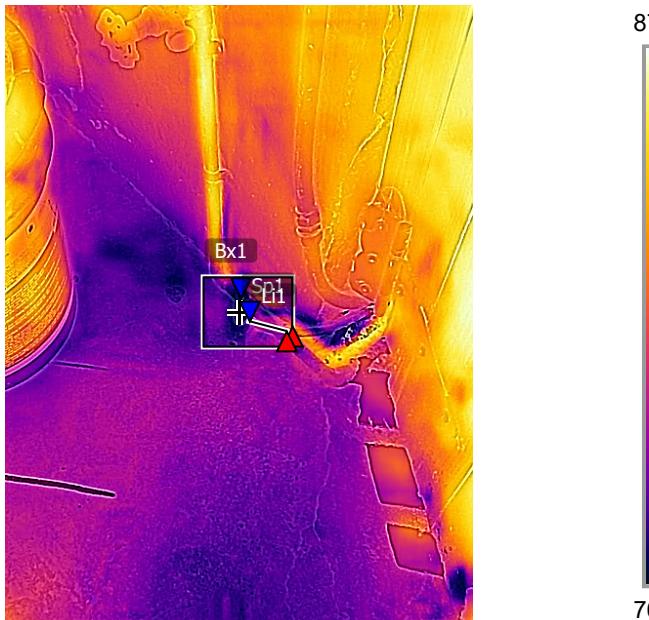
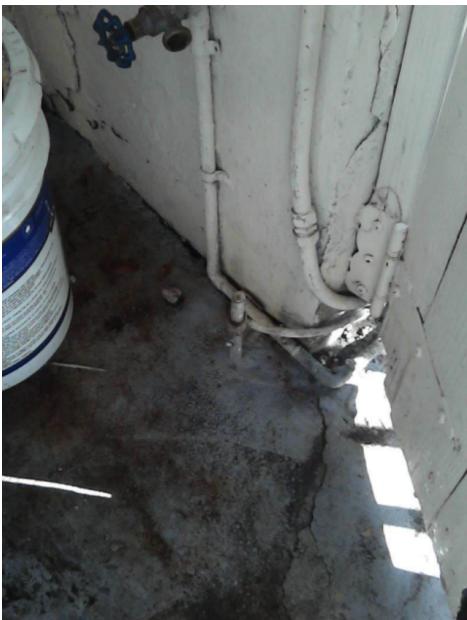
Bx1	Max	82.4 °F
	Min	77.4 °F
	Average	79.8 °F
Sp1		78.0 °F
Li1	Max	80.7 °F
	Min	79.8 °F
	Average	80.2 °F
Dt1	Bx1.Max - Sp1	4.4 °F

9. Grounding of Service
Location: West Exterior Wall
