Inspection Report

433 SE Lake Circle Drive
Stuart FL 34994

Professional View Home Inspection Services

Date: 11/6/2023	Time: 10:30:00 AM	Report ID: 110623JH1
Property: 433 SE Lake Circle Drive Stuart FL 34994	Customer: Rosi Shepard	Real Estate Professional:

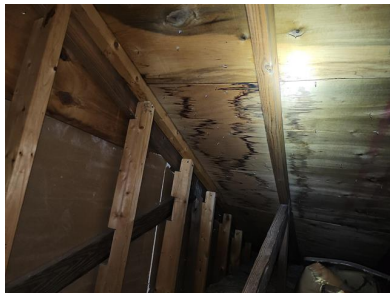
1.0 Item 1 (Picture)

(1) The roof covering has multiple repairs. There was staining present appears to old. I recommend checking with homeowners for warranty information.

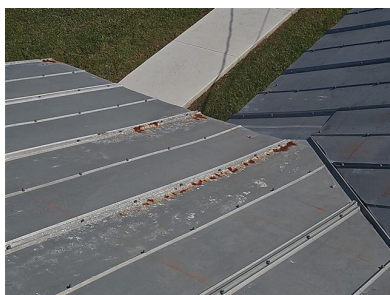
1.0 Item 3 (Picture)

(3) The roof covering has corrosion and rust in areas. This can allow moisture intrusion. Multiple metal roof panels are installed improperly. This cause wind to uplift certain areas of the covering. Multiple attachment screws were backing out of position.

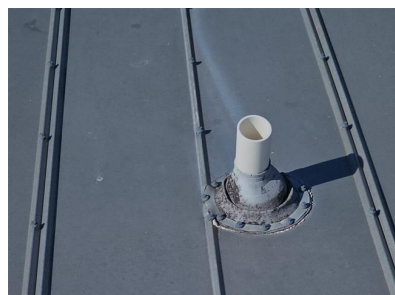
1.2 Item 1 (Picture)

Multiple plumbing vent pipe flashings are in need of replacement. The seals are starting to separate in areas.

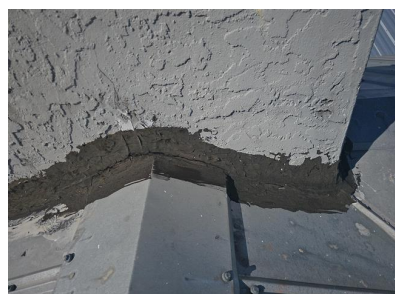
1.3 Item 1 (Picture)

The tar seals around the chimney are considered temporary repairs. I recommend further evaluation. This can allow moisture intrusion. The chimney have been capped off. There not in use anymore.

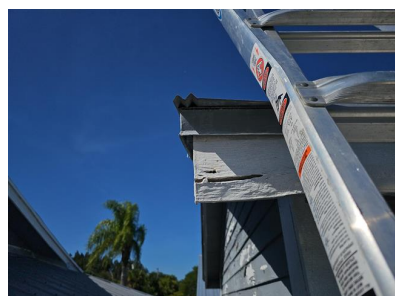
2.0 Item 1 (Picture)

The fascia at the left and right side duplexes have deterioration of the wood in multiple locations. Multiple soffit vents were not fully secured at the time of the inspection. This can allow insects and rodents access to the attic. The soffits have gaps in areas.

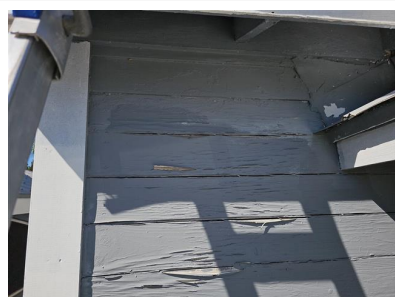
2.1 Item 1 (Picture)

The exterior siding has deterioration of the wood in multiple locations at the right side building. This is allowing insects rodents access to the attic. The siding has staining in areas. The siding has settlement cracking in areas.

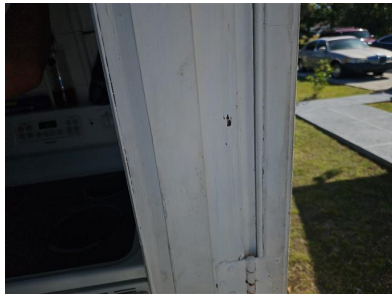
2.2 Item 1 (Picture)

(1) The front right building left side unit front door frame has insect related damage. The door has deterioration of the wood. Multiple interior door were missing attachment screws in both duplexes.

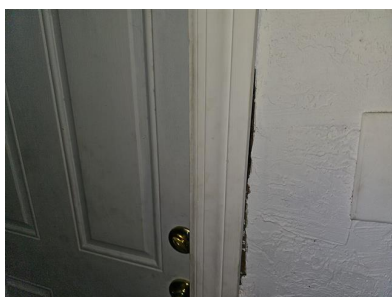
2.2 Item 10 (Picture)

(2) Multiple exterior exit doors were blocked by tenants personal items. The front right side building left unit rear exit door stucco is missing around the perimeter. The doors have deterioration of the wood near the bottom. This is cause by constant moisture contact.

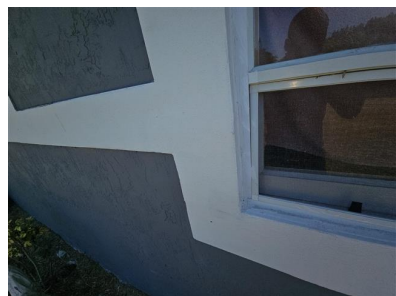
2.3 Item 1 (Picture)

(1) The caulking around multiple exterior windows is missing in areas including but not limited too right and left side buildings. I recommend re-sealing to prevent moisture intrusion.

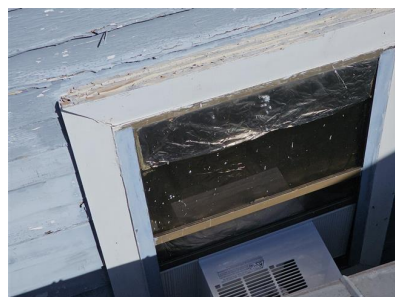
2.3 Item 9 (Picture)

(2) Multiple exterior and interior windows were damaged at the time of the inspection and did not open. I recommend having all windows serviced in both buildings.

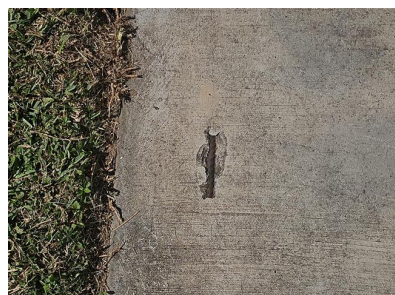
2.4 Item 1 (Picture)

(1) The sidewalk has damage in areas. The rebar was exposed.

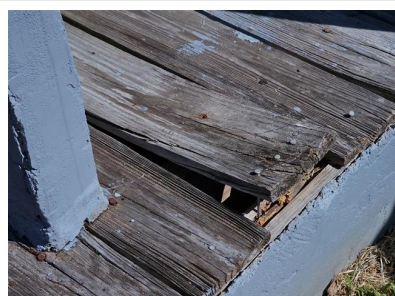
2.4 Item 2 (Picture)

(2) Multiple deck boards were damaged at the time of the inspection. Deterioration of the wood was present at the time of the inspection. I recommend further evaluation by a qualified contractor.

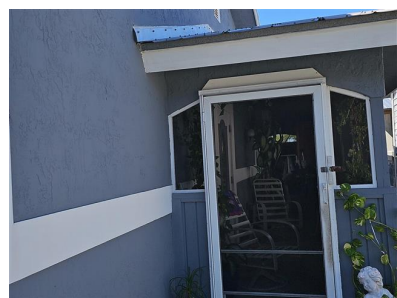
2.6 Item 1 (Picture)

The left side building right unit screen room door return is missing.

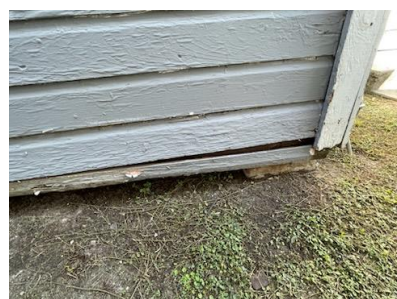
3.0 Item 1 (Picture)

The crawl space skirting was missing in multiple locations at the time of the inspection. This can allow critters access to underneath home.

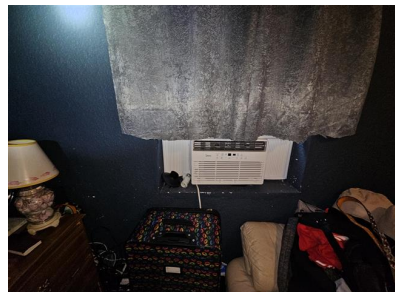
4.6 Item 1 (Picture)

We do not inspect window units. The window units appear to have not been done by a professional. Correction as needed.

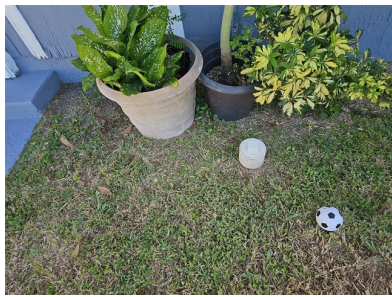
5.1 Item 1 (Picture)

(1) The main cleanout is located at the front of the home. (3)

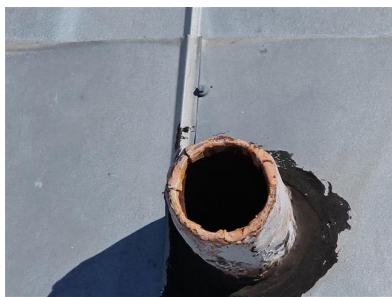
5.1 Item 4 (Picture)

(2) Cast iron waste pipes last anywhere between 50 and 100 years. However, it may be time to replace cast iron pipes long before their lifetime is up. Deterioration of cast iron pipes is normal after just 25 years, so homeowners should conduct routine inspections.

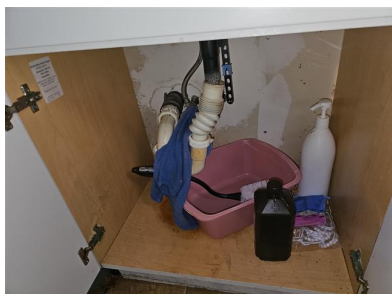
5.1 Item 5 (Picture)

(3) Multiple bathroom in both duplexes drain lines have flex pipe installed. This plumbing tends to trap debris. The left side unit bathroom sink drains slow. Multiple interior plumbing drain lines and toilet supply lines have corrosion.

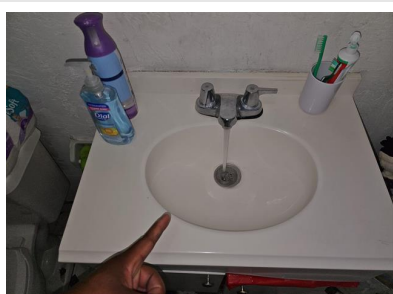
5.1 Item 14 (Picture)

(5) The front right side unit sink stop did not function at the time of the inspection. The front right side unit toilet secure bolts have corrosion in areas. The toilet supply lines are in need of updating. Multiple sink stops were missing.

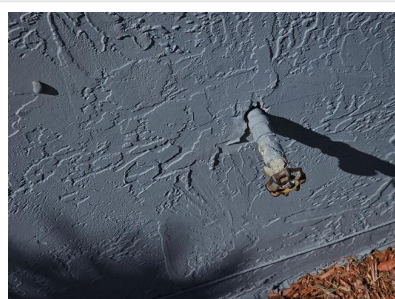
5.2 Item 1 (Picture)

Multiple exterior hose bibs were loose inside the wall.

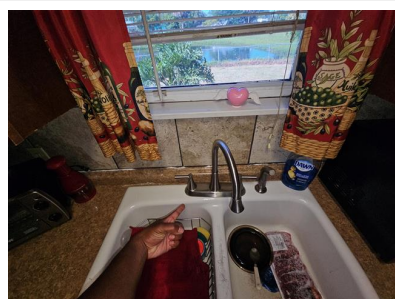
5.3 Item 1 (Picture)

(1) The left side building right unit kitchen sink faucet handles are installed backwards. The left side building left unit sink was damaged.

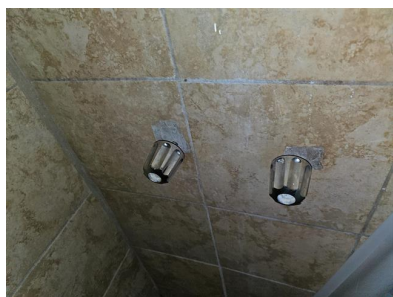
5.3 Item 3 (Picture)

(2) The front right side unit bathroom shower mixer valves are installed improperly. I recommend further evaluation by a qualified plumbing contractor. The left side right unit mixer valve loose at the wall.

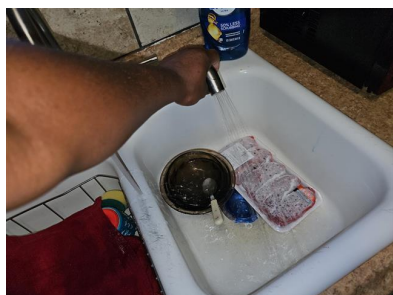
5.3 Item 5 (Picture)

(3) The front right building left side plumbing lines are not fully sealed at the wall. This is allowing moisture intrusion. The water pressure inside the left side building right unit was low at the time of the inspection.

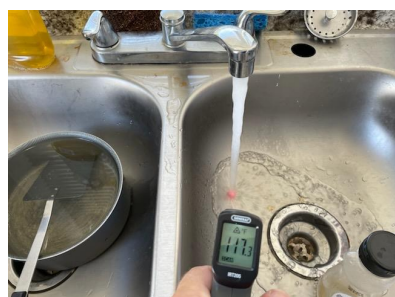
5.4 Item 3 (Picture)

(4) The hot water temperature 115 degrees. (Left Side Building Left Unit)
120 degrees Fahrenheit is the safety recommendation against scalding, but 140° is the common default setting. Most experts agree that anything below 120 degrees creates a risk for bacteria to develop inside your water heater from stagnant water, such as legionella that causes Legionnaire's disease.

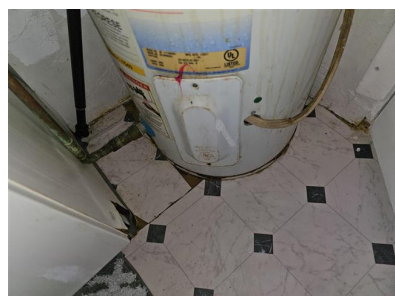
5.4 Item 5 (Picture)

(6) The water heater overflow pans are missing at the right side building units. The water heaters have rust and corrosion at the bottom and top. The water main cord has been installed improperly and the wiring is not protected. Duct tape is used for support.

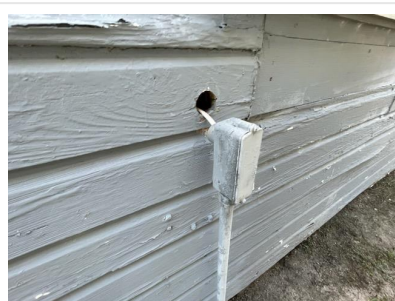
6.2 Item 1 (Picture)

(1) The junction box at the left side of the right side building was not fully secured at the time of the inspection.

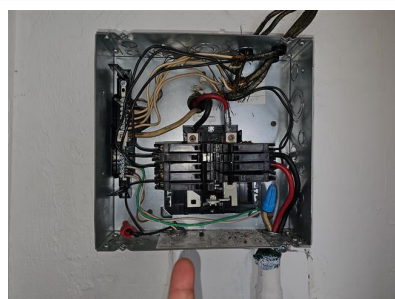
6.2 Item 2 (Picture)

(2) The front right left unit and left side duplex right unit electrical panels have multiple loose circuit breakers. The panel was buzzing at the time of the inspection. Typical indication there's a potential short. I recommend further evaluation licensed electrician.

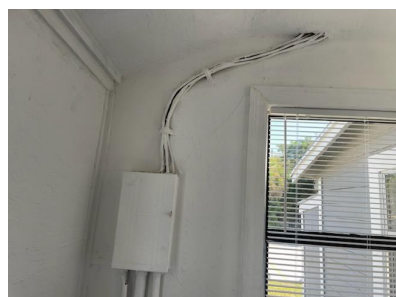
6.2 Item 6 (Picture)

(3) Wiring is unprotected at multiple electrical panels. Wherever wiring can be damaged during normal day to day use should be protected in conduit. All electrical panels in both buildings do not have proper space requirements per code.

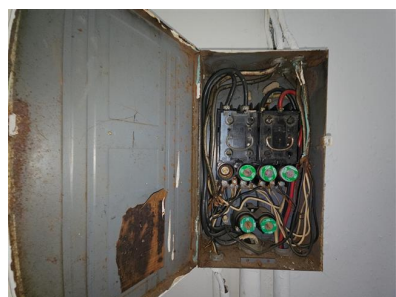
6.2 Item 8 (Picture)

(4) I recommend replacement of the fuse panel located at the front right side unit, loose or damaged wiring, overloaded circuits, or a faulty electrical service. Solutions: Check for loose bulbs or fixtures. If the issue persists, consult an electrician to inspect your wiring and electrical service. They may need to replace damaged wiring or upgrade your electrical panel. Multiple neutrals and grounds were under the same lug. I recommend further evaluation by a licensed electrician.

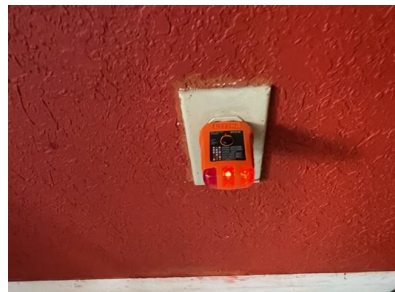
6.3 Item 1 (Picture)

(1) The master bedroom outlet in the left side duplex right side unit. Multiple light bulbs were out at the time of the inspection. All items near a water source should be enclosed.

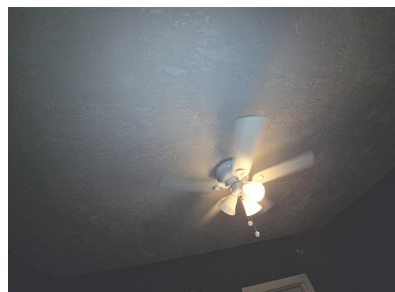
6.3 Item 3 (Picture)

(2) The front right and left side units bedroom ceiling fans were out of balance. Multiple interior outlet junction boxes were loose inside the wall at the time of the inspection including but not limited too ,right building,left-right unit,left side building.

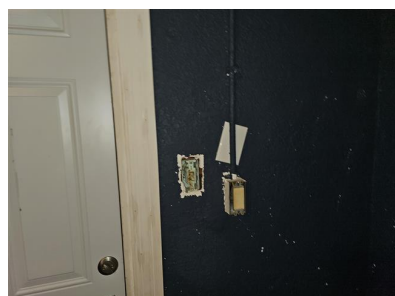
6.3 Item 7 (Picture)

(3) Multiple interior and exterior outlet cover plates are missing. There was wiring exposed in multiple locations around the home including but not limited too interior, exterior. Multiple exterior outlet cover plates were damaged at the time of the inspection.

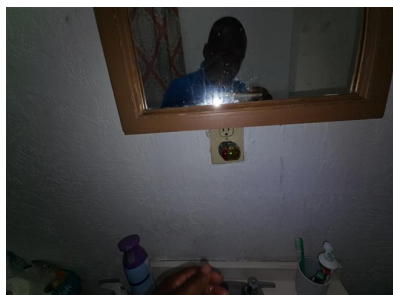
6.5 Item 1 (Picture)

The kitchen and exterior and some of the bathroom outlets are not GFCI protected, are designed to prevent bodily harm from electrical faults that could cause electricity to flow through you to ground. When a GFCI breaker trips, it quickly disconnects the current flowing through an unintended ground path even if the amount of current is too small to trip a typical circuit break

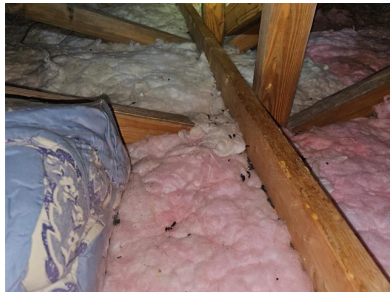
7.0 Item 1 (Picture)

The left side building attic insulation is matted down with rodent feces in urine. I recommend further evaluation by a pest control company.

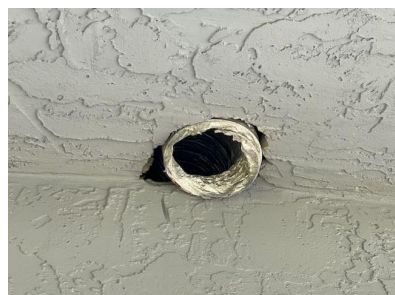
7.2 Item 1 (Picture)

(1) Multiple dryer vents in both duplexes are not proper sealed at the wall. The left side unit duplex exhaust fan is not fully sealed.

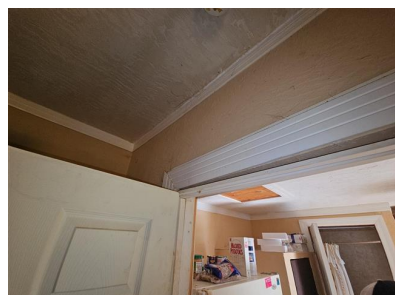
8.1 Item 1 (Picture)

(1) The left side building left unit entry door was damaged and missing multiple door hinge attachment screws. The left side building left unit bathroom entry door was damaged.

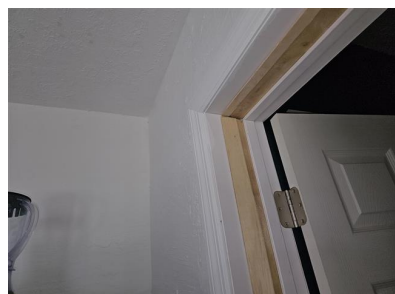
8.1 Item 4 (Picture)

(2) The right side front unit bedroom entry door frame is improperly installed. The front right side unit bedroom closet pivot wheel is missing.

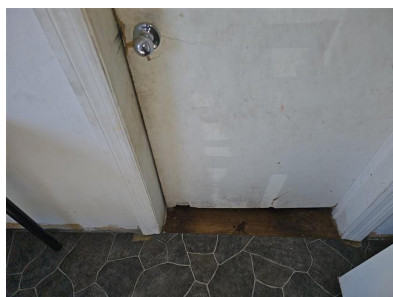
8.1 Item 9 (Picture)

(3) The front right side building left side unit bedroom entry door was damaged at the time of the inspection. The door is missing multiple attachment screws.

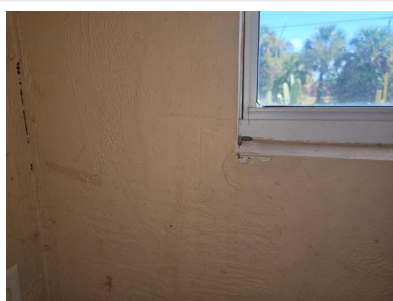
8.2 Item 1 (Picture)

(1) The interior walls have settlement cracking in areas. This appears to be normal settlement cracking.

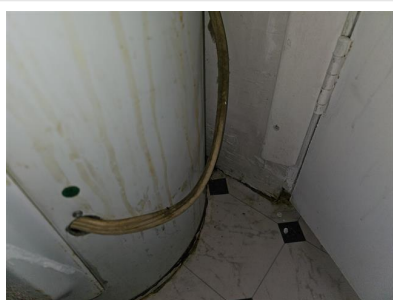
8.2 Item 3 (Picture)

(2) The front right side unit bathroom walls have moisture damage in areas. The areas were dry at the time the of the inspection.

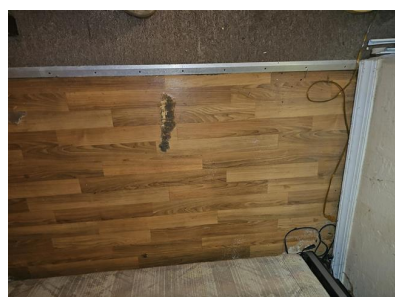
8.3 Item 1 (Picture)

(1) The interior laminate floors have damage in areas.

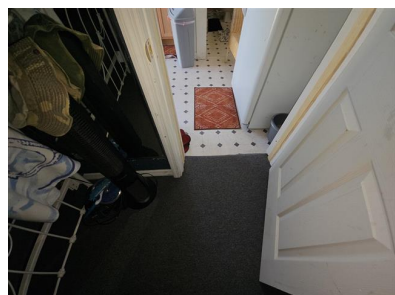
8.3 Item 2 (Picture)

(2) The interior floors in the right side building have multiple soft spots. I recommend further evaluation. The sub floor has moisture damage. The vinyl flooring in the front right building left side unit is tearing in areas. There was active moisture at the time of the inspection.

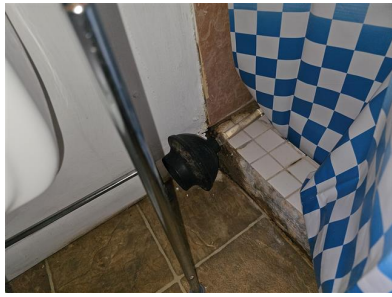
8.4 Item 1 (Picture)

The front right duplex left side unit shower does not have a shower pan installed. Concrete shower enclosure is not code. Moisture is present underneath tiles. I recommend further evaluation. The shower's has grout missing in areas. Multiple tiles were damaged at the time of the inspection. The shower head was leaking. Multiple showers drain slow.

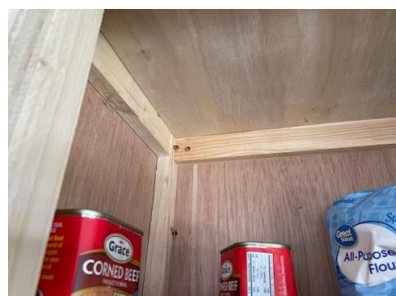
8.6 Item 1 (Picture)

(1) Multiple kitchen cabinets have sheet metal screws installed. Proper cabinet screws are required.

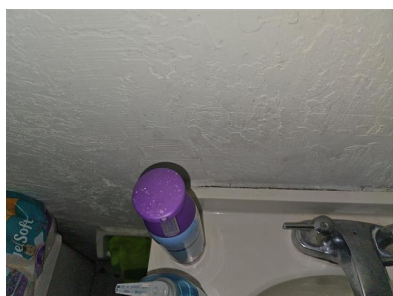
8.6 Item 5 (Picture)

(2) Multiple kitchen and bathroom backsplash caulking was missing in areas. Multiple kitchen cabinets were not fully secured at the time of the inspection.

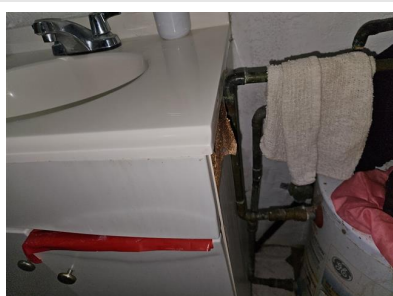
8.6 Item 11 (Picture)

(3) The kitchen and bathroom cabinets and both right and left side duplex unit's have water damage. There was active moisture at the time of the inspection. Moisture can cause unseen damage. The cabinets are starting to cave in.
