# ***Pacific Coast Home Inspections***

***Steve Spisak***

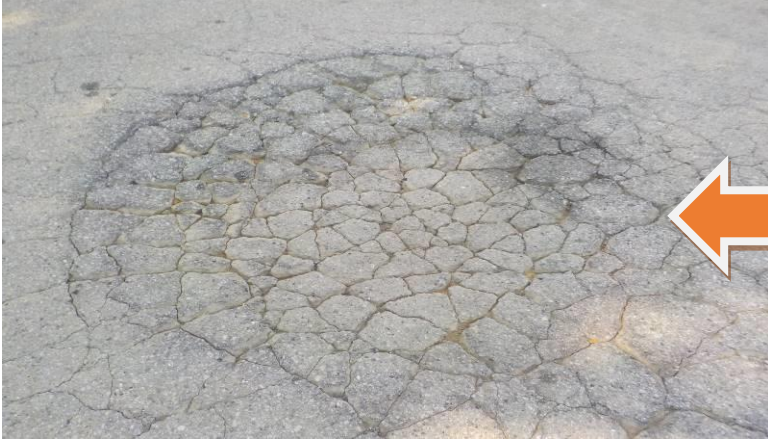
**Item #0-Parking lot-At the back corner of the parking lot, there are a few areas where the asphalt is cracking and settling**

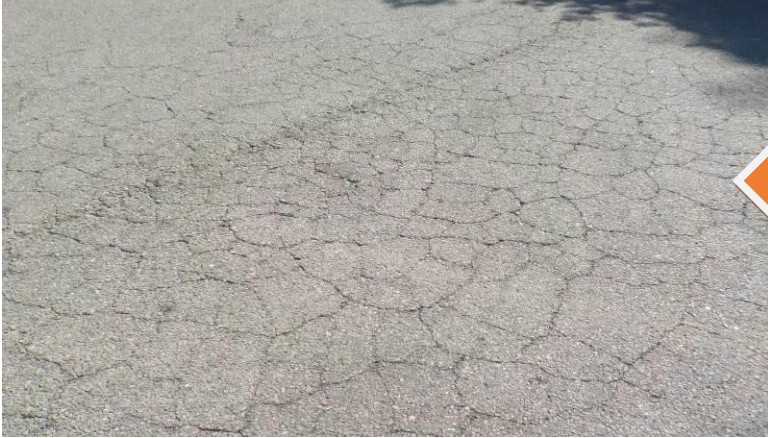
**Item #13-Deck-At the end of the deck near unit D, wood damage to the deck support post**

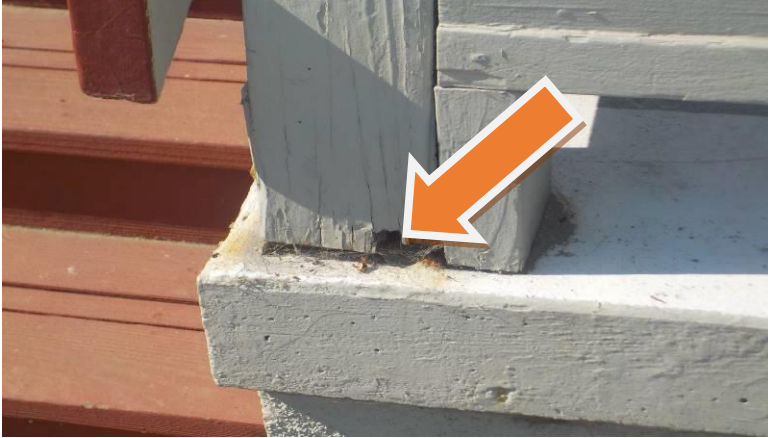
**Item #13-Deck-At the end of the deck near unit D, wood damage to the deck step railing**

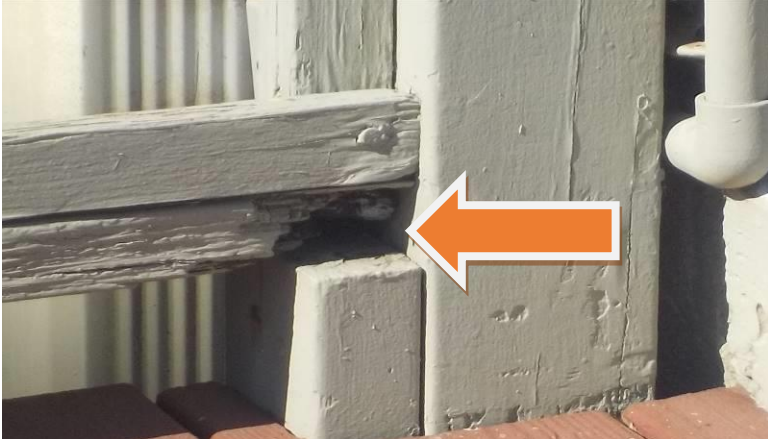
**Item #16-Exterior, electrical outlets-At the outlet for JJ's storage room, the top portion of the outlet is broken/outlets are not GFCI protected**

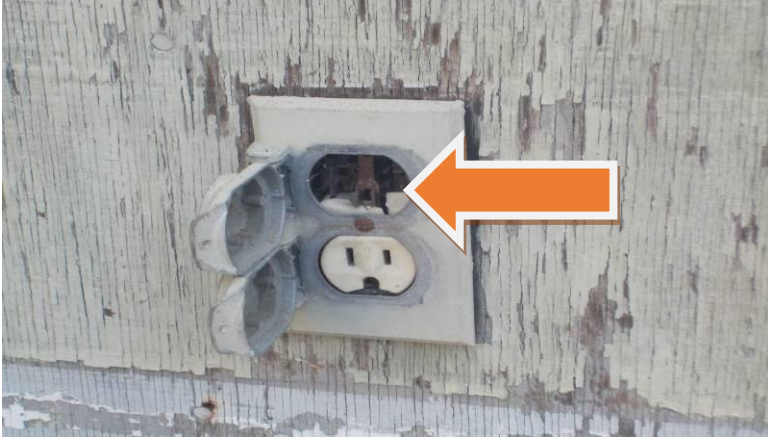
**Item #19-Rain gutters-There are no rain gutters over the front and side edges of the roof/gutters are recommended**

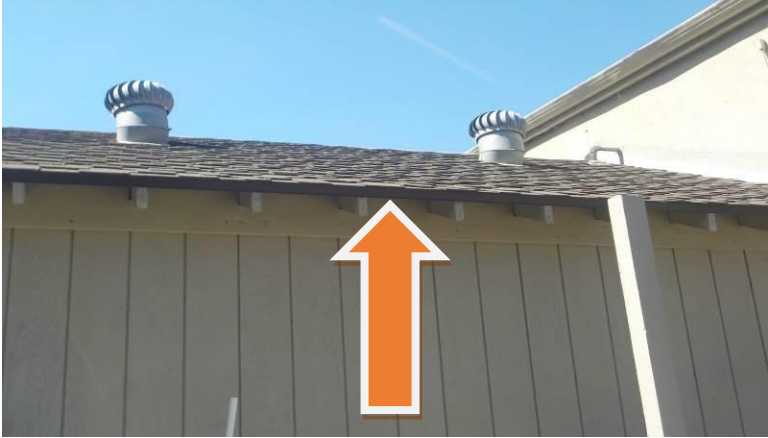
**Item #19-Rain gutters-There are no rain gutters over the front and side edges of the roof/gutters are recommended**

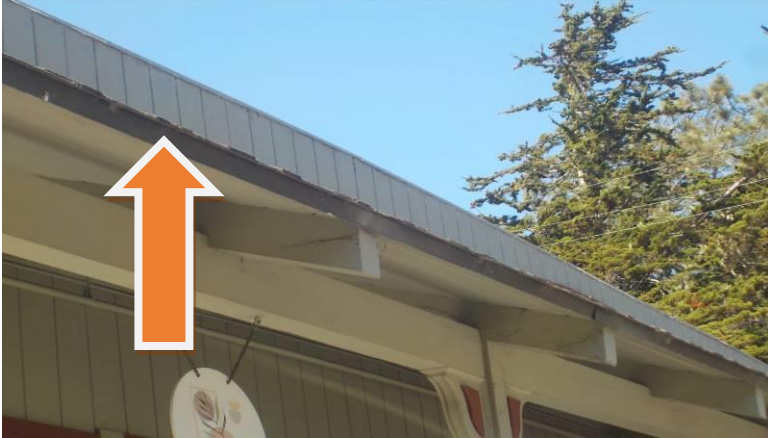
**Item #19-Rain gutters-There are no rain gutters over the front and side edges of the roof/gutters are recommended**

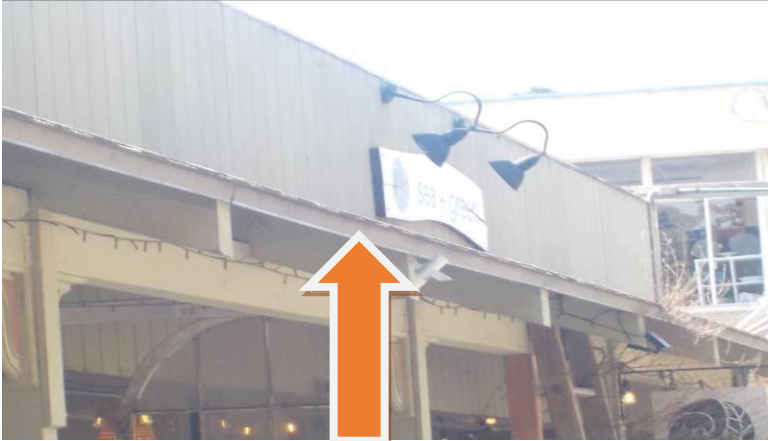
**Item #19-Rain gutters-Across the rear of the building, some of the gutter material is dented**

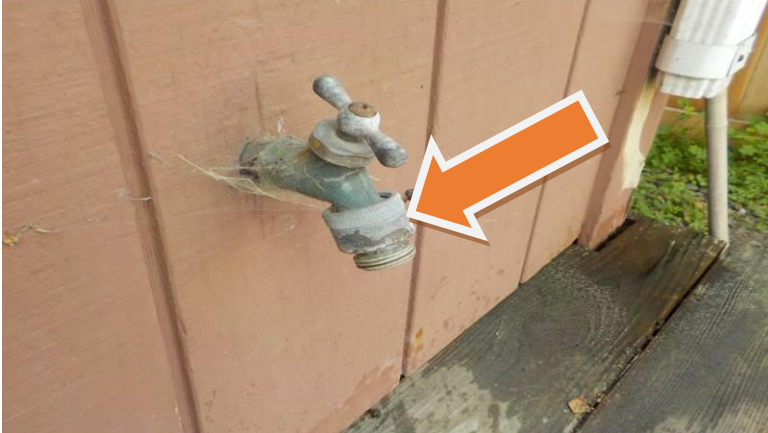
**Item #23-Siding-At the storage area near the rear of Wild Ginger, some of the wood siding is damaged**

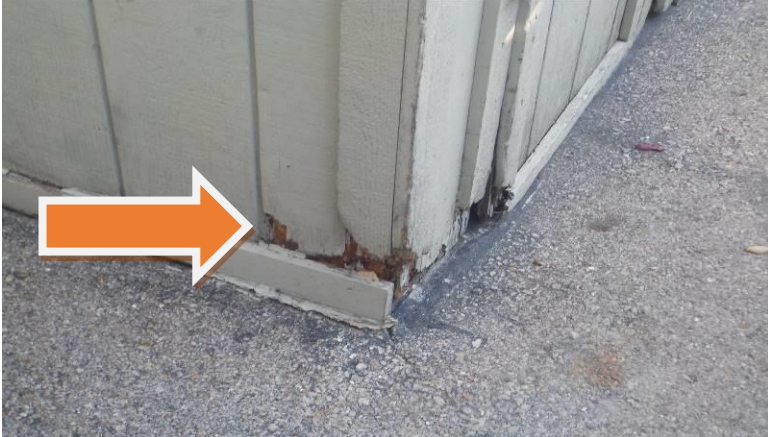
**Item #23-Siding-At the storage area near the rear of Wild Ginger, some of the wood siding is damaged**

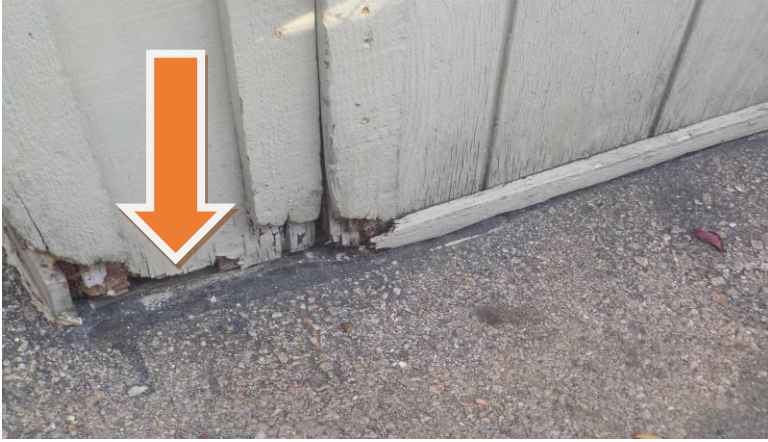
**Item #23-Siding-At the storage area near the rear of Wild Ginger, some of the wood siding is damaged**

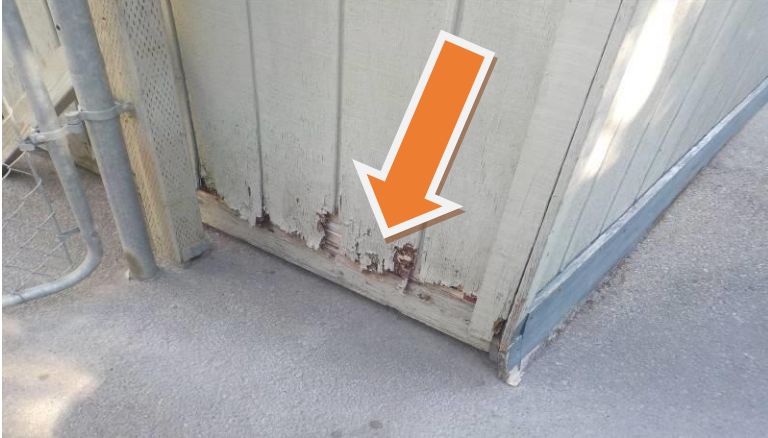
**Item #23-Siding-At the fire sprinkler storage room on the side of Wild Ginger, some of the wood siding is damaged**

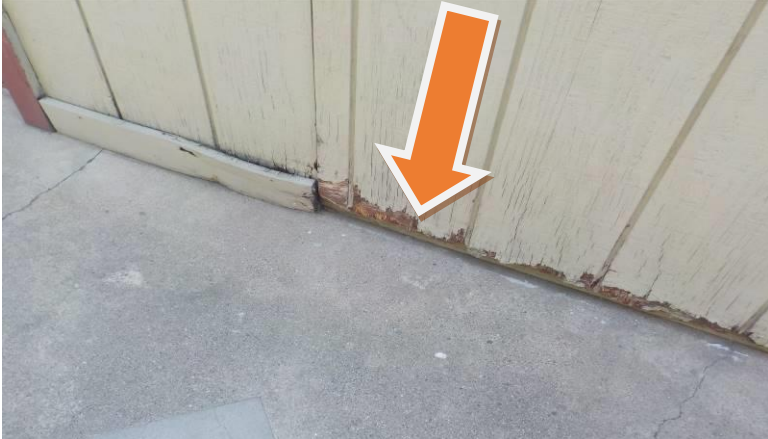
**Item #26-Exterior trim-At the storage area near the rear of Wild Ginger, some of the wood trim is damaged/missing**

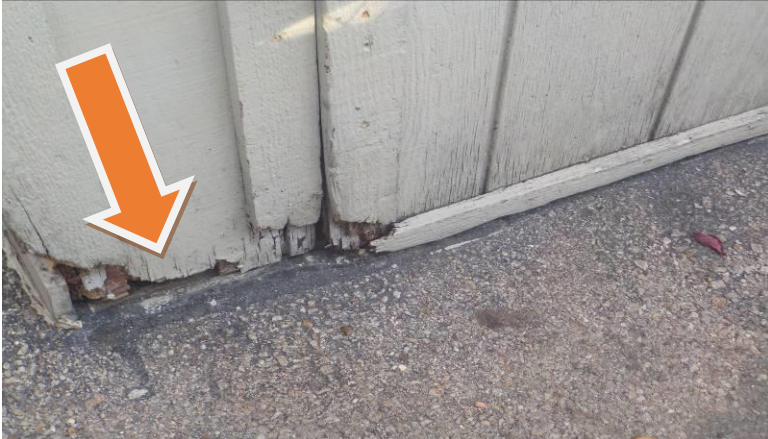
**Item #26-Exterior trim-At the storage area near the rear of Wild Ginger, some of the wood trim is damaged/missing**

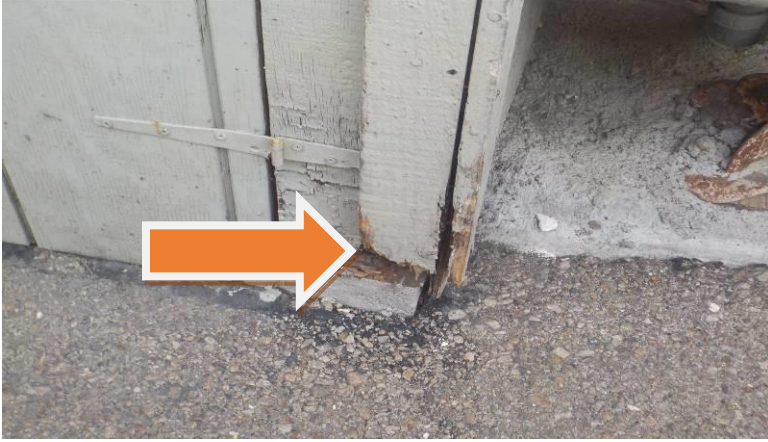
**Item #28-Roof, plumbing vents-The exhaust vent over unit A heater is missing the rain/vent cap**

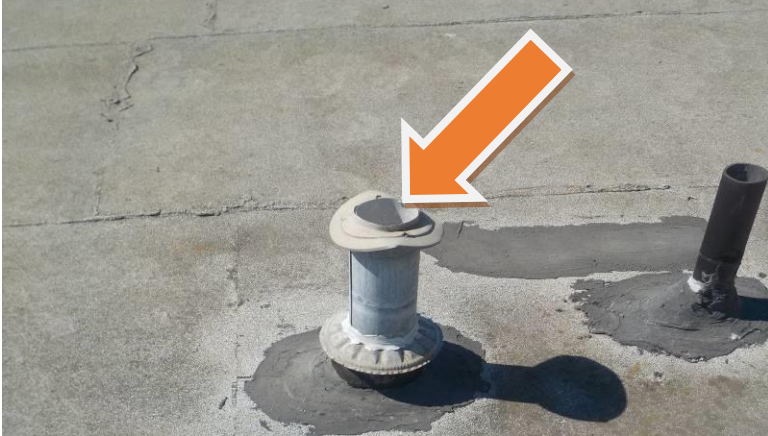
**Item #29-Roof-Some of the roofing material over unit B has been patched and caulked**

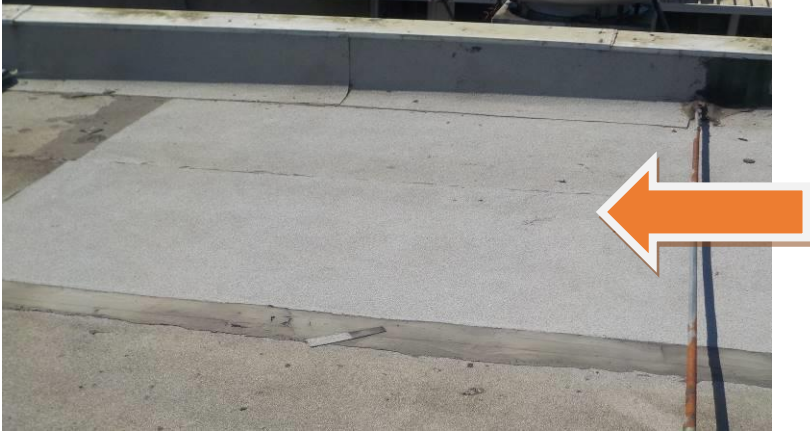
**Item #29-Roof-The 'Torch' style roofing material is in fair condition/below; over unit D**

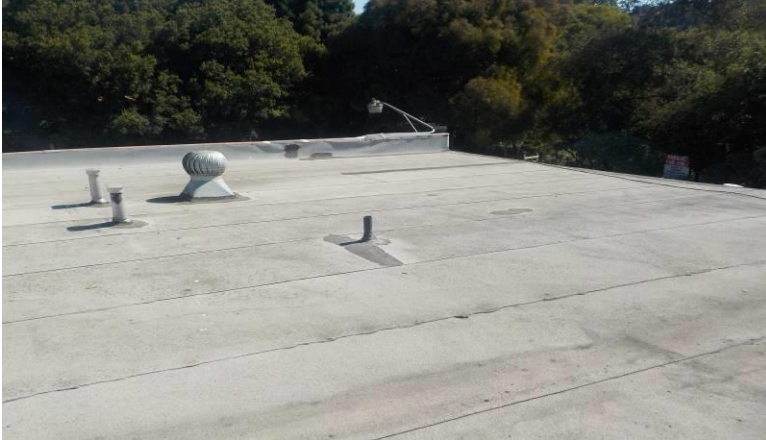
**Item #29-Roof-The 'Torch' style roofing material is in fair condition/below; over unit C**

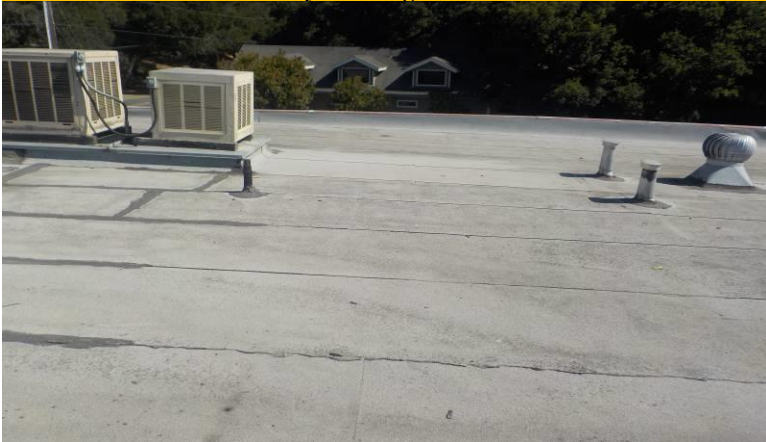
**Item #29-Roof-The 'Torch' style roofing material is in fair condition/below; over unit B**

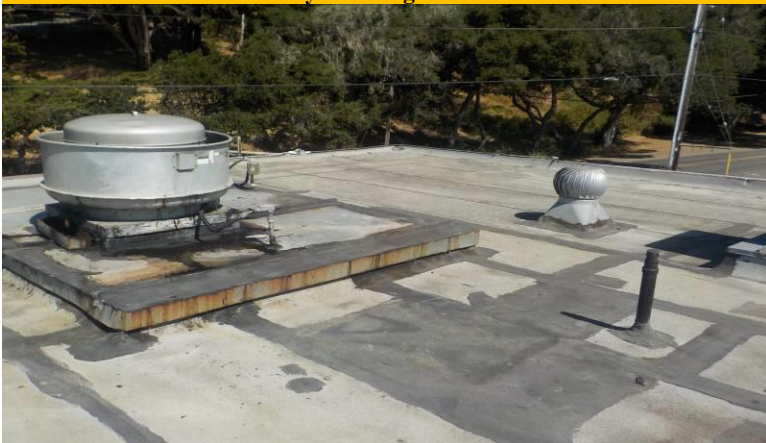
**Item #29-Roof-The 'Torch' style roofing material is in fair condition/below; over the front half of units B and E**

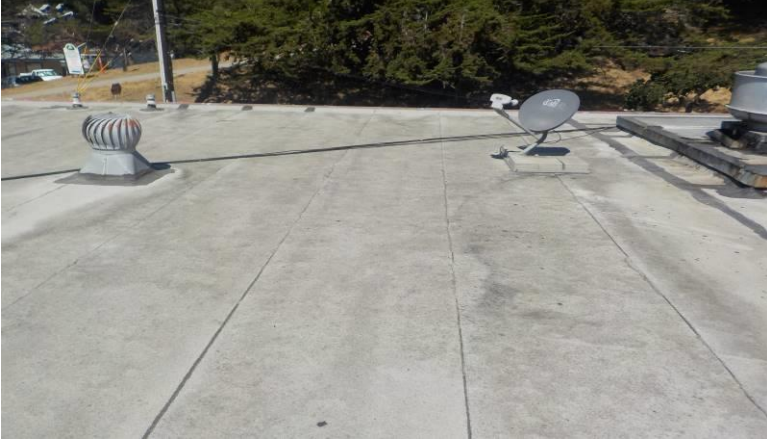
**Item #29-Roof-The 'Torch' style roofing material is in fair condition/below; over the rear half of units B and E**

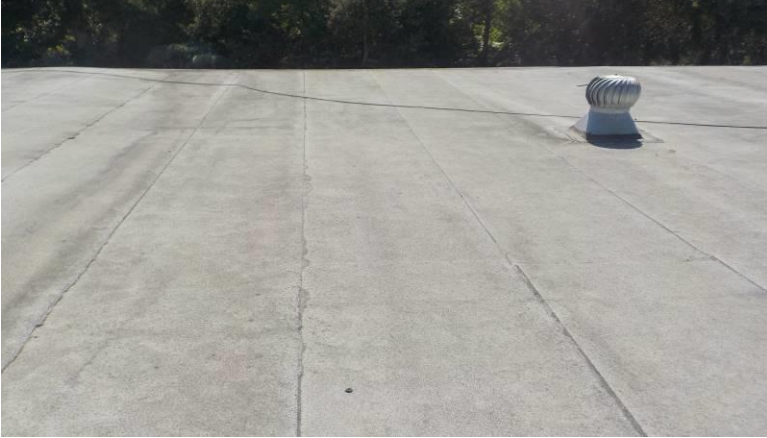
**Item #29-Roof-The 'Torch' style roofing material is in fair condition/below; over the front half of unit A**

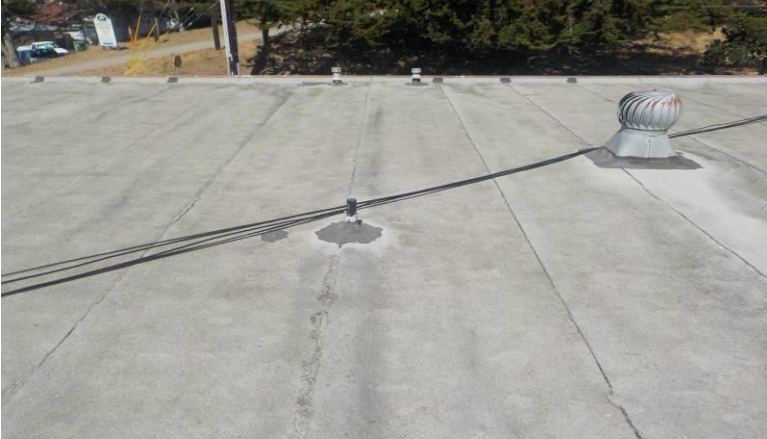
**Item #29-Roof-The 'Torch' style roofing material is in fair condition/below; over the rear half of unit A**

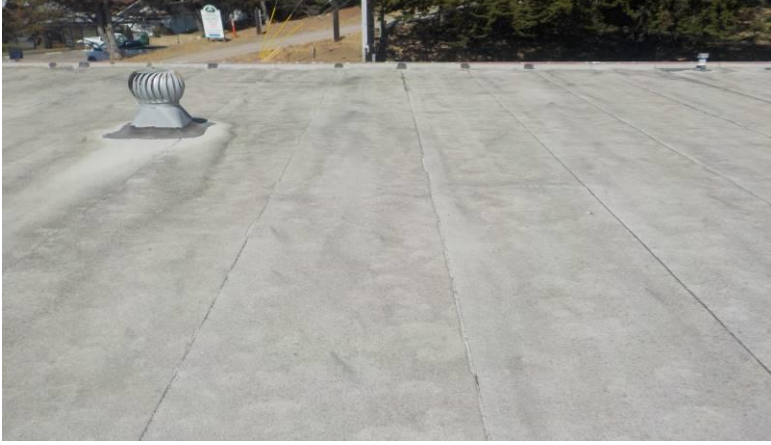
**Item #29-Roof-The 'Torch' style roofing material is in fair condition/below; over the rear half of units A and F**

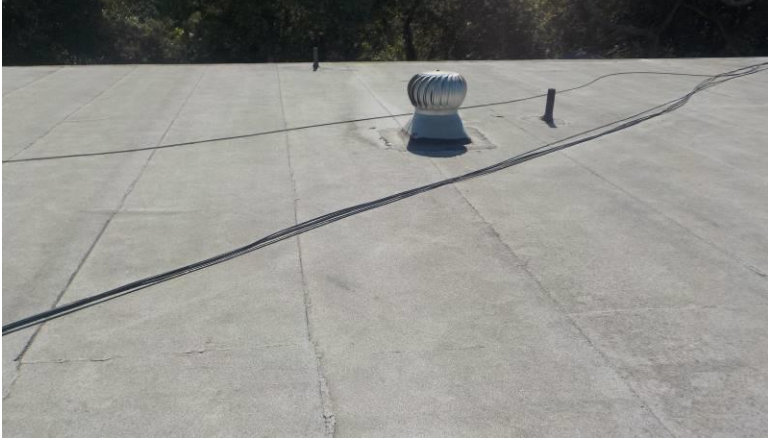
**Item #29-Roof-The 'Torch' style roofing material is in fair condition/below; over the front half of unit G**

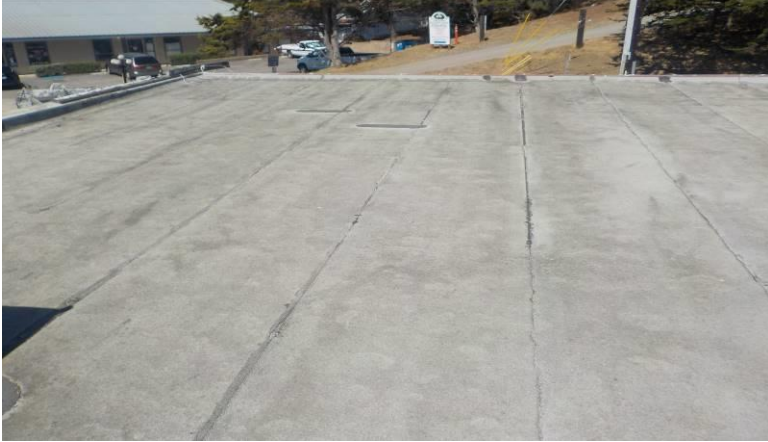
**Item #29-Roof-The 'Torch' style roofing material is in fair condition/below; over the rear half of unit G**

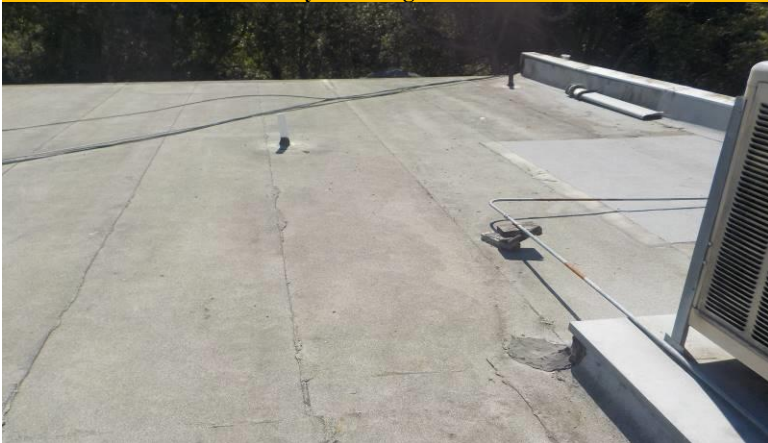
**Item #29-Roof-The 50-year composite shingle roofing material is in good condition/below; over the storage roof for unit B**

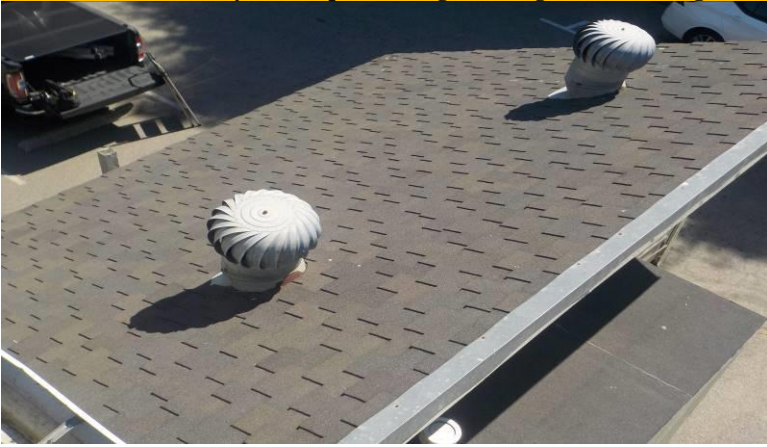
**Item #29-Roof-The 50-year composite shingle roofing material is in good condition/below; over the front entry of units D and C**

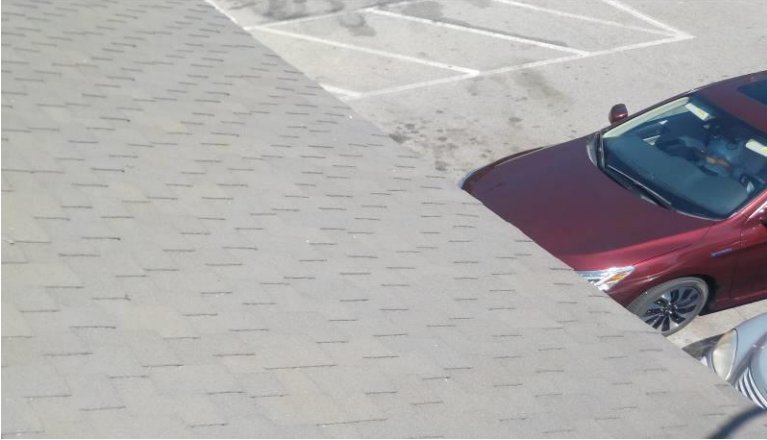
**Item #29-Roof-The 50-year composite shingle roofing material is in good condition/below; over the front entry of units C and B**

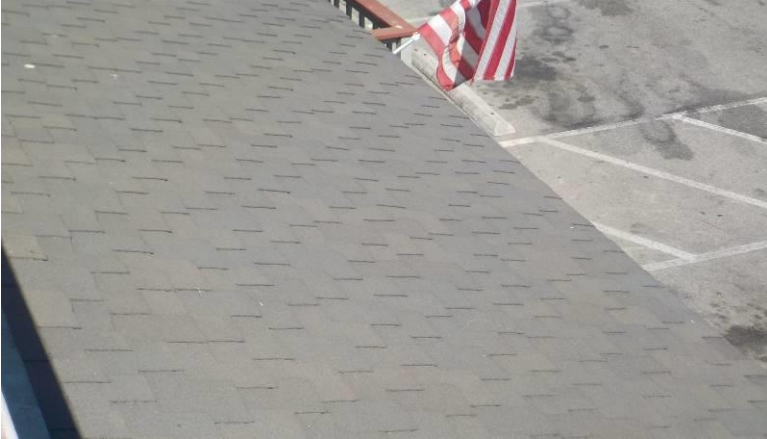
**Item #29-Roof-The 50-year composite shingle roofing material is in good condition/below; over the front entry of unit B**

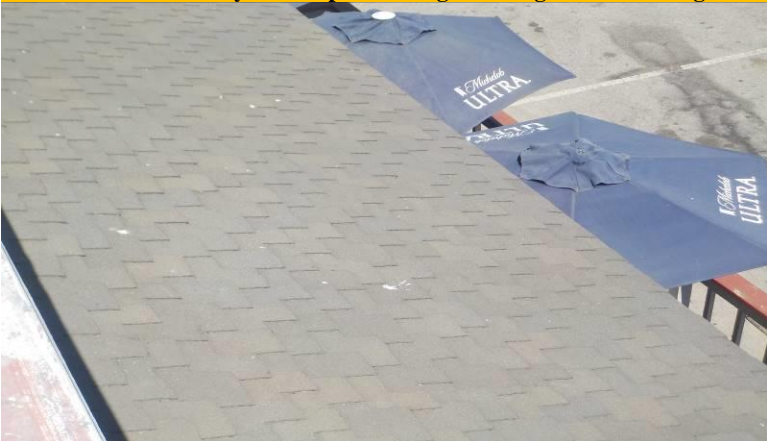
**Item #29-Roof-The 50-year composite shingle roofing material is in good condition/below; over the front entry of units A and F**

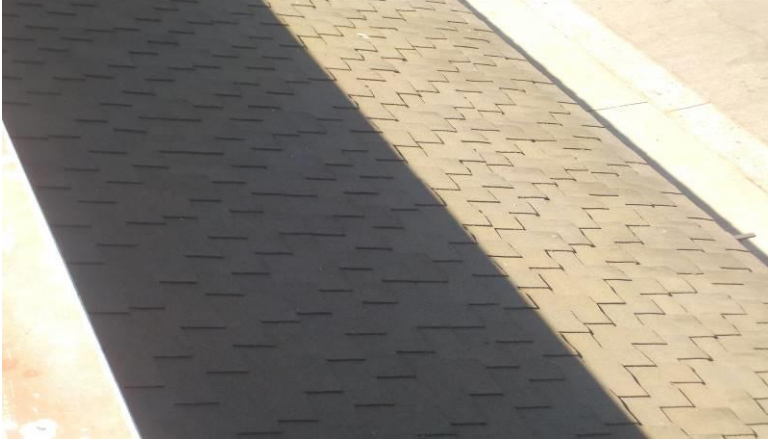
**Item #29-Roof-The 50-year composite shingle roofing material is in good condition/below; over the front entry of unit G**

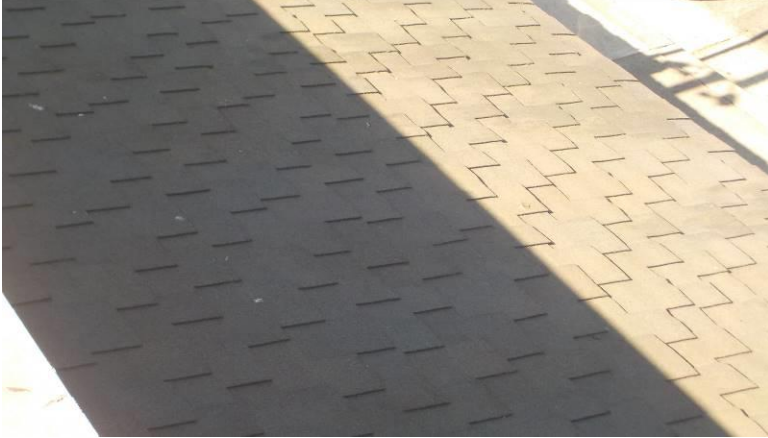
**Item #29-Roof-The 50-year composite shingle roofing material is in good condition/below; over the front corner of unit G**

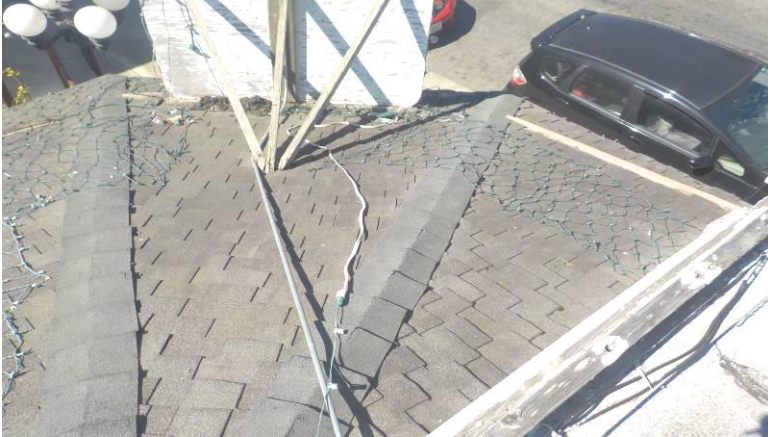
**Item #29-Roof-The 50-year composite shingle roofing material is in good condition/below; over the end of unit G**

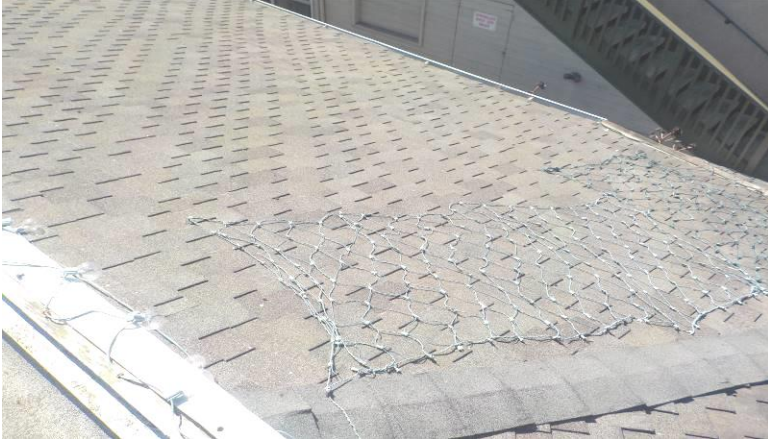
**Item #29-Roof-The 50-year composite shingle roofing material is in good condition/below; over the end of unit G**

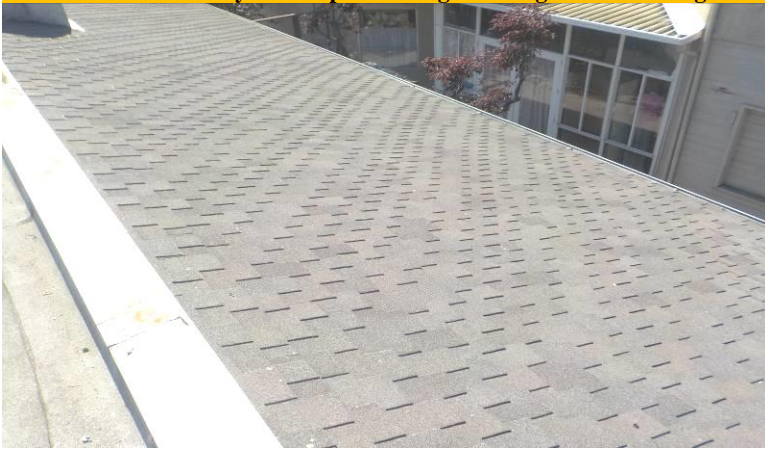
**Item #29-Roof-The 50-year composite shingle roofing material is in good condition/below; over the end of unit G**

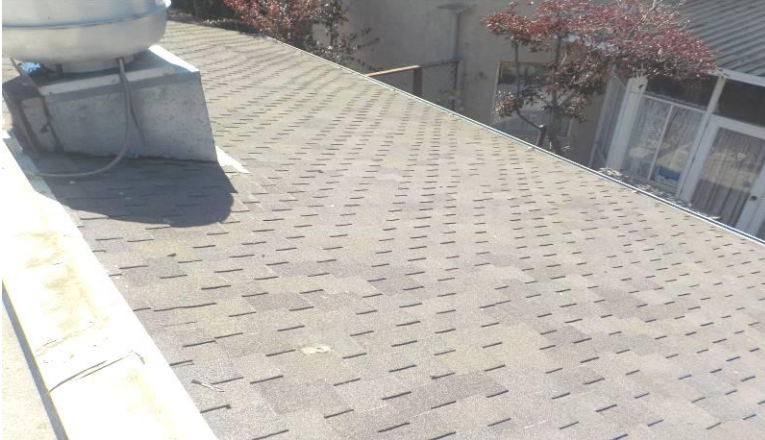
**Item #29-Roof-The 50-year composite shingle roofing material is in good condition/below; over the end of unit G**

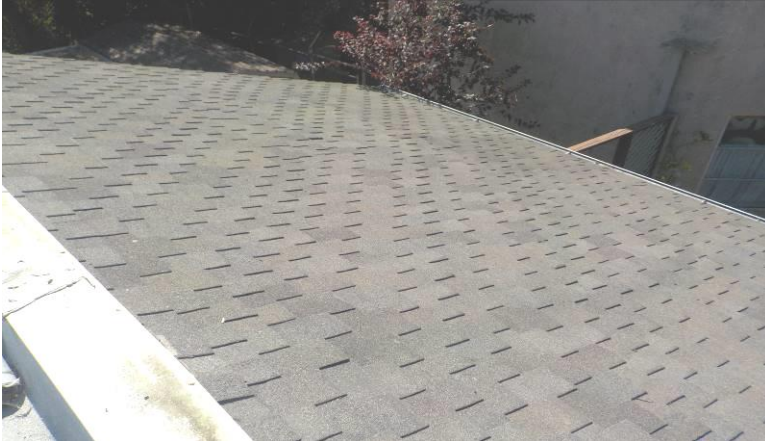
**Item #72-JJ's kitchen, floor-There are a few cracked floor tiles, but with little or no separation, various locations**

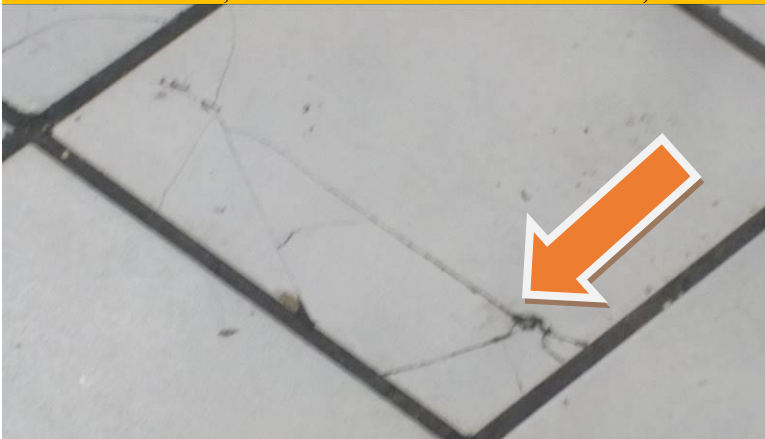
Item #72-JJ's kitchen, floor-There are a few cracked floor tiles, but with little or no separation, various locations

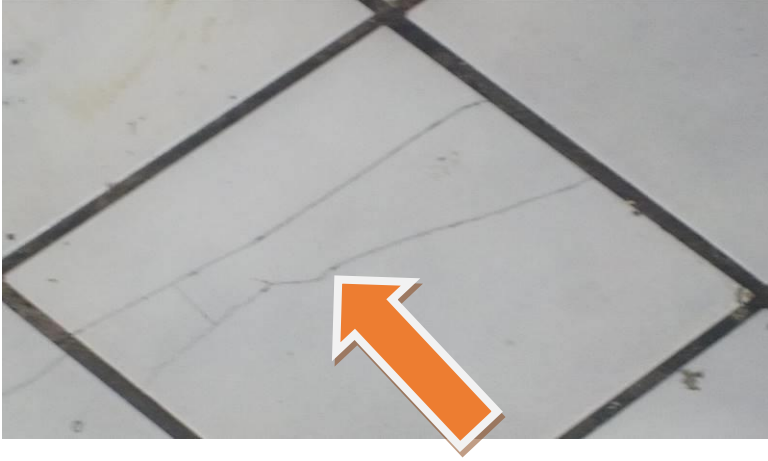
Item #72-JJ's kitchen, floor-There are a few cracked floor tiles, but with little or no separation, various locations

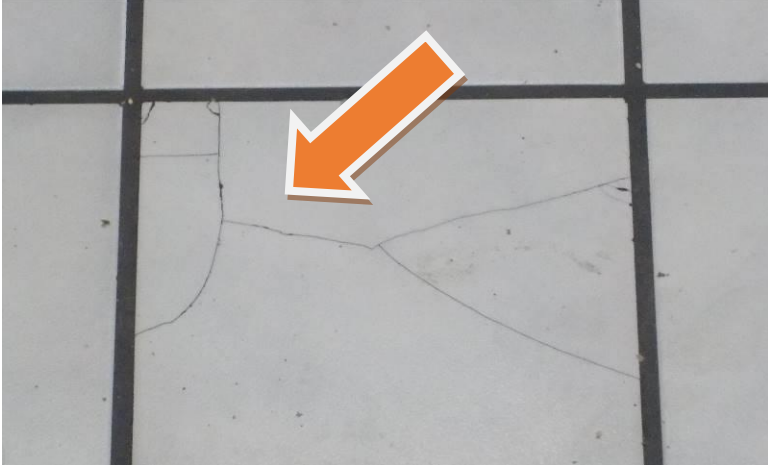
Item #88a-#3 water heater (Wild Ginger)-At the pressure relief valve, an extension is required to discharge within 6" of the ground

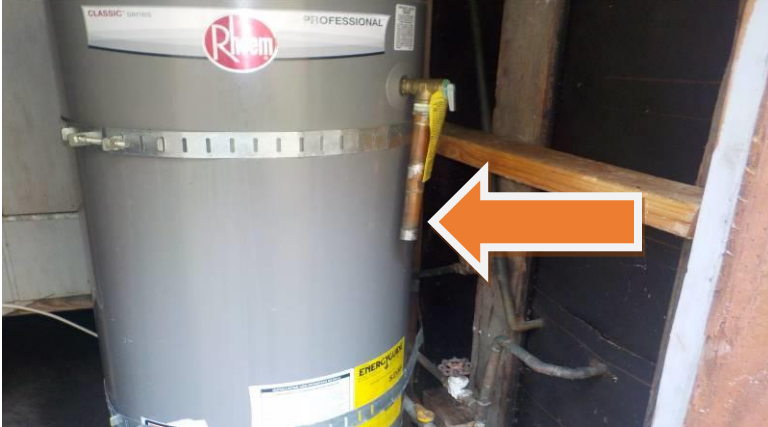
Item #159-Wild Ginger restroom, walls and door-There are a few cracks in the walls/this room and floor appear to be tilting toward the rear

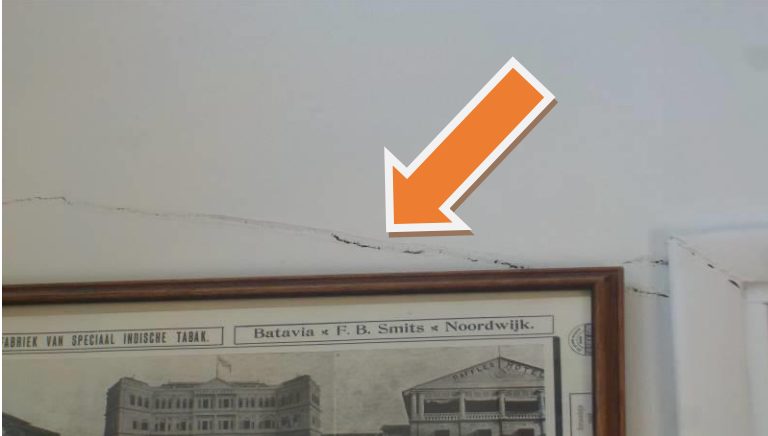
**Item #159-Wild Ginger restroom, walls and door-There are a few cracks in the walls/this room and floor appear to be tilting toward the rear**

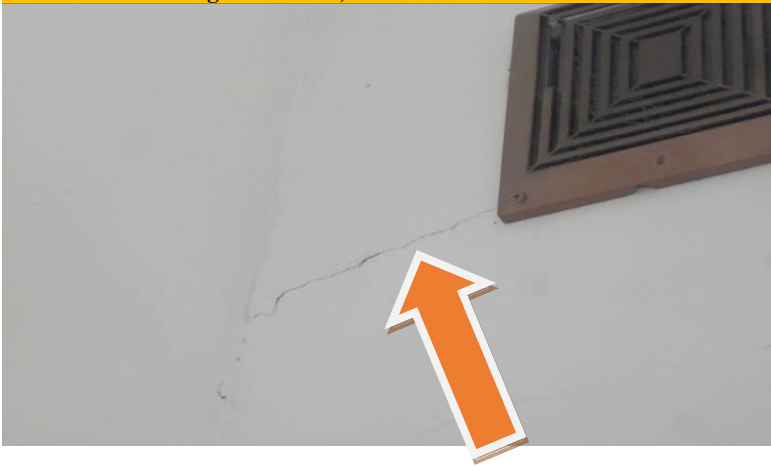
**Item #159-Wild Ginger restroom, walls and door-The descending gap at the top of the door to door frame is probably due to the room slanting**

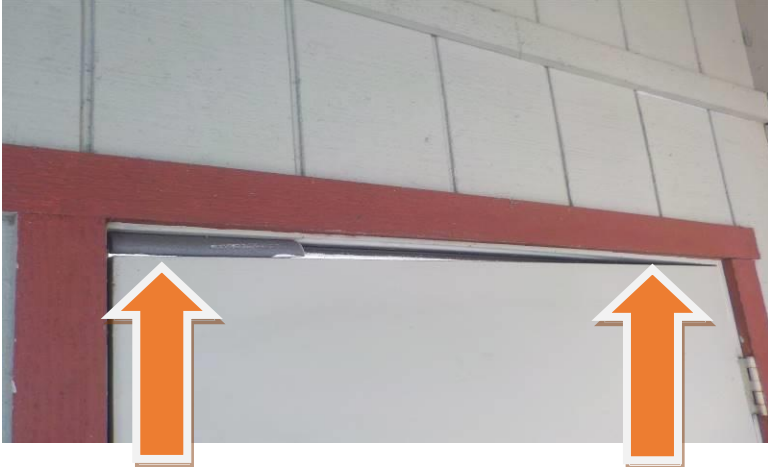
**Item #214-JJ's eating area, floor-There are a few cracked floor tiles, but with no separation at any of the cracks**

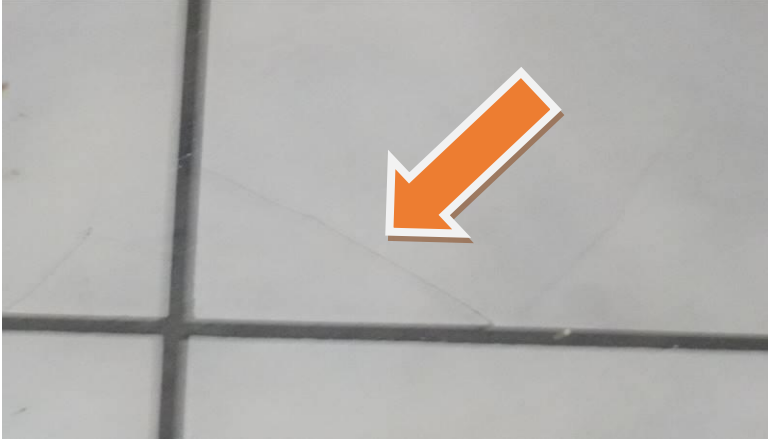
**Item #214-JJ's eating area, floor-There are a few cracked floor tiles, but with no separation at any of the cracks**

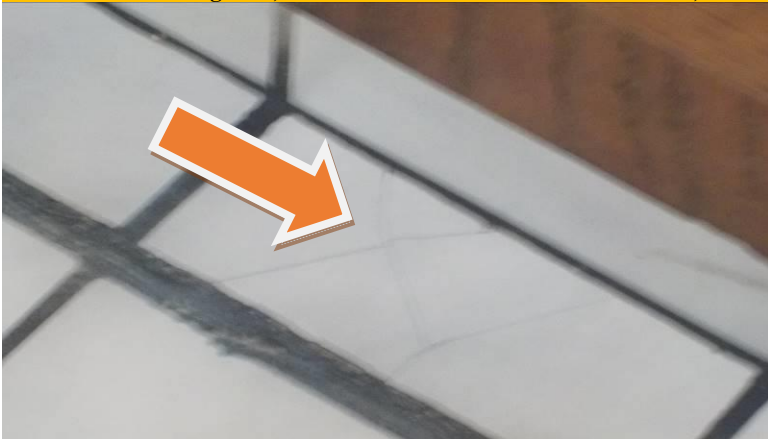
**Item #221-Unit E, lighting-At the rear of the retail area/Smoke Shop, the light fixture has been removed/the termination of wiring is not safe**

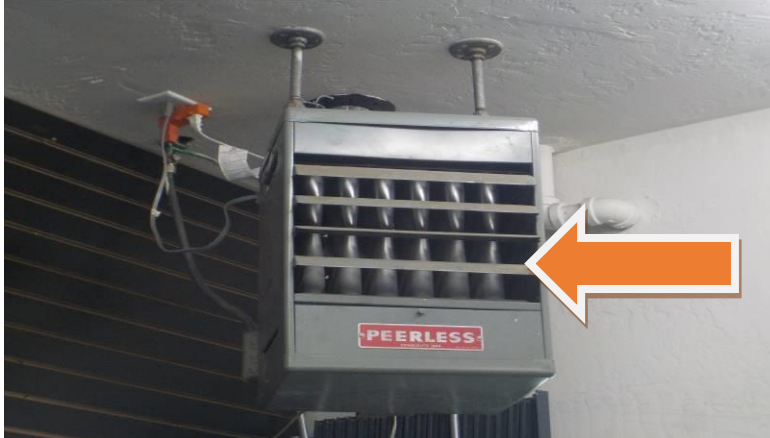
**Item #259-Sea Green left side display room, floor-Toward the rear of the room, there are a few cracks, some wider than others/sloping floor**

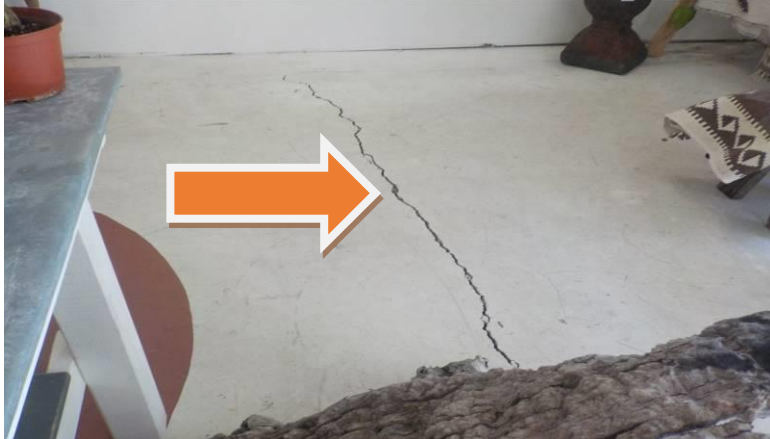
**Item #259-Sea Green left side display room, floor-Toward the rear of the room, there are a few cracks, some wider than others/sloping floor**

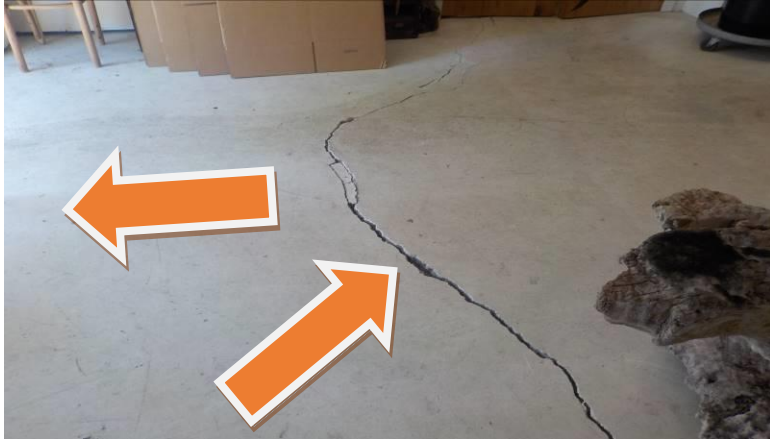
**Item #259-Sea Green left side display room, floor-Toward the rear of the room, there are a few cracks, some wider than others/sloping floor**

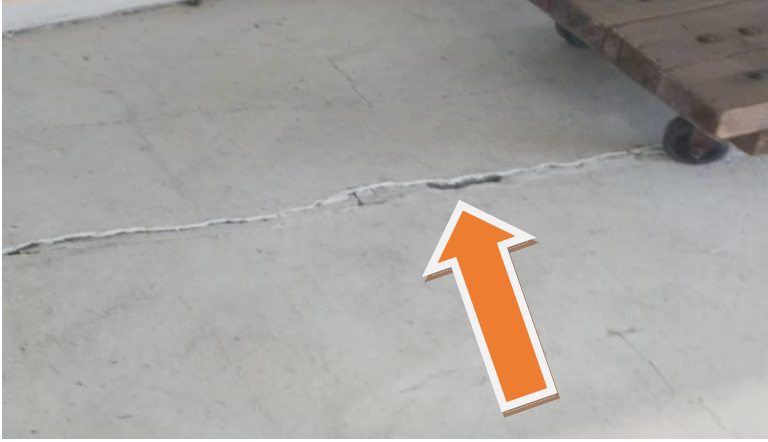
**Item #270-Sea Green storage room, walls-At the entry door from the display room, there is a crack in the wall (may be associated with item #259)**

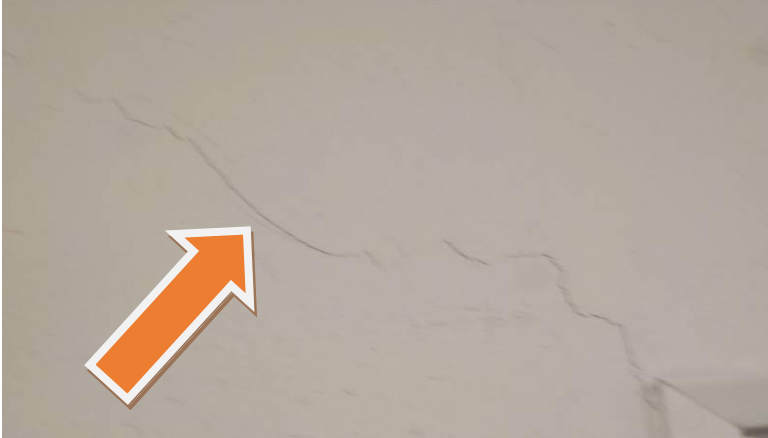
**Item #310-#1 electrical sub panel (For JJ's)-Six (6) breakers are missing/recommend breaker blank caps or breakers to fill the voids**

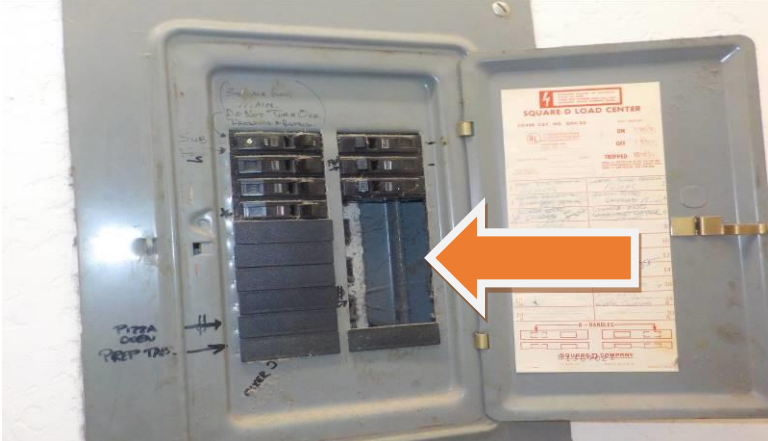
**Item #310a-Wild Ginger electrical breaker panel-Not all of the breakers are identified as to which circuit they represent**
