# REPORT ON PHASE 1 ENVIRONMENTAL SITE ASSESSMENT

HUDSON VALLEY RESORT
395 AND 400 GRANITE ROAD
PARCEL ID NUMBERS 76.4-1-39.100 AND 76.4-1-56.110
KERHONSKON (TOWN OF ROCHESTER),
ULSTER COUNTY, NEW YORK 12446

July 28, 2023

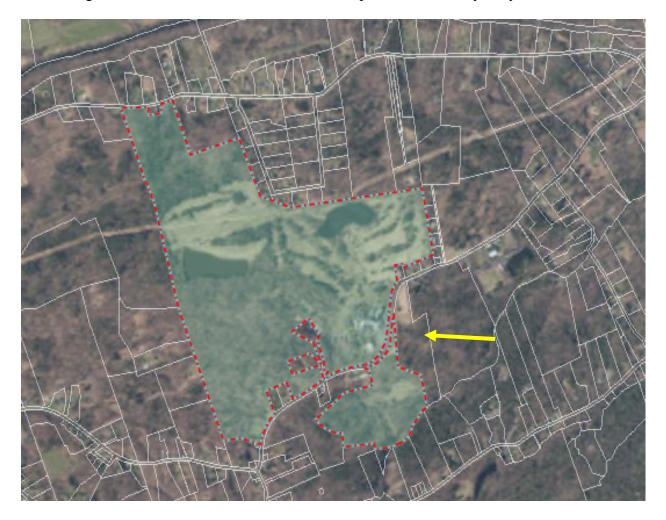
The property consists of two contiguous lots located at 395 and 400 Granite Road in Kerhonkson (Town of Rochester), Ulster County, New York and identified as Parcel ID numbers 76.4-1-39.100 and 76.4-1-56.110, respectively. The property is shown below on a tax map/2021 aerial photograph obtained from the Ulster County website; 400 Granite Road is the large parcel shaded in green and 395 Granite Road is the smaller parcel indicated by the yellow arrow.

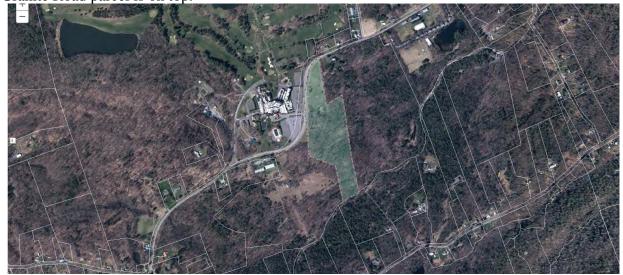
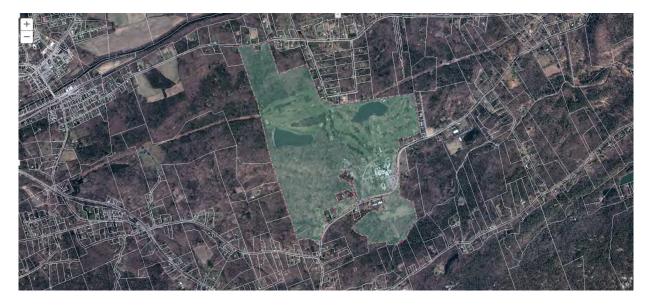
The property consists of two contiguous lots located at 395 and 400 Granite Road in Kerhonkson (Town of Rochester), Ulster County, New York and identified as Parcel ID numbers 76.4-1-39.100 and 76.4-1-56.110, respectively. The parcel locations shown on a tax maps/2016 aerial photographs from the Ulster County website are below with the parcel shaded in green. The 395 Granite Road parcel is on top.

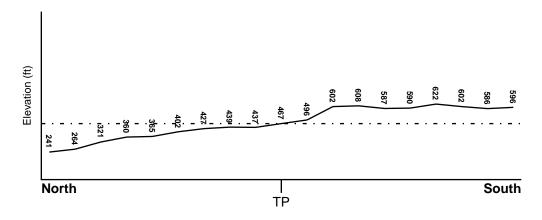
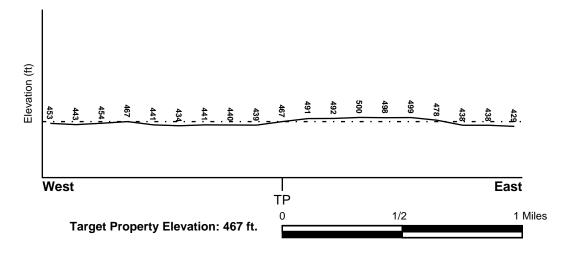
#### SURROUNDING TOPOGRAPHY: ELEVATION PROFILES

Source: Topography has been determined from the USGS 7.5' Digital Elevation Model and should be evaluated on a relative (not an absolute) basis. Relative elevation information between sites of close proximity should be field verified.
