PHASE I ENVIRONMENTAL SITE ASSESSMENT

± 73-ACRE HIGHWAY 321 RAIL SITE

LEXINGTON COUNTY, SOUTH CAROLINA

Project No. 25168-0032

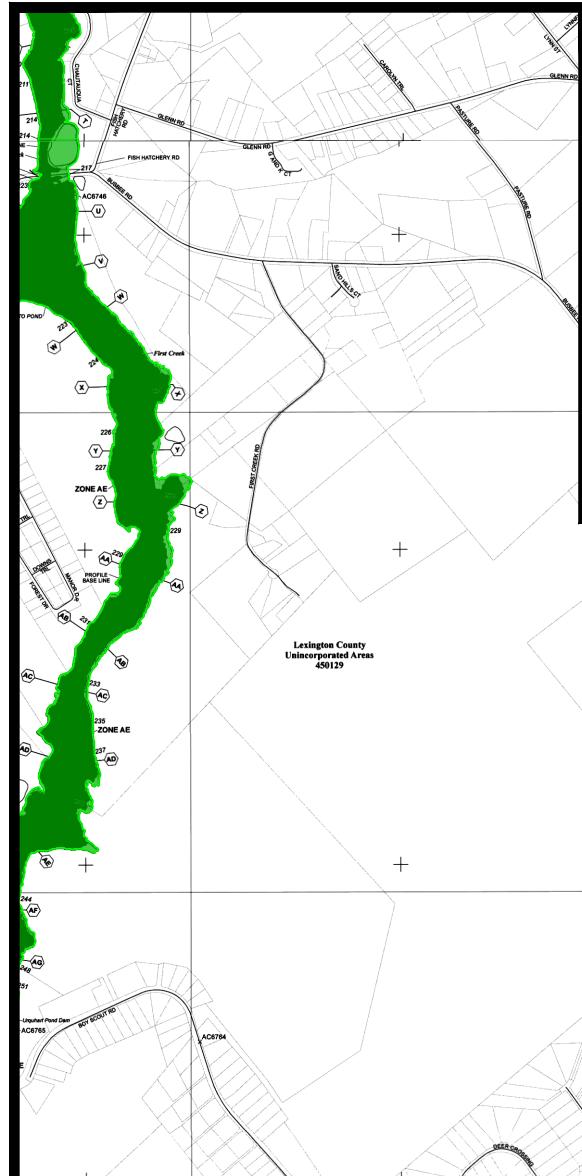
EXHIBIT F

**HIGHWAY 321 RAIL SITE
LEXINGTON COUNTY, SOUTH CAROLINA
FEMA FLOOD MAP**

PREPARED BY:
ALLIANCE CONSULTING ENGINEERS, INC.
INFORMATION FROM:
FEMA FLOOD MAP CATALOG
PANEL NO. 45063C0405J, 45063C0401J,
45063C0288J
DATED 07/05/2018
