**WOTUS & Wetland Delineation
2015 West Pembroke Avenue
Hampton, Virginia
WSSI #32576.01**

**Re: Preliminary Jurisdictional Determination Request
2015 W. Pembroke Ave (± 10.7 acres)
Hampton, Virginia 23661
WSSI Project # 32576.01**

**October 2022 Natural Color Imagery
2015 West Pembroke Avenue
WSSI #32576.01**

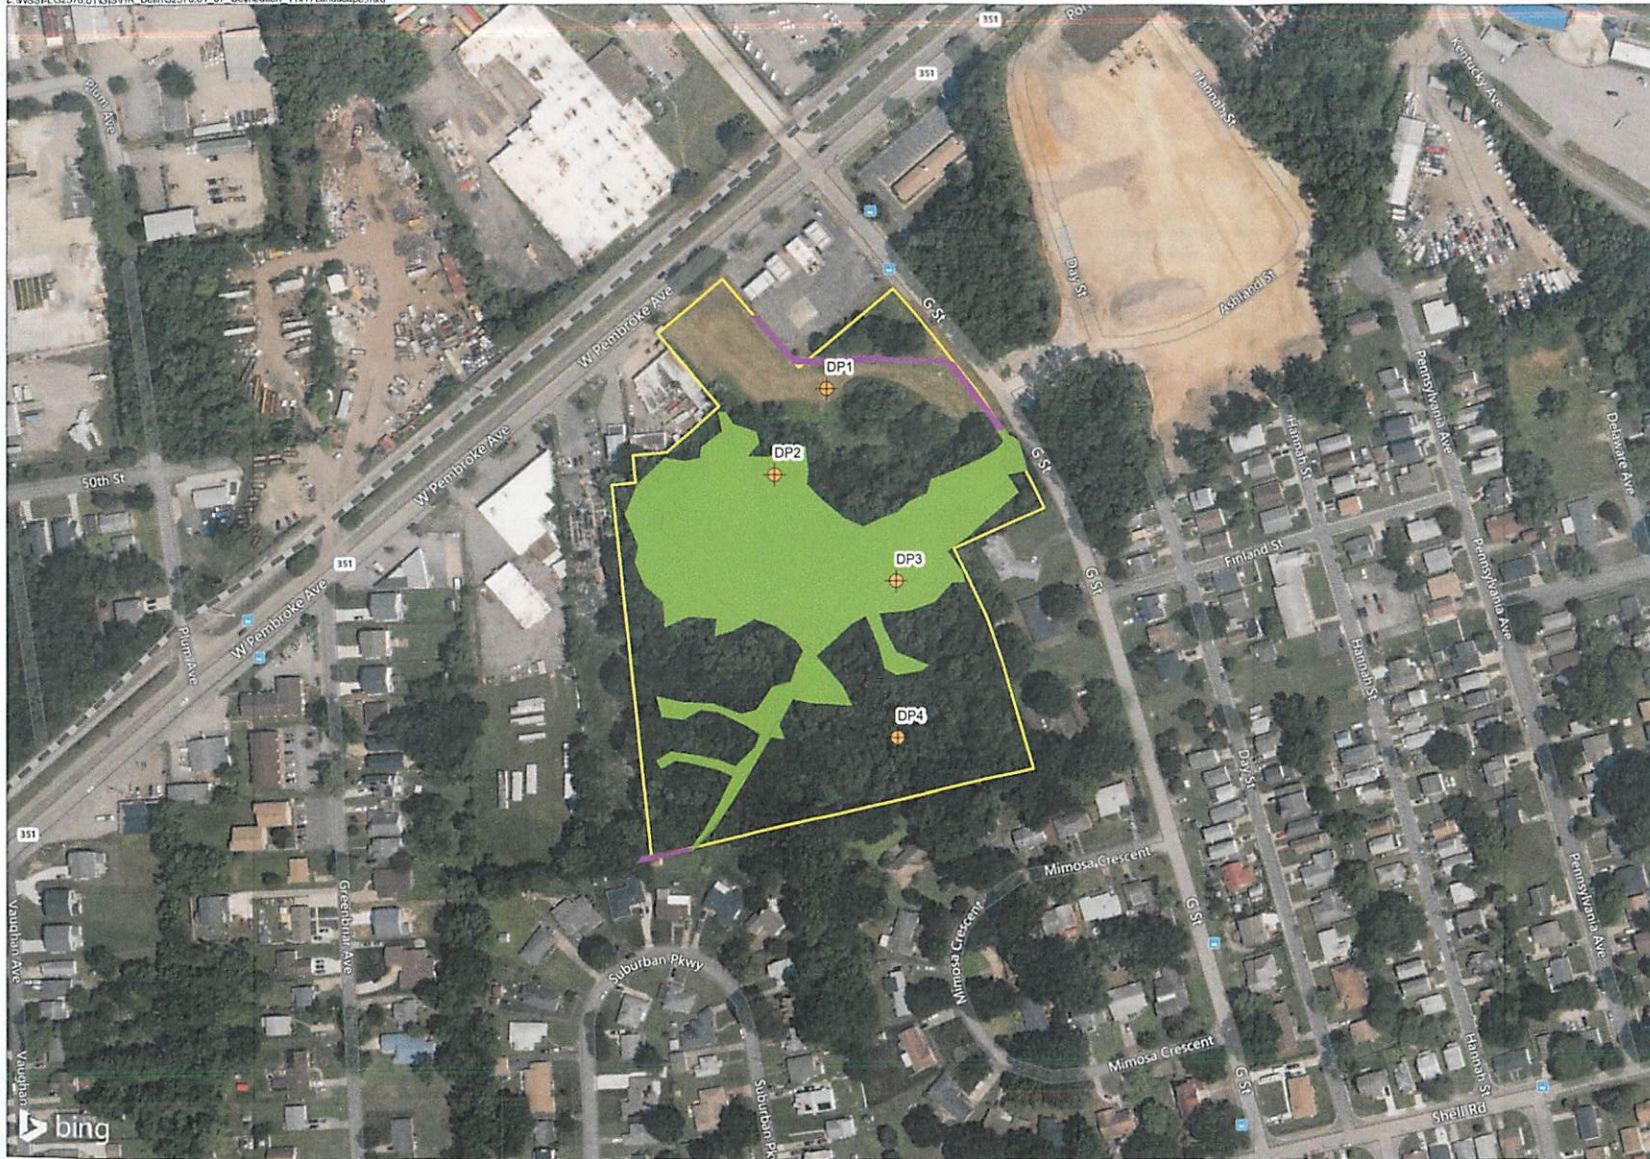
Project Area (±10.7 ac)

Wetland Data Points

Aquatic Resources

Wetlands (±3.6 ac)

Ditch (±574 lf)

Notes:
In-field wetland delineation performed on February 15, 2023 by J. Armentrout, PWS, PWD, and C. Hemphill.

The delineation effort identified the following aquatic resources wetlands and WOTUS on the site (Exhibit 7).

- 3.6 acres of wetlands
- 574 linear feet (0.1 acres) of ditch

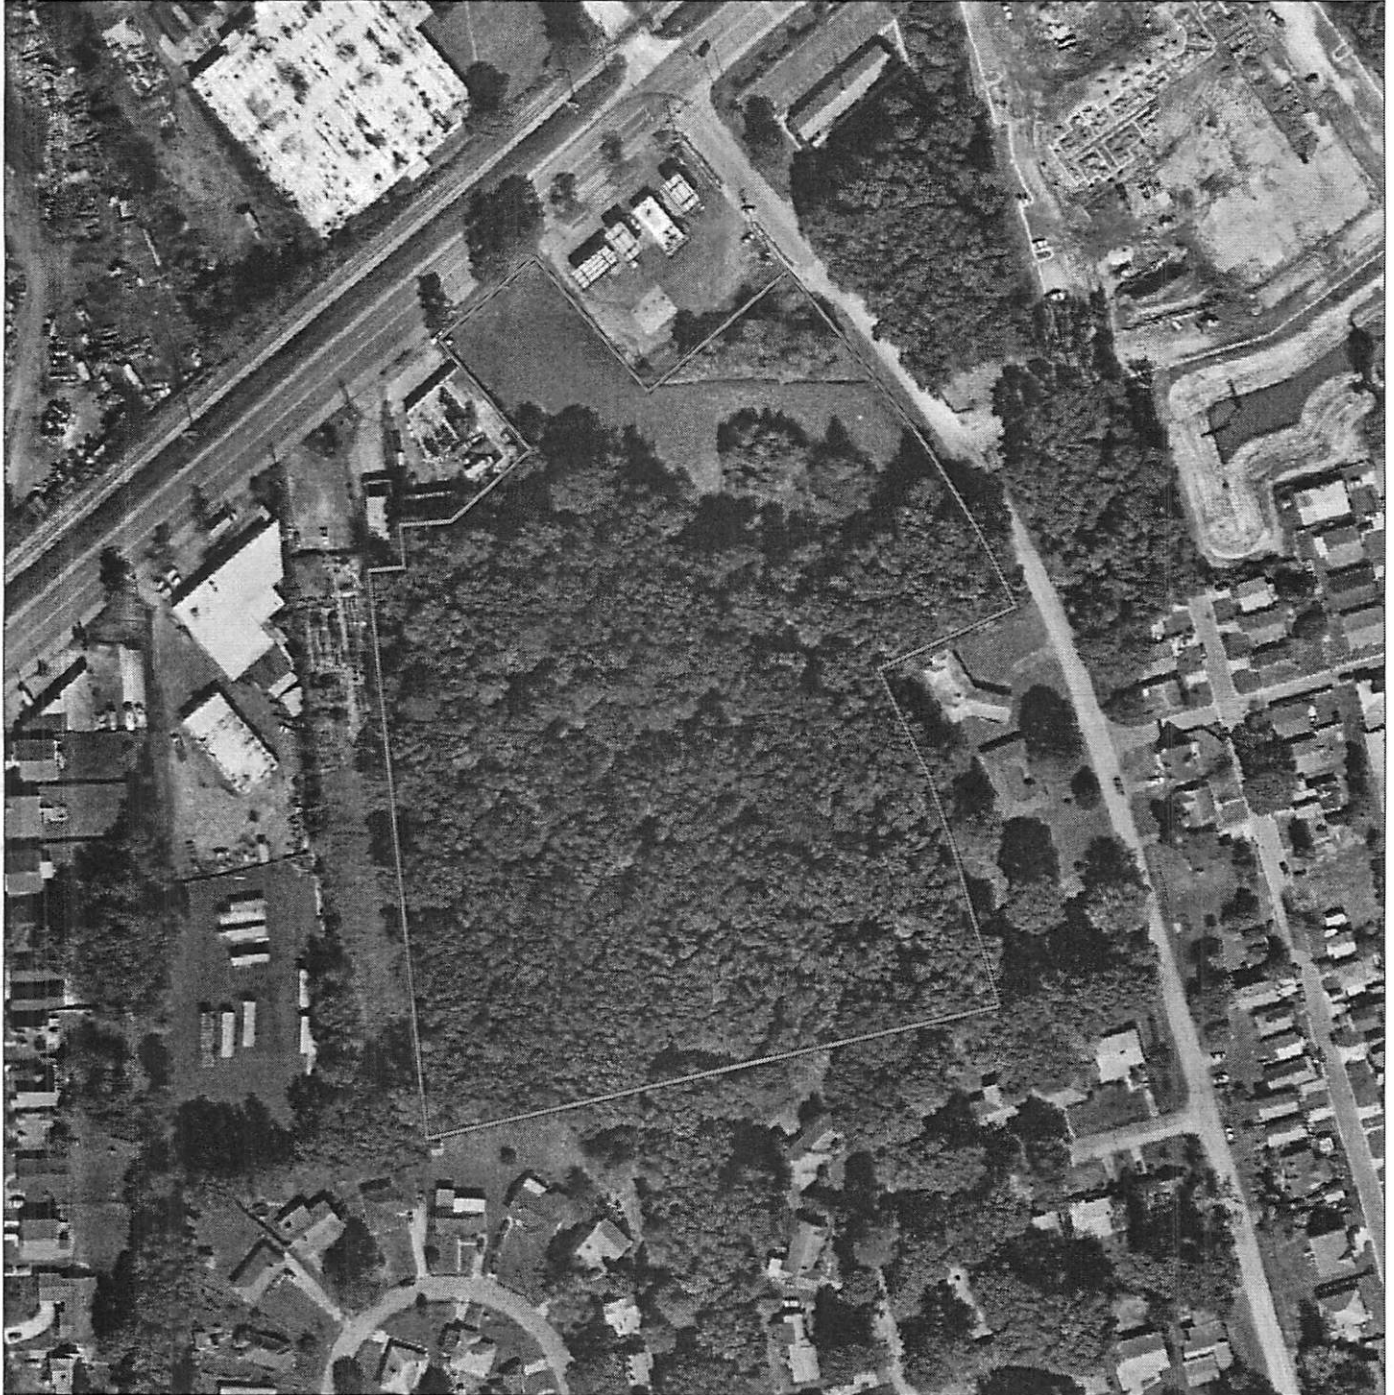
Project Area

Newport News North, VA 1986
 Latitude: 37°0'24"N
 Longitude: 76°23'31"W
 Hydrologic Unit Code (HUC): 020802080303
 HUC12 Name: Hampton River-Hampton Roads
 COE Region: Atlantic and Gulf Coastal Plain

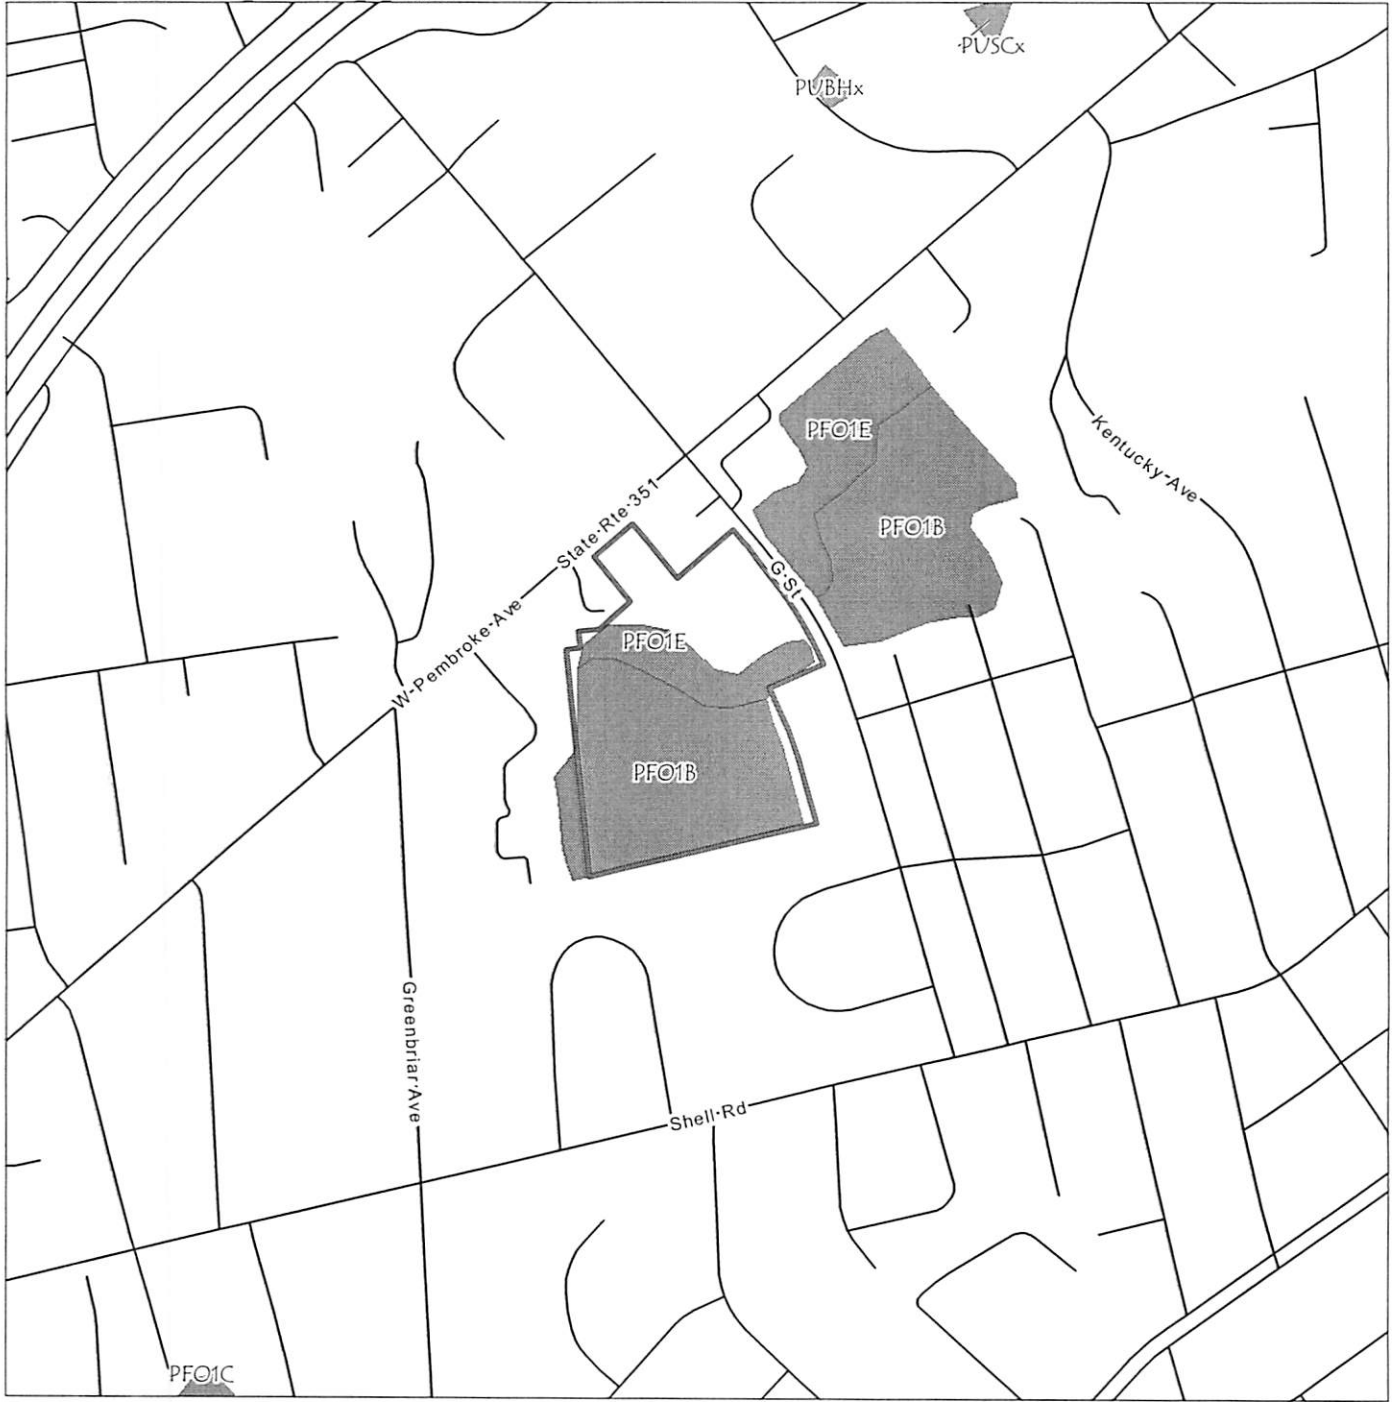
Figure 4

Digital National Wetlands Inventory
2015 West Pembroke Avenue
WSSI #32576.01

Source: U.S. Fish and Wildlife Service; December 2021

The on-line National Wetland Inventory (attached) identifies PFO1E, PFO1B wetlands within the subject property.

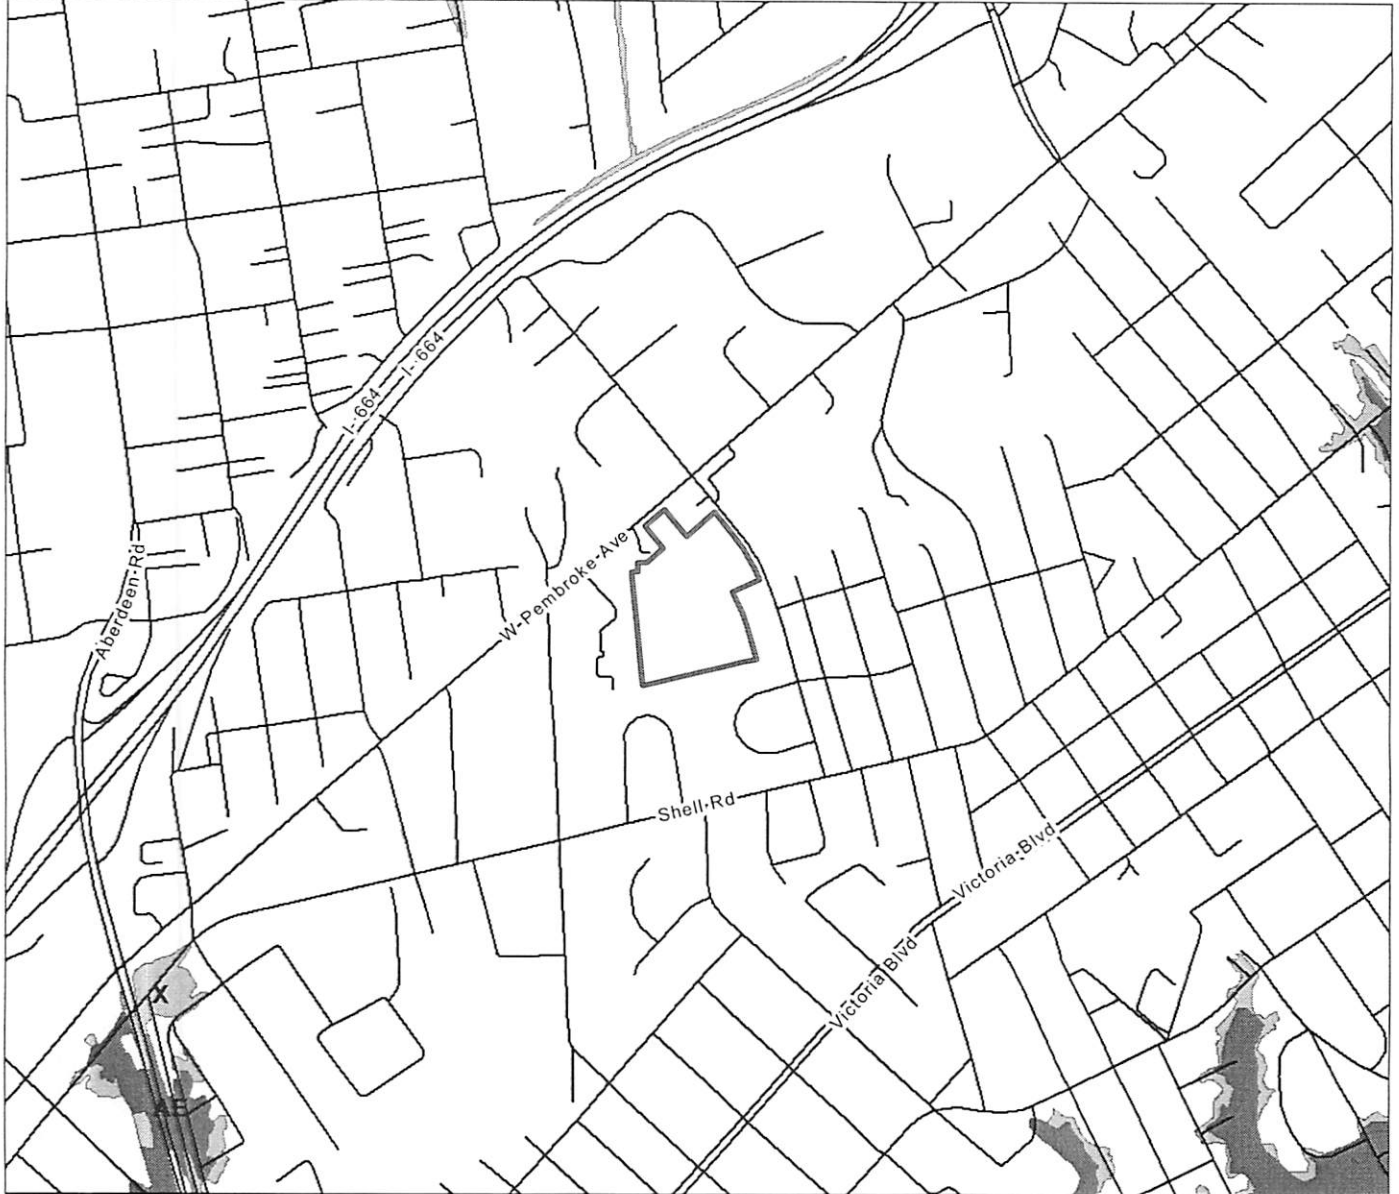
**FEMA Digital Flood Insurance Rate
2015 West Pembroke Avenue
WSSI #32576.01**

Panel: 5155270024H, Effective: 05/16/2016

As depicted on the Federal Emergency Management Agency’s (FEMA) on-line Flood Insurance Rate Map # 5155270024H, effective date 05/16/2016 the property lies within Unshaded Zone X.

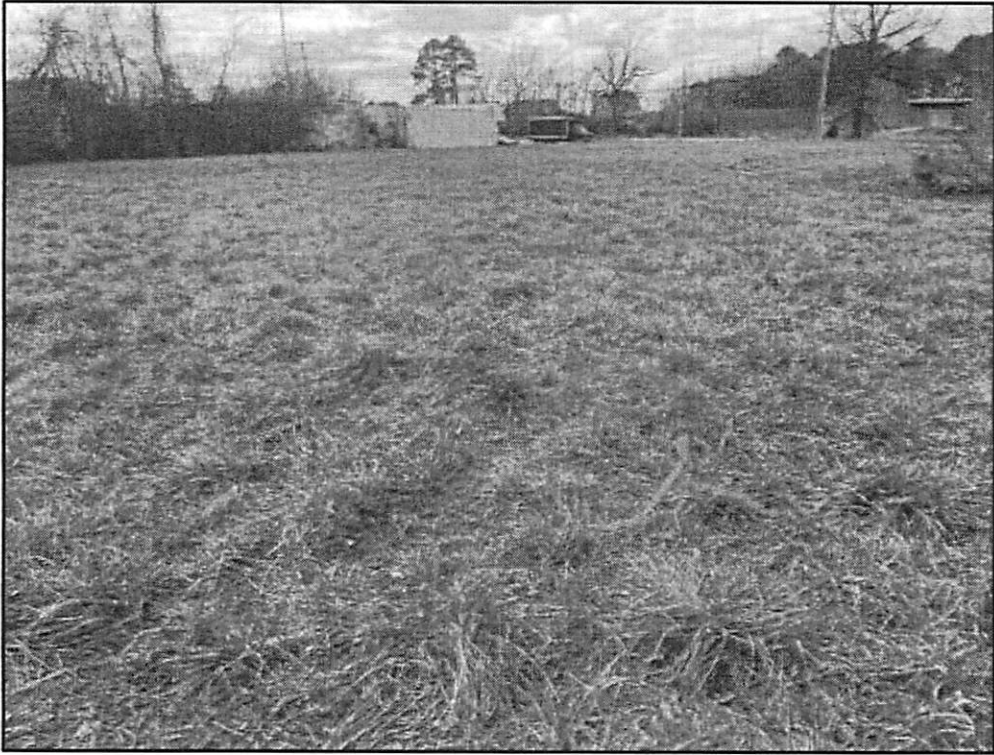
Photograph 1: View of surrounding vegetation facing northwest at Data Point 1.

Hydrophytic Vegetation Present? Yes <input checked="" type="checkbox"/> No _____ Hydric Soil Present? Yes _____ No <input checked="" type="checkbox"/> Wetland Hydrology Present? Yes _____ No <input checked="" type="checkbox"/>	Is the Sampled Area within a Wetland? Yes _____ No <input checked="" type="checkbox"/>
Remarks: Data point collected on northern portion of site in maintained field. Wetter than normal conditions present.

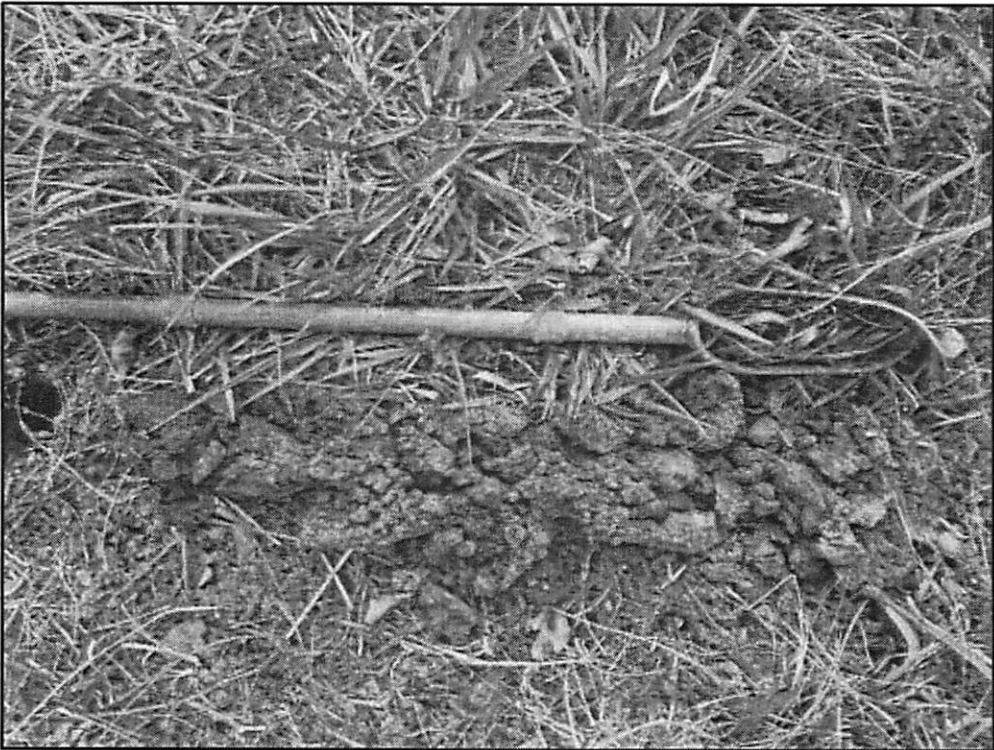
Photograph 2: View of non-hydric soil profile at Data Point 1.

Profile Description: (Describe to the depth needed to document the indicator or confirm the absence of indicators.)								
Depth (inches)	Matrix		Redox Features				Texture	Remarks
	Color (moist)	%	Color (moist)	%	Type ¹	Loc ²		
0 - 4	10YR 3/2	100					Sandy Loam	
4 - 22	10YR 5/4	98	7.5YR 6/8	2			Sandy Clay Loam	Soil mixing from fill
22 - 24	10YR 5/2	98	7.5YR 6/8	2			Sandy Clay Loam	Soil mixing from fill
-								
-								
-								
-

Restrictive Layer (if observed): Type: _____ Depth (inches): _____	Hydric Soil Present? Yes _____ No <input checked="" type="checkbox"/>
--------------------------------------------------------------------------	-----------------------------------------------------------------------------

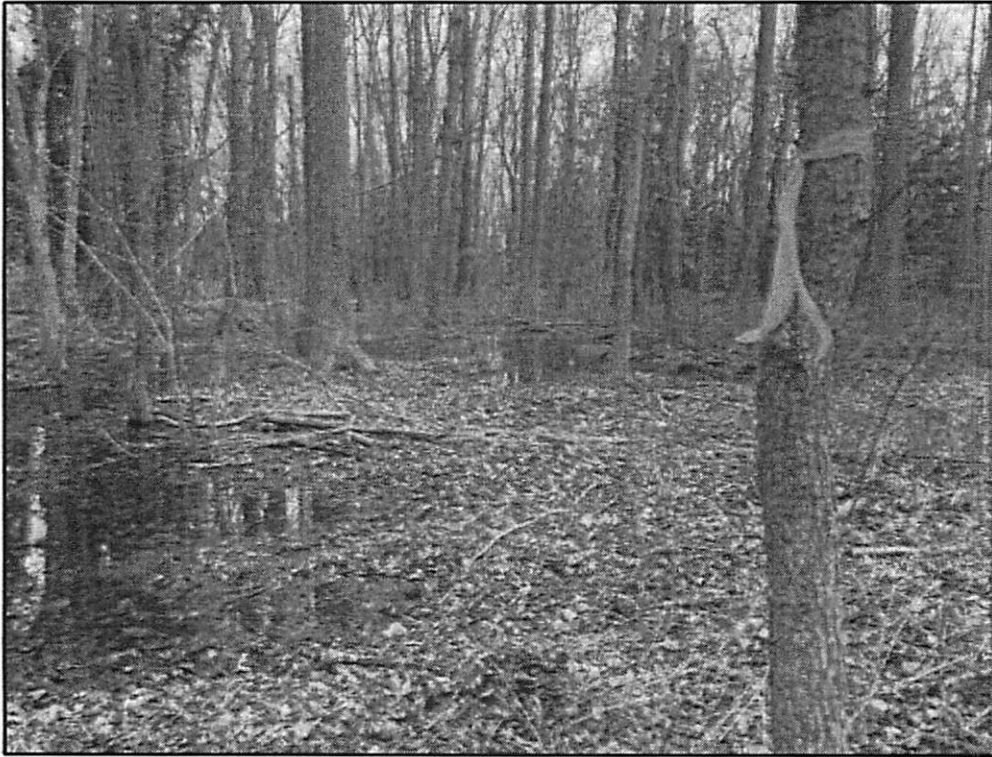
Photograph 3: View of surface water facing west at Data Point 2.

Hydrophytic Vegetation Present? Yes <input checked="" type="checkbox"/> No _____ Hydric Soil Present? Yes <input checked="" type="checkbox"/> No _____ Wetland Hydrology Present? Yes <input checked="" type="checkbox"/> No _____	Is the Sampled Area within a Wetland? Yes <input checked="" type="checkbox"/> No _____
Remarks: Data point collected in forested flat with wetland drainage patterns. Wetter than normal conditions present.

Field Observations: Surface Water Present? Yes <input checked="" type="checkbox"/> No _____ Depth (inches): <u>2</u> Water Table Present? Yes <input checked="" type="checkbox"/> No _____ Depth (inches): <u>2</u> Saturation Present? Yes <input checked="" type="checkbox"/> No _____ Depth (inches): <u>2</u> (includes capillary fringe)	Wetland Hydrology Present? Yes <input checked="" type="checkbox"/> No _____
Describe Recorded Data (stream gauge, monitoring well, aerial photos, previous inspections), if available:	
Remarks:

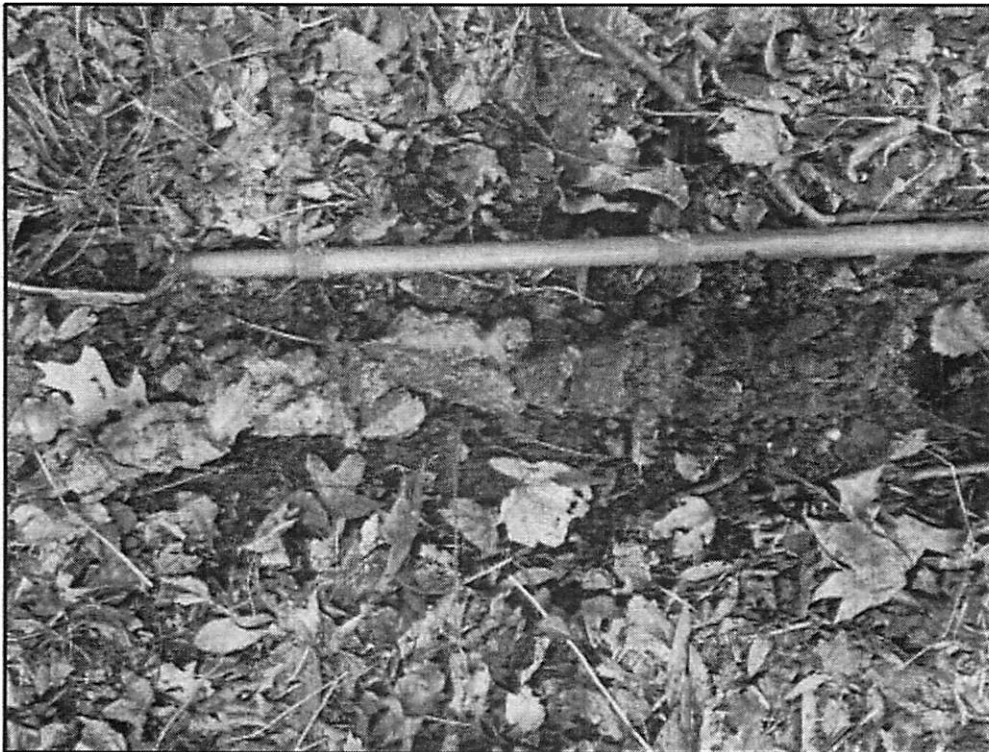
Photograph 4: View of hydric soil profile at Data Point 2.

Profile Description: (Describe to the depth needed to document the indicator or confirm the absence of indicators.)								
Depth (inches)	Matrix		Redox Features				Texture	Remarks
	Color (moist)	%	Color (moist)	%	Type ¹	Loc ²		
0 - 10	10YR 3/1	100					Sandy Loam	
10 - 14	10YR 4/1	100					Sandy Clay Loam	
14 - 24	7.5YR 5/1	95	7.5YR 5/6	5	C	M	Sandy Clay Loam	
-								
-								
-								
-

Restrictive Layer (if observed): Type: _____ Depth (inches): _____	Hydric Soil Present? Yes <input checked="" type="checkbox"/> No _____
---------------------------------------------------------------------------------	--------------------------------------------------------------------------

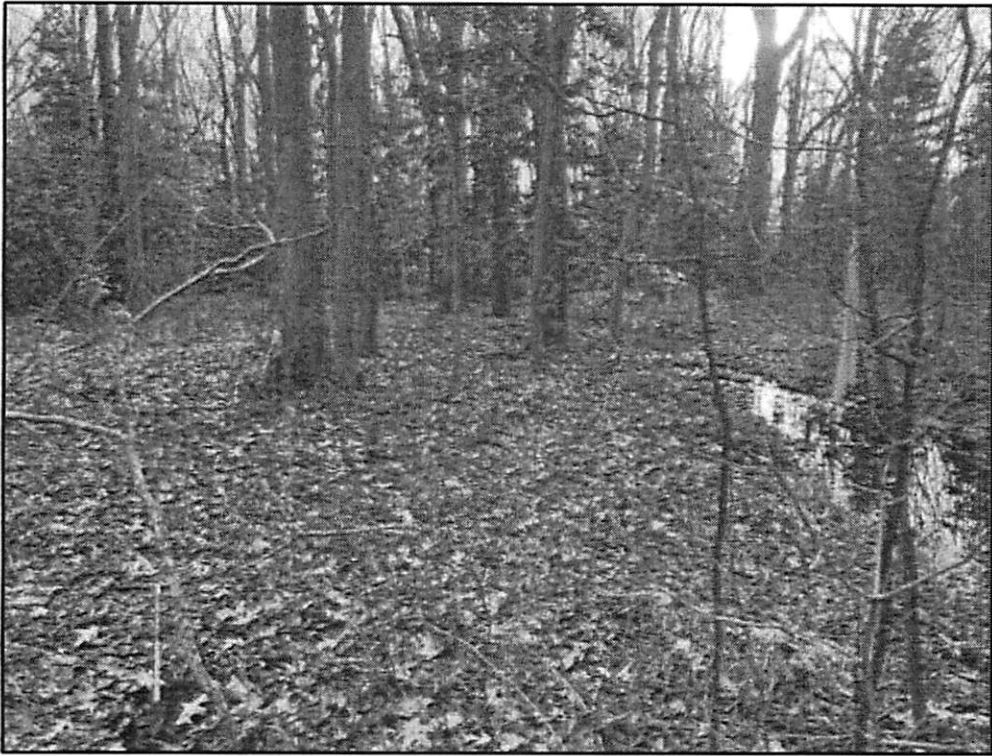
Photograph 5: View of surrounding wetland landscape facing north at Data Point 3.

Hydrophytic Vegetation Present? Yes <input checked="" type="checkbox"/> No _____ Hydric Soil Present? Yes <input checked="" type="checkbox"/> No _____ Wetland Hydrology Present? Yes <input checked="" type="checkbox"/> No _____	Is the Sampled Area within a Wetland? Yes <input checked="" type="checkbox"/> No _____
Remarks: Data point collected on eastern portion of site within hardwood forest. Wetter than normal conditions present.

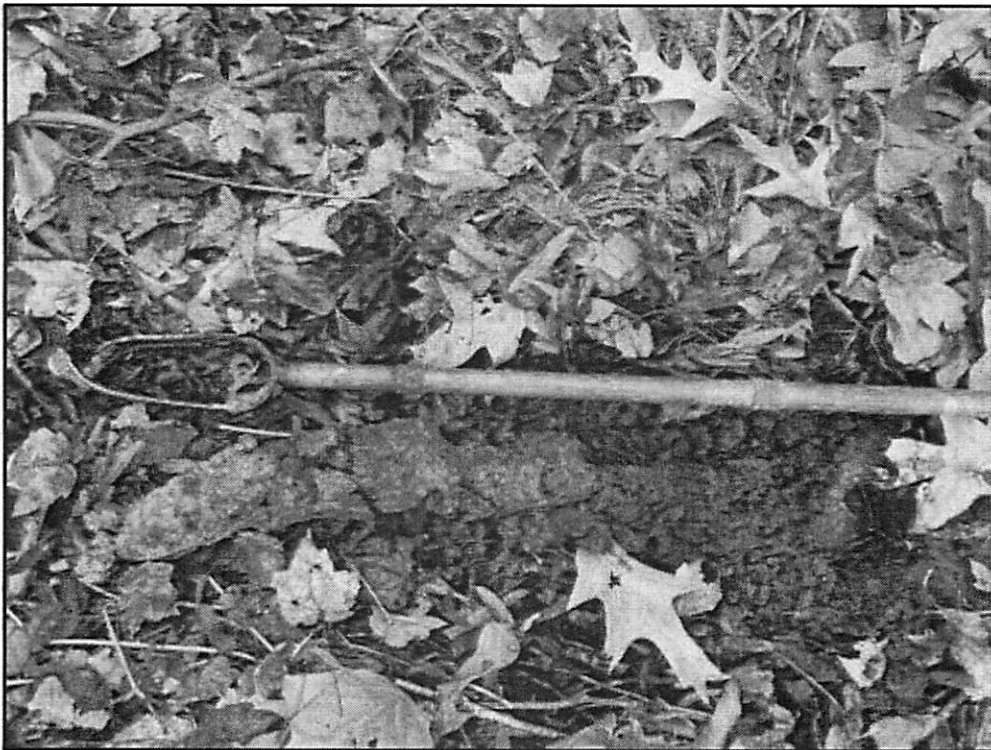
Photograph 6: View of hydric soil profile at Data Point 3.

Profile Description: (Describe to the depth needed to document the indicator or confirm the absence of indicators.)								
Depth (inches)	Matrix		Redox Features				Texture	Remarks
	Color (moist)	%	Color (moist)	%	Type ¹	Loc ²		
0 - 10	10YR 3/1	100					Sandy Loam	
10 - 20	10YR 4/1	100					Sandy Clay Loam	
20 - 24	10YR 5/2	98	7.5YR 5/6	2	C	M	Sandy Clay	
-								
-								
-								
-

Restrictive Layer (if observed): Type: _____ Depth (inches): _____	Hydric Soil Present? Yes <input checked="" type="checkbox"/> No _____
--------------------------------------------------------------------------	--------------------------------------------------------------------------

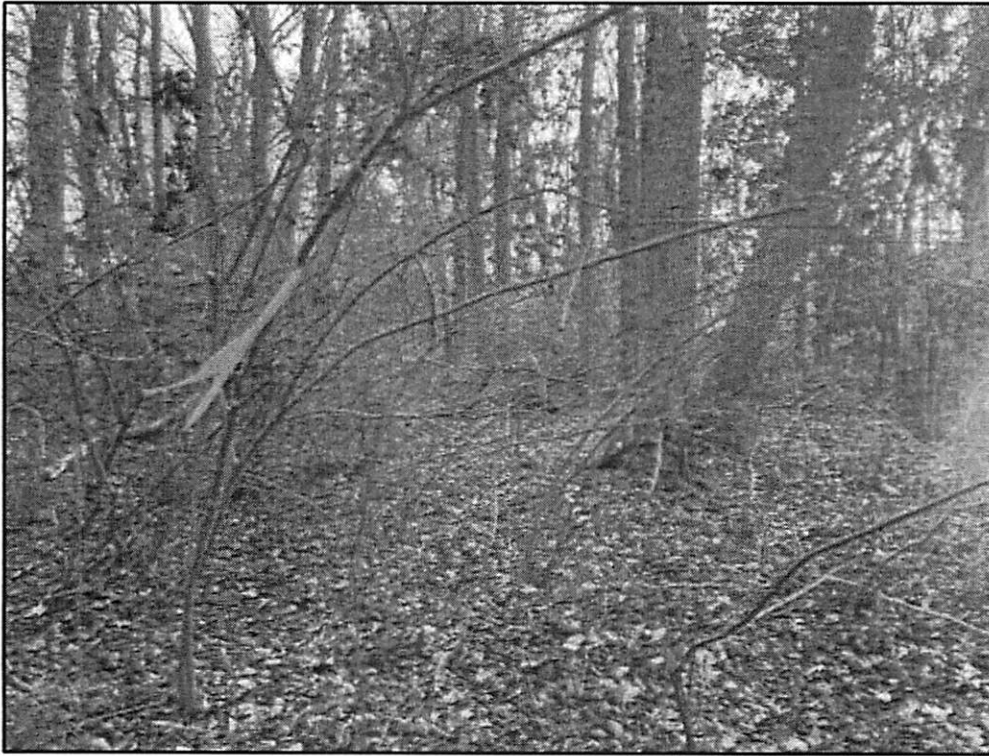
Photograph 7: View of uplands facing southwest at Data Point 4.

Hydrophytic Vegetation Present? Yes <input checked="" type="checkbox"/> No _____ Hydric Soil Present? Yes _____ No <input checked="" type="checkbox"/> Wetland Hydrology Present? Yes _____ No <input checked="" type="checkbox"/>	Is the Sampled Area within a Wetland? Yes _____ No <input checked="" type="checkbox"/>
Remarks: Data point collected in southern portion of site within hardwood forest. Wetter than normal conditions present.

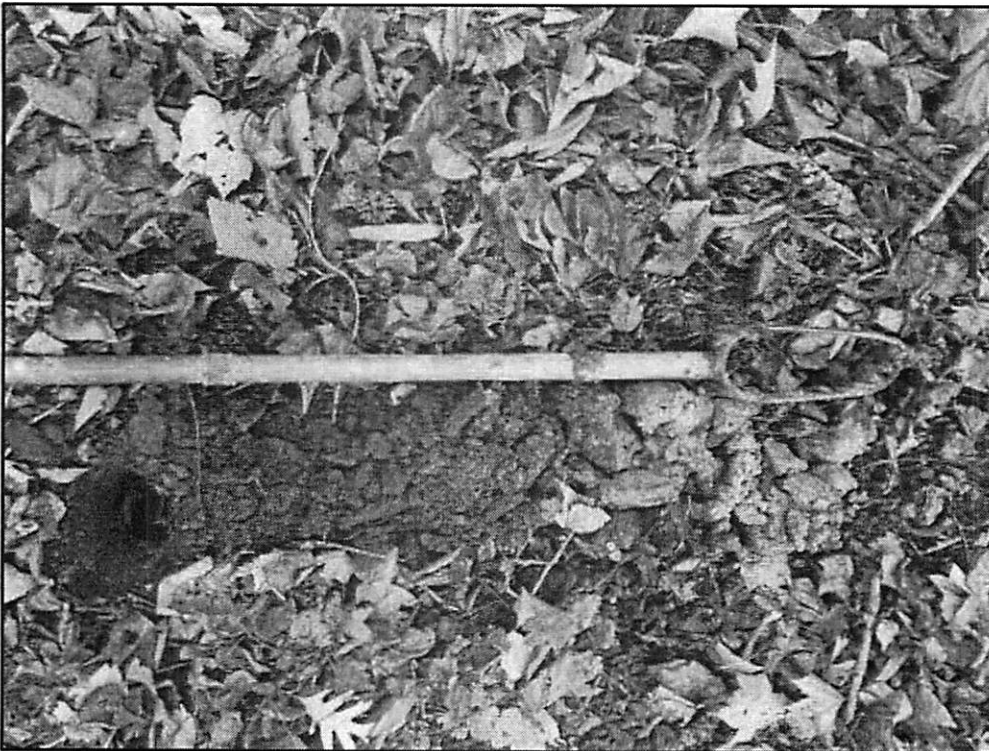
Photograph 8: View of non-hydric soil profile at Data Point 4.

Profile Description: (Describe to the depth needed to document the indicator or confirm the absence of indicators.)								
Depth (inches)	Matrix		Redox Features				Texture	Remarks
	Color (moist)	%	Color (moist)	%	Type ¹	Loc ²		
0 - 12	2.5Y 3/3	100					Sandy Loam	
12 - 24	10YR 5/2	98	7.5YR 5/6	2	C	M	Sandy Clay

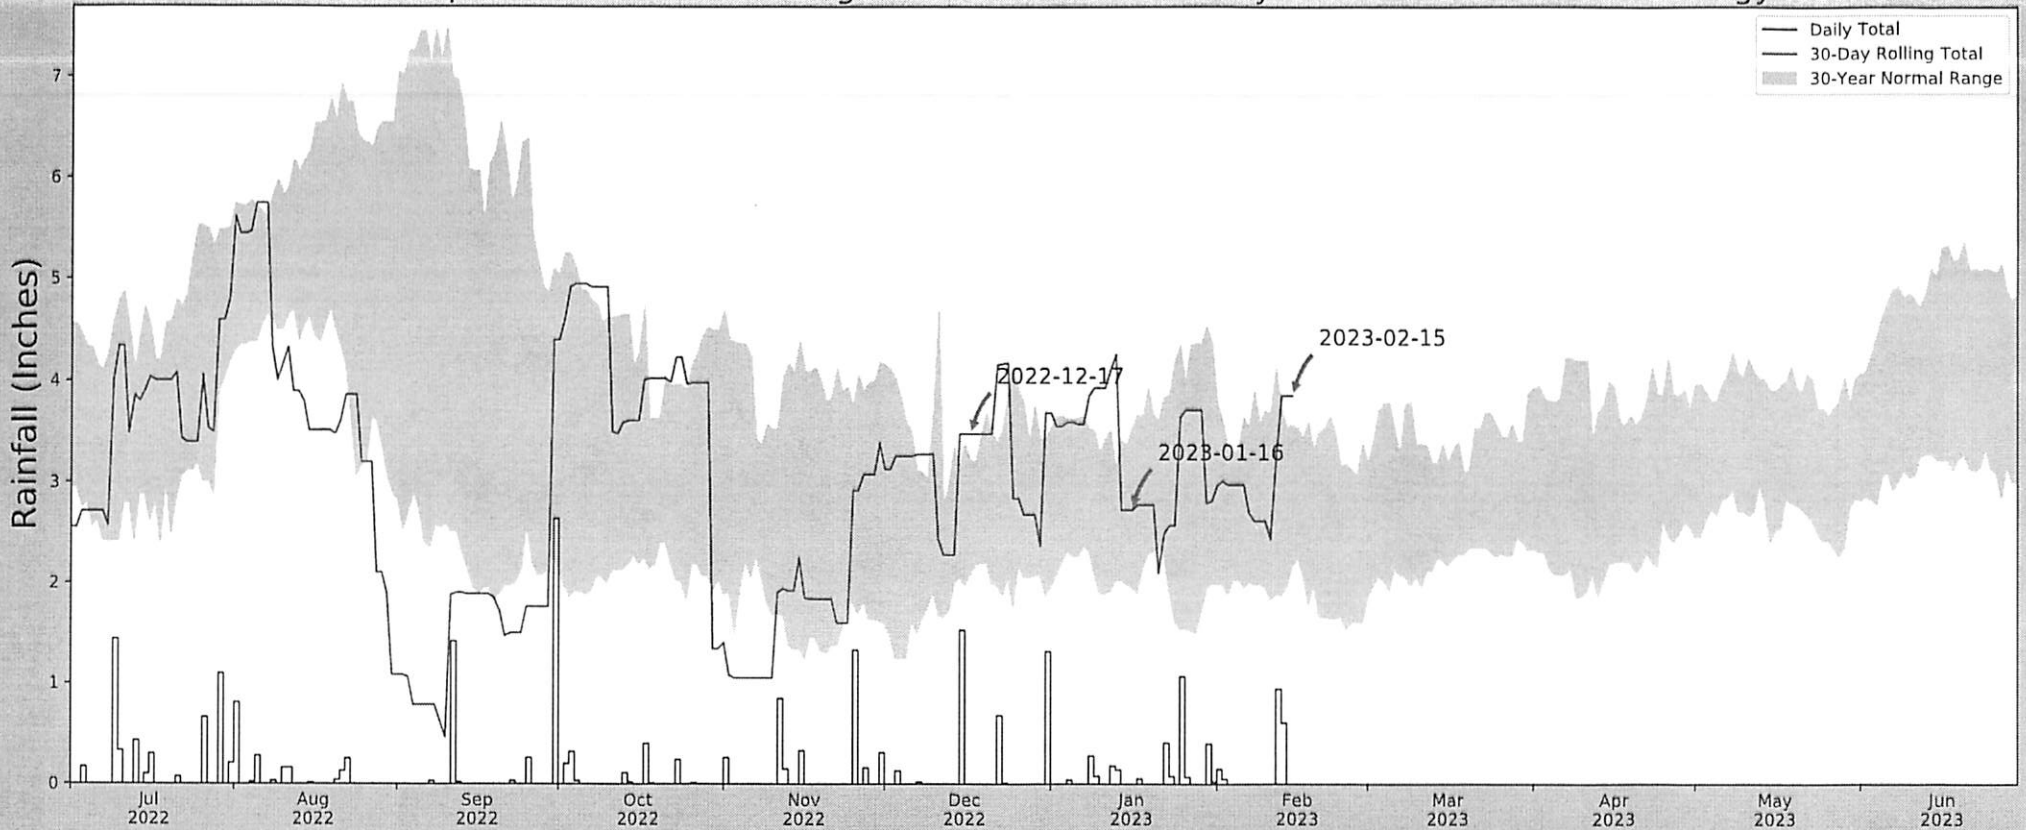
Antecedent Precipitation vs Normal Range based on NOAA's Daily Global Historical Climatology Network

Coordinates	37.006763, -76.391982
Observation Date	2023-02-15
Elevation (ft)	13.12
Drought Index (PDSI)	Mild drought (2023-01)
WebWIMP H ₂ O Balance	Wet Season

30 Days Ending	30 th %ile (in)	70 th %ile (in)	Observed (in)	Wetness Condition	Condition Value	Month Weight	Product
2023-02-15	2.175197	3.573228	3.862205	Wet	3	3	9
2023-01-16	1.96378	3.535827	2.732284	Normal	2	2	4
2022-12-17	2.095276	3.227559	3.484252	Wet	3	1	3
Result							Wetter than Normal - 16

Additionally, the USACE's Antecedent Precipitation Tool (APT) was analyzed to determine whether "Normal Conditions" were present at the time of field data collection. The APT was run on February 17, 2023, for February 15, 2023, the date which on-site delineation was performed. For February 15, 2023, the APT identified "Wetter than Normal" conditions for the site with "Mild Drought" noted by the Drought Index.
