## **OAKSTEAD AUTO**

**Geotechnical Services**

**Report Number. 242571A**

Re: Final Geotechnical Investigation – Oakstead Auto  
¼ mile East of Oakstead Boulevard on State Road 54, Lutz, Florida  
(Parcel: 27-26-18-0000-00100-0040, Pasco County, Fla.)  
CFTL Report No. 242571A

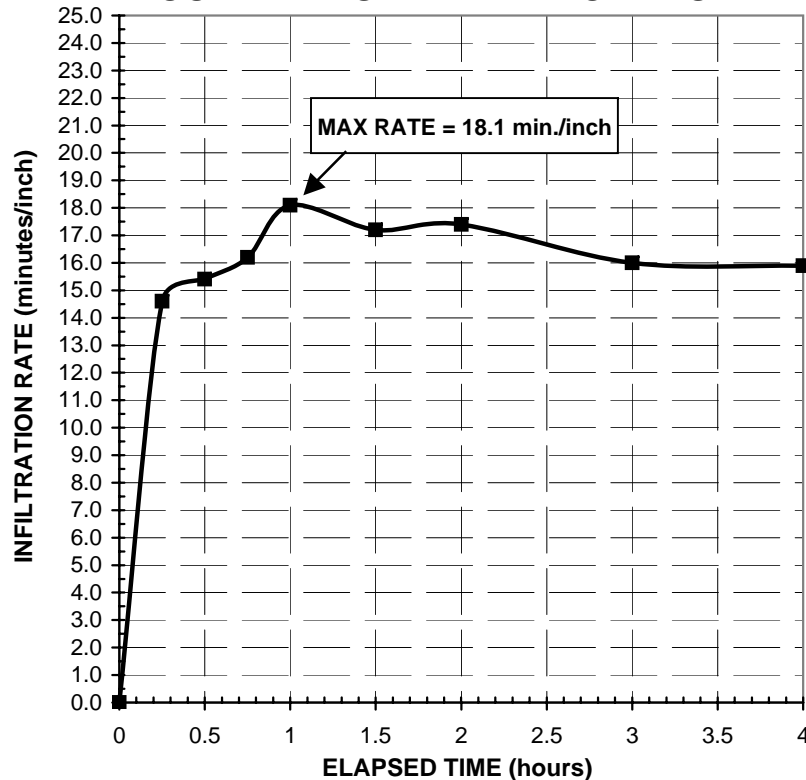
## DOUBLE RING INFILTRATION TEST

**Maximum Infiltration Rate (min./in.): 18.1**

The DRI was conducted in the center of the proposed Stormwater Retention Area located in the southeastern portion of the site. Soils encountered in the shallow auger boring performed adjacent to the DRI location are described as at least 6 feet of varying colors of relatively thin layers of sandy soils. The shallow static water table at this location was 2.3 feet below the surface. An estimate of the seasonal high water table (SHWT) level in the Retention Area was 1 foot below the surface. This was based on a thin layer of light colored sand sandwiched between two dark layers of sandy soils.

**The maximum infiltration rate at the DRI location was determined to be a moderate rate of 18.1 minutes per inch (3.3 inches/hr.) after 4 hours of testing. Due to the shallow water table being 2.3 feet below the surface, the test apparatus was seated at 1 foot below the surface.**
