WETLAND AND WATER RESOURCE DELINEATION REPORT

**Undeveloped 4.87-Acre (Approximate) Property
Northwest of SR 7 and Underridge Road
Conneaut, Ashtabula County, Ohio
(Parcel ID 12-316-00-026-00)**

October 7, 2022

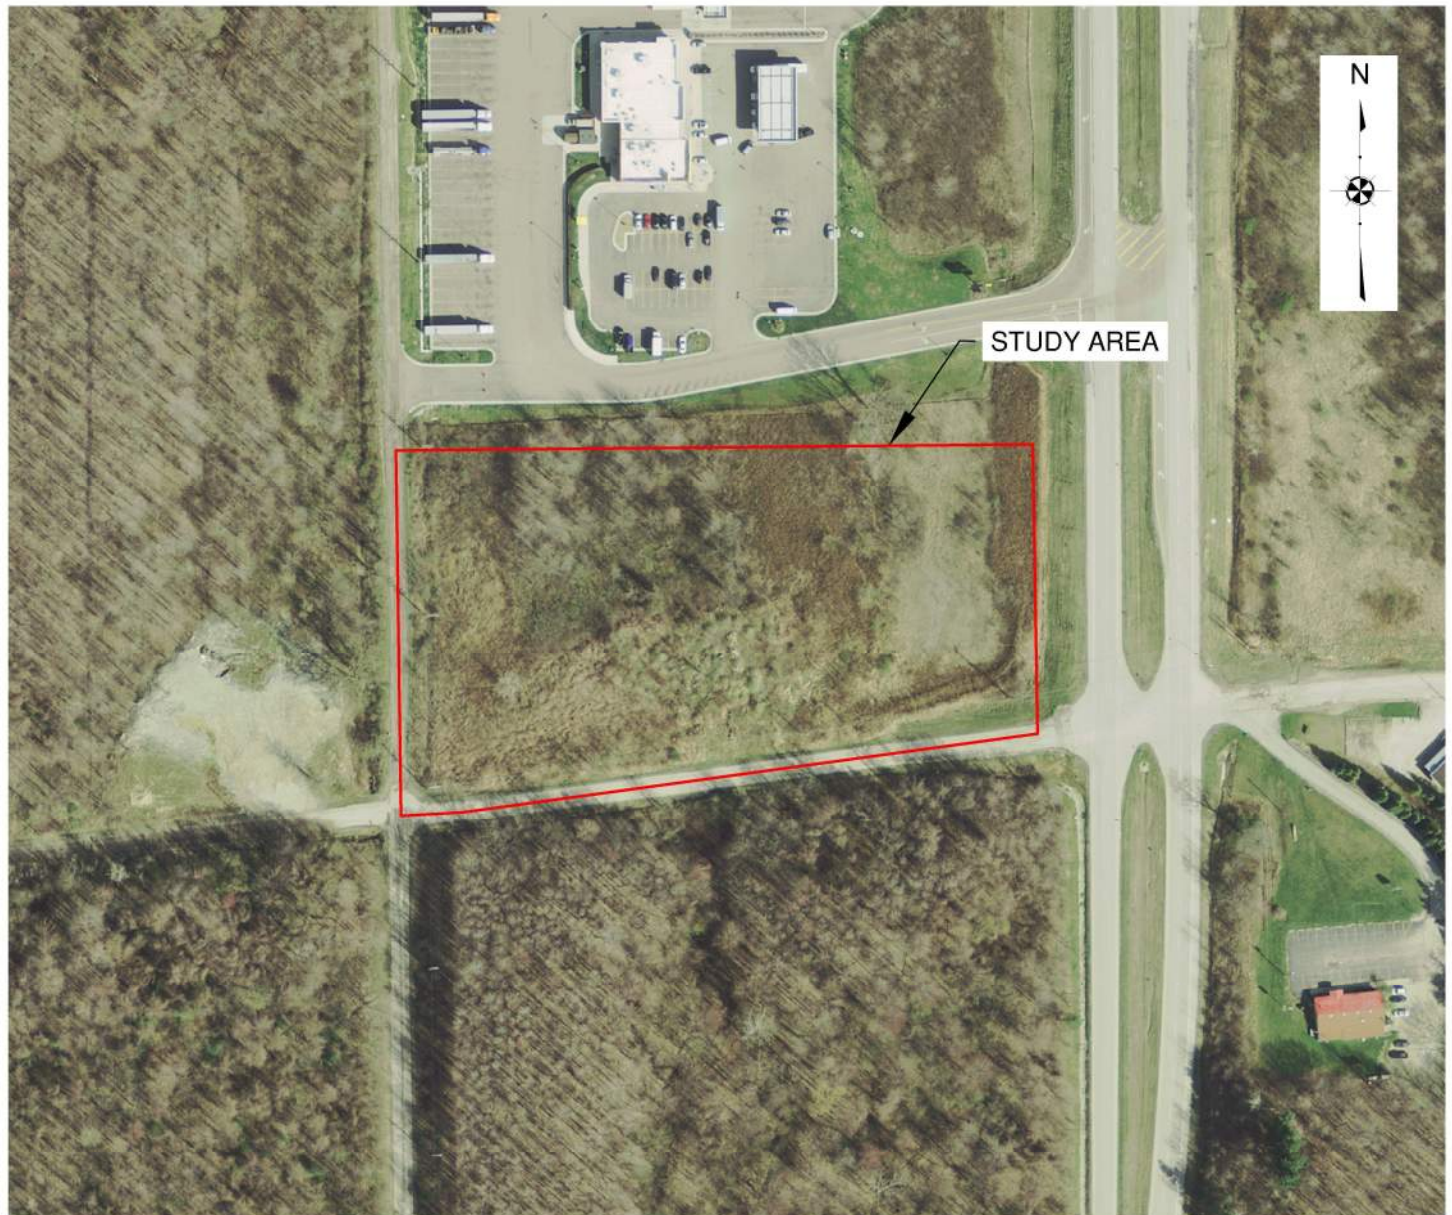
FIGURE 2
NATIONAL WETLANDS INVENTORY MAP
HIGH POINT CHARITABLE SERVICES, INC.
NW OF SR 7 & UNDERRIDGE RD., CONNEAUT, ASHTABULA COUNTY, OHIO

A review of the USFWS National Wetlands Inventory (NWI) map of Conneaut, Ohio indicates there are no wetlands or streams identified within the Project Area (**Appendix A, Figure 2**). Note that NWI maps were derived from aerial photo interpretation and are designed for general planning purposes only.

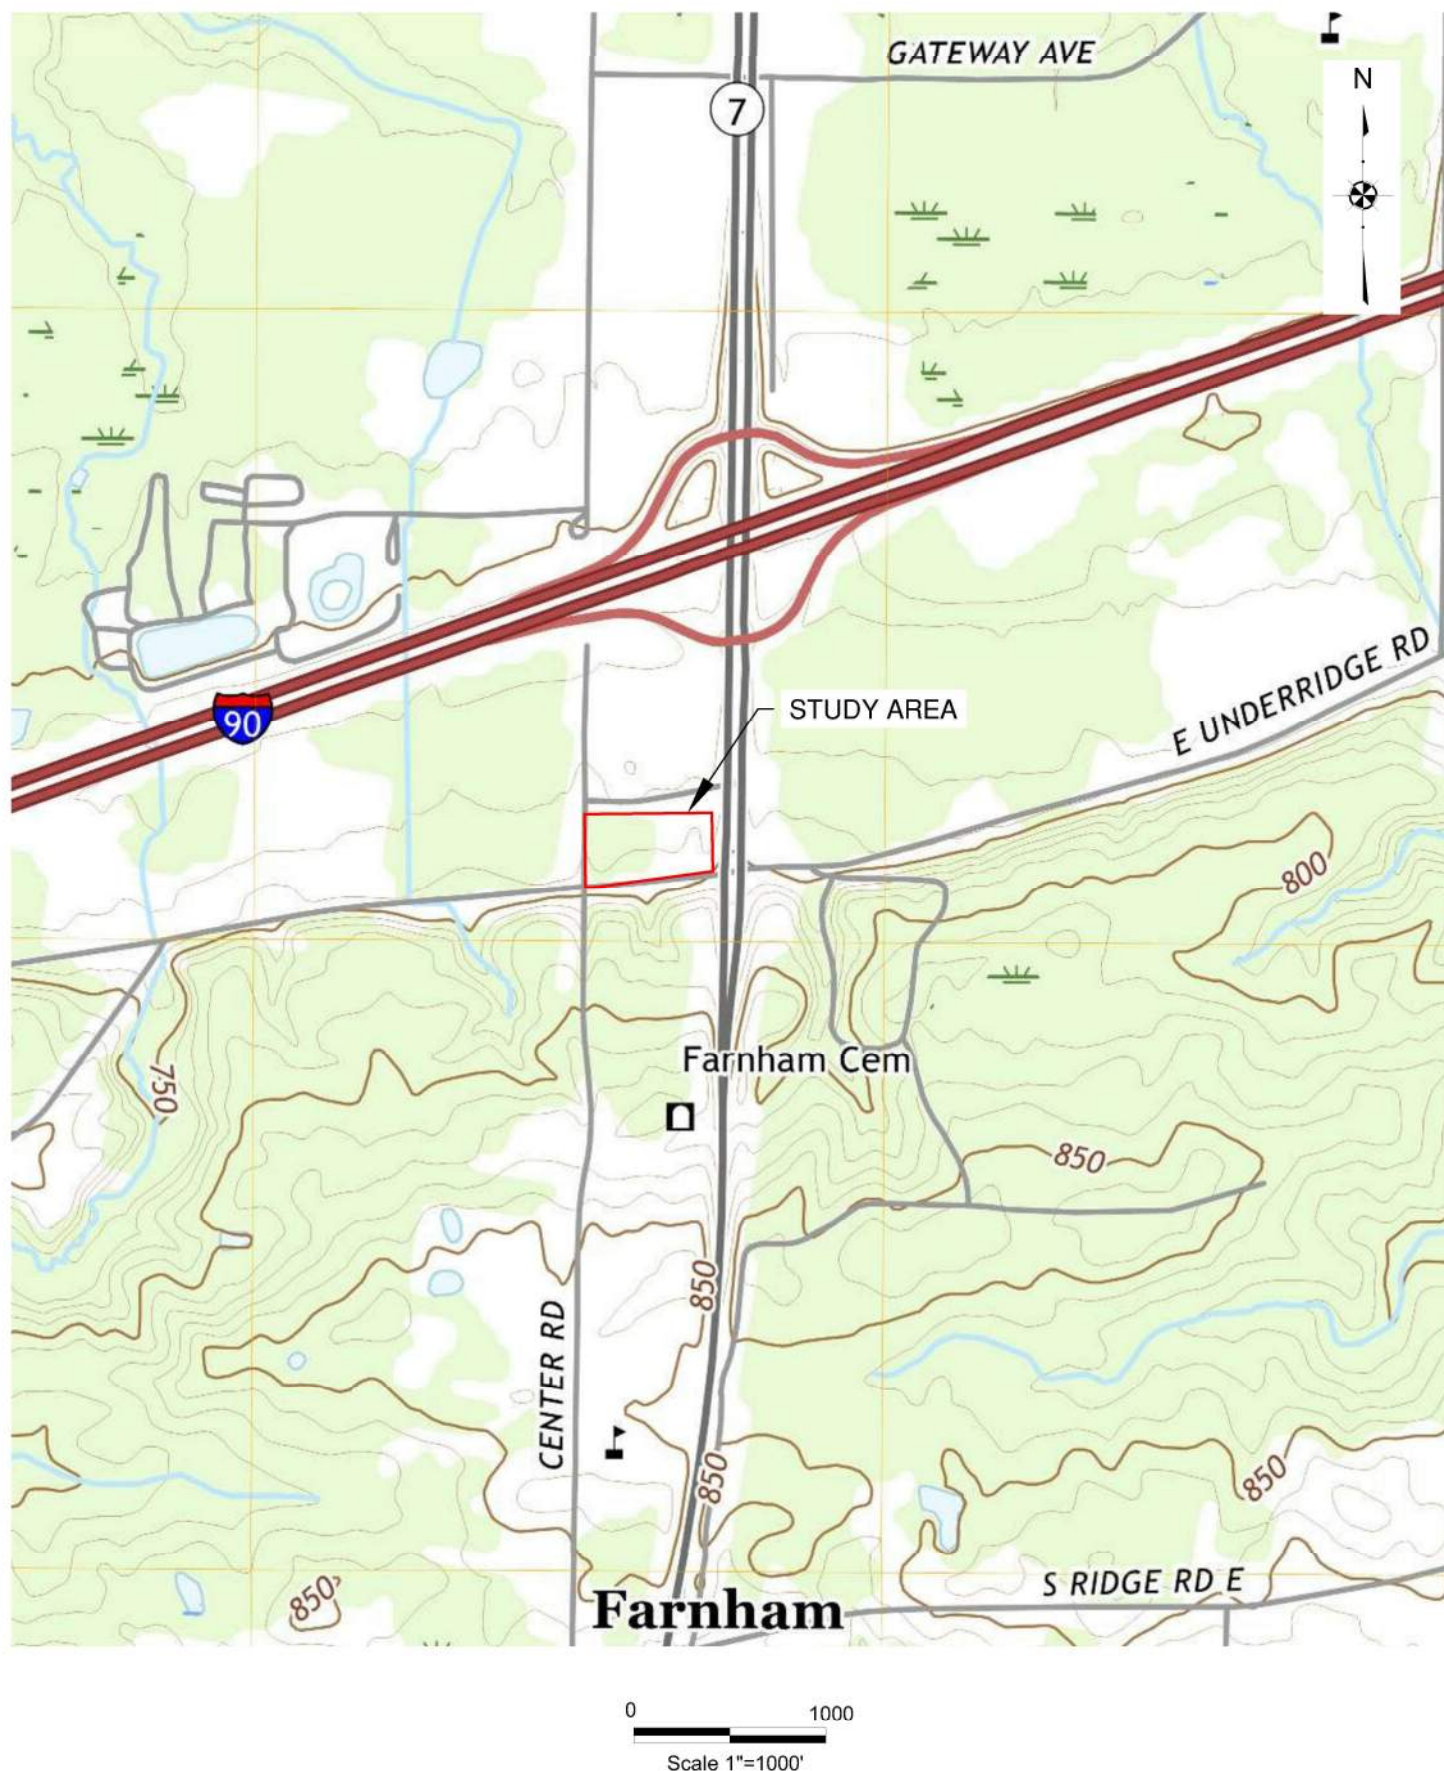
FIGURE 3
USGS TOPOGRAPHIC MAP
HIGH POINT CHARITABLE SERVICES, INC.
NW OF SR 7 & UNDERRIDGE RD., CONNEAUT, ASHTABULA COUNTY, OHIO

The Project Area is comprised of a relatively flat topography that gently slopes from the southern portion to the northern portion. Review of the Conneaut, Ohio USGS 7.5-minute Topographic Quadrangle map and USGS Lidar Point Cloud data (2019) indicates that the existing topography on the site ranges between 732 to 752 feet in elevation above the National Geodetic Vertical Datum (NGVD). The portion of the USGS Topographic map showing the Project Area is included in **Appendix A** as **Figure 3**.

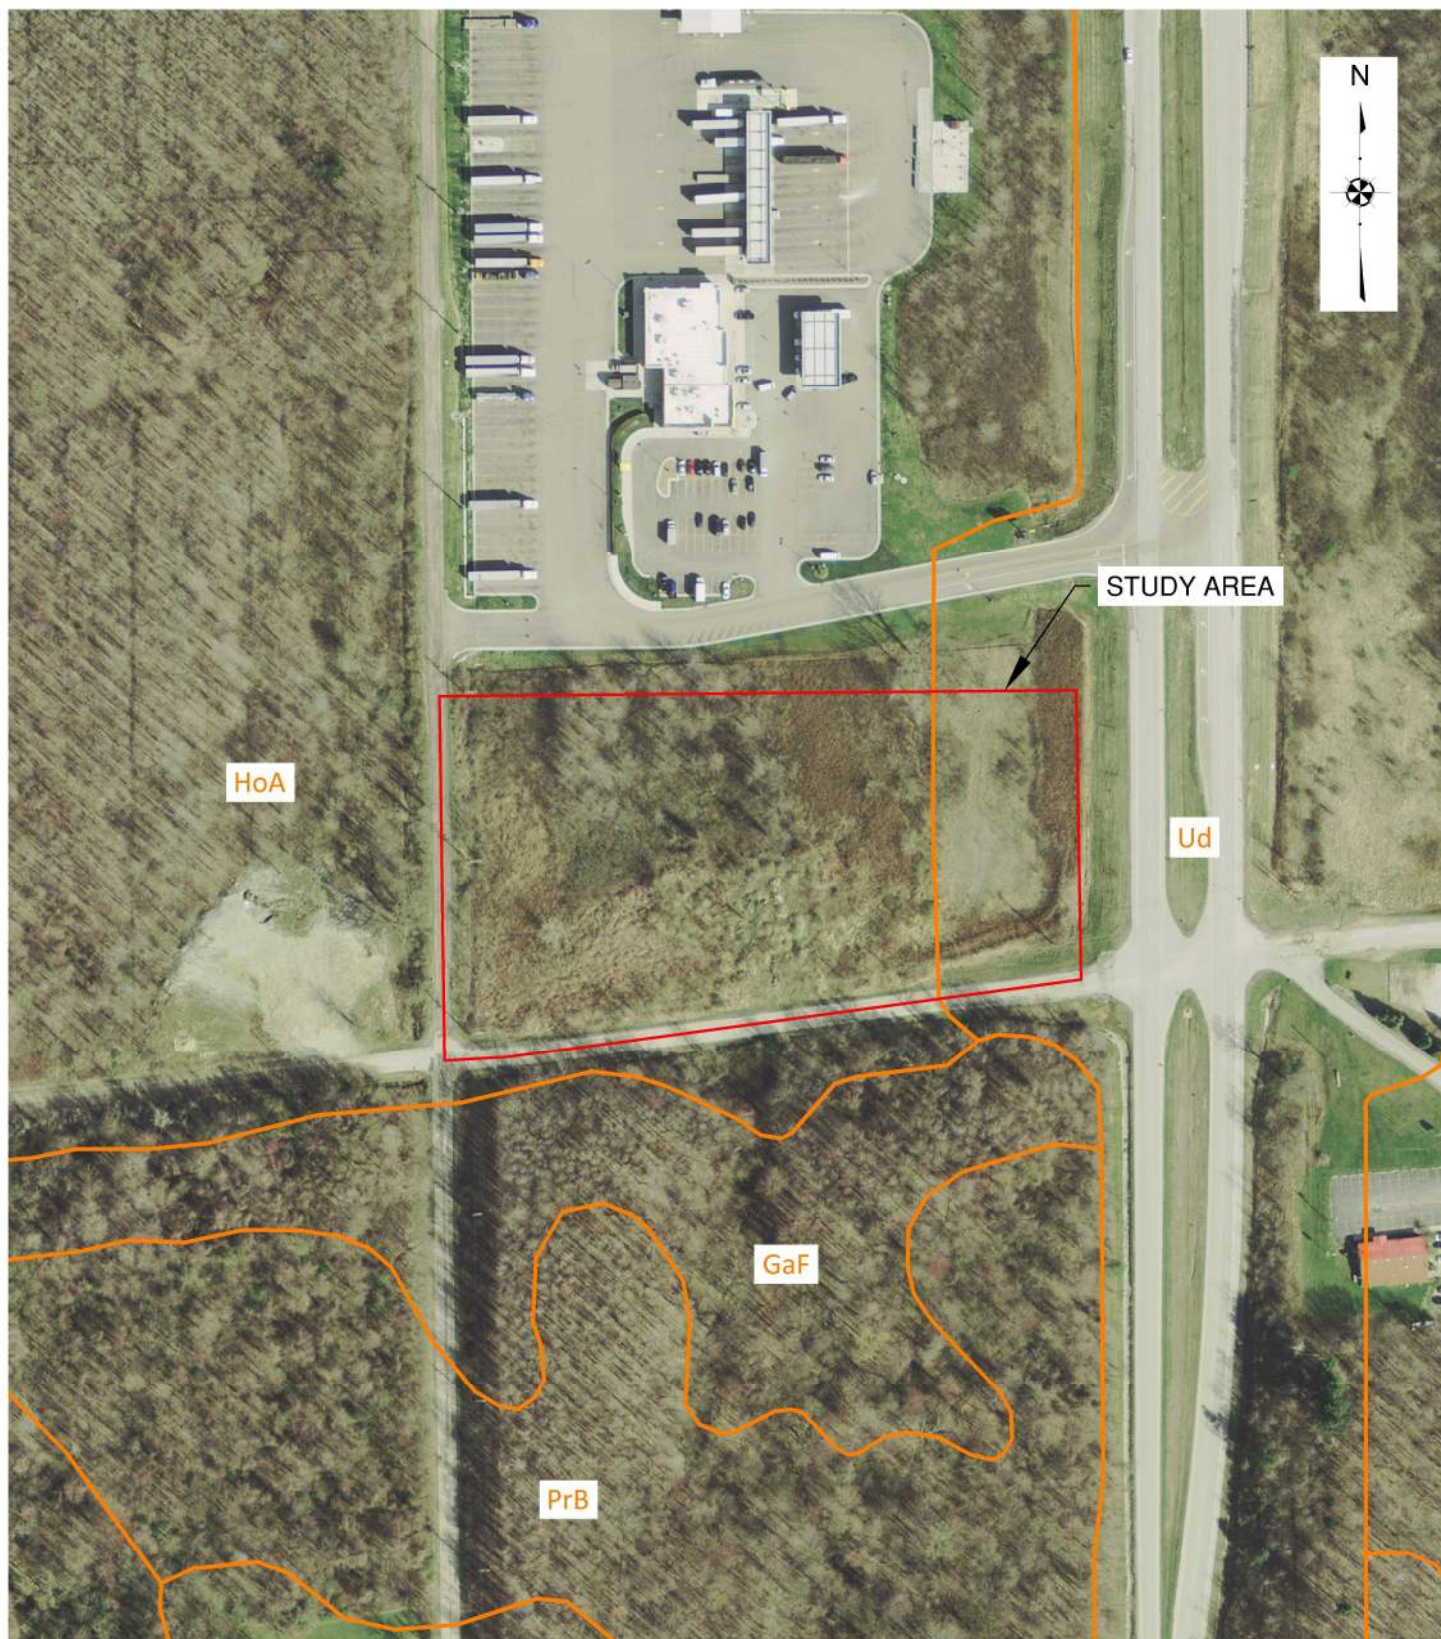
FIGURE 4
NRCS SOIL SURVEY MAP
HIGH POINT CHARITABLE SERVICES, INC.
NW OF SR 7 & UNDERRIDGE RD., CONNEAUT, ASHTABULA COUNTY, OHIO

The Soil Survey of Ashtabula County, Ohio (<http://websoilsurvey.nrcs.usda.gov/app/WebSoilSurvey.aspx>) and Ashtabula County GIS indicate two (2) soils mapped within the Project Area: Hornell silt loam, 0 to 2% slopes (HoA) and Udorthents (Ud). The Ashtabula County GIS Map showing the soils is provided as **Appendix A, Figure 4**. HoA is considered a somewhat poorly drained soil, and Ud does not have a drainage class. Ashtabula County Natural Resource Conservation Service (NRCS) designates HoA as non-hydric with hydric inclusions, and Ud is not designated. No water resources are indicated on the NRCS mapping.

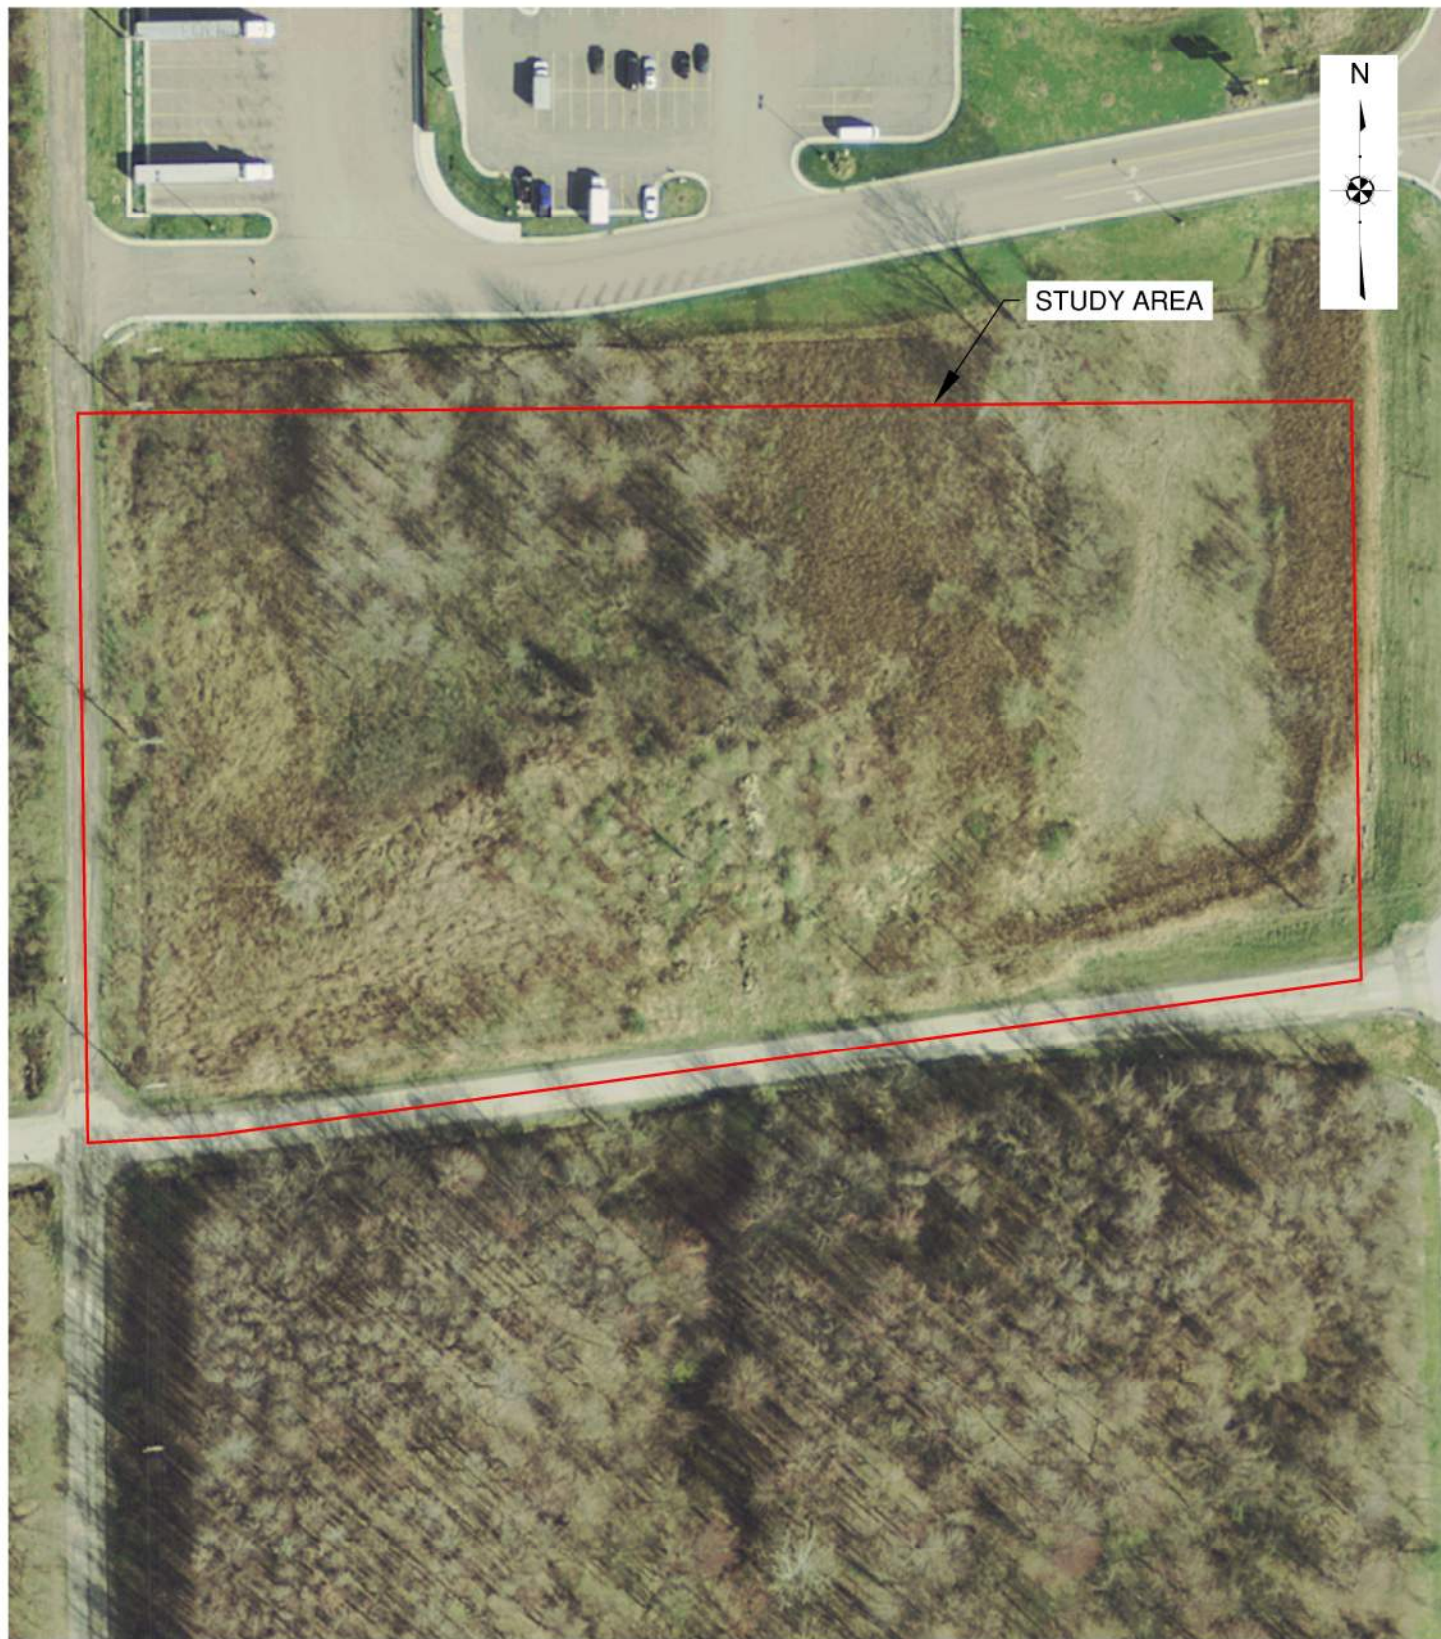
FIGURE 5
AERIAL PHOTOGRAPH MAP (2012 - OSIP II)
HIGH POINT CHARITABLE SERVICES, INC.
NW OF SR 7 & UNDERRIDGE RD., CONNEAUT, ASHTABULA COUNTY, OHIO

A review of aerial imagery from the Ohio Department of Administration (2012) and the Ashtabula County GIS (2020) shows that the Project Area has remained largely undeveloped since at least 1993. Aerial imagery prior to 1993 shows the Project Area was previously used for agriculture. A roadside ditch was created in the eastern and southeastern portion of the Project Area around 1993 and appears to have since become vegetated and have ponded water, indicating a potential wetland. The eastern portion appears to have been graded around 2004. There are no other wetlands or other water features visible from review of the aerial imagery within the Project Area. Aerial imagery from OSIP II is provided in **Appendix A** as **Figure 5**.

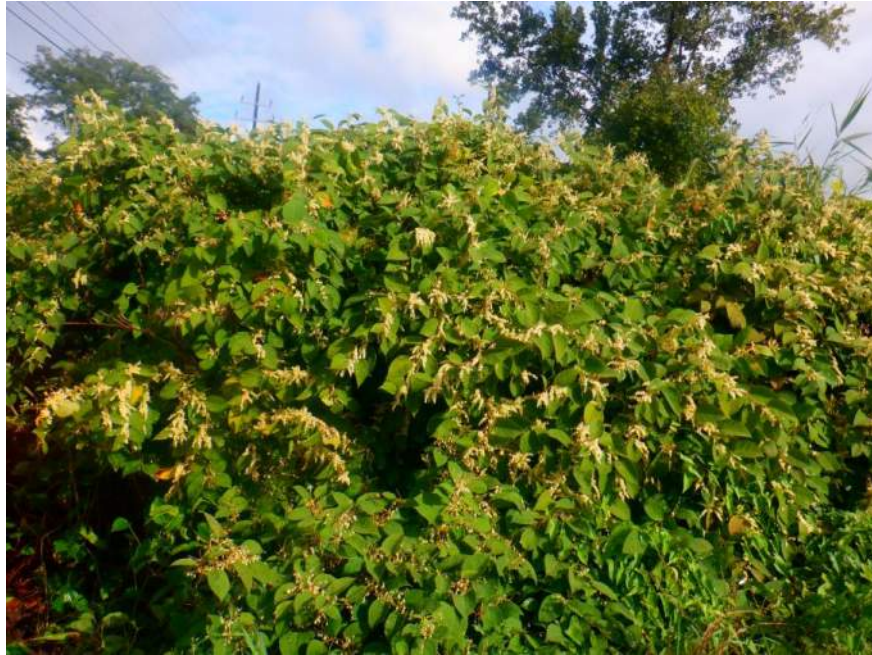
Photograph 1

View facing north showing the herbaceous habitat at non-wetland data point DP1, located in the southwestern portion of the Project Area.

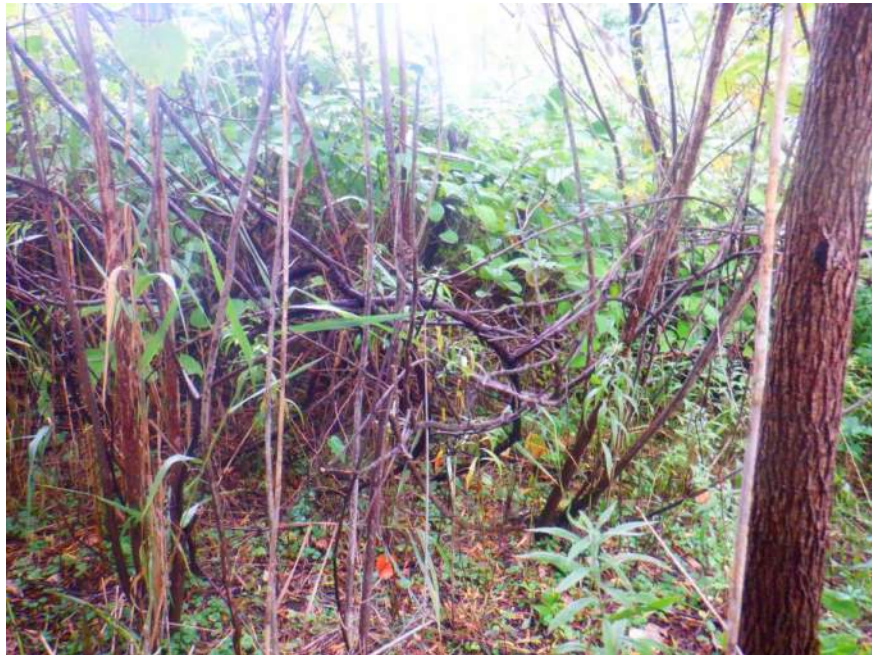
Photograph 2

View facing north showing the herbaceous habitat at non-wetland data point DP2, located in the southern portion of the Project Area.

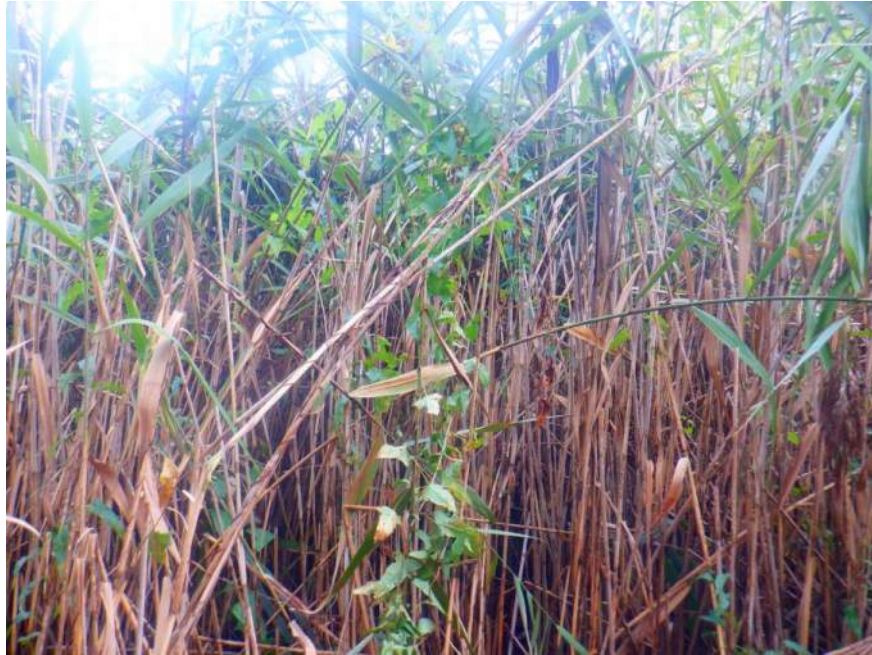
Photograph 3

Wetland A was designated as Palustrine Emergent which is consistent with the Cowardin (1979) classification of PEM. Wetland A totals 1.98 acres in size on-site and is located at DP3 in the western and northwestern portions of the Project Area. The tree stratum and shrub stratum consist of no plants. The dominant herbaceous stratum consists of *Phragmites australis* (common reed). Positive primary hydrology indicators of high water table (A2) and saturation (A3) were present. The hydric soil indicator was met as a depleted matrix (F3).

View facing north showing the emergent habitat of Wetland A at data point DP3, located in the central portion of the Project Area.

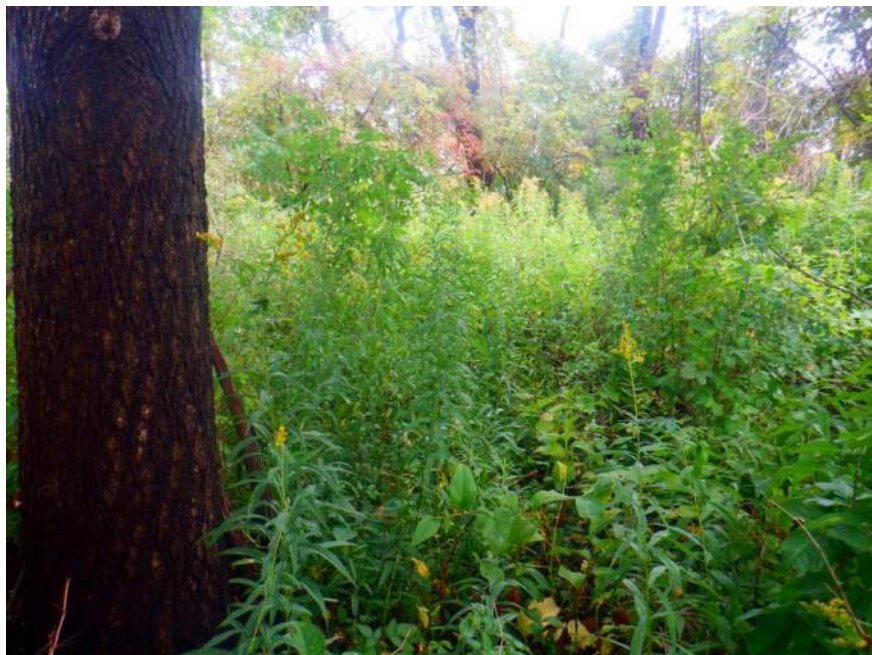
Photograph 4

View facing east showing the herbaceous habitat at non-wetland data point DP4, located in the northeastern portion of the Project Area.

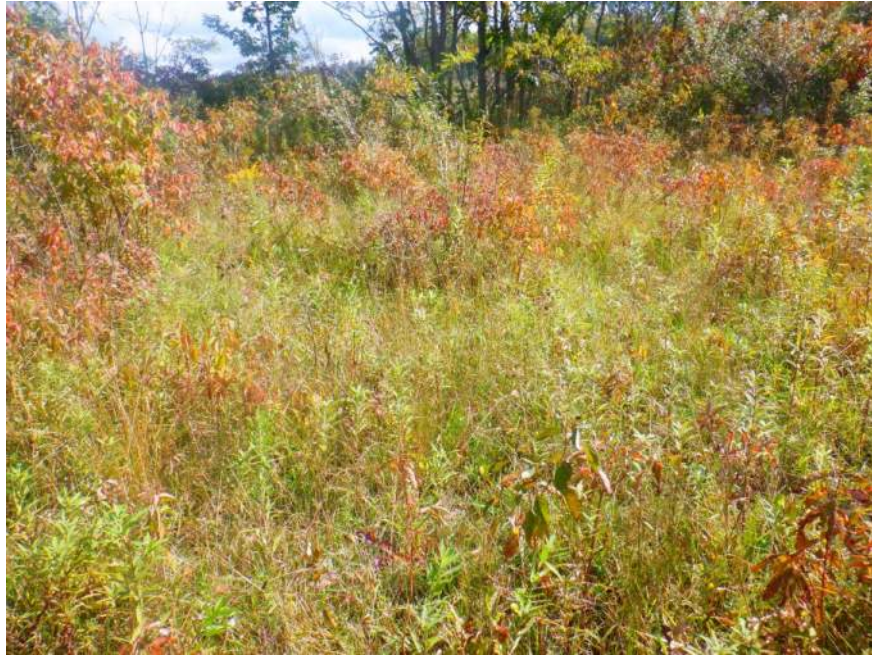
Photograph 5

View facing north showing the herbaceous habitat at non-wetland data point DP5, located in the northeastern portion of the Project Area.

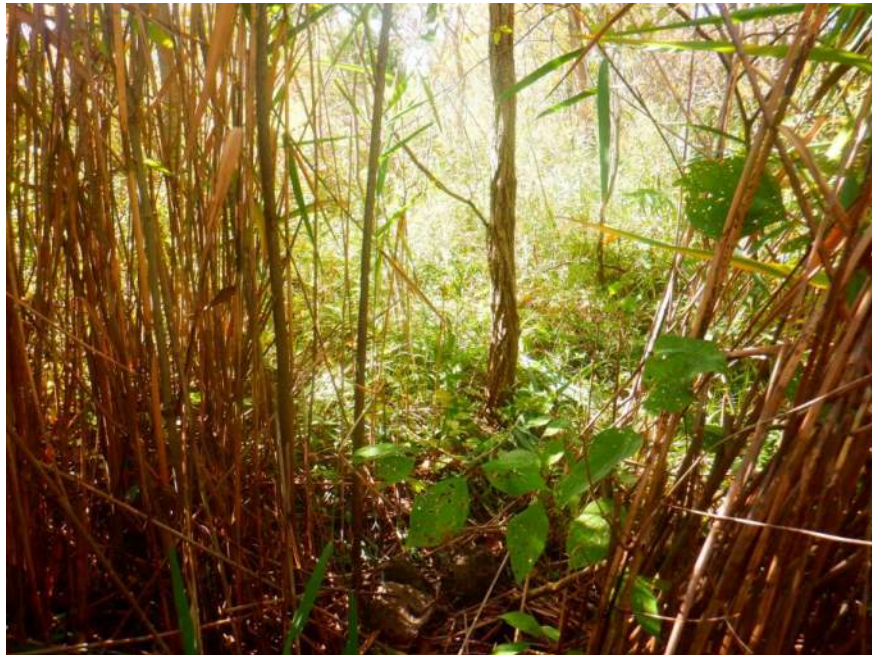
Photograph 6

Wetland B was designated as Palustrine Emergent which is consistent with the Cowardin (1979) classification of PEM. Wetland B totals 0.53 acres in size on-site and is located at DP6 in the eastern and southeastern portions of the Project Area. The tree stratum consists of no plants. The shrub stratum consists of *Viburnum dentatum* (southern arrowwood) and *Cornus amomum* (silky dogwood). The dominant herbaceous stratum consists of *Phragmites australis* (common reed). Positive primary hydrology indicators of surface water (A1), high water table (A2), saturation (A3), hydrogen sulfide odor (C1), and oxidized rhizospheres along living roots (C3) were all present. The hydric soil indicator was met as a loamy gleyed matrix (F2) and depleted matrix (F3).

View facing west showing the emergent habitat of Wetland B at data point DP6, located in the eastern portion of the Project Area.
