# BRICK AND MORTAR HOME SERVICES

## RESIDENTIAL INSPECTION

939 Sycamore St  
Elmira, NY 14904

Vineyard Capital Partners  
10/28/2025

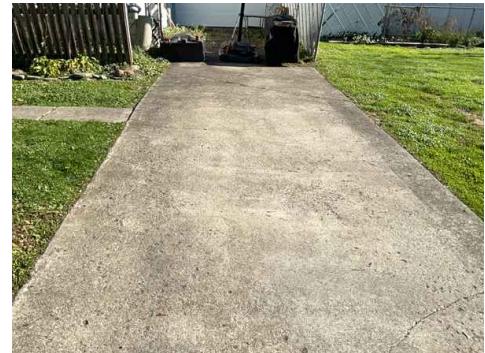
#### **MINOR CRACKING AT DRIVEWAY**

I observed indications of minor cracking at the driveway.

Correction and further evaluation is recommended.

Contact a qualified concrete contractor.

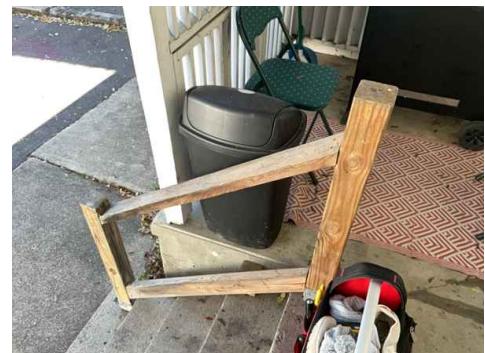
#### **LOOSE RAILING COMPONENT**

I observed a loose railing component. This condition is a safety hazard.

Correction and further evaluation is recommended.

Contact a qualified handyman.

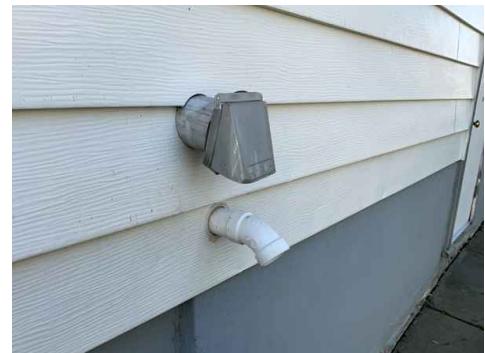
### 2.8.1 Wall-Covering, Flashing & Trim

#### **PIPE PENETRATIONS MISSING SEALANT**

Pipes that penetrate through the structure are missing sealant. Recommend correcting to prevent moisture intrusion.

Contact a qualified professional.

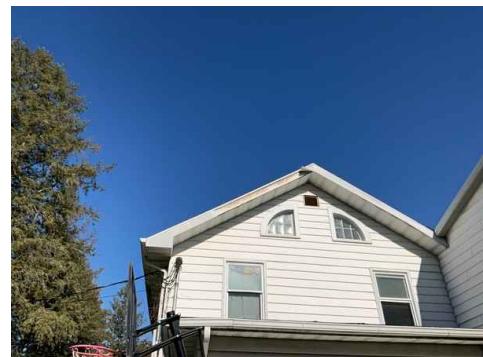
## 2.9.1 Eaves, Soffits &amp; Fascia

**DAMAGE OBSERVED AT FASCIA**

I observed indications that one or more areas of the fascia were damaged.

Correction and further evaluation is recommended.

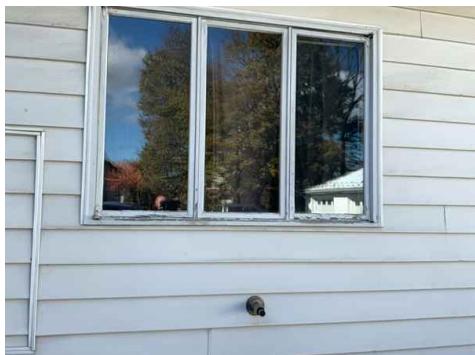
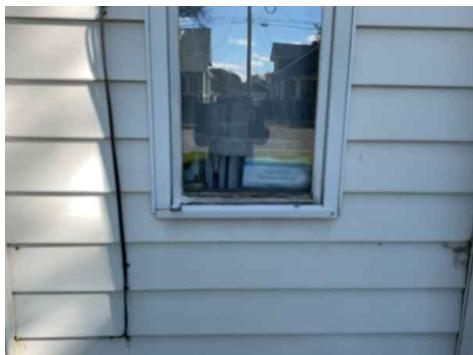
## 2.11.1 Windows

**MINOR DAMAGE TO WINDOWS**

Minor damage such as peeling paint and/or age related deterioration is present. Recommend monitoring and or repair by a qualified contractor.

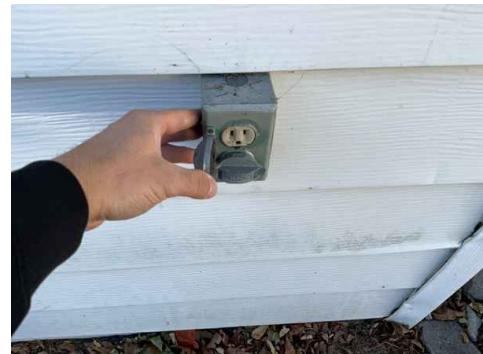
## 2.15.1 GFCIs &amp; Electrical

**MISSING GFCI**

I observed indications that a GFCI is missing in an area that is required to keep people safe. Recommend replacement by a qualified professional.

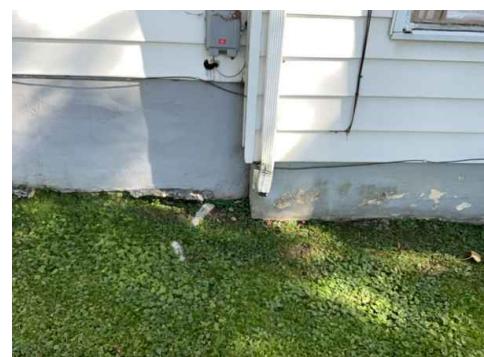
One or more downspouts drain too close to the home's foundation. This can result in excessive moisture in the soil at the foundation, which can lead to foundation/structural movement. Recommend a qualified contractor adjust downspout extensions to drain at least 6 feet from the foundation. A handy homeowner should be able to do this project.

Recommended DIY Project

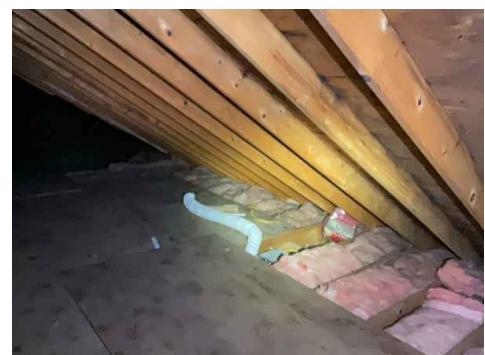
I observed that the bathroom ventilation fan exhausted into the attic space. This can cause moisture and mold issues. All mechanical exhaust fans must terminate outside.

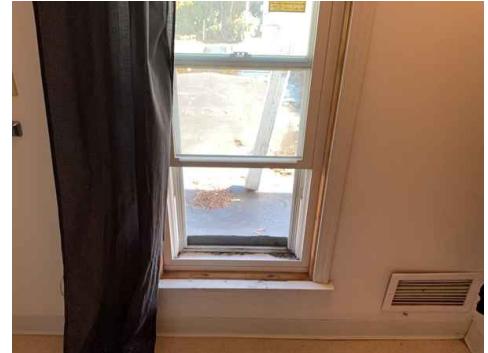
A usable interior window led to an exposed rooftop area void of guardrails. This condition should be corrected in particular if children present.

Contact a qualified professional.

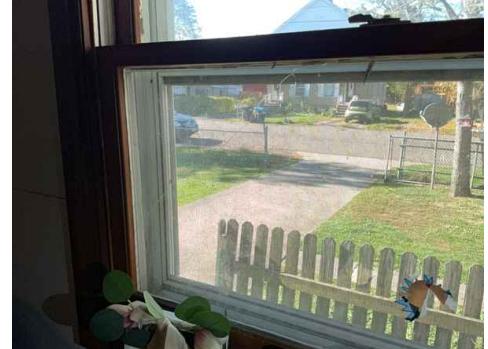
## 7.2.1 Windows

**CRACKED GLASS**

I observed cracked windowpane glass. Hazardous. Recommend repair by a qualified professional.

Contact a qualified window repair/installation contractor.

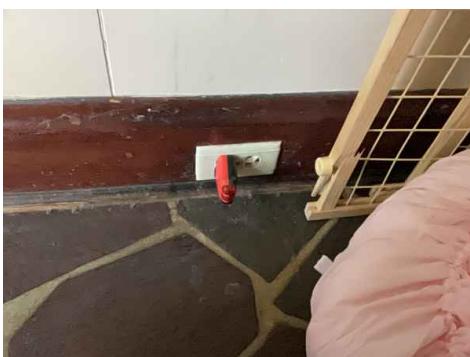
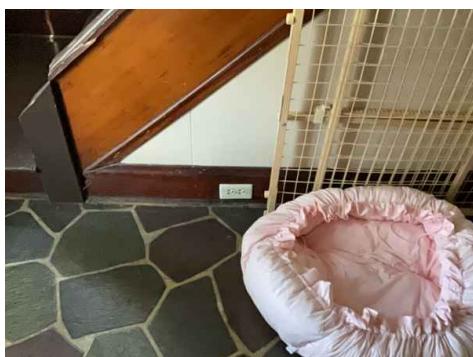
## 7.3.1 Switches, Fixtures &amp; Receptacles

**POWER NOT PRESENT AT RECEPTACLE**

I observed indications that power was not present at a receptacle.

Contact a qualified professional.

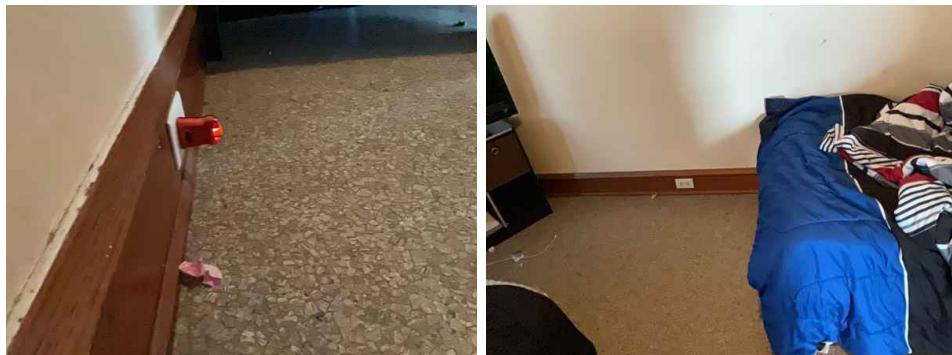
## 7.3.2 Switches, Fixtures &amp; Receptacles

I observed indications of one or more wall receptacles that have been wired with reversed polarity. This could create an electrical shock hazard. Recommend repair by a qualified professional.

Contact a qualified electrical contractor.

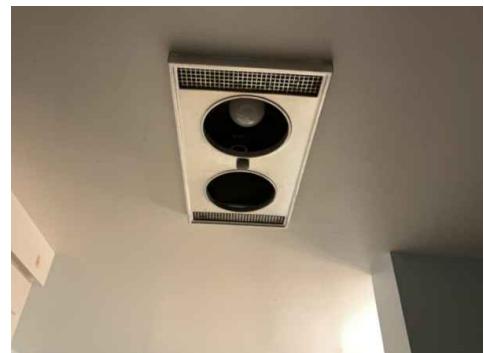
## 7.3.3 Switches, Fixtures &amp; Receptacles

I observed one or more lights that were not turning on. A new light bulb was possibly needed. We recommend asking the homeowner about why this light fixture did not turn on.

Contact a qualified electrical contractor.

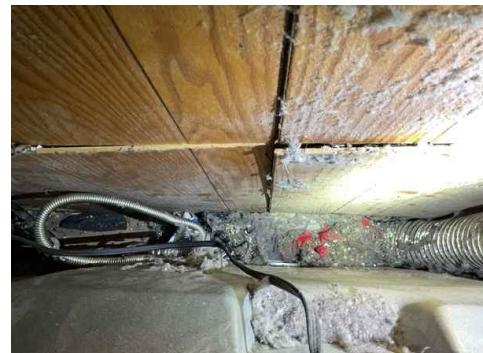
### 10.2.1 Clothes Dryer

#### **DRYER NOT EXHAUSTING OUTSIDE**

Contact a qualified appliance repair professional.

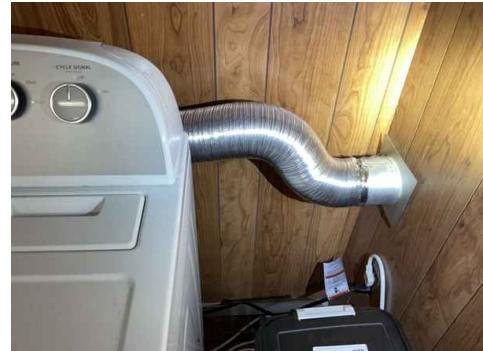
### 10.2.2 Clothes Dryer

#### **DRYER VENT NOT UL RATED**

Contact a qualified professional.

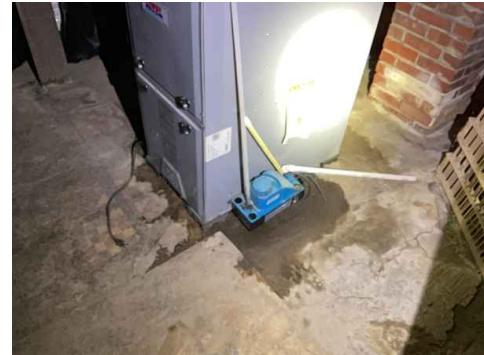
## 12.1.3 Heating System Information

**CONDENSATE PUMP MALFUNCTION**

Repair/Replace

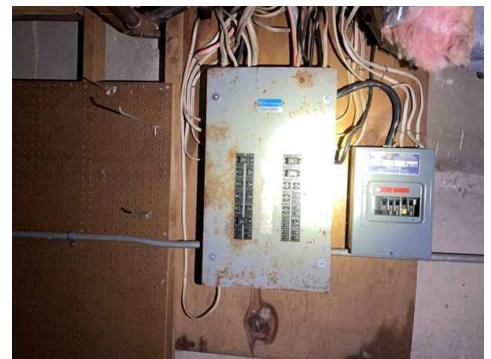
13.8.2 Panelboards & Breakers

### WADSWORTH PANEL

Contact a qualified electrical contractor.

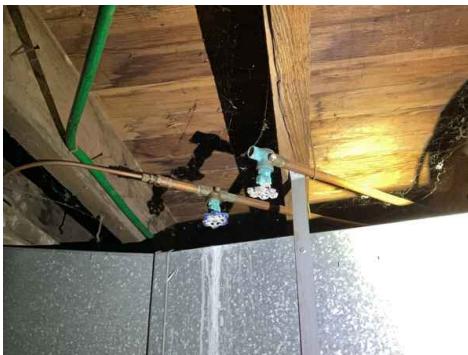
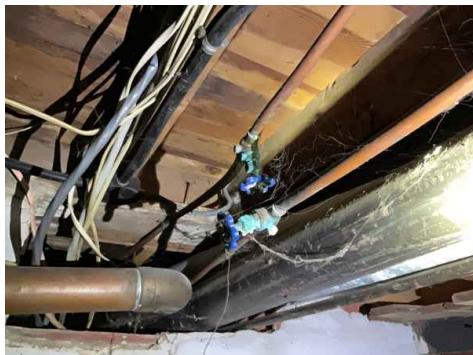
## 14.7.1 Water Supply &amp; Distribution Systems

**CORROSION AT WATER SHUT-OFF VALVE**

Maintenance/Monitor

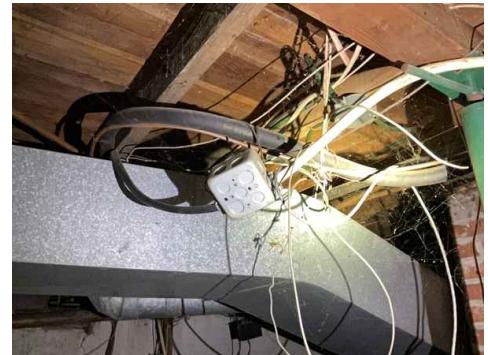
## 15.10.1 Electrical In Basement

**POOR SUPPORT WIRING/OUTLET**

Contact a qualified professional.

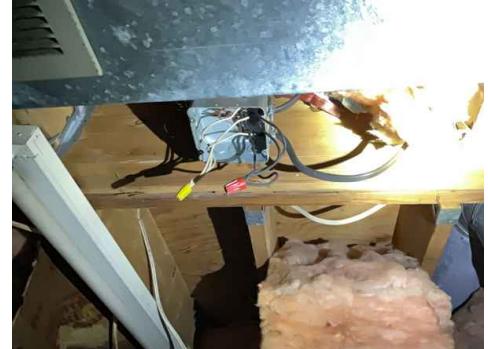
## 15.10.2 Electrical In Basement

**MISSING COVER PLATES**

Contact a qualified professional.
