Inspection Report

Property Address:
9304 - 9306 Fox Creek Dr
Stockton CA 95210

Choice Home Inspections

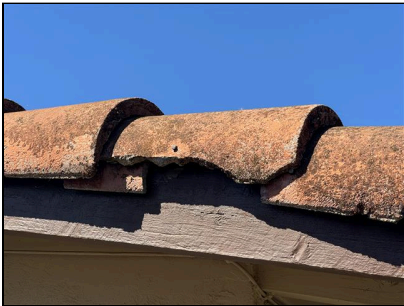
1.0 Item 1(Picture)

1.0 The roof covering and shingles are chipped and worn. These areas will need periodical maintenance. A qualified contractor should inspect and repair as needed.

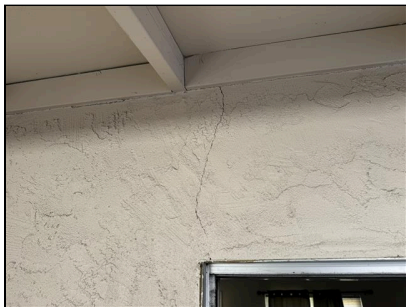
2.0 Item 1(Picture)

2.0 (1) The Stucco coating at the exterior in areas is cracked and damaged. Deterioration can eventually occur if not corrected. A qualified person should repair or replace as needed.

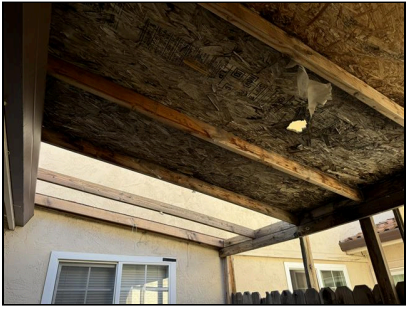
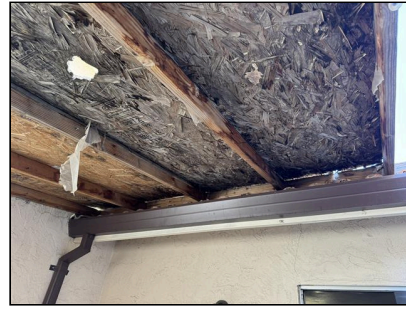
2.5 Item 1(Picture)

2.5 The wooden patio cover is damaged, deteriorated, and not painted or sealed. A qualified contractor

should inspect further and repair or replace as needed.

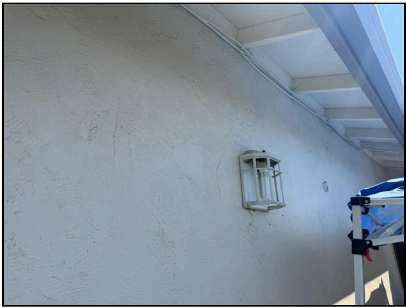
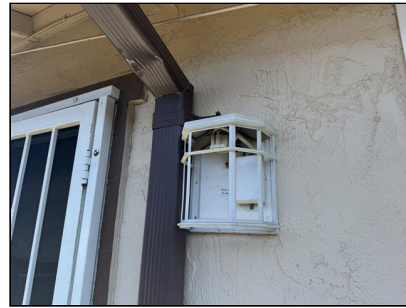
2.6 Item 1(Picture)

2.6 (1) The exterior lights are damaged, missing covers, and bulbs. This is a maintenance issue for your information.

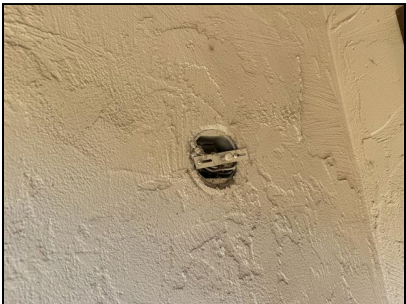
2.6 Item 4(Picture)

2.6 (2) The electrical box of the exterior of the home has exposed wiring and missing a cover. This is for your information. A qualified licensed electrical contractor should perform repairs that involve wiring.

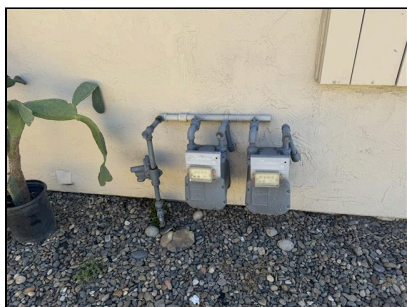
4.5 Item 2(Picture)

4.5 (2) The main fuel shut off is at gas meter outside

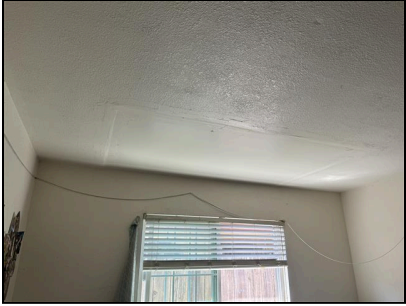
5.0.A Item 1(Picture)

5.0.A The sheetrock on the ceiling is cracked, worn, and patched in areas. This is a cosmetic issue for your information. A qualified person should repair or replace as needed.

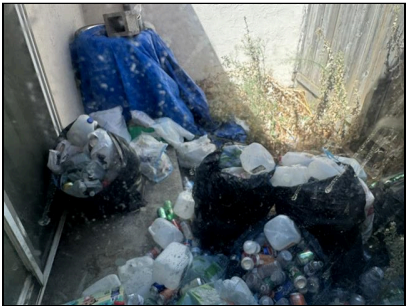
5.2.A Item 1(Picture)

5.2.A (1) The exterior patio was full of personal items and not fully inspected. This is for your information.

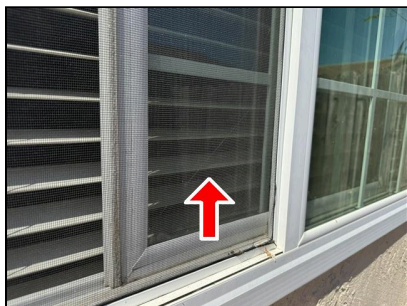
5.4.A Item 1(Picture)

5.4.A The window pane in the bedroom is cracked and damaged. This is a maintenance issue for your information. A qualified person should repair or replace as needed.

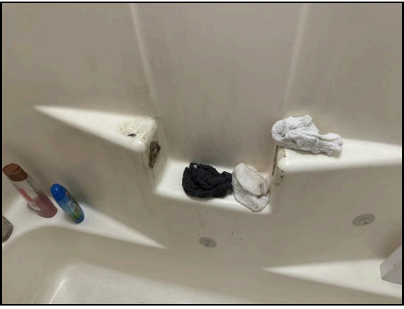
5.6.A Item 1(Picture)

5.6.A (1) The bathroom shower enclosure is worn, damaged, and not fully sealed. Water intrusion is possible

if not repaired. A qualified contractor should repair as needed.

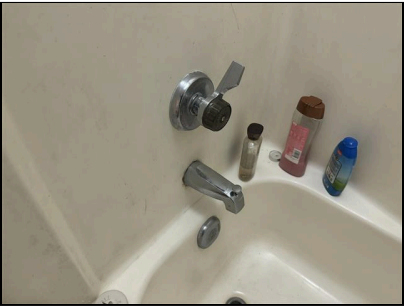
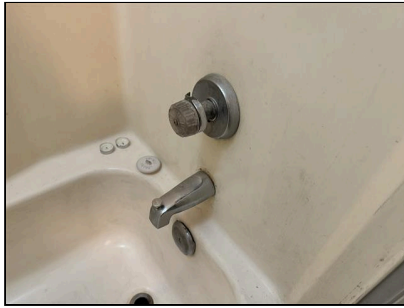
5.6.A Item 2(Picture)

5.6.A (2) The control knob and tub spout are loose in wall and missing grout or caulking. Repairs are needed to stop leaking water from damaging the wall or to eliminate moisture that may contribute to fungi growth. A qualified person should repair as necessary.

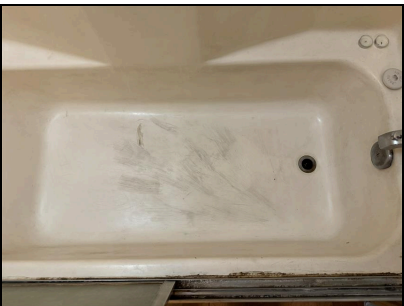
5.6.A Item 4(Picture)

5.6.A (3) The bathtub is scratched and worn. This is for your information. A qualified person should monitor and repair as necessary.

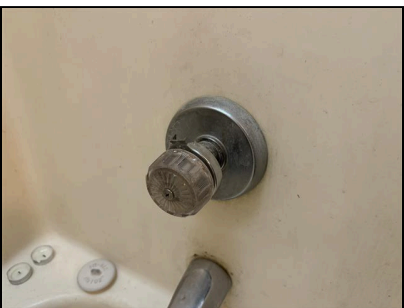
5.6.A Item 5(Picture)

5.6.A (4) The master bathroom shower control knob is broken and damaged. This is for your information. A qualified person should repair as necessary.

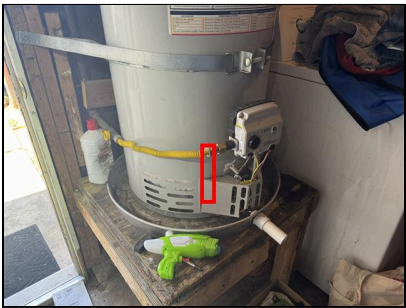
5.8.A Item 1(Picture)

5.8.A The Sediment Trap (Drip Leg) for gas lines should be installed at the furnace and at the water heater. This is for your information. I recommend a Qualified plumber to fix/repair the issue

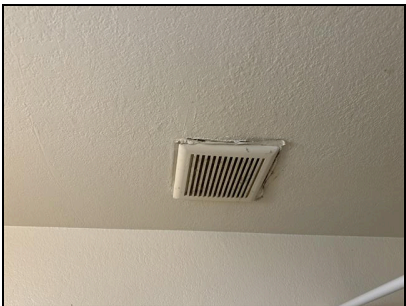
5.9.A Item 1(Picture)

5.9.A The exhaust fan is loose and noisy in the bathroom. This is for informational purpose to you. I recommend repair as desired.

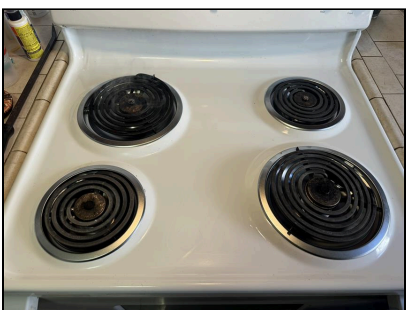
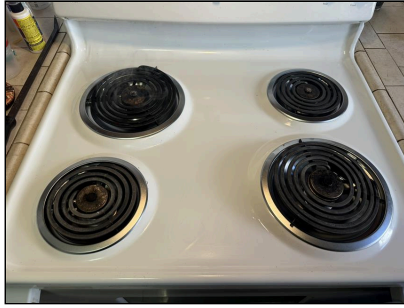
5.11.A Item 1(Picture)

5.11.A The right rear coil element for the stove does not fit flush against the stove. This is a cosmetic issue for your information. I recommend repair as needed.

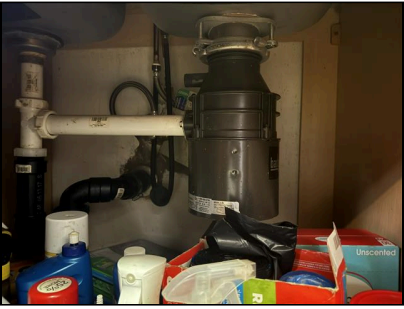
5.14.A Item 1(Picture)

5.14.A The food disposer would not operate or non functional at the time of the inspection. I recommend

repair as needed.

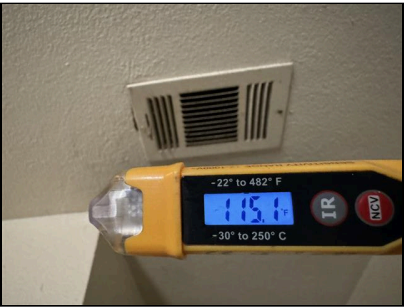
5.17.A Item 1(Picture)

5.17.A (1) The ambient air test was performed by using thermometers on the heater. The return air temperature was 115 degrees. This indicates the unit is working properly.

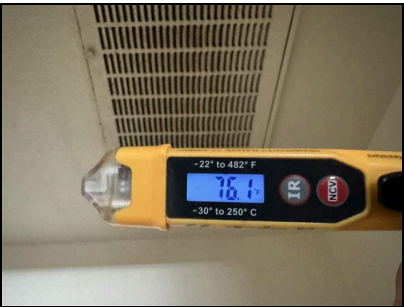
5.19.A Item 1(Picture)

5.19.A (1) The ambient air test was performed by using thermometers on the air handler of the air conditioner to determine if the difference in temperatures of the supply and return air are between 14 degrees and 22 degrees, which indicates that the unit is cooling as intended. The supply air temperature on your system read 76 degrees, and the return air temperature was 59 degrees. This indicates the range in temperature drop is normal.

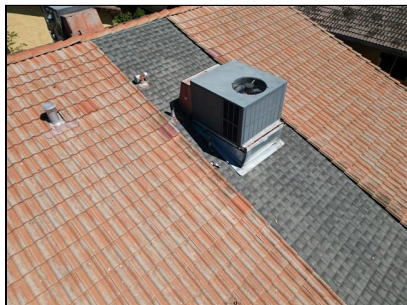
5.19.A Item 3(Picture)

5.19.A (2) The HVAC system is located on the roof. Annual maintenance is recommend by a qualified HVAC technician.

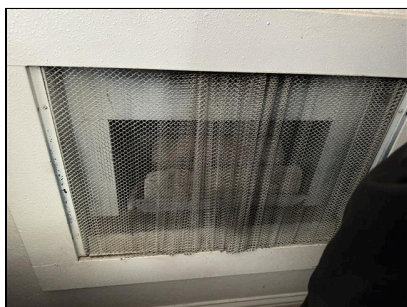
5.25.A Item 1(Picture)

5.25.A The fireplace in the living room is cracked and worn. This is a maintenance issue that should be cleaned and maintained.

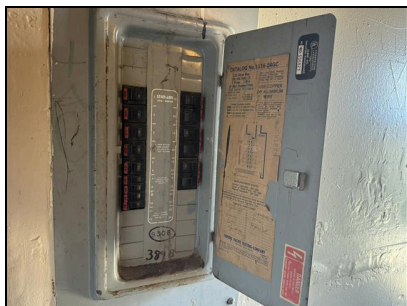
5.28.A Item 1(Picture)

5.28.A The electrical panel have circuit breakers that need labels identifying their location. A qualified electrician should inspect and label all breakers.

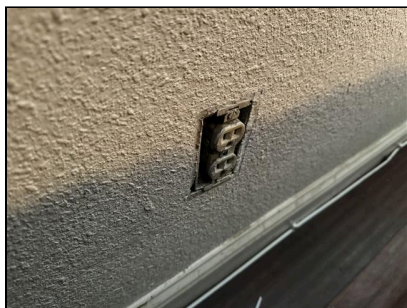
5.31.A Item 1(Picture)

⚡ **5.31.A** "Three-prong" outlets are missing cover-plates in the bedroom. This is for your information. A qualified person should replace to prevent further issues.

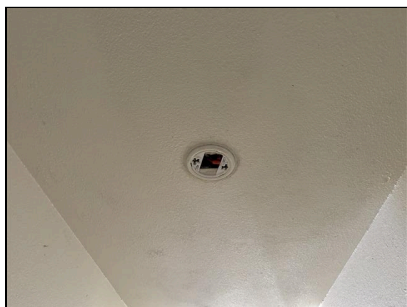
5.32.A Item 1(Picture)

📍 **5.32.A** The smoke detector is missing and not installed. Without a working smoke detector in your building you have no first alert to a possible fire. A qualified person should repair or replace as needed.

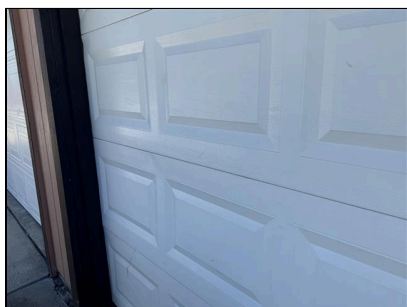
5.34.A Item 1(Picture)

5.34.A (1) The garage door panels are dented, damaged, and worn. This is a maintenance issue and is for your information. A qualified person should repair or replace as needed.

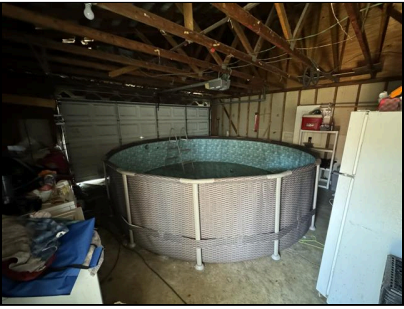
5.34.A Item 3(Picture)

5.34.A (2) The garage was full of personal items and not fully inspected. This is for your information.

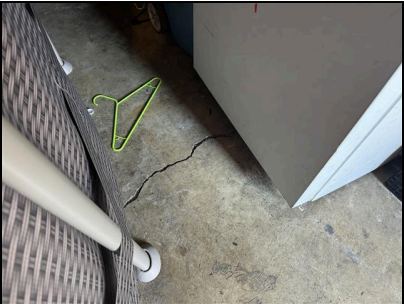
5.34.A Item 4(Picture)

5.34.A (3) The concrete floor of garage is cracked in areas. This is for your information.

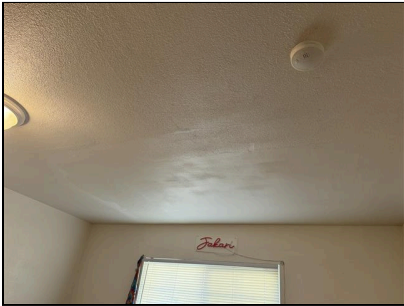
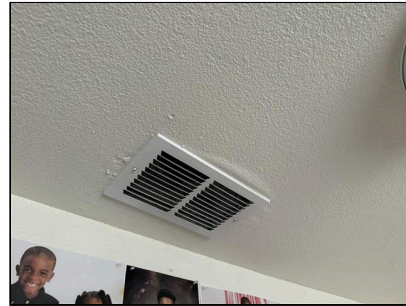
5.0.B Item 2(Picture)

5.0.B (2) The sheetrock on the ceiling is cracked, worn, and patched in areas. This is a cosmetic issue for your information. A qualified person should repair or replace as needed.

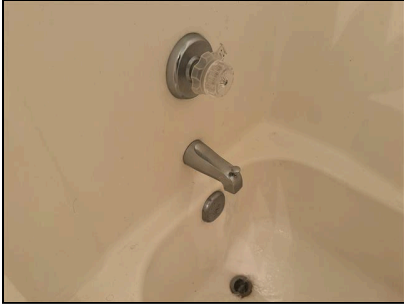
5.6.B Item 3(Picture)

needed to stop leaking water from damaging the wall or to eliminate moisture that may contribute to fungi growth. A qualified person should repair as necessary.

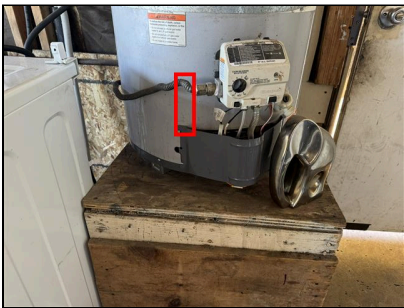
5.8.B Item 2(Picture)

5.8.B (2) The Sediment Trap (Drip Leg) for gas lines should be installed at the furnace and at the water heater. This is for your information. I recommend a Qualified plumber to fix/repair the issue

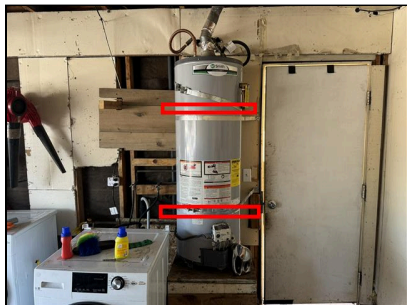
5.8.B Item 3(Picture)

5.8.B (3) Water heaters shall be anchored or strapped to resist horizontal displacement due to earthquake motion. Strapping shall be at points within the upper one third and lower one-third of its vertical dimensions. At the lower point, a minimum distance of 4" inches shall be maintained above the controls with the strapping. (2010 CPC 508.2). These straps are not properly installed. Refer to the county code or manufacture instructions.

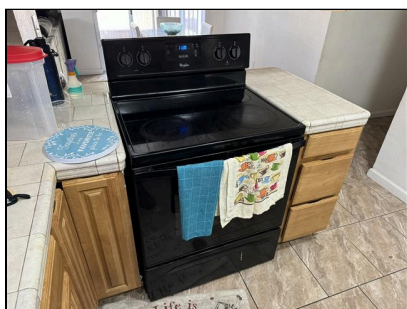
5.11.B Item 1(Picture)

5.11.B (1) The anti-tip bracket for the stove is missing or not installed. I recommend repair as needed.

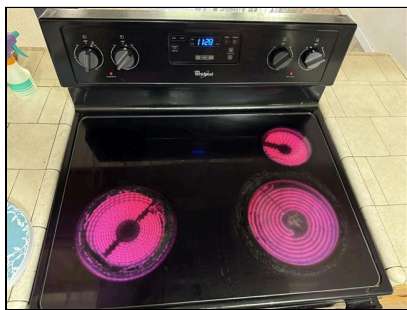
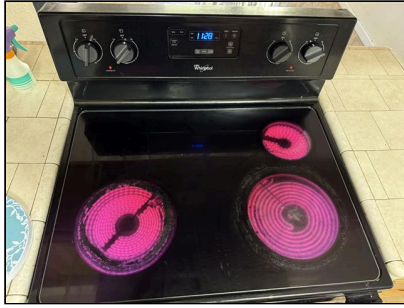
5.11.B Item 2(Picture)

5.11.B (2) The left rear burner for the stove did not work when tested. I recommend repair as needed.

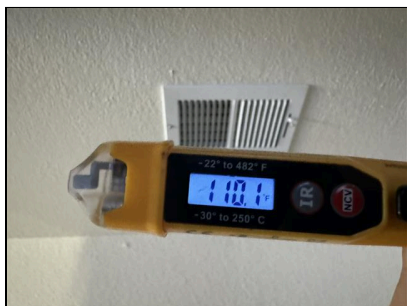
5.17.B Item 1(Picture)

5.17.B (1) The ambient air test was performed by using thermometers on the heater. The return air temperature was 110 degrees. This indicates the unit is working properly.

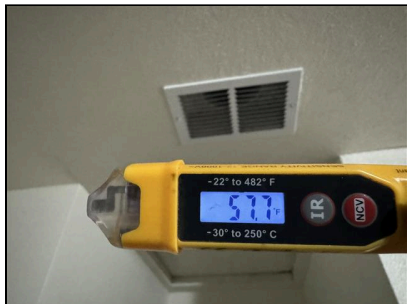
5.19.B Item 1(Picture)

5.19.B (1) The ambient air test was performed by using thermometers on the air handler of Air conditioner to determine if the difference in temperatures of the supply and return air are between 14 degrees and 22 degrees which indicates that the unit is cooling as intended. The supply air temperature on your system read 72 degrees, and the return air temperature was 57 degrees. This indicates the range in temperature drop is normal.

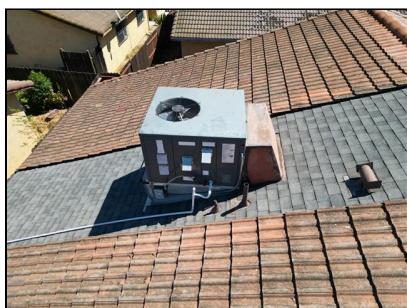
5.19.B Item 3(Picture)

5.19.B (2) The HVAC system is located on the roof. Annual maintenance is recommended by a qualified HVAC technician.

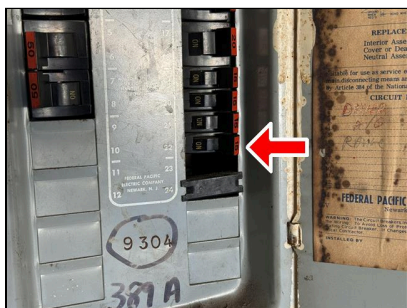
5.28.B Item 1(Picture)

5.28.B (1) The electrical panel is missing knockouts. Electrical issues are considered a hazard until repaired. A qualified licensed electrical contractor should perform repairs that involve wiring.

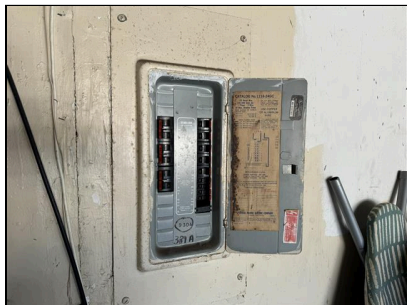
5.28.B Item 2(Picture)

5.28.B (2) The main panel has circuit breakers that need labels identifying their location. A qualified electrician should inspect and label all breakers.

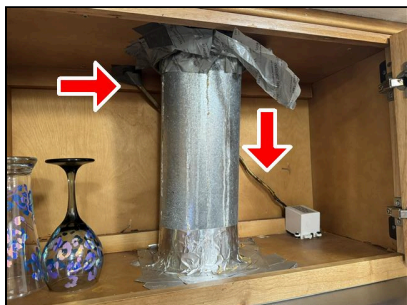
5.30.B Item 1(Picture)

5.30.B Exposed wiring not in conduit was found in the kitchen. Electrical issues are considered a hazard until repaired. A qualified licensed electrical contractor should perform repairs that involve wiring.

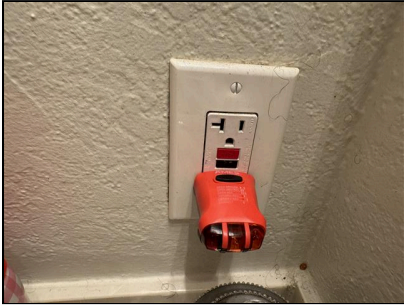
5.31.B Item 2(Picture)

⚡ **5.31.B** (2) GFCI (Ground Fault Circuit Interrupter) outlets are worn and did not trip when tested (possibly defective). Electrical issues are considered a hazard until repaired. I recommend repair as needed.

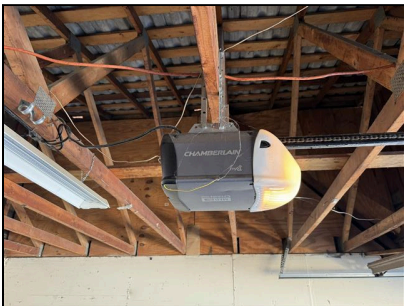
5.35.B Item 2(Picture)

🏠 **5.35.B** (2) The garage door operator is in working order. The sensors are in place and will reverse when met with resistance. This is for your information

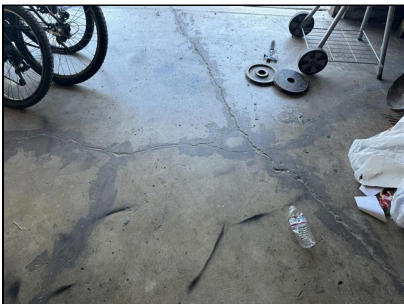
5.35.B Item 3(Picture)

🏠 **5.35.B** (3) The concrete floor of garage is cracked in areas. This is for your information. A qualified person should monitor and repair as needed.

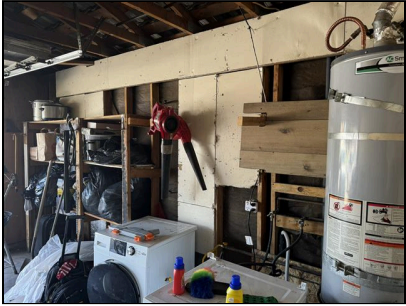
5.35.B Item 5(Picture)

**5.35.B** (4) The interior garage walls are worn and missing in areas. This is a cosmetic issue for your information. A qualified person should maintain and repair as needed.

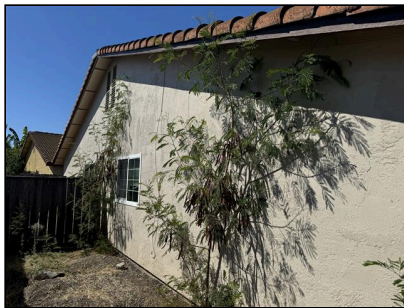
2.4 Item 2(Picture)

(2) The vegetation and tree limbs that are in contact with home or roof should be trimmed. This is a maintenance issue for your information.

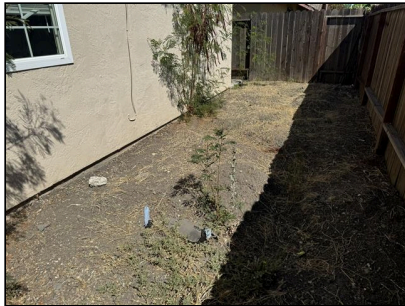
2.4 Item 3(Picture)

(3) There is a negative slope towards the property. This area does not appear to drain water away from building and needs landscaping and drainage corrected.

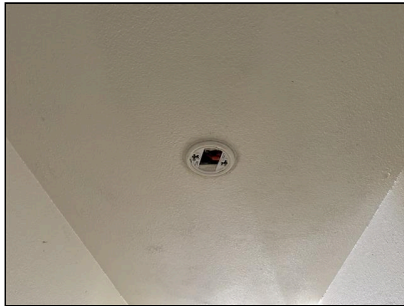
5.32.A Item 1(Picture)

The smoke detector is missing and not installed. Without a working smoke detector in your building you have no first alert to a possible fire. A qualified person should repair or replace as needed.

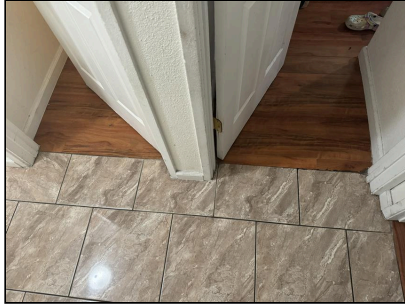
5.2.B Item 5(Picture)

(2) The transition strips between flooring are missing or not installed. This is a cosmetic issue for your information. A qualified person should repair or replace as needed.

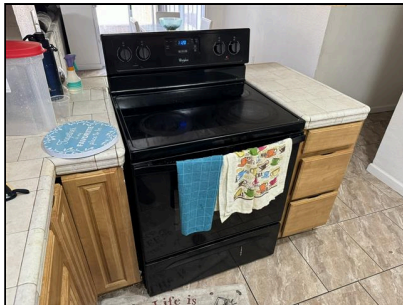
5.11.B Item 1(Picture)

(1) The anti-tip bracket for the stove is missing or not installed. I recommend repair as needed.

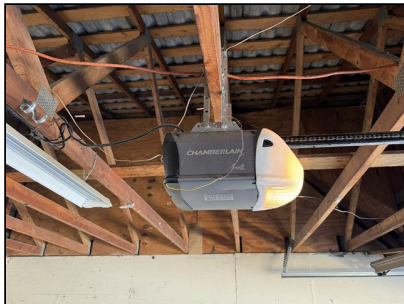
5.35.B Item 2(Picture)

(2) The garage door operator is in working order. The sensors are in place and will reverse when met with resistance. This is for your information.

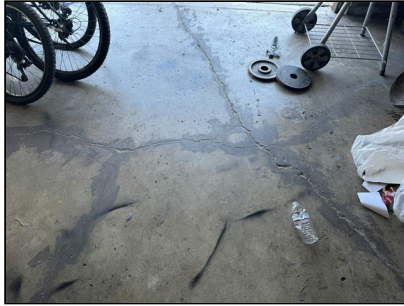
5.35.B Item 3(Picture)

(3) The concrete floor of the garage is cracked in areas. This is for your information. A qualified person should monitor and repair as needed.

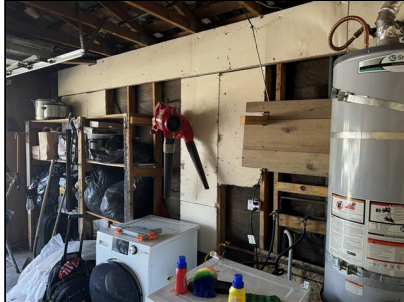
5.35.B Item 5(Picture)

(4) The interior garage walls are worn and missing in areas. This is a cosmetic issue for your information. A qualified person should maintain and repair as needed.

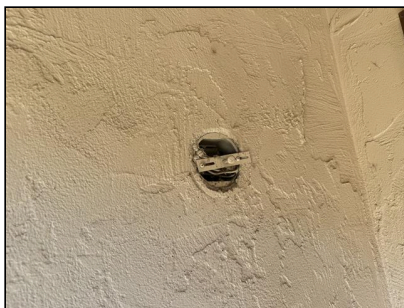
2.6 Item 4(Picture)

(2) The electrical box of the exterior of the home has exposed wiring and missing a cover. This is for your information. A qualified licensed electrical contractor should perform repairs that involve wiring.

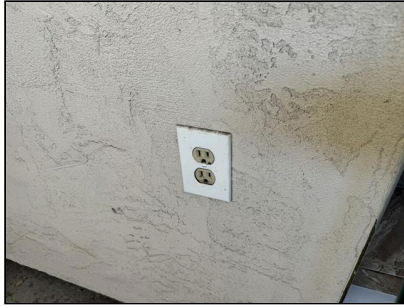
5.31.B Item 1(Picture)

5.31.B (1) The exterior outlet is missing a protective cover. Electrical issues are considered a hazard until repaired. I recommend repair as needed.

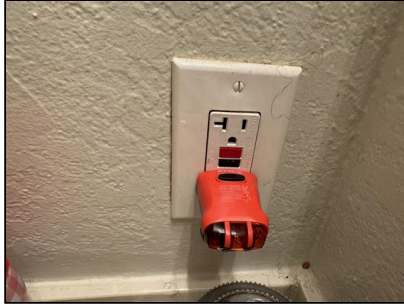
5.31.B Item 2(Picture)

(2) GFCI (Ground Fault Circuit Interrupter) outlets are worn and did not trip when tested (possibly defective). Electrical issues are considered a hazard until repaired. I recommend repair as needed.

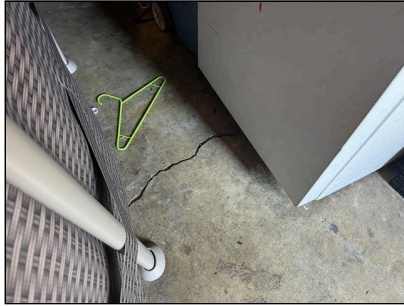
5.34.A Item 4(Picture)

- ☒ (3) The concrete floor of garage is cracked in areas. This is for your information.

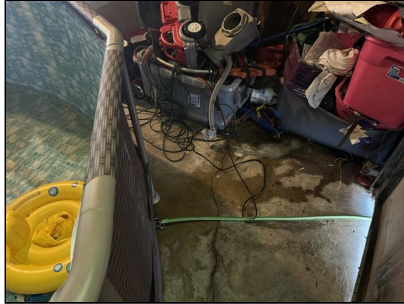
5.34.A Item 6(Picture)

(4) The concrete floor of the garage has water intrusion from the draining pool. This is for your information.

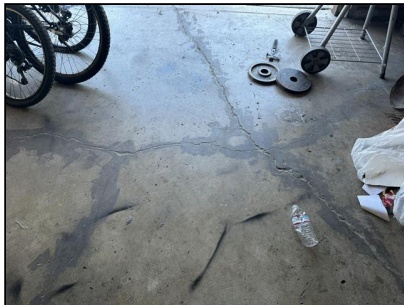
5.35.B Item 3(Picture)

(3) The concrete floor of garage is cracked in areas. This is for your information. A qualified person should monitor and repair as needed.
