**PHASE I
ENVIRONMENTAL SITE ASSESSMENT**

**COMMERCIAL PROPERTY
91 SAINTE-ANNE STREET
SAINTE-ANNE-DE-BELLEVUE, QUÉBEC
H9X 1L9**

REFERENCE: 22-5958

FINAL REPORT

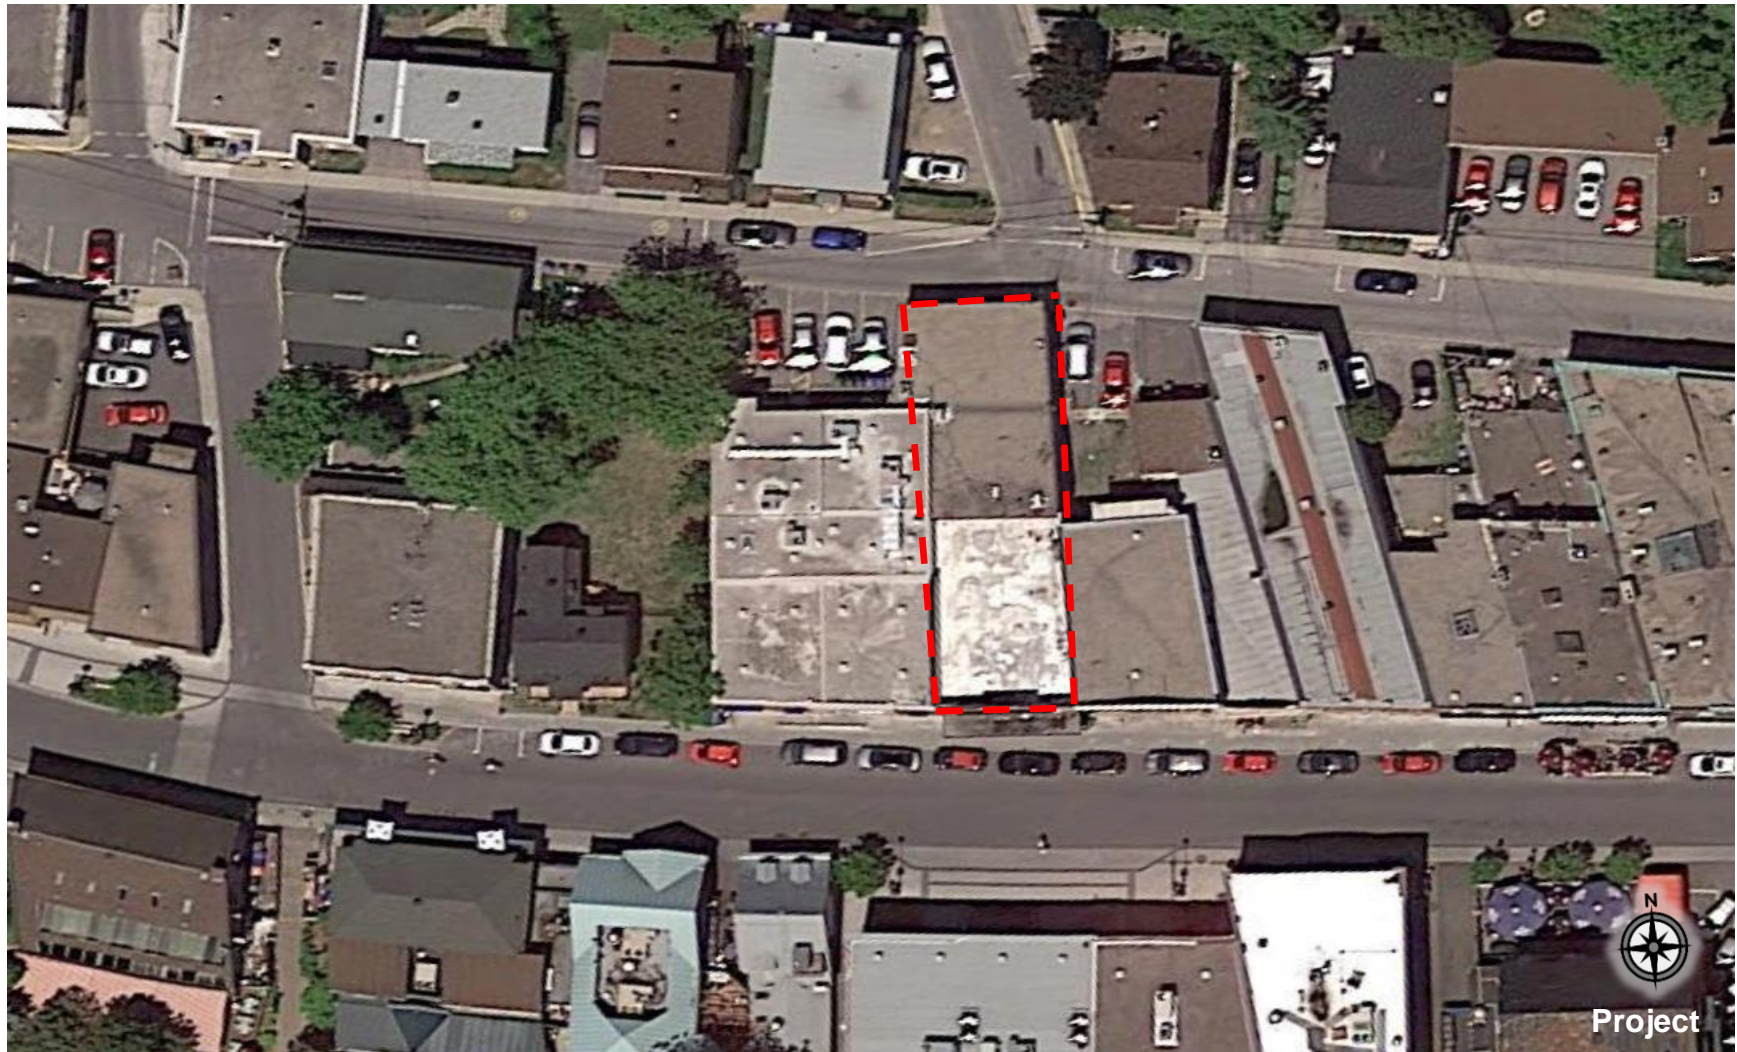
Figure 3 – Aerial Photograph of the Subject Site and Surroundings

The red dashed line represents the approximate limits of the subject site

Aerial photographs from 1954, 1969, 1993, 1998 and 2003 were consulted by D&G. In addition, satellite images from 2005, 2010 and 2012-2020 were reviewed on the Google Earth™ web site. The 2020 image is presented in **Figure 3**.

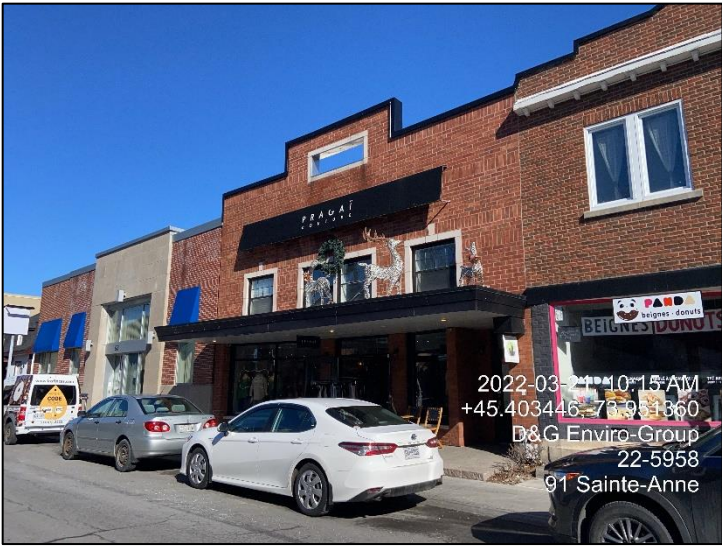
Photo 1 – General view of the subject site.

The subject site was observed to be in good condition at the time of the site visit.

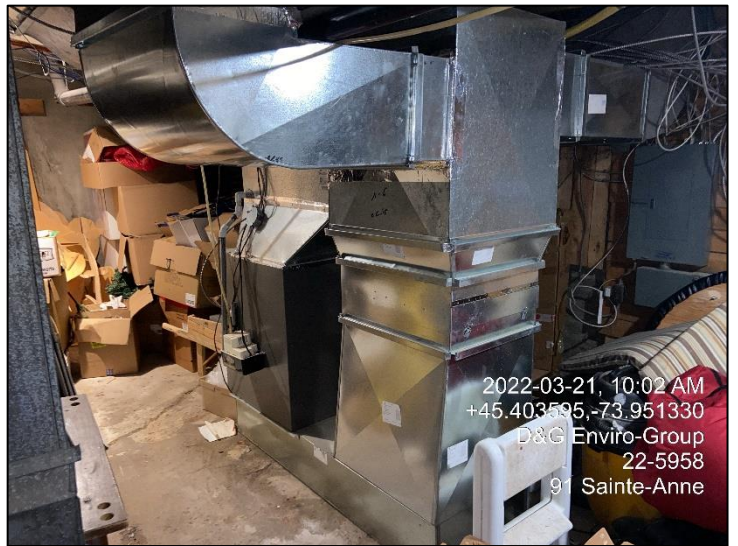
Photo 4 – Furnace room.

No evidence of current or former underground or above ground heating oil tank installations was observed at the time of the site visit. According to the site representative, a former above ground storage tank was located in the furnace room. This tank was reportedly dismantled in about 2010. Capped fuel fill or vent pipes were observed on the northern building exterior wall. No evidence of contamination was observed in the furnace room.

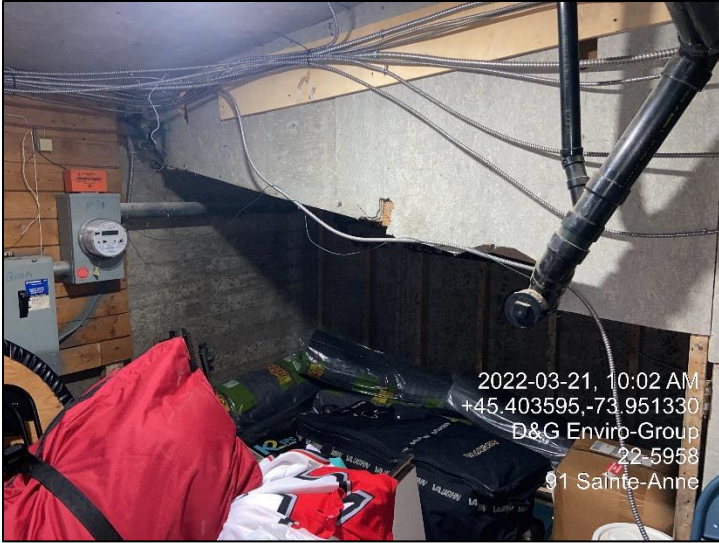
Photo 5 – Reported location of the former above ground storage tank.

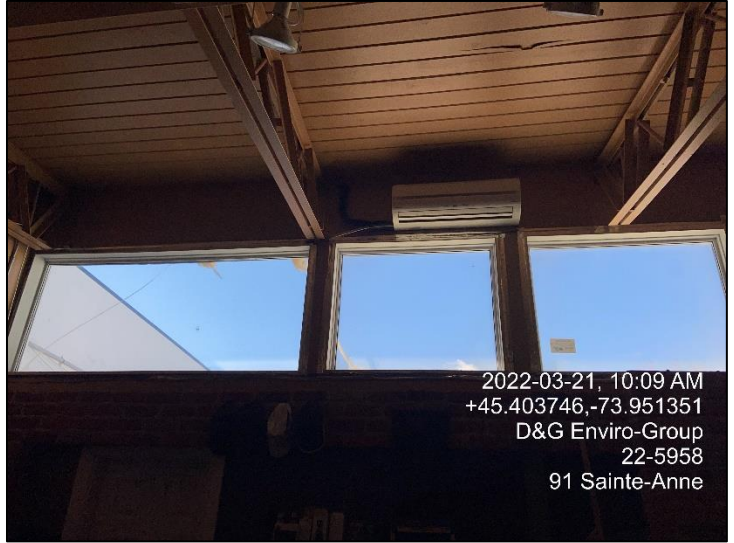
Photo 6 – Air conditioning unit located in one of the commercial units.

The building is heated by an electric HVAC unit observed on the roof and cooled by separate wall mounted electric air conditioning units in some of the commercial units. Domestic hot water is provided by an electric hot water heater. A natural gas entry was observed on the southern exterior wall of the building.

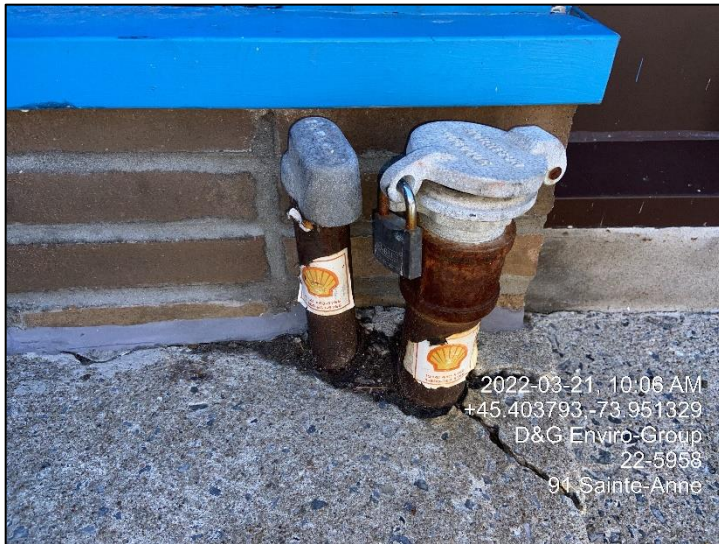
Photo 7 – Capped fill and vent pipes located on the northern exterior wall.

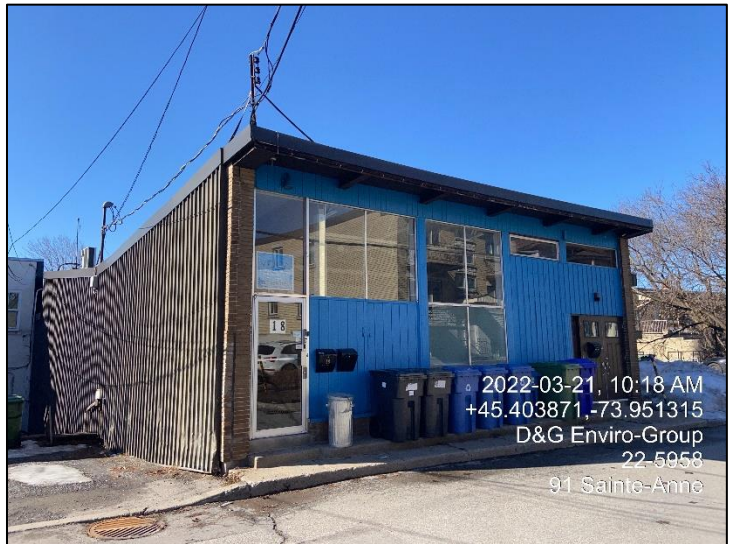
Photo 8 – Rear of the building.
