PROPERTY CONDITION ASSESSMENT (PCA)

7800 Cleveland Ave NW North Canton, OH 44720

> Prosper Mamane JANUARY 19, 2024

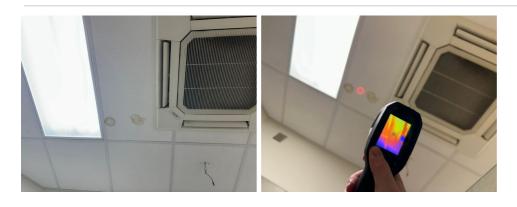
5.5.2 Ceilings

DRY A/C COMPONENT STAIN

OFFICE

A stain(s) on a ceiling surface is observed to test low for moisture content using moisture meters or thermal imaging camera. The source of the moisture intrusion is suspected to be from a past air conditioning component leak.

Stained ceiling areas below air conditioning components can originate from simple condensation build up due to humidity within a confined space or water leaks from the air conditioning condensate components. The area above the ceiling should be investigated further by a licensed air conditioning contractor in order to determine methods for prevention of future occurrence.

Review

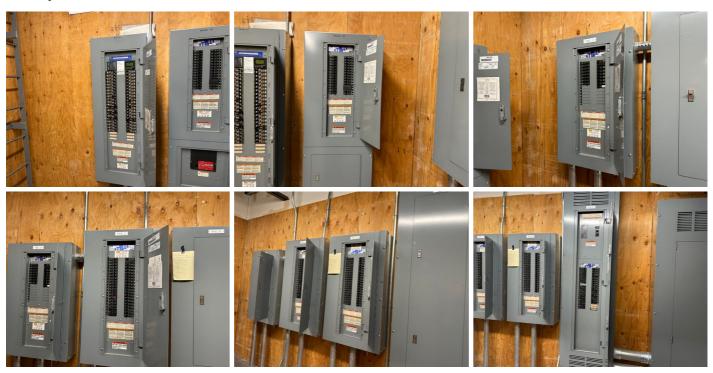
Main & Subpanels, Service & Grounding, Main Overcurrent Device: Sub Panel Location(s) Utility Room
