Subject: Sampling Results for the Phase II Environmental Site Assessment (ESA)
700 Flaugherty Run Road
Parcel 1049-M-383
Findlay Township, Allegheny County, Pennsylvania

APPLIED GEOLOGY AND ENVIRONMENTAL SCIENCE, INC.
PHOTOGRAPHIC RECORD
PHOTOGRAPH NUMBERS 1 AND 2

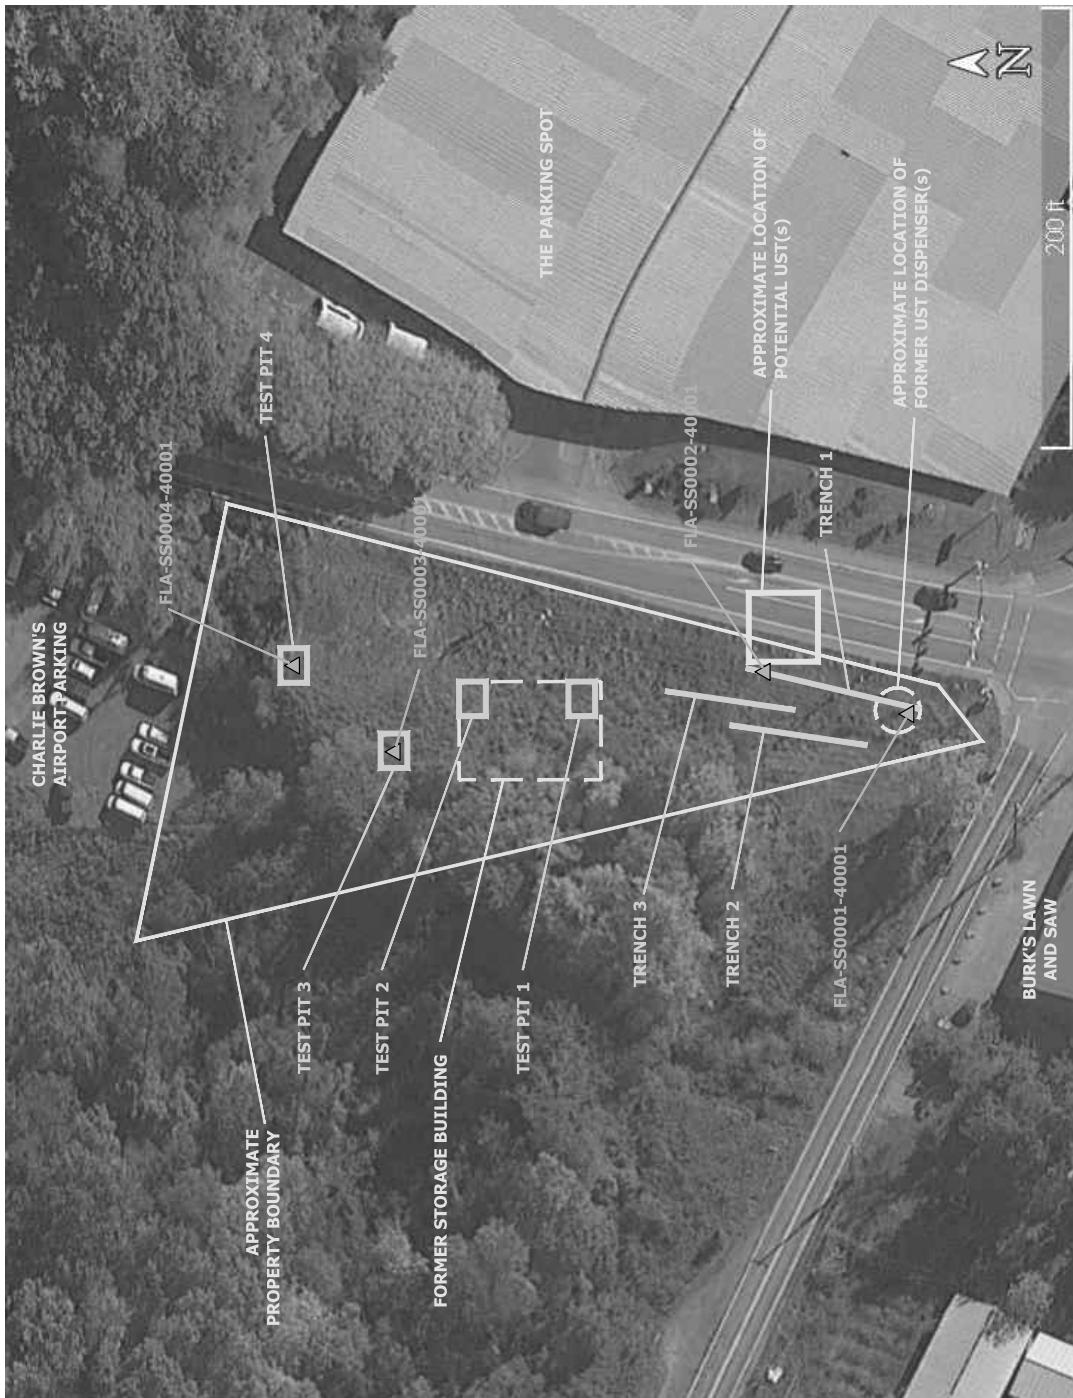
DRAWN BY	JM	MAX FELDMAN
DATE		PHASE II ENVIRONMENTAL SITE ASSESSMENT
CHECKED BY		700 FLAUGHERY RUN ROAD
JOB NO.	20211187-2-FEL	FINDLAY TOWNSHIP, ALLEGHENY COUNTY, PENNSYLVANIA
DWG FILE	20211187_Feldman_Test Pits_ph2.dwg	SAMPLE LOCATION MAP
DRAWING SCALE	NOT TO SCALE	DRAWING NAME
		FIGURE 1
		REV. 0

Trenches 2 and 3 were excavated to approximately three (3) feet bgs (Figure 1). Fill material was observed to a depth of approximately two (2) feet bgs. The fill material was composed of asphalt, brick, blacked soils, crushed terracotta tiles, and concrete fragments. Below two (2) feet, the soils were composed of gray/brown clay. No signs of petroleum impacted soils were observed and PID levels were recorded at 0.5 ppm. No soil samples were therefore collected at this location.

Test Pit 3 was excavated in the northwest portion of the site (Figure 1). This test pit was excavated to a depth of seven (7) feet bgs. Black asphaltic materials were observed in Test Pit 3 to a depth of five (5) feet bgs. Gray/brown clay was observed from five (5) feet bgs to seven (7) feet bgs. Soil sample FLA-SS0003-40001 was collected at a depth of four (4) feet bgs from the black asphaltic material and recorded a PID level of 0 ppm.

Test Pit 4 was excavated in the northern-central portion of the site (Figure 1). This test pit was excavated to a depth of five (5) feet bgs and was predominantly composed of crushed concrete material. The mini excavator reached refusal at approximately five (5) feet bgs. Soil sample FLA-SS0004-40001, composed of the fill material, was collected at five (5) feet bgs and recorded a PID level of 0 ppm.

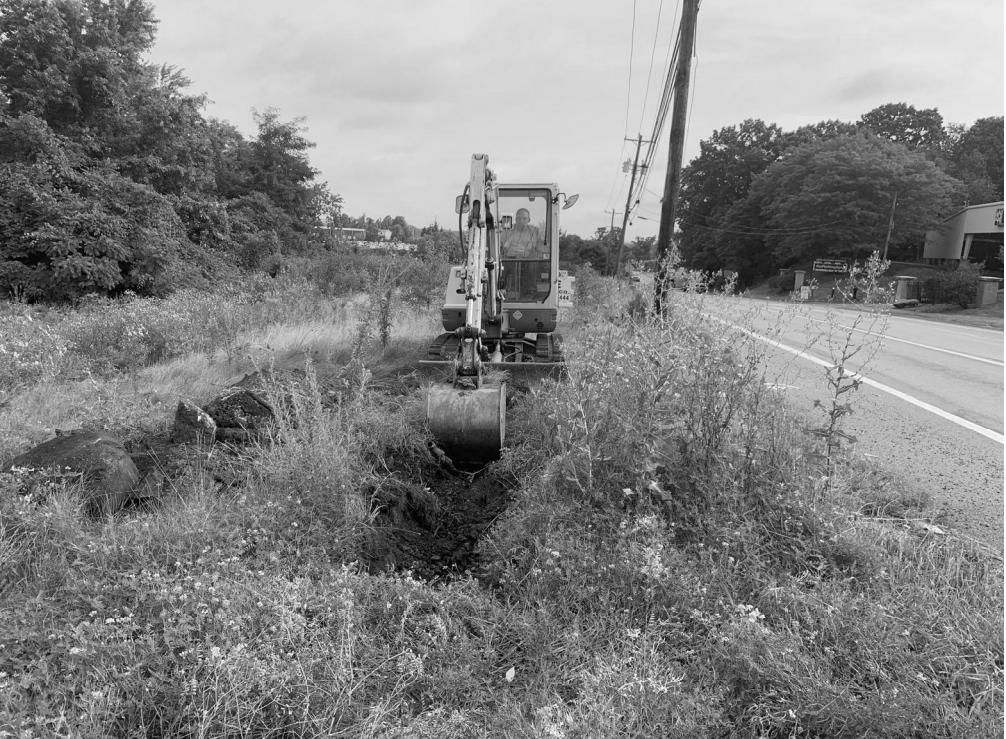
The field investigation commenced in the southeast corner of the site within proximity of the former fuel dispenser (Trench 1). Two (2) fuel pipes, approximately 2" diameter, were located within Trench 1. Both pipes recorded a petroleum odor and registered a PID level of approximately 40 parts per million (ppm). The fuel pipes originated from the area of the former dispenser. Soil sample FLA-SS0001-40001 was collected from 1.5 feet below ground surface (bgs) where both pipes converged. No signs of petroleum impacts were observed and PID levels in exposed soils were recorded at 1.5 ppm.

DATE: August 11, 2021	
DIRECTION: North	
COMMENTS: Beginning excavation of Trench 1.	
PHOTOGRAPHER: AGES, Inc.

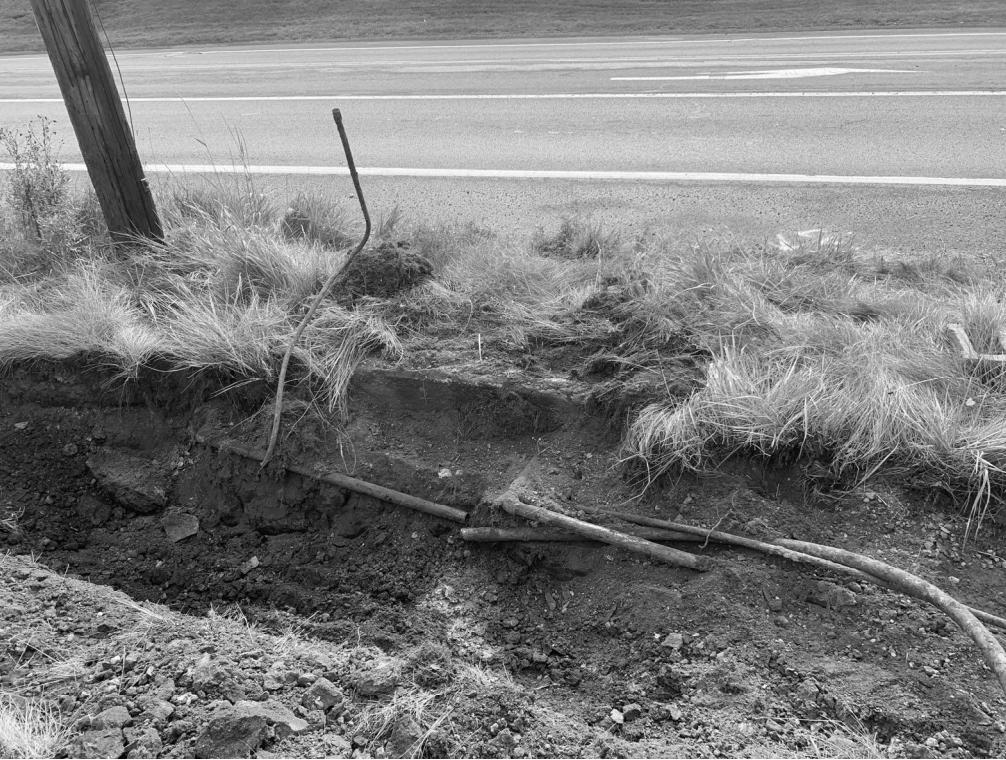
From the dispenser, the fuel pipes ran parallel to Flaugherty Run Road in a northerly direction until south of the utility pole where they turned 90 degrees east toward Flaugherty Run Road. Due to the presence of a concrete berm just below the ground surface; the proximity of Flaugherty Run Road and utility pole; and an undefined property boundary, further investigation toward the east was not possible during this phase of work. Although no USTs were observed

DATE: August 11, 2021	
DIRECTION: East	
COMMENTS: Fuel piping next to Flaugherty Run Road.

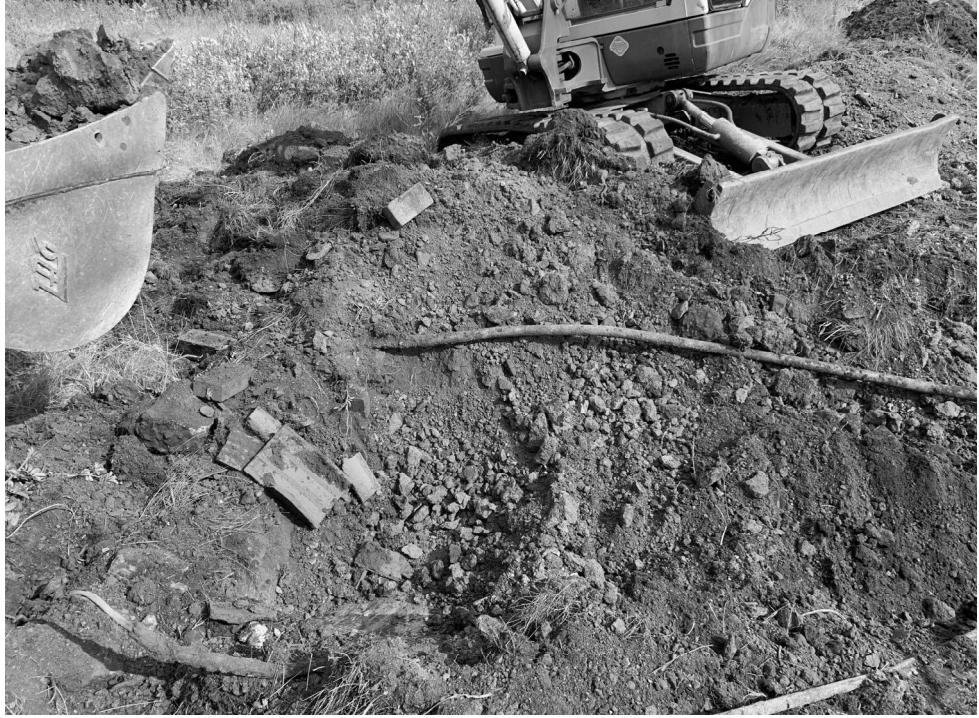
DATE: August 11, 2021	
DIRECTION: NW	
COMMENTS: Fuel piping and fill materials close to former fuel dispenser location.	
PHOTOGRAPHER: AGES, Inc.

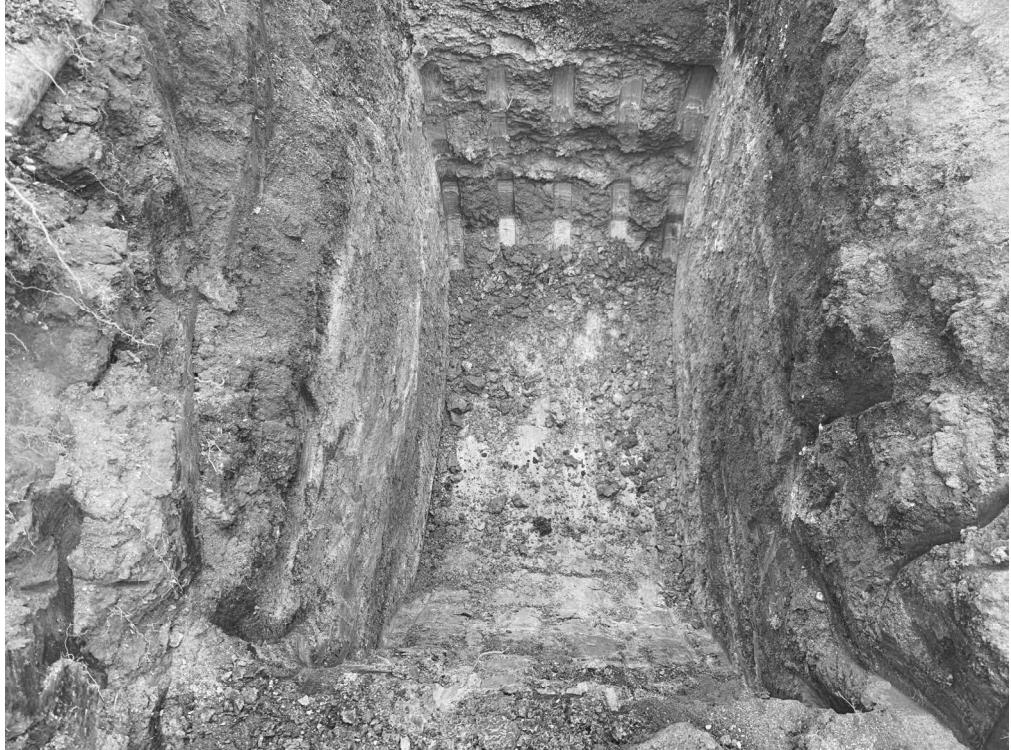
during this investigation, the excavation of two (2) fuel pipes indicated the potential presence of two (2) USTs under Flaugherty Run Road. A pit was excavated to a depth of seven (7) feet bgs within a section of Trench 1, directly to the west of the potential tank area to evaluate for the presence of impacted soils. The top two (2) feet of soils were predominantly composed of fill materials while soils from two (2) to seven (7) feet bgs were classified as naturally occurring gray/brown clay. Soil sample FLA-SS0002-40001 was collected in the test pit at a depth of 6.5 feet bgs (Figure 1). No signs of petroleum impacted soils were observed and PID levels were recorded at 0.5 ppm.

DATE: August 11, 2021	
DIRECTION: South	
COMMENTS: Excavation to 7 feet below ground surface to the west of potential tank location. SS0002 collected here.

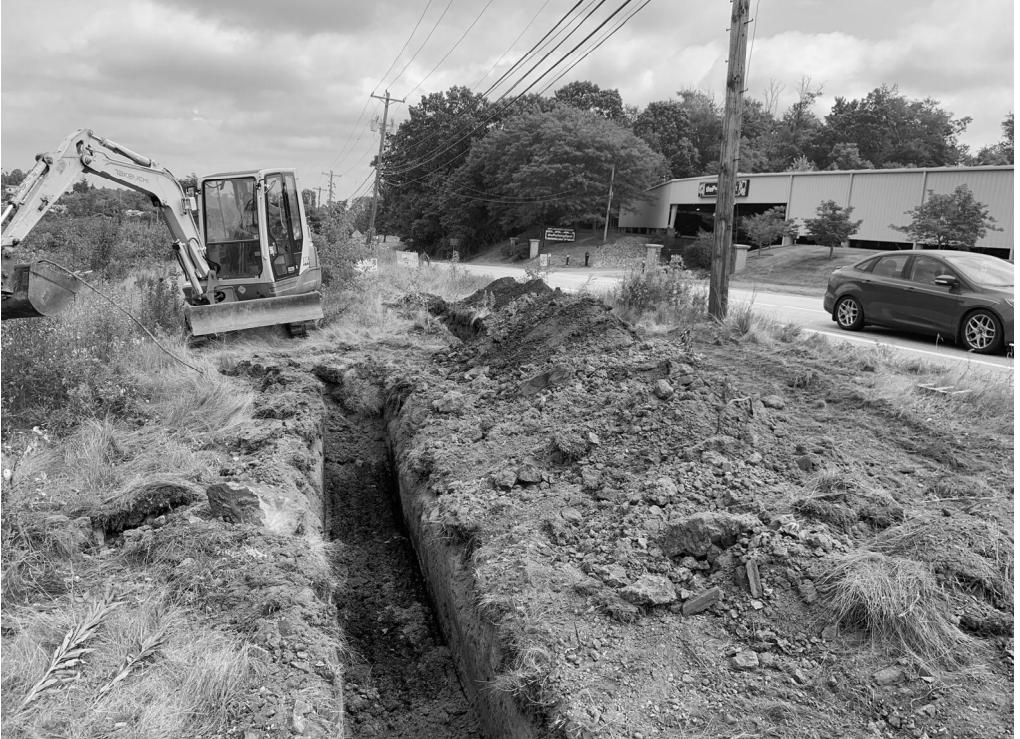
DATE: August 11, 2021	
DIRECTION: North	
COMMENTS: Excavation of Trench 2.	
PHOTOGRAPHER: AGES, Inc.

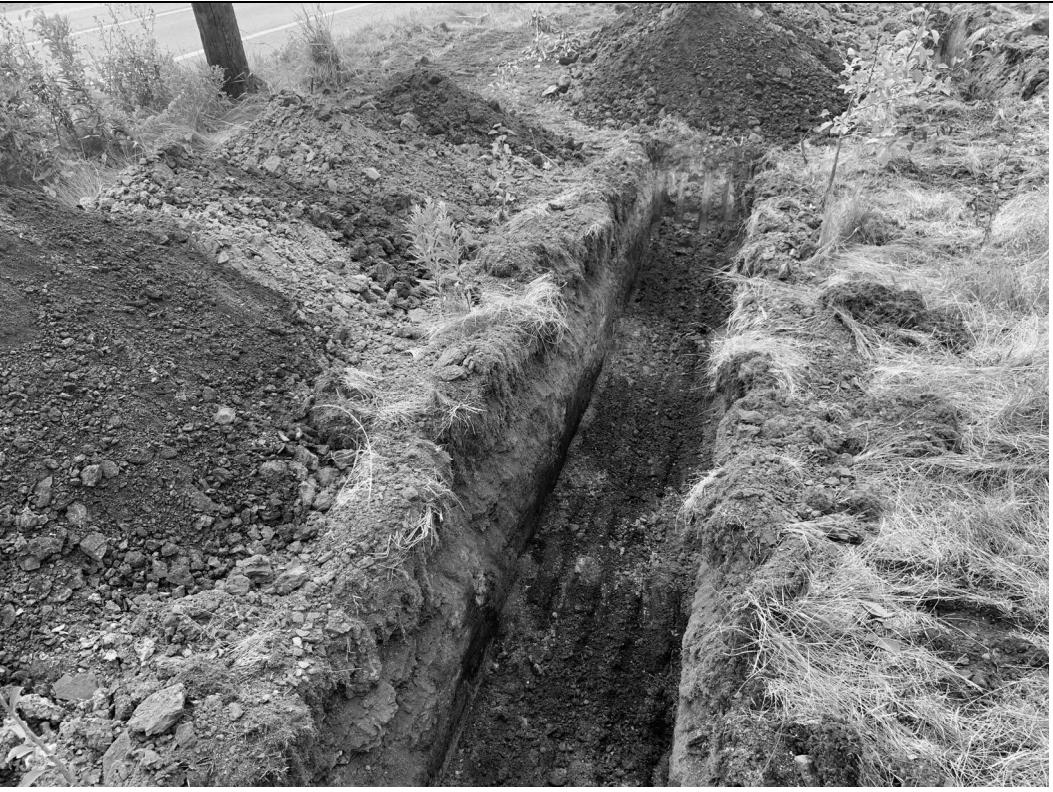
DATE: August 11, 2021	
DIRECTION: NE	
COMMENTS: Excavation of Trench 3.

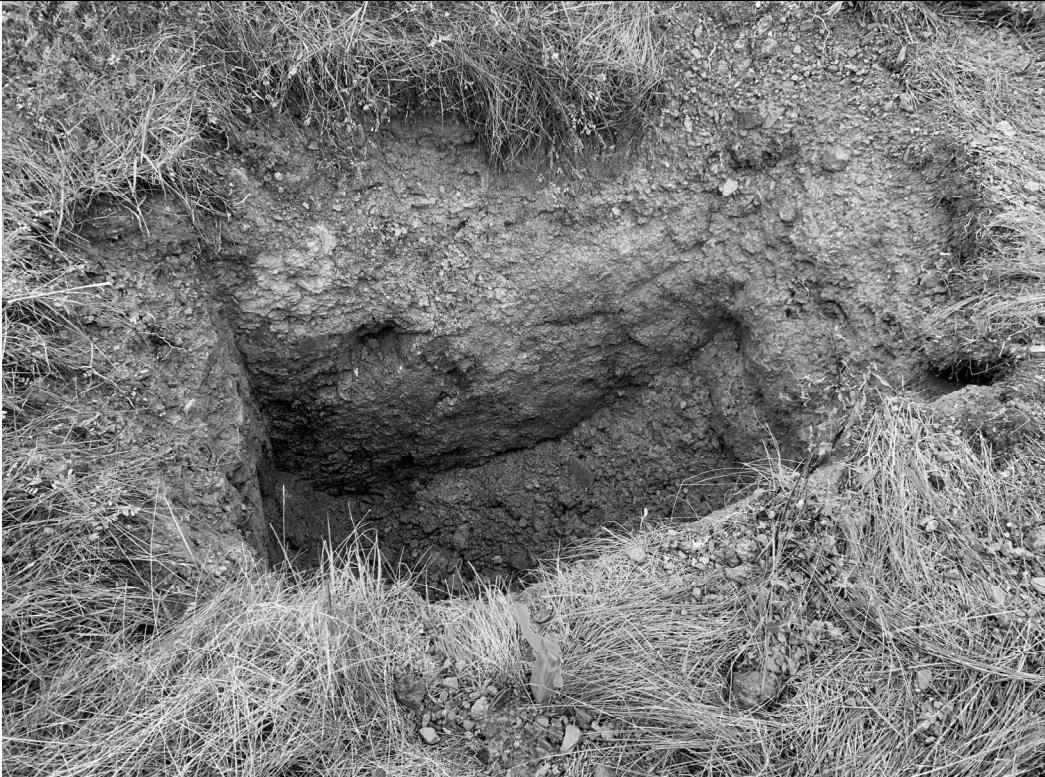
Four (4) test pits were excavated in the northern half of the site to evaluate near surface soils. Test Pit 1 and Test Pit 2 were excavated in the general area of the southeast and northeast corners of the former storage building, respectively (Figure 1). The test pits were excavated to a total depth of six (6) feet bgs. Both excavations were composed of fill materials similar to the trenches described above however, the fill materials were present at a greater depth, approximately four (4) feet bgs. Underlying the fill materials was natural gray/brown clay. No signs of petroleum impacted soils were observed and PID levels were recorded at 0 ppm. No soil samples were therefore collected at either location.

Test Pit 1. Six (6) feet below ground surface.

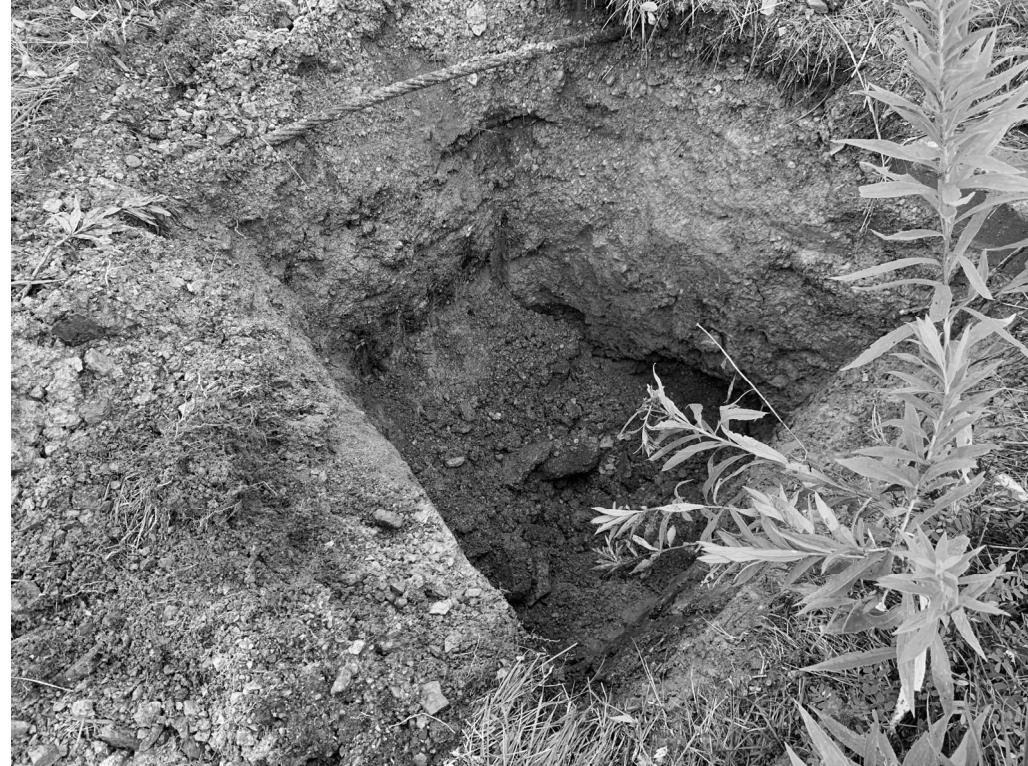
Test Pit 2. Six (6) feet below ground surface.

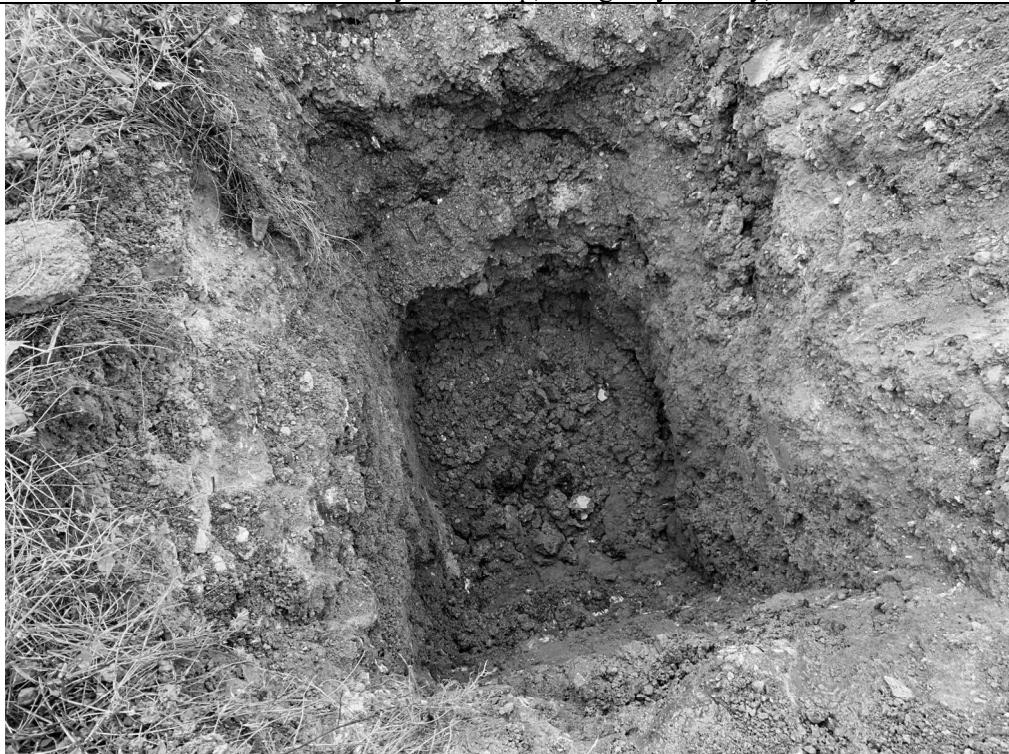
Test Pit 3. Seven (7) feet below ground surface.

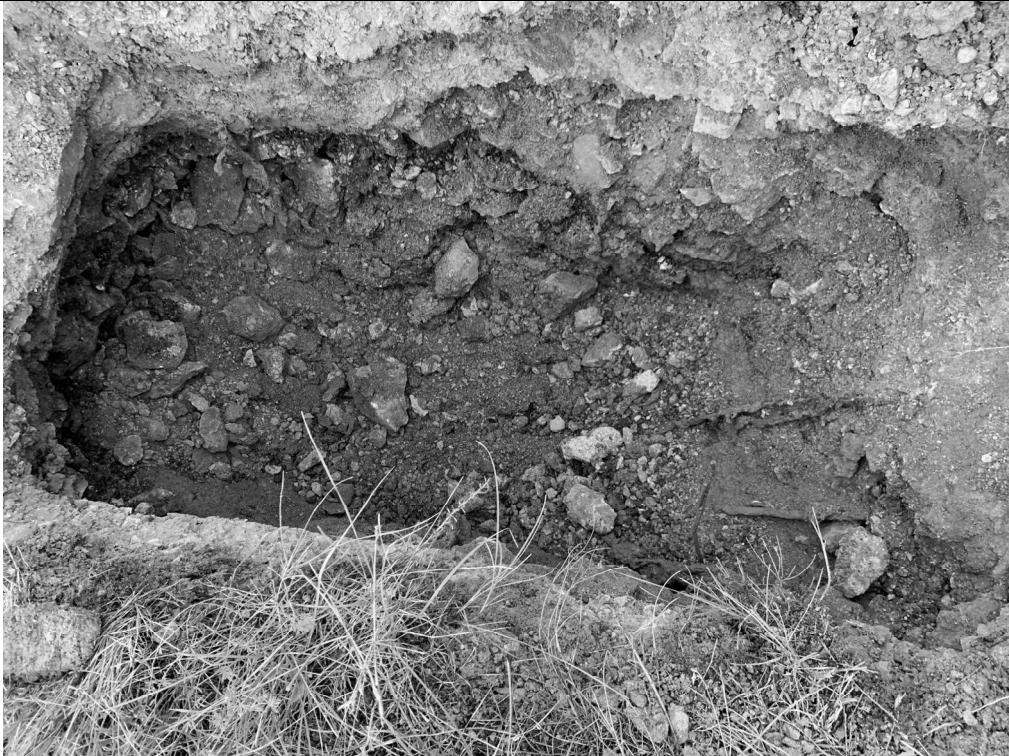
Test Pit 4. Five (5) feet below ground surface.
