# 5 POINT HOME INSPECTIONS

## RESIDENTIAL INSPECTION COPY

201 Covala Dr  
Cedar Park, TX 78613

# PROPERTY INSPECTION REPORT FORM

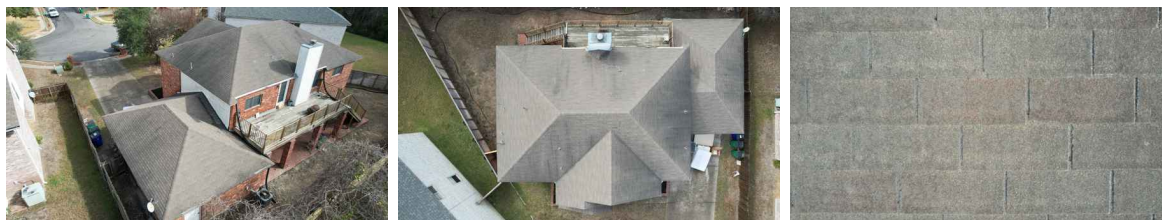
*Type: 3-tab asphalt:* The roof was covered with 3-tab fiberglass asphalt shingles. These shingles are composed of a fiberglass mat embedded in asphalt and covered with ceramic-coated mineral granules. An asphalt sealant strip binds shingles together so that they act as a single membrane. 3-tab shingles usually have a 20-30 year warranty. The actual useful lifespan varies with shingle quality. Determining shingle quality or remaining shingle roof lifespan lies beyond the scope of the General Home Inspection.

*Viewed From:* Drone

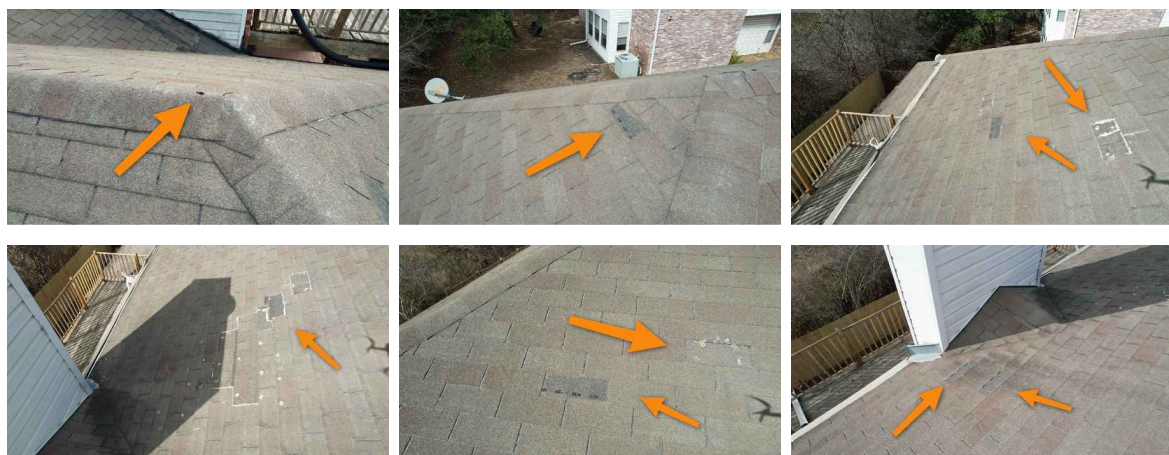
## 1: Damaged Coverings

Observation: Roof coverings exhibited general damage that could affect performance.

Implication: Damaged roof coverings can lead to leaks, water intrusion, and potential structural damage, compromising the integrity of the home.

Recommendation: Recommend a qualified roofer evaluate and repair the roof coverings.

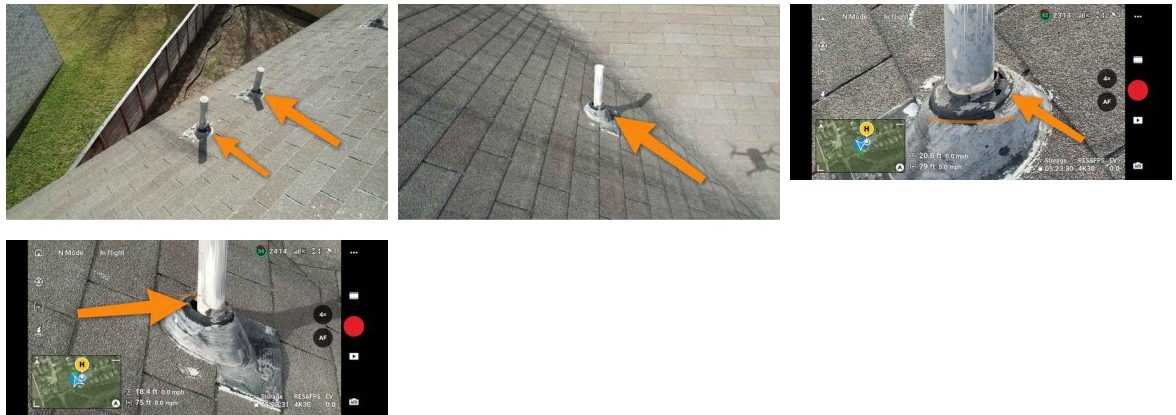
**4: Plumbing Vent Boot Damaged**

Observation: The plumbing vent boot was observed to be damaged.

Implication: A damaged plumbing vent boot can lead to water intrusion, potentially causing moisture-related issues in the roof structure and interior of the home.

Recommendation: It is recommended to replace the damaged plumbing vent boot to ensure proper sealing and prevent water leakage.

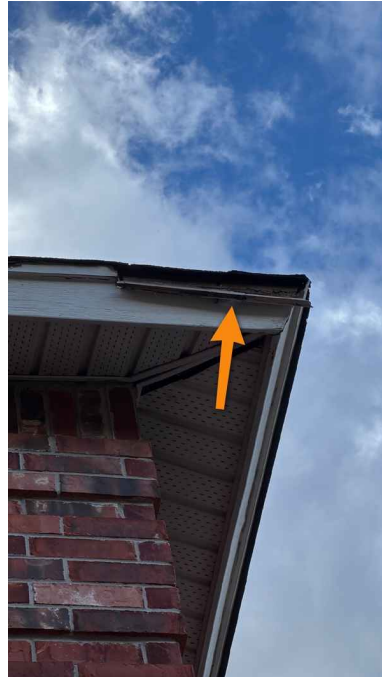
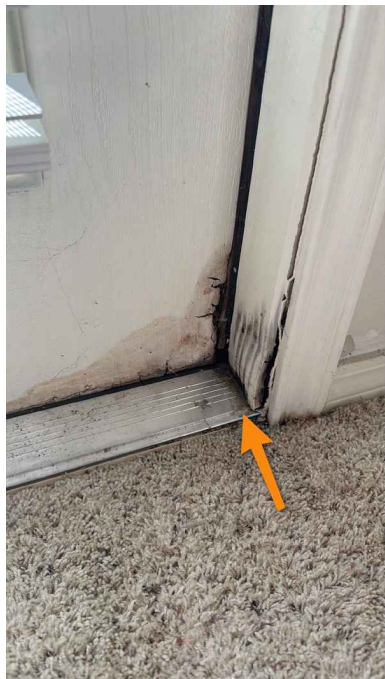
**2: Wood Deterioration**

Observation: Areas of wood were observed to be deteriorating. This may include signs of rot, decay, softness, or surface breakdown.

Implication: Wood deterioration is commonly caused by prolonged moisture exposure and can reduce the strength and durability of the affected components. If left uncorrected, deterioration may worsen and lead to structural or cosmetic damage.

Recommendation: I recommend evaluation and repair by a qualified contractor. Damaged wood should be repaired or replaced as needed, and the source of moisture contributing to the deterioration should be identified and corrected to prevent recurrence.

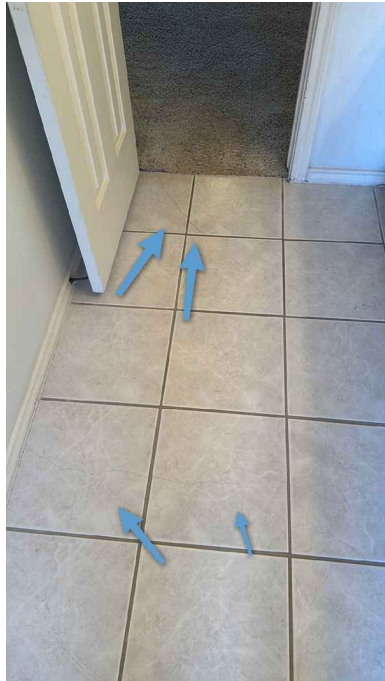
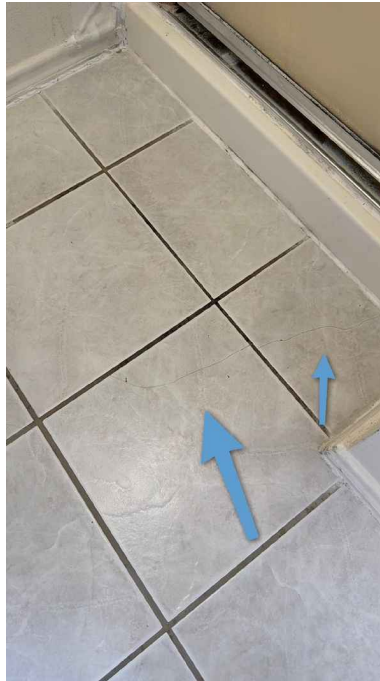
**1: Floor Tile Cracked**

Observation: One or more floor tiles were cracked.

Implication: Cracked floor tiles can lead to further damage, create tripping hazards, and may allow moisture to seep through, potentially damaging the subfloor.

Recommendation: Recommend replacing the cracked tiles to restore the surface and prevent potential issues.

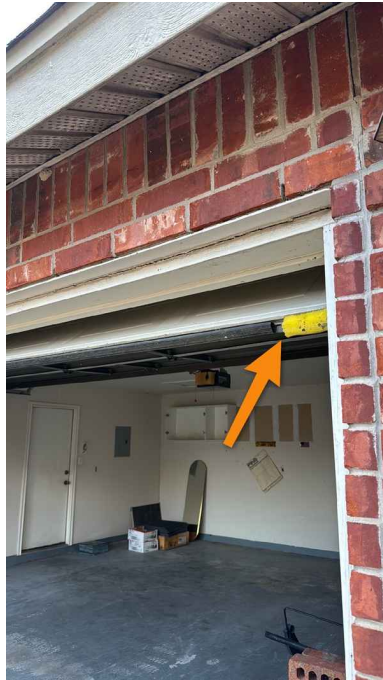
During the inspection the garage vehicle door did not completely seal allowing light to shine through. This can allow pests into the garage. Recommend proper adjustment of the garage door to improve the seal.

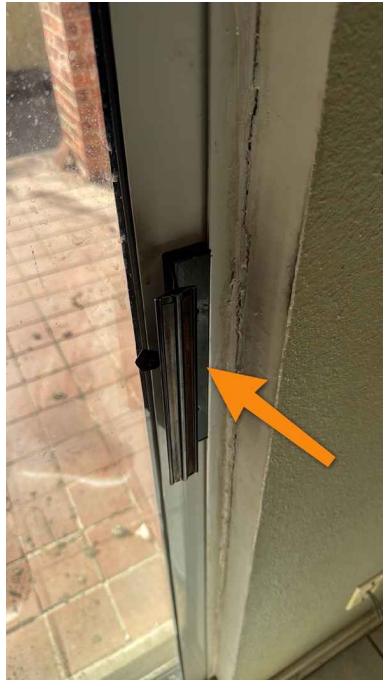
Back Door

Observation: The sliding door was observed to not lock properly when tested.

Implication: A door that does not lock compromises the security of the home and may allow unintended access. This condition may be caused by misalignment, worn locking hardware, or an improper installation.

Recommendation: I recommend evaluation and repair by a qualified contractor or door specialist. The locking mechanism should be adjusted or replaced as needed to ensure proper security and safe operation.

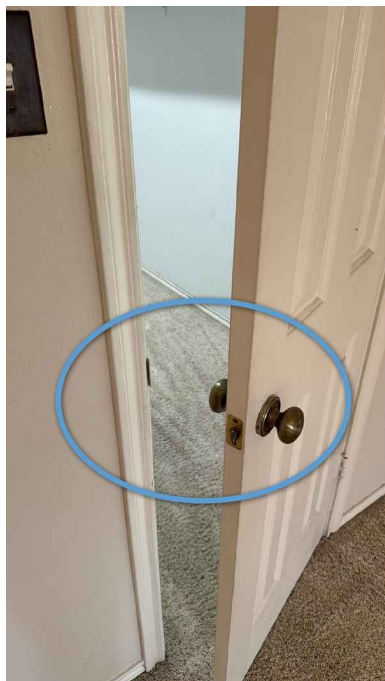
Primary Bedroom Closet Door

Observation: One or more doors were observed with hardware that is misaligned or not operating smoothly, indicating that adjustment is needed.

Implication: Misaligned door hardware can cause difficulty opening or closing the door, improper latching, or premature wear of hinges and latch components. If left uncorrected, this condition may lead to further damage to the door or frame.

Recommendation: I recommend adjustment of the door hardware by a qualified contractor or handyman to ensure proper alignment and smooth operation.

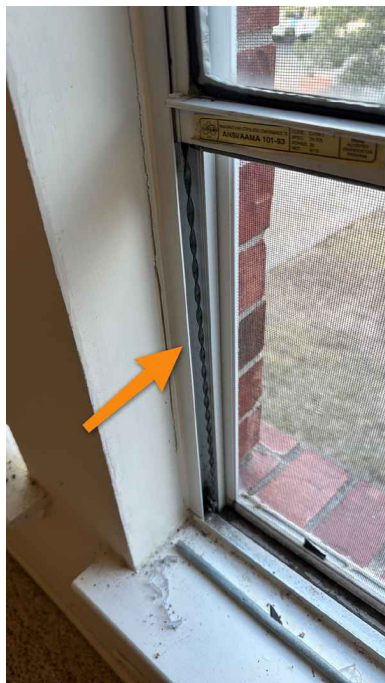
Front Bedroom

Observation: One or more windows were found to have issues with the balancer mechanism, such as being difficult to open or close, or not staying open once raised. The balancer is responsible for assisting with the window's movement and keeping it in place.

Implication: A malfunctioning or broken balancer can cause the window to be difficult or unsafe to operate. In some cases, it may cause the window to fall suddenly, posing a safety risk, especially for children. Additionally, this issue can affect the window's energy efficiency if it does not seal properly when closed.

Recommendation: I recommend having the balancer mechanism evaluated and repaired or replaced by a qualified window professional to restore proper function and safety to the window.

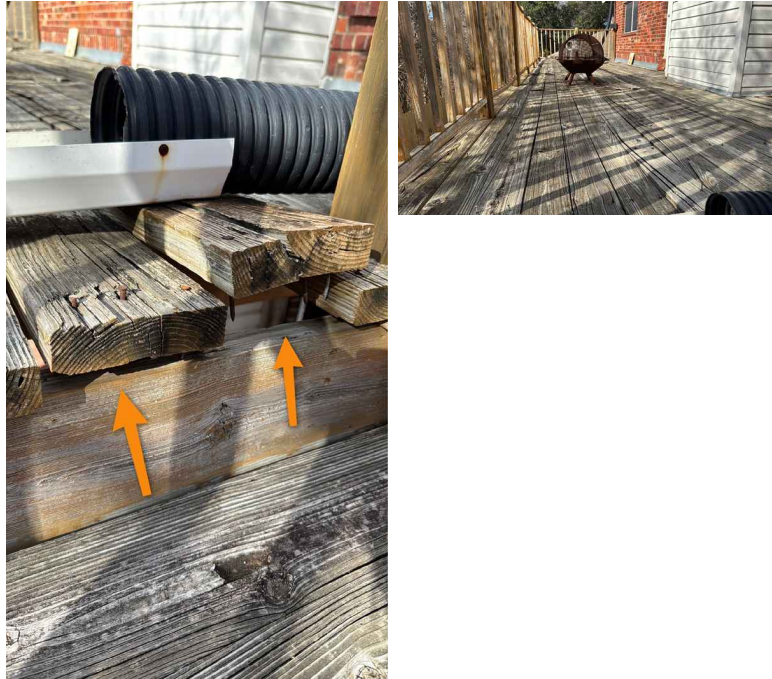
Multiple Locations

Observation: One or more deck boards were observed to be loose and not securely fastened to the underlying framing.

Implication: Loose deck boards can create a trip hazard and may shift under foot traffic, increasing the risk of injury. Over time, continued movement can also lead to further deterioration of fasteners or framing members.

Recommendation: I recommend securing or replacing the affected deck boards using appropriate fasteners. A qualified contractor or handyman should perform the repairs to ensure safe and stable deck surfaces.

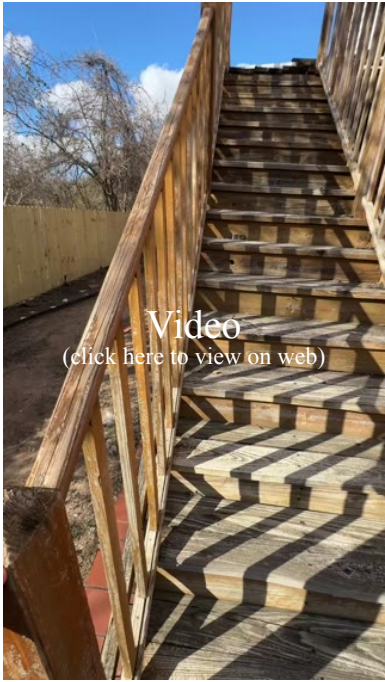
### 3: Wobbly Handrail

Observation: The handrail was observed to be loose and wobbly when tested.

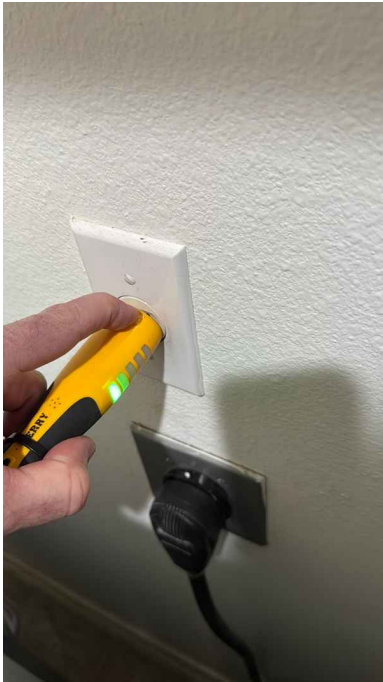
Laundry Room

**3: Smoke Alarms Missing, Defective Or Outdated**

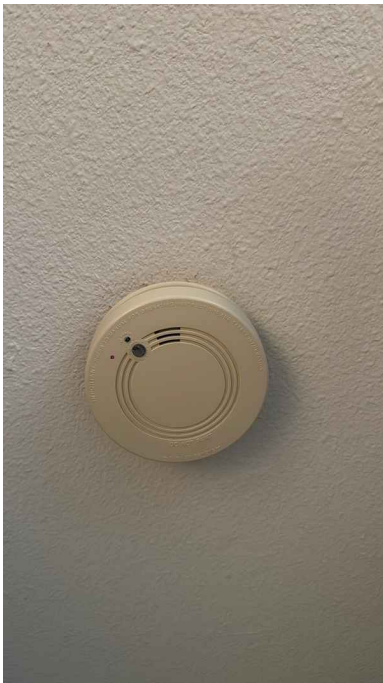
**4: SMOKE DETECTORS BEEPING**

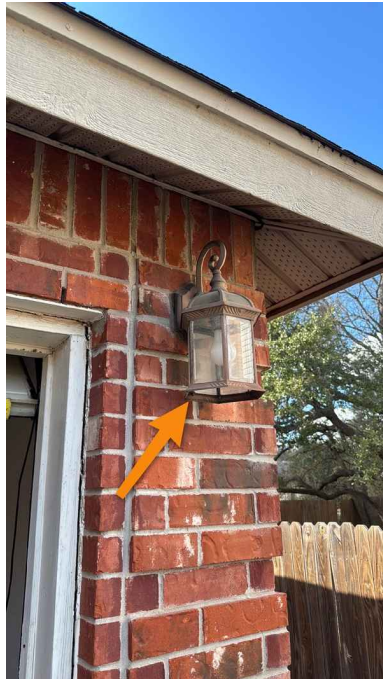
Front Right Side Of Home

Light bulb did not function at the time of inspection. Socket had power but bulb did not light. This is most likely caused by a bad bulb.

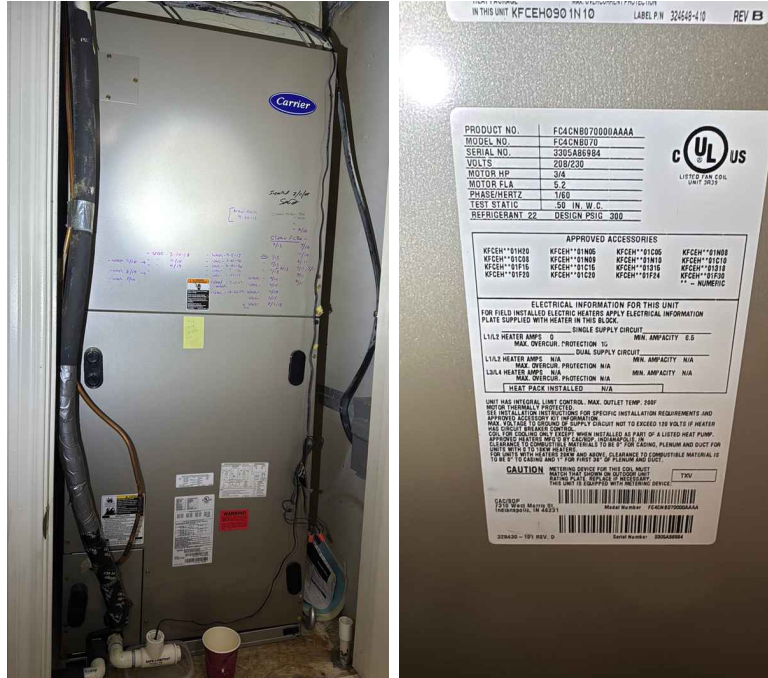
*Photo Of Unit And Serial Number:*

*Manufacturer:* Carrier

*Year of Manufacture:* 2005

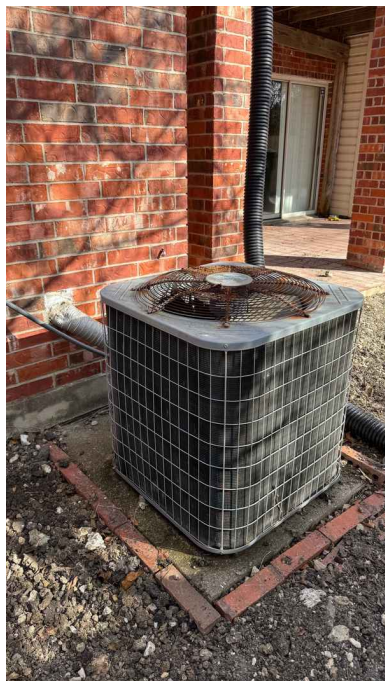
The HVAC equipment appeared to be an older appliance at the end of its lifespan, and the future life expectancy cannot be determined without further evaluation.

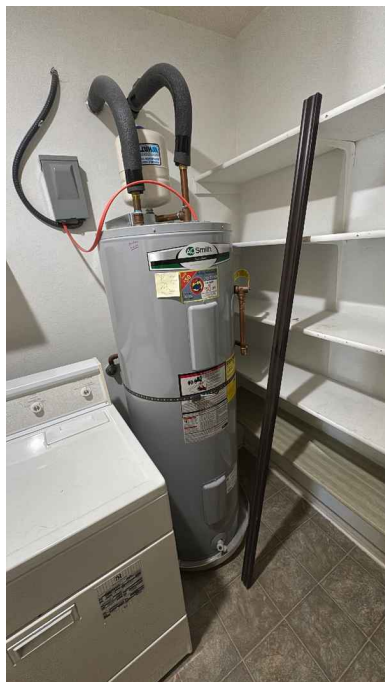
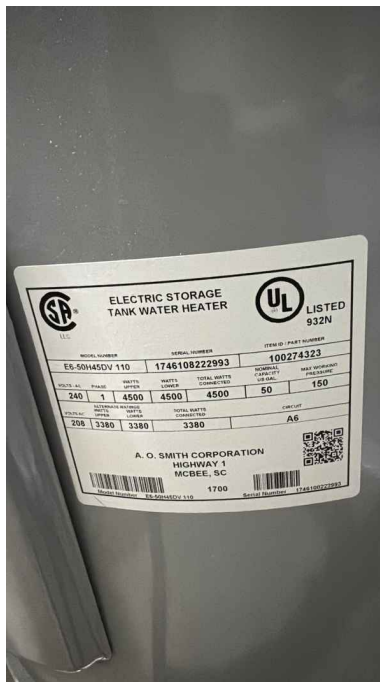
- ☒
☐
☐
☐ 
 C. Water Heating Equipment  
*Photo of Unit And Serial Number:*

Manufacturer: AO Smith  
 Year of Manufacture: 2017  
 Capacity: 50 Gallons

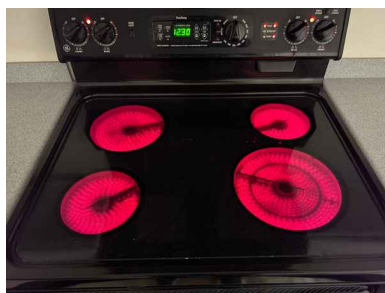
The heating elements were set to high and inspected for proper functionality. No deficiencies were found unless noted below.

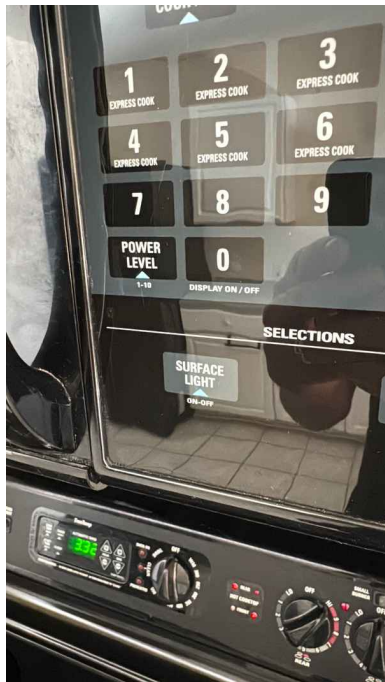
The light on the microwave was not functioning at the time of inspection. This may be a bulb or a loose connection. Recommend further evaluation from a qualified professional.

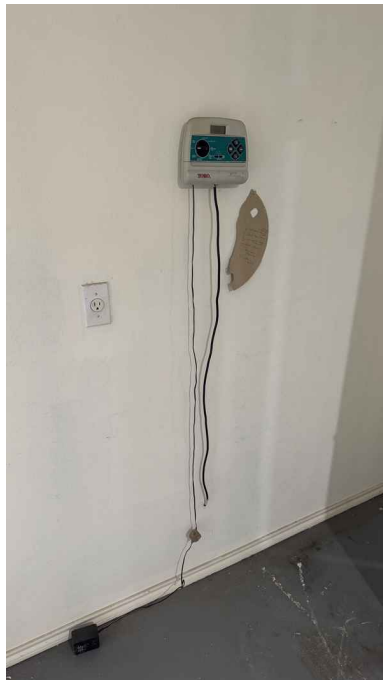
The irrigation controller was unplugged and not inspected for normal operating conditions
