**RE: Mountain View Residential Property, Loudoun County, Virginia
Wetland Delineation and Jurisdictional Determination Request**

USGS Quadrangle Map
Mountain View Residential Property
38°54'53" N, 77°29'56" W, Herndon, VA and Arcola, VA USGS Quadrangle Maps
PL45 (Cub Run), HUC 02070010 (Middle Potomac-Anacostia-Occoquan)
Loudoun County, Virginia

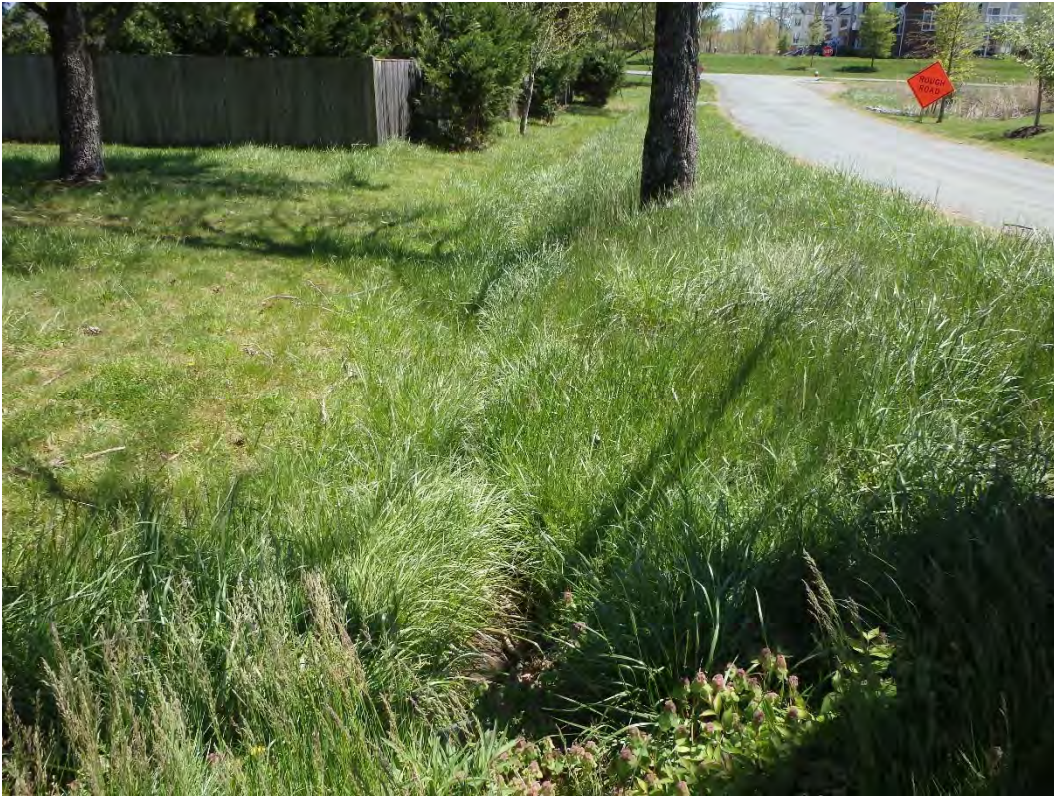
Two roadside ditches are located along Mountain View Drive within the southern portion of the Property (Photo #1) and one roadside ditch is located along Mountain View Drive within the western portion of the Property (Photo #2). No jurisdictional features were identified within these areas. Data Point DP-C1 was collected within a depression in the western portion of PIN 128396515 (Photo #3). This area supports hydrophytic vegetation (silver maple, green ash, and broad-leaf cattail) and exhibits surface water, water-stained leaves, and hydric soils with a depleted matrix. However, it is evident that this area has developed within uplands after construction of an adjacent sanitary sewer. Therefore, this depression should not be considered a jurisdictional feature.

Photo #1: View to the southeast of a roadside ditch along Mountain View Drive in the southern portion of the Property; no jurisdictional features were identified within this area (April 22, 2020, by B. Noveno, BCG).

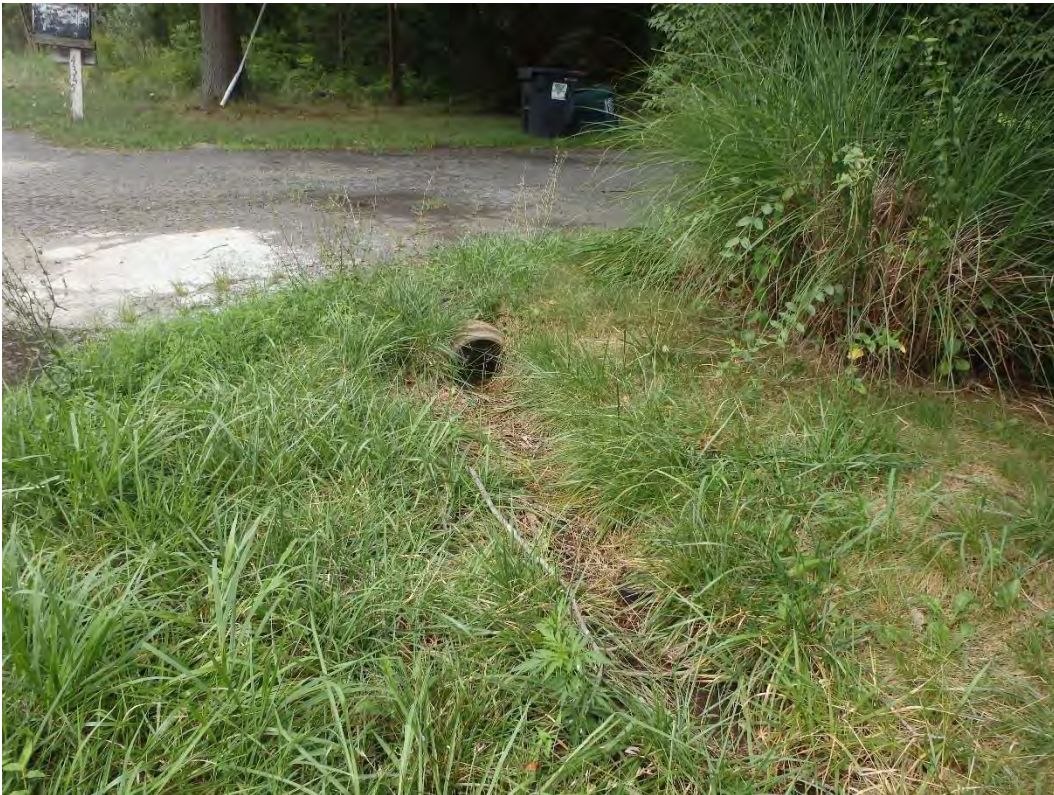
Photo #2: View to the northwest of a roadside drainage ditch along Mountain View Drive within the western portion of the Property; no jurisdictional features were identified within this area (August 5, 2020, by B. Noveno, BCG).

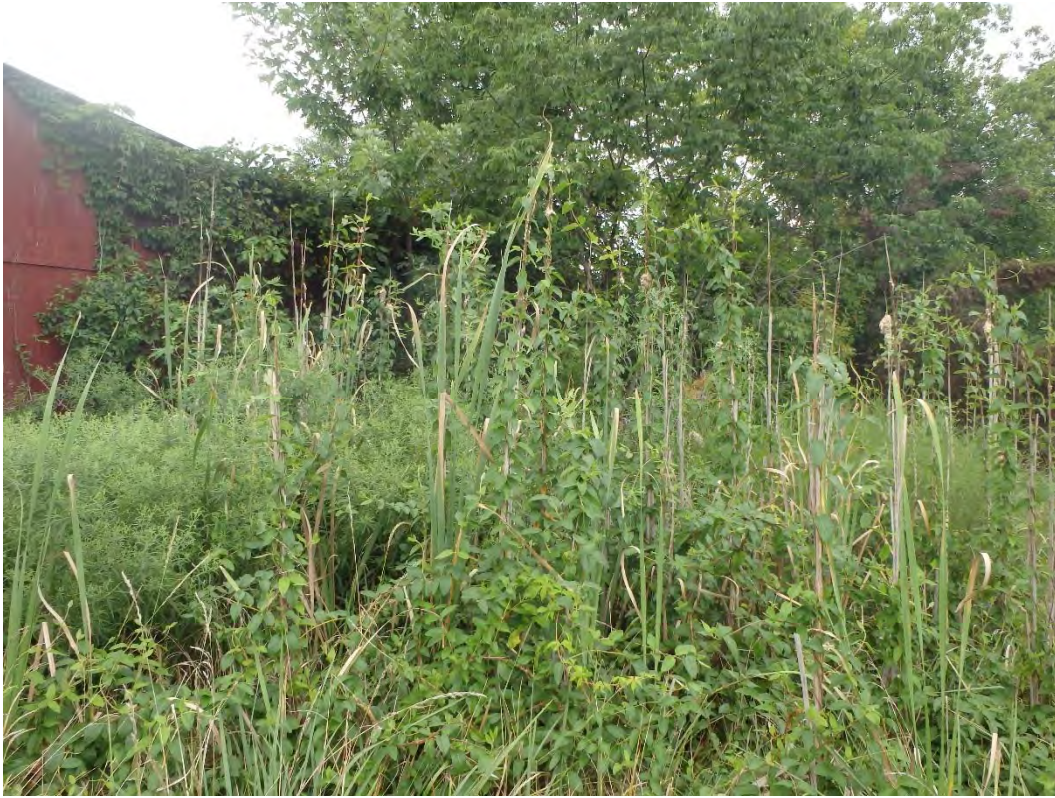
Photo #3: View to the northwest of Data Point DP-C1, which was collected within a depression in the western portion of PIN 128396515; this area exhibits all three wetland parameters. However, it is evident that it has developed within a recently disturbed area associated with the recently constructed adjacent sanitary sewer (August 5, 2020, by B. Noveno, BCG).

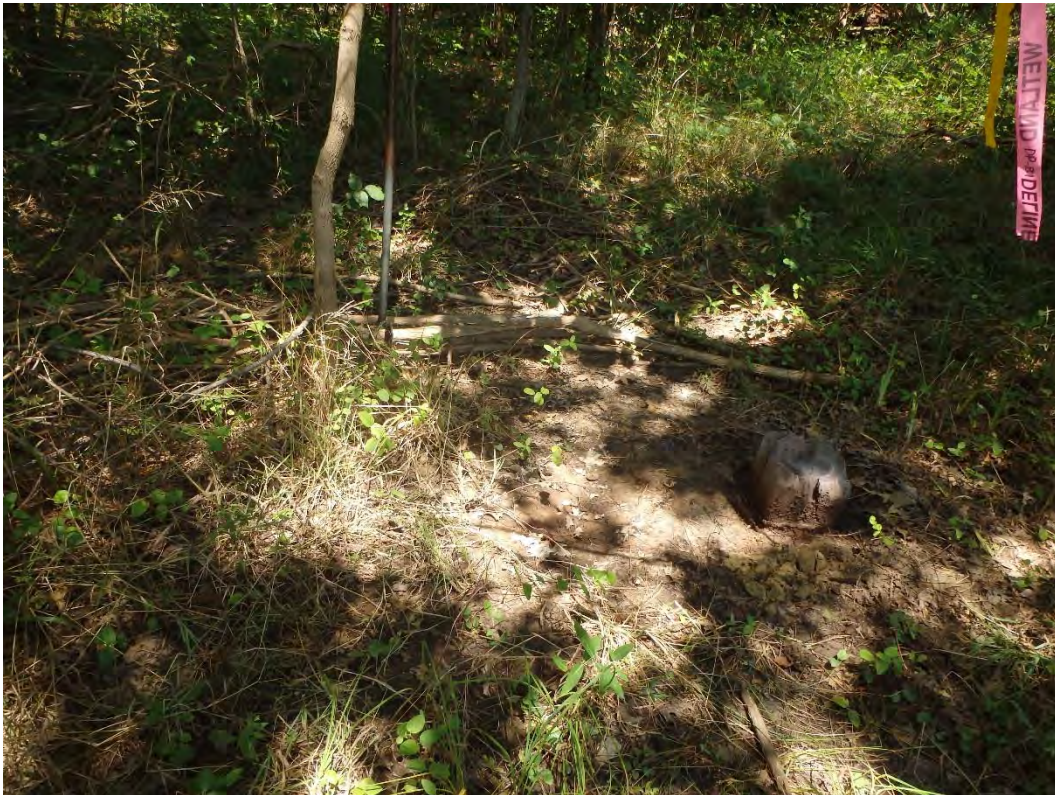
Wetland B, a palustrine forested wetland flagged B1/B2 through B7/B16, and measuring approximately 1,625 square feet (0.04 acre), is located within the western portion of the Property. Data Point DP-B1 was collected within the upper portion of Wetland B near Flags B1/B2 (Photo #4); this area supports hydrophytic vegetation (pin oak, green ash, silver maple, and poison ivy) and exhibits water-stained leaves, drainage patterns, FAC-neutral test, and hydric soils with a depleted matrix. Data Point DP-B2 was collected within the lower portion of Wetland B near Flags B14/B16 (Photo #5); this area supports hydrophytic vegetation (green ash, pin oak, silver maple, and poison ivy) and exhibits water-stained leaves, drainage patterns, FAC-neutral test, and hydric soils with a depleted matrix. Data Point DP-B3 was collected just downslope and outside of Wetland B near Flags B7/B16 (Photo #6); this area supports hydrophytic vegetation (green ash, pin oak, persimmon, and poison ivy) but does not exhibit hydric soils or wetland hydrology. A direct jurisdictional connection to downstream waters was not observed downslope of Wetland B.

Photo #4: View to the northwest of Data Point DP-B1, which was collected within the upper portion of Wetland B near Flags B1/B2 (August 5, 2020, by B. Noveno, BCG).

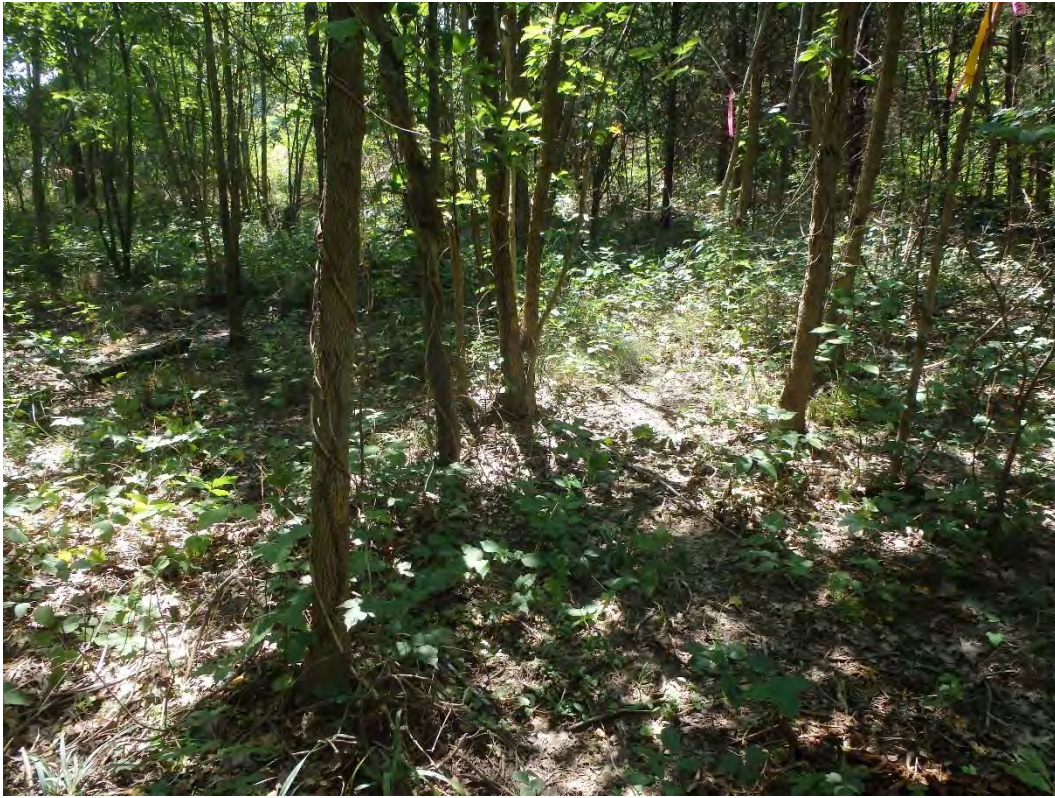
Photo #5: View to the southeast of Data Point DP-B2, which was collected within the lower portion of Wetland B near Flags B14/B16 (August 5, 2020, by B. Noveno, BCG).

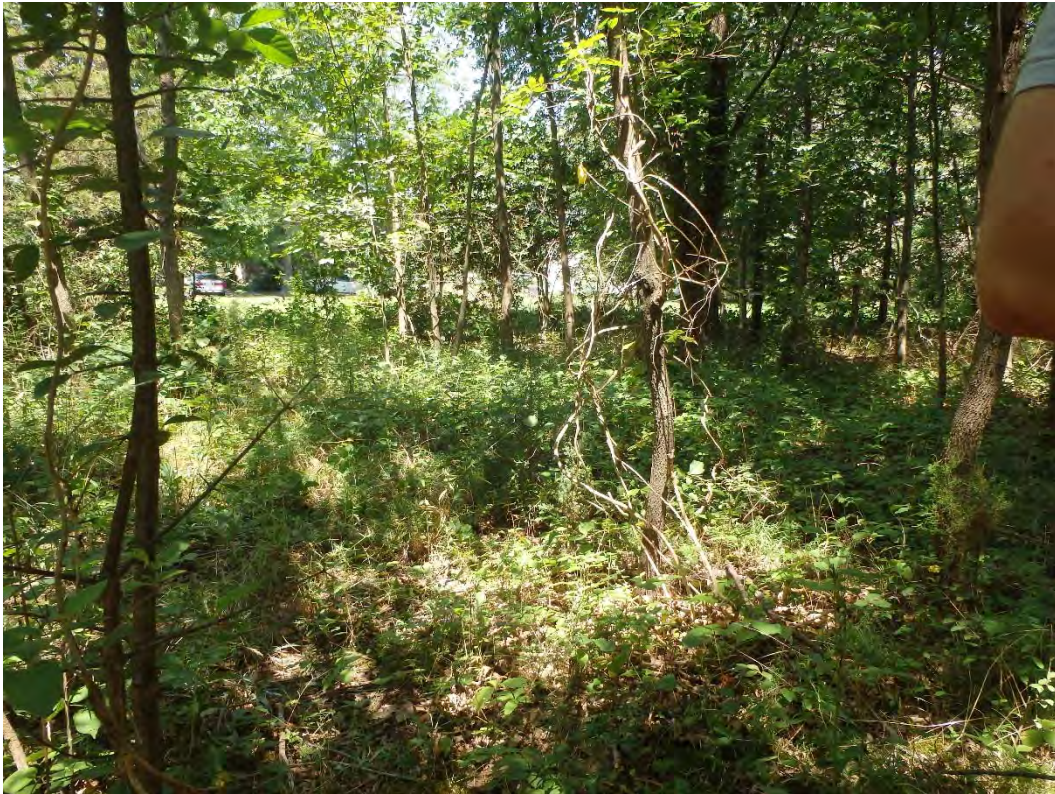
Photo #6: View to the northwest of Data Point DP-B3, which was collected just downslope and outside of Wetland B near Flags B7/B16; this area supports hydrophytic vegetation but does not exhibit hydric soils or wetland hydrology (August 5, 2020, by B. Noveno, BCG).

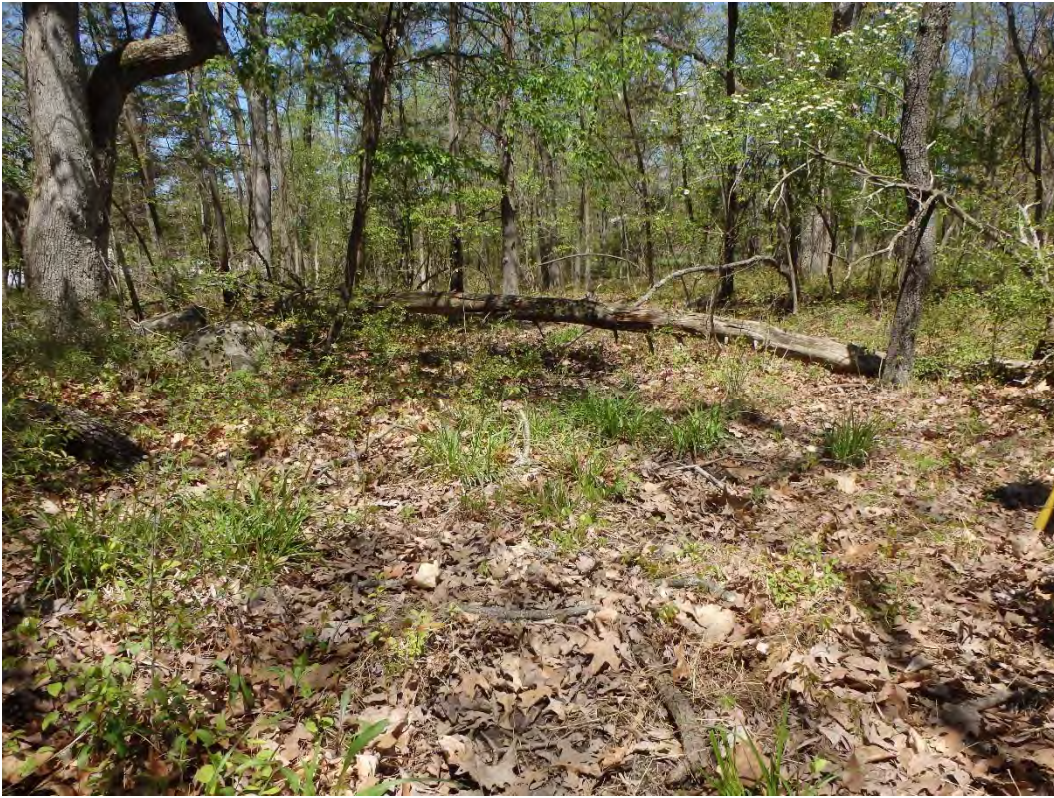
Wetland A, a palustrine forested wetland flagged A1/A2 through A12/A19, and measuring approximately 1,787 square feet (0.04 acre) within its upper portion, is located within the northwestern portion of the Property (Photo #7). Data Point DP-A1 was collected within Wetland A near Flags A13/A15 (Photo #8); this area supports hydrophytic vegetation (slippery elm and pin oak) and exhibits a high water table, algal mat or crust, water-stained leaves, drainage patterns, FAC-neutral test, and hydric soils with a depleted matrix. Data Point DP-A2 was collected just upslope and outside of Wetland A near Flags A13/A15 (Photo #9); this area does not exhibit any of the three wetland parameters. Wetland A transitions to a palustrine emergent wetland flagged A12/A19 through A14/A21 and measuring approximately 414 square feet (0.01 acre) within a sanitary sewer easement at Flags A12/A19 (Photo #10). Wetland A transitions back to palustrine forested wetland flagged A14/A21 through Flags A24/A29, measuring approximately 1,154 square feet (0.03 acre) within the Property at Flags A14/A21. Photo #11 provides a representative view of the lower portion of Wetland A near Flags A20/A25. Wetland A continues to the north and outside the limits of investigation at Flags A26/A31 (Photo #12).

Photo #7: Downslope view of Wetland A from its origin at Flags A1/A2 (April 22, 2020, by B. Noveno, BCG).

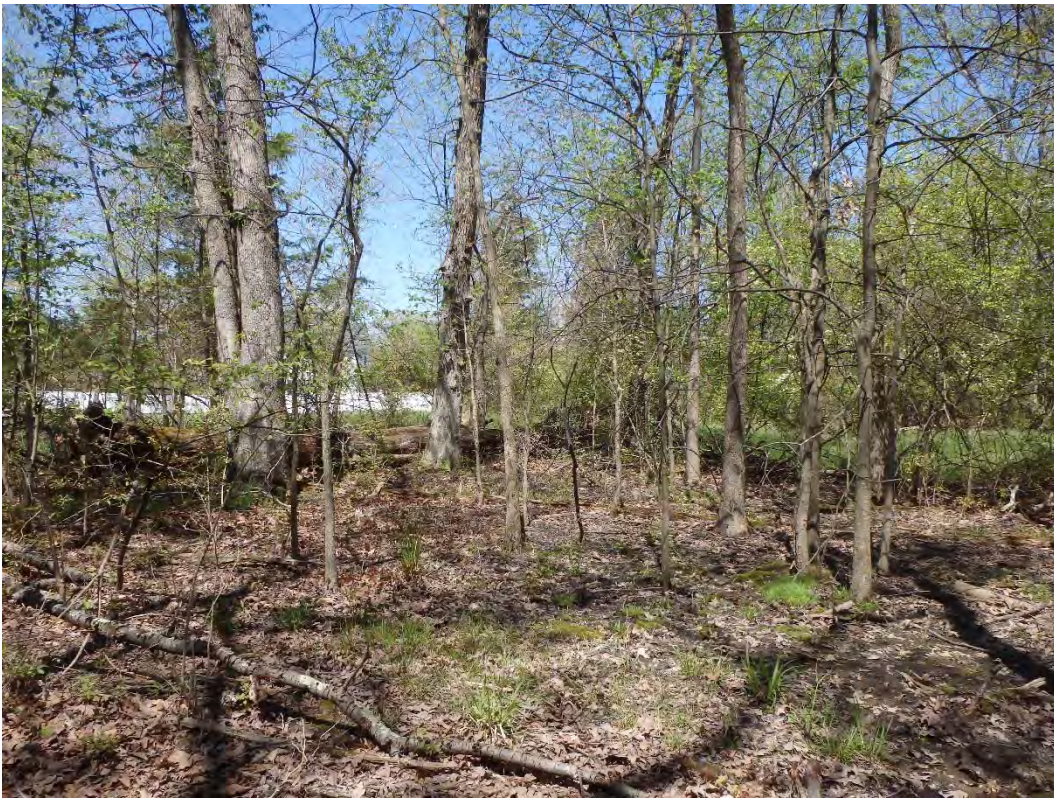
Photo #8: View to the northwest of Data Point DP-A1, which was collected within the upper portion of Wetland A near Flags A13/A15 (April 22, 2020, by B. Noveno, BCG).

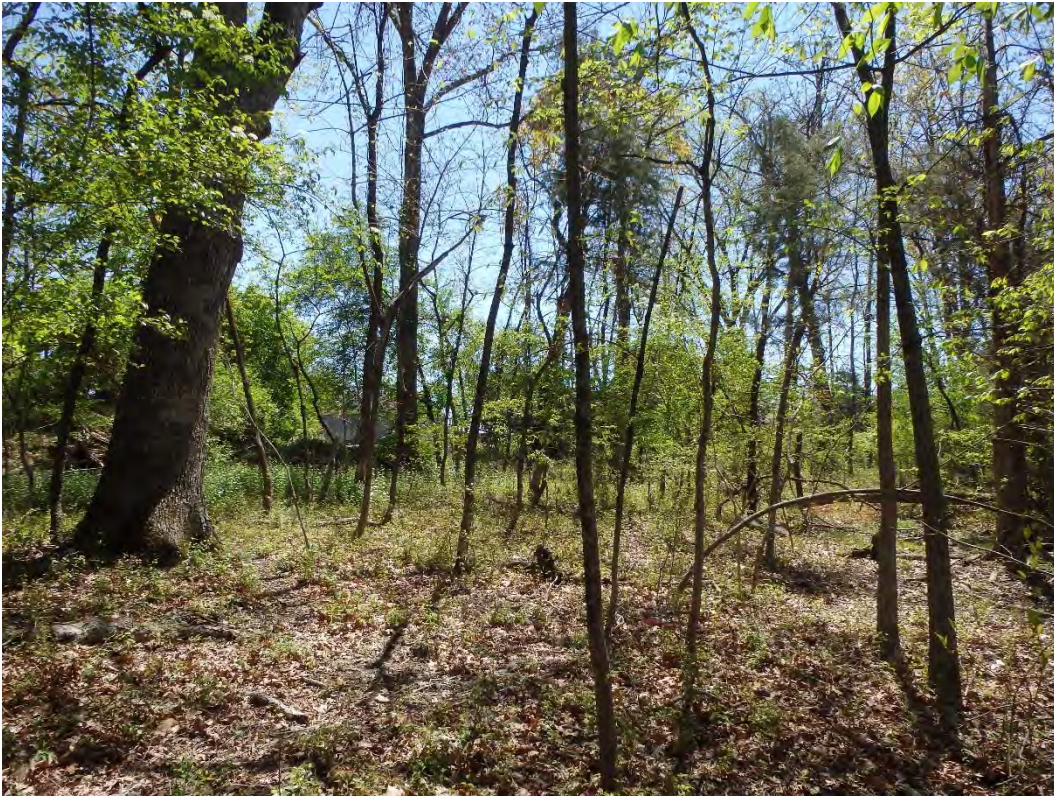
Photo #9: View to the east of Data Point DP-A2, which was collected just upslope and outside of Wetland A near Flags A13/A15; this area does not exhibit any of the three wetland parameters (April 22, 2020, by B. Noveno, BCG).

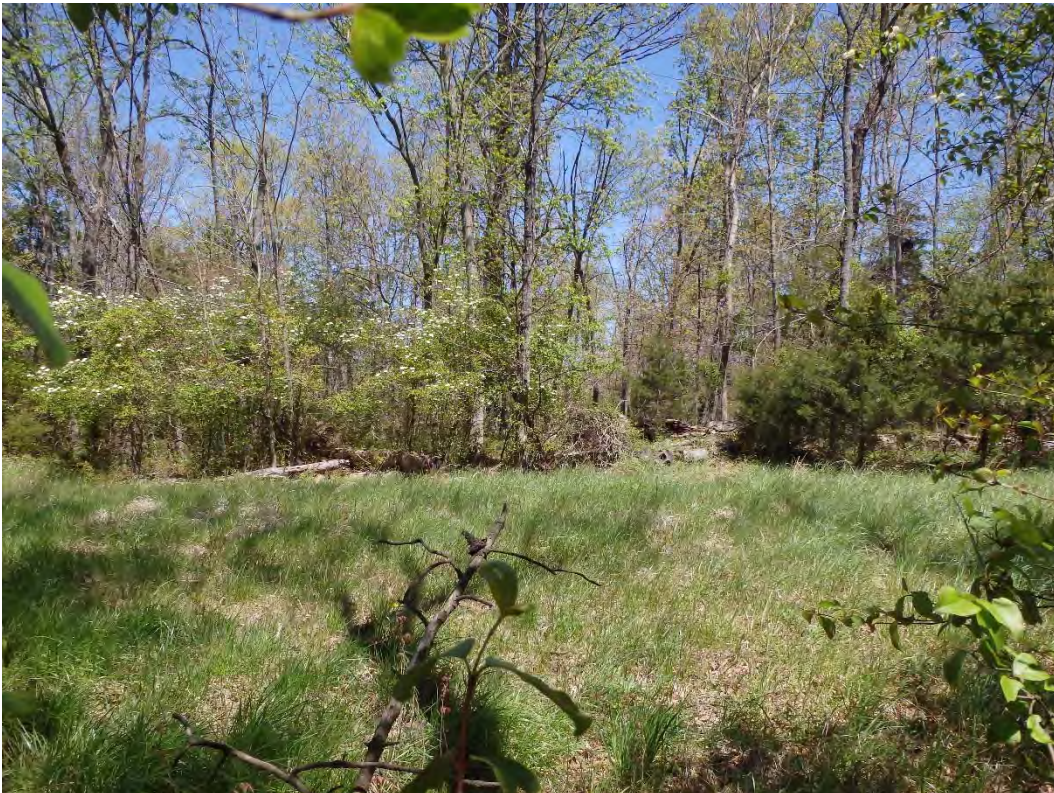
Photo #10: Downslope view of Wetland A from near Flags A12/A19, where it transitions to palustrine emergent wetland (April 22, 2020, by B. Noveno, BCG).

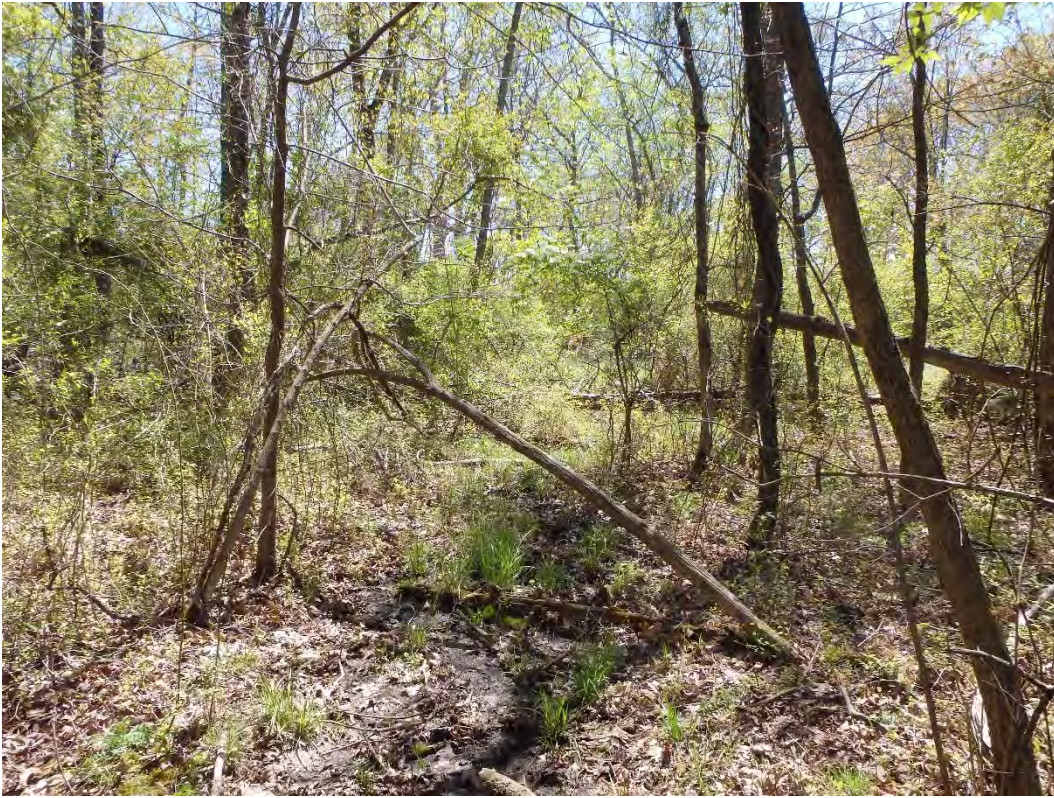
Photo #11: Upslope view within the lower portion of Wetland A from Flags A20/A25 (April 22, 2020, by B. Noveno, BCG).

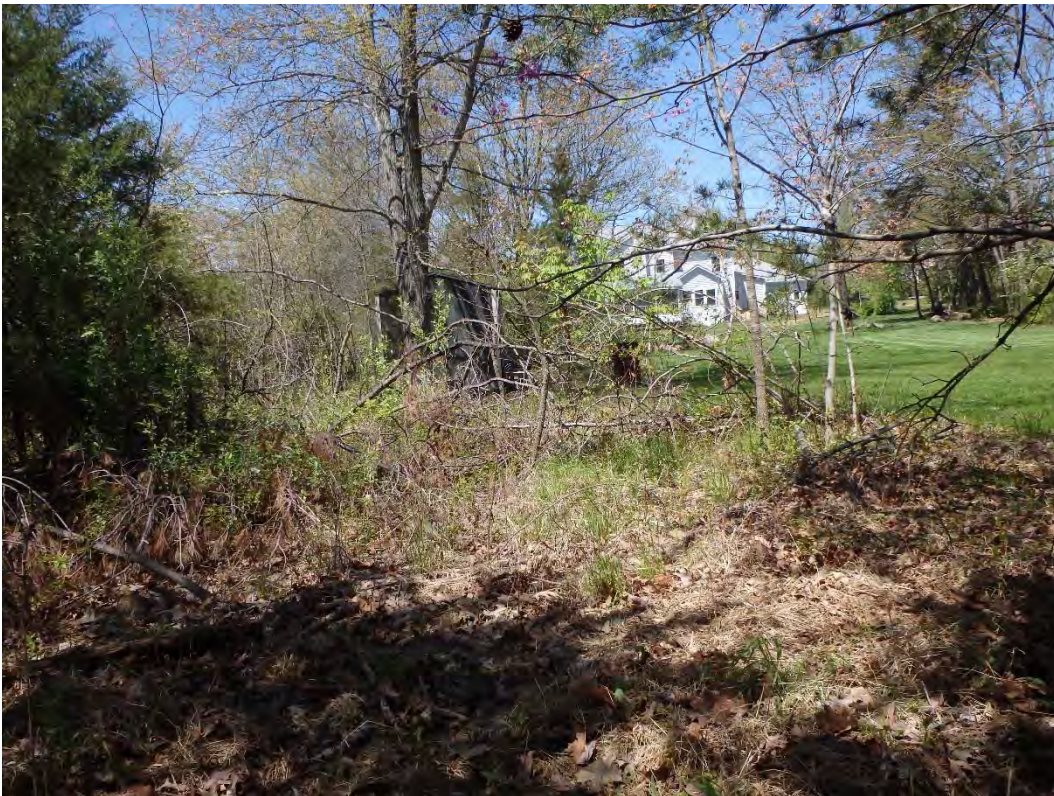
Photo #12: Downslope view of Wetland A from Flags A26/A31, where Wetland A continues to the north and outside the limits of investigation (April 22, 2020, by B. Noveno, BCG).
