Phase One Environmental Site Assessment - 19 Tamblyn Road, Orono, Ontario

May 8, 2024

Prepared for:
Creative Millwork Inc.

Cambium Reference: 19462-001

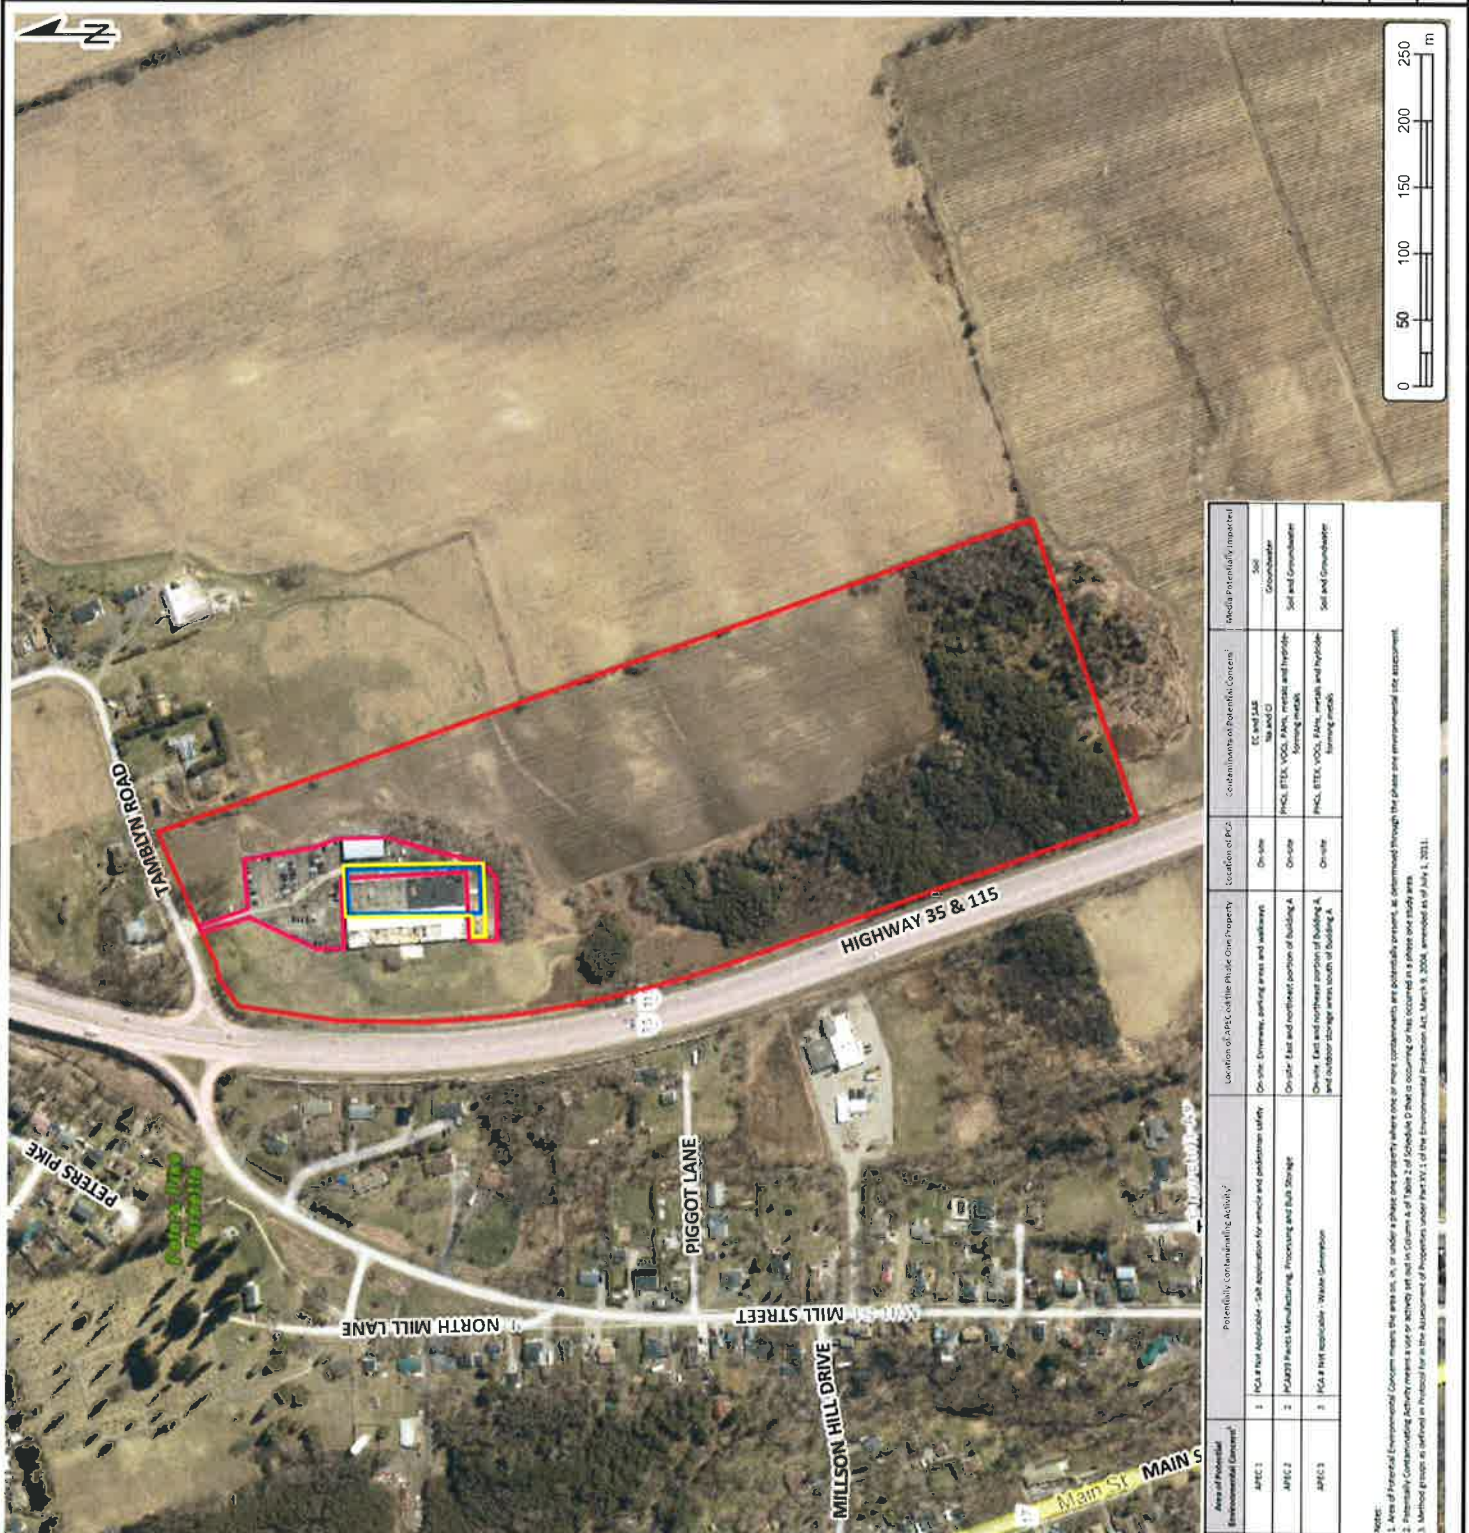
CONCEPTUAL SITE MODEL
SITE PLAN

Area of Potential Environmental Concern	Potentially Contaminating Activity?	Location of APEC on the Phase One Property	Location of APEC	Contaminants of Potential Concern	Media potentially impacted
APEC 1	1. HCA #1 not applicable - Call Application for vehicle and pedestrian safety	On-site: Driveway, parking area and walkways	On-site	EC, and LULU	Soil
APEC 2	2. HCA#2 Parts: Manufacturing, Processing and Bulk Storage	On-site: East and northwest portion of Building A and outdoor storage areas south of Building A	On-site	PHCL, BTEX, VOCs, PAHs, metals and hydrocarbons, burning metals	Soil and Groundwater
APEC 3	3. HCA #3 not applicable - Waste Generation	On-site: East and northwest portion of Building A, and outdoor storage areas south of Building A	On-site	PHCL, BTEX, VOCs, PAHs, metals and hydrocarbons, burning metals	Soil and Groundwater

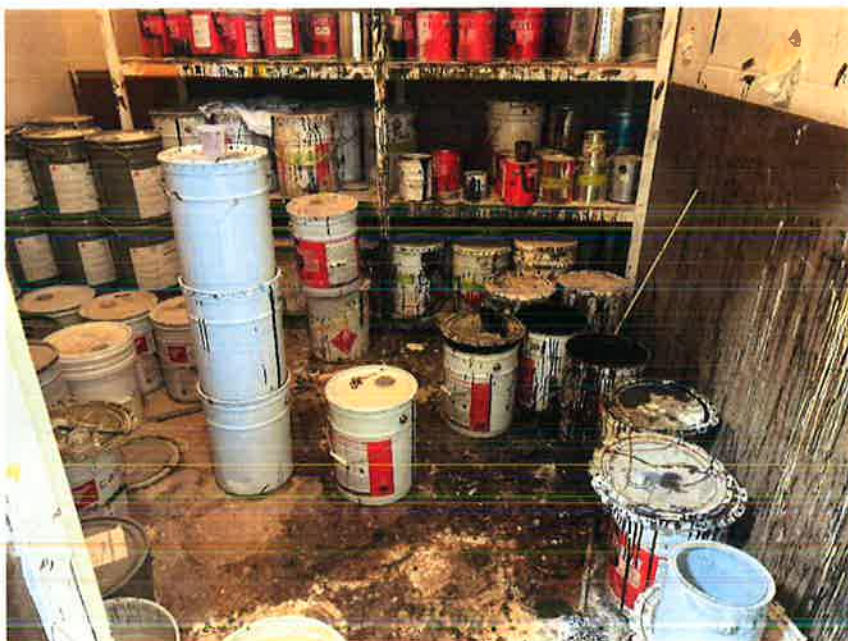
Varnishes, paints, solvents, and adhesive materials were observed during the Site visit in 20 L plastic pails and 205 L steel drums throughout the east side of Building A in the painting area. Off-spray and paint stains were observed in the vicinity of the storage areas; however, the concrete floor appear competent without pitting or cracks. Floor drains were not observed in the vicinity of painting or material storage areas. As previously noted, the on-site spray-painting and associated waste generation are considered PCAs that contribute to APECs.

Photo 1 Paint products storage area inside Building A, January 2024.

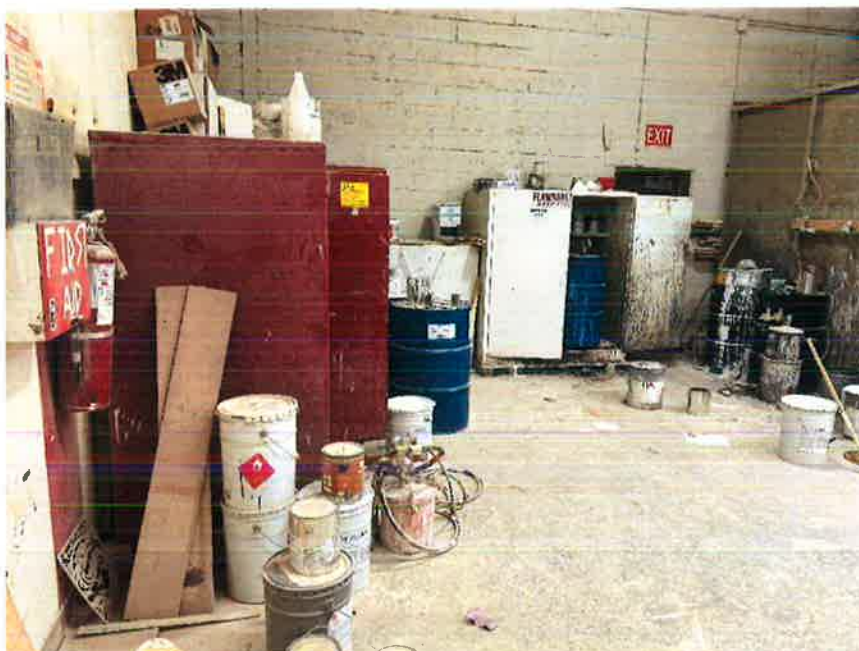
Building A largely consisted of active machineries related to custom millwork and painting areas. Active storage of raw timber, wood sheets and industrial paint products in 20 L plastic pails and 205 L steel drums were observed in Building A.

Photo 2 Interior of work area inside Building A, January 2024.

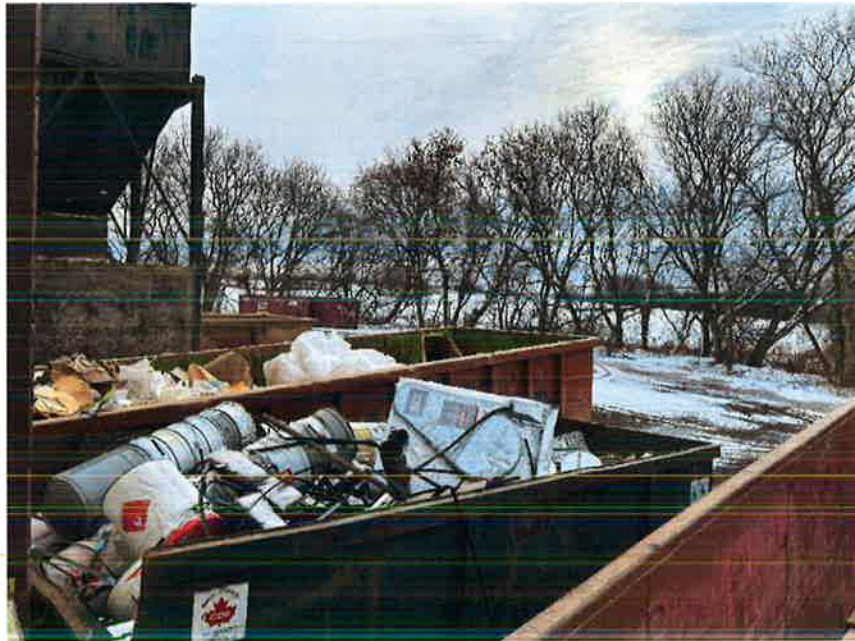
Saw dust waste was observed at the Site as part of the millwork processing during the site visit. The southern portion of the warehouse consists of a large industrial grade dust collection unit actively collecting the saw dust from the millwork activities and is stored in drums until removal. Spent/leftover paint and solvent related wastes are stored in drums and dumpsters until removal.

Photo 5 Dumpsters at southern docks of Building A, January 2024.

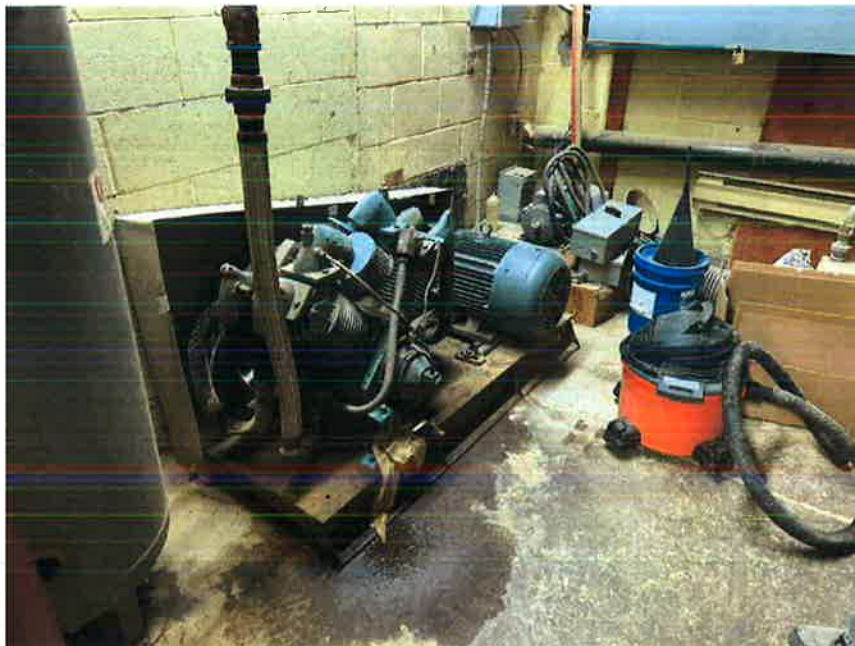
- A small leak of compressor fluid was observed in Building A; however, the concrete floor was competent without pitting or cracks in the vicinity of the leak.
- Off-spray and paint stains were observed in the vicinity of the paint storage areas in Building A; however, the concrete floor was competent without pitting or cracks.

Photo 6 Compressor and adjacent small leak inside Building A, January 2024.

No other indications of significant spills were observed during the site visit. Based on the small size of the compressor fluid leak it is recommended the flooring in this area is cleaned, and the compressor is serviced. Based on the competent concrete flooring in the vicinity of these spills they are not considered PCAs; however, as previously noted the on-site operations and associated waste generation are considered PCAs that contribute to APECs.

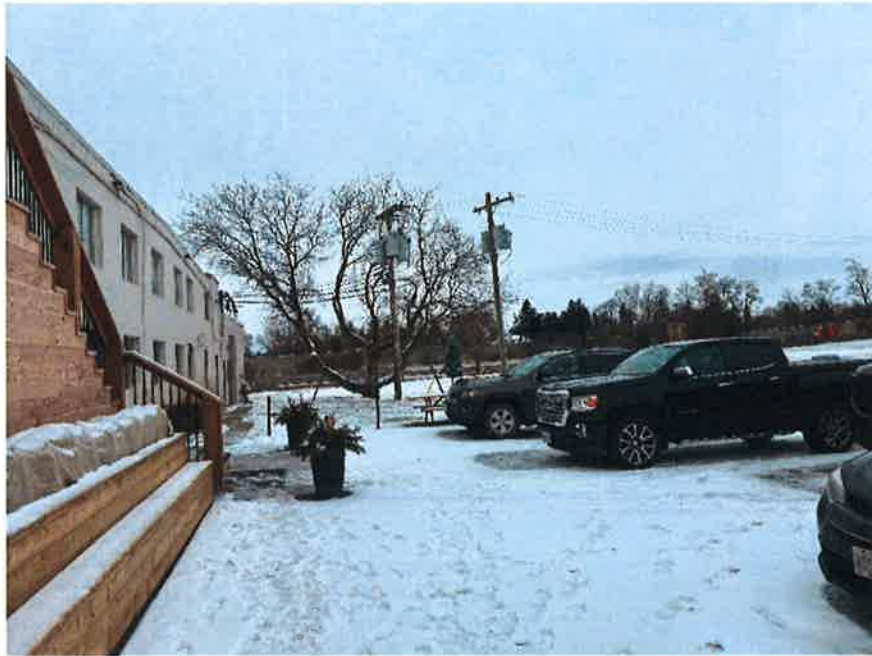
Electricity is supplied through overhead wires. A pole mounted transformer unit was observed on the north portion of the Site. No staining was observed, and no spills were reported in relation to this transformer, therefore this is not considered a PCA.

Photo 7 Looking west at the pole mounted transformers at the north of Building A, January 2024.

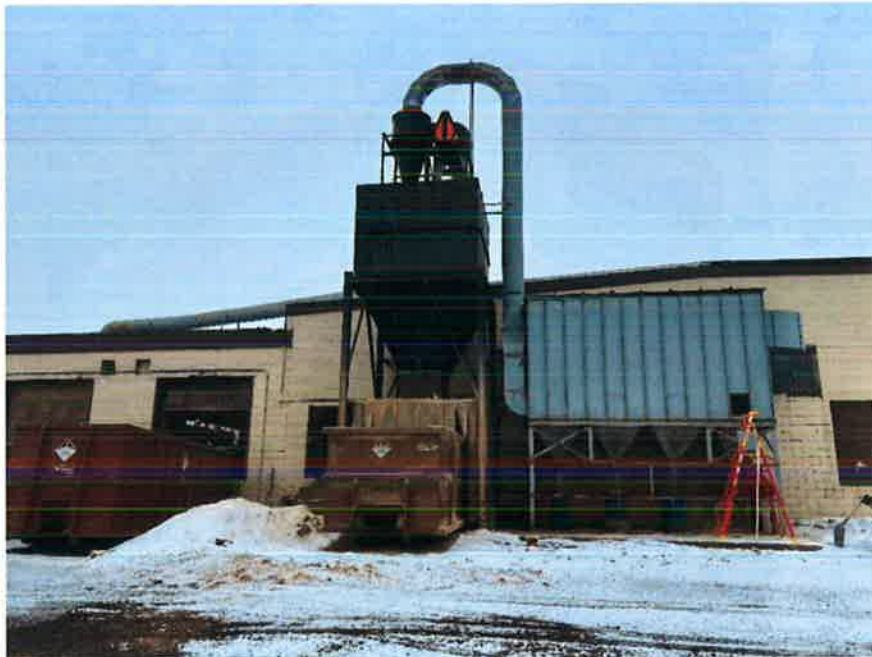
No significant by-products or waste are currently generated at the Site, with the exception of saw dust waste and spent/leftover paint and solvent related wastes. A dust collection unit and waste storage are located on the south side of Building A. Hazardous wastes are removed off-site on a regular basis (monthly) by Sav-tech Solvent Inc. As previously noted, the on-site associated waste generation is considered a PCA that contributes to an APEC.

Photo 10 Looking north at the dust collection unit located south of Building A, January 2024.
