## Environmental Overview

14 125<sup>th</sup> St Gulf, Marathon

The applicant is proposing to build a resort for disabled veterans. This will include utilizing the existing two-story building, and constructing 10 individual modulars, a tiki, pool, and dock.

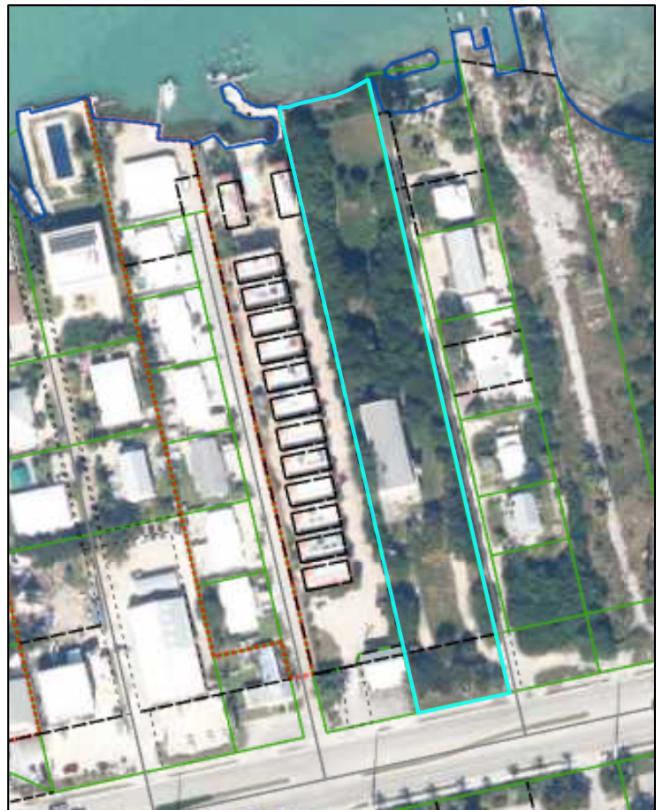
Figure 1- Subject Parcel

As shown in Figure 1, the parcel is bordered on the west by a multi structure development. It is bordered on the north by an unarmored shoreline and on the east and south by paved roads, 125<sup>th</sup> street and US 1 respectively. For purposes of this report, the front of the parcel will be considered that which borders US 1.

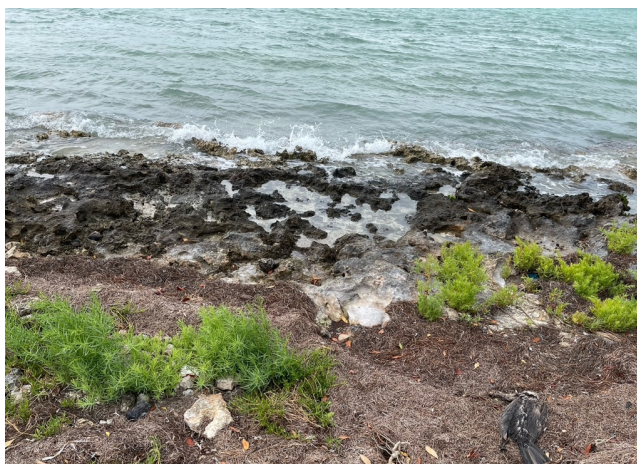
The shoreline is unarmored. A sharp coral rock is the located along the waters edge. A strip of wetland vegetation is located landward of the coral rock and the parcel quickly transitions to uplands. Pictures of the property are provided in Attachment A.

Shoreline

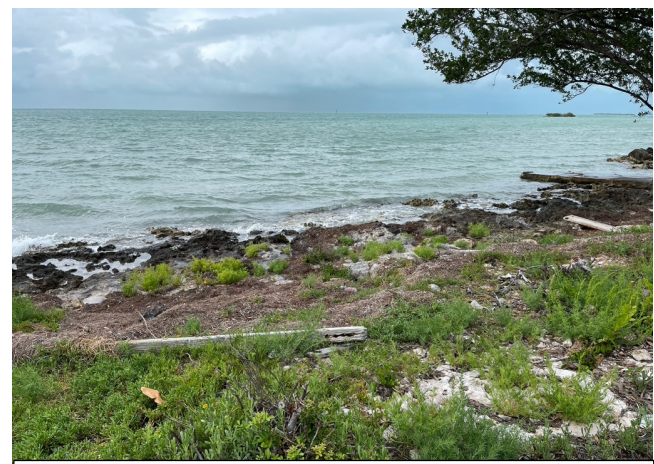
Shoreline
