# Uniform Mitigation Verification Inspection Form

Inspection Date: Monday, November 21, 2022		
<b>Owner Information</b>		
Owner Name:		Contact Person:
Address: 7724 Front Beach Rd		Home Phone:
City: Panama City Beach	Zip: 32407	Work Phone:
County: Bay		Cell Phone:
Insurance Company:		Policy #:
Year of Home: 1985	# of Stories: 1	Email:

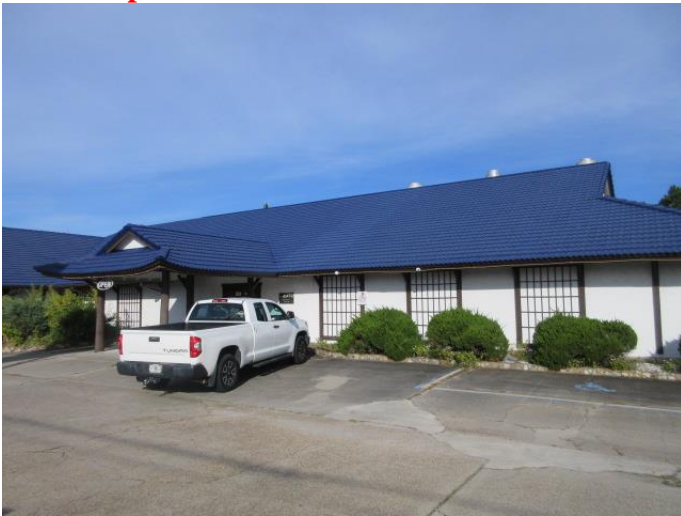
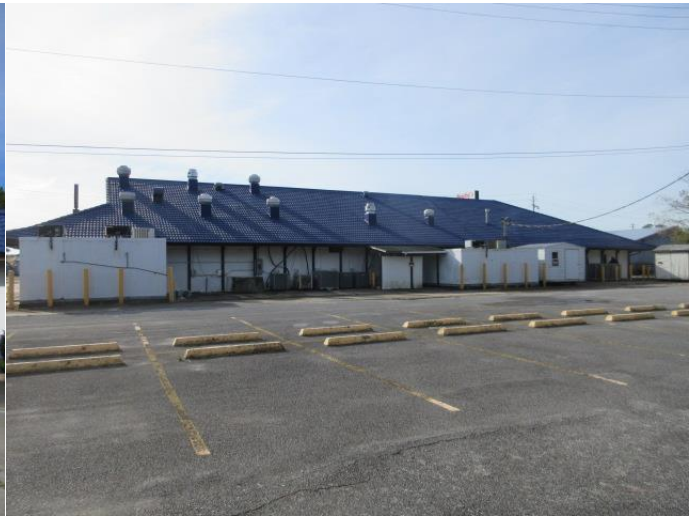
**Roof Shape:**

- A. Hip Roof Hip roof with no other roof shapes greater than 10% of the total roof system perimeter.  
Total length of non-hip features: 48 feet; Total roof system perimeter: 498 feet
- B. Flat Roof Roof on a building with 5 or more units where at least 90% of the main roof area has a roof slope of less than 2:12. Roof area with slope less than 2:12 \_\_\_\_\_ sq ft; Total roof area \_\_\_\_\_ sq ft
- C. Other Roof Any roof that does not qualify as either (A) or (B) above.
