El-Shabazz Academy

*1028 W. Barnes Avenue
Lansing, Michigan 48910*

Summary of Significant Property Characteristics & Factors

Subject Property: An Elementary school property

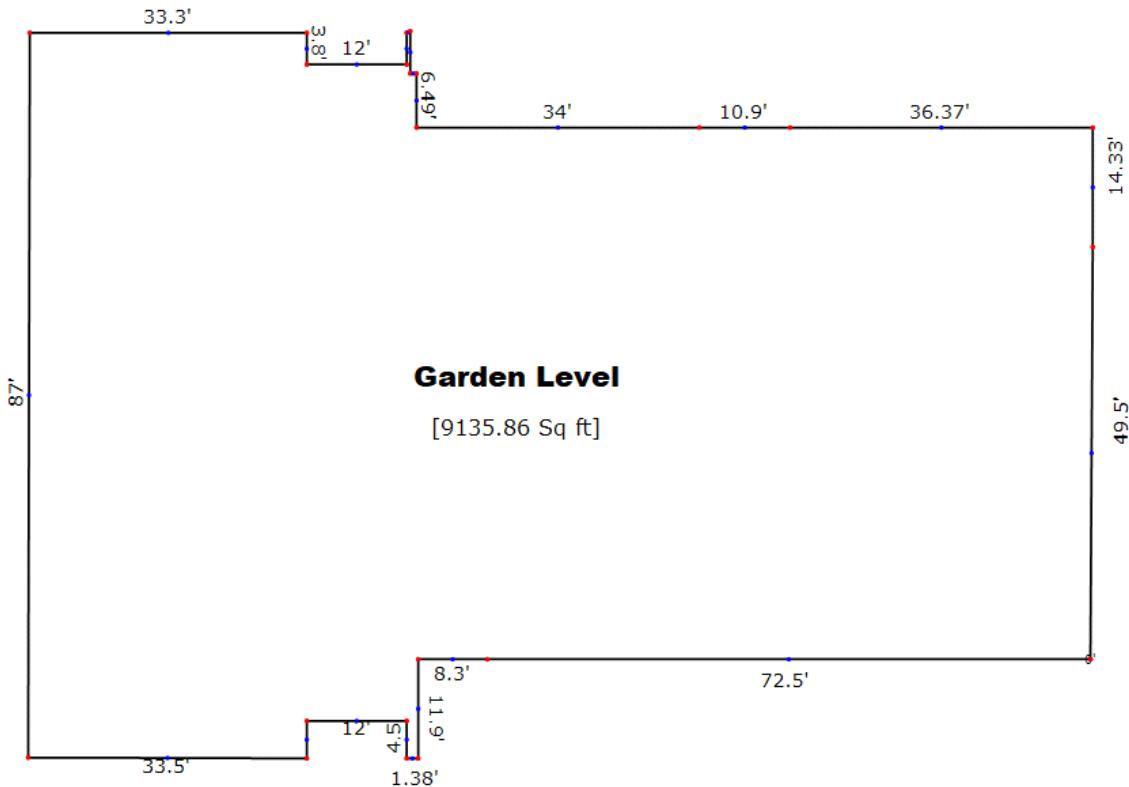
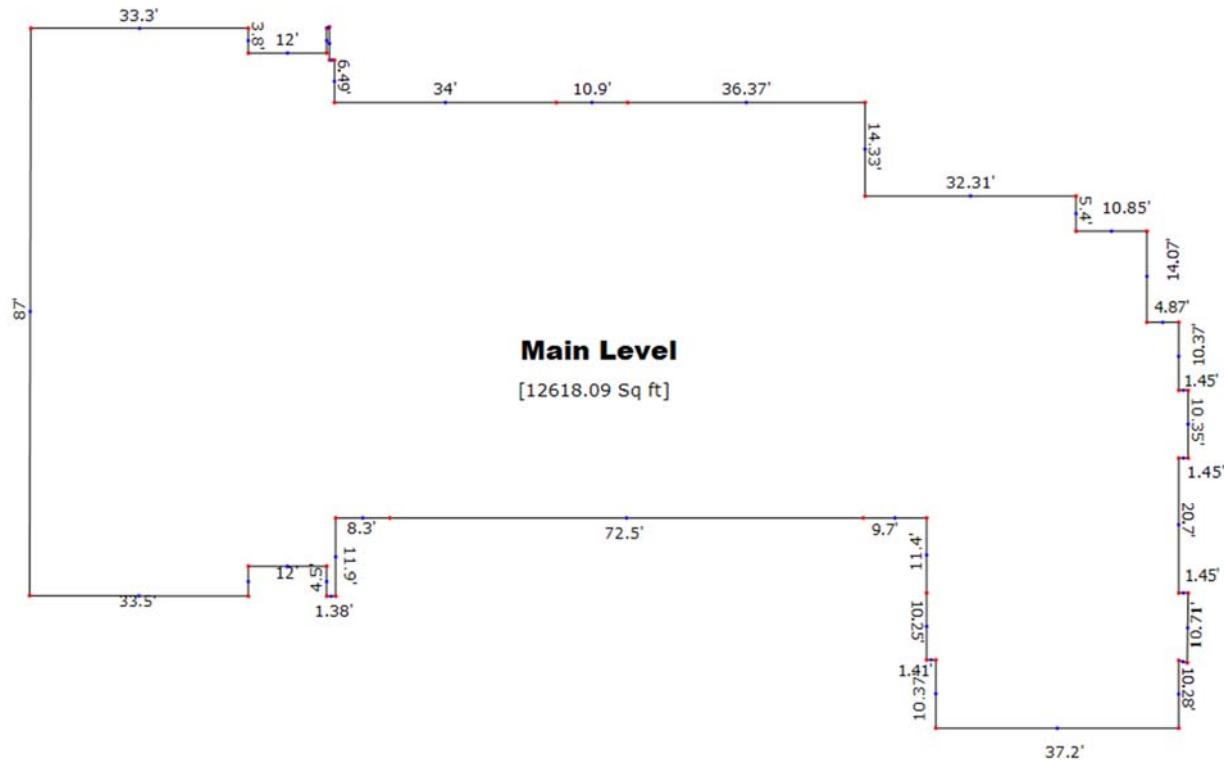
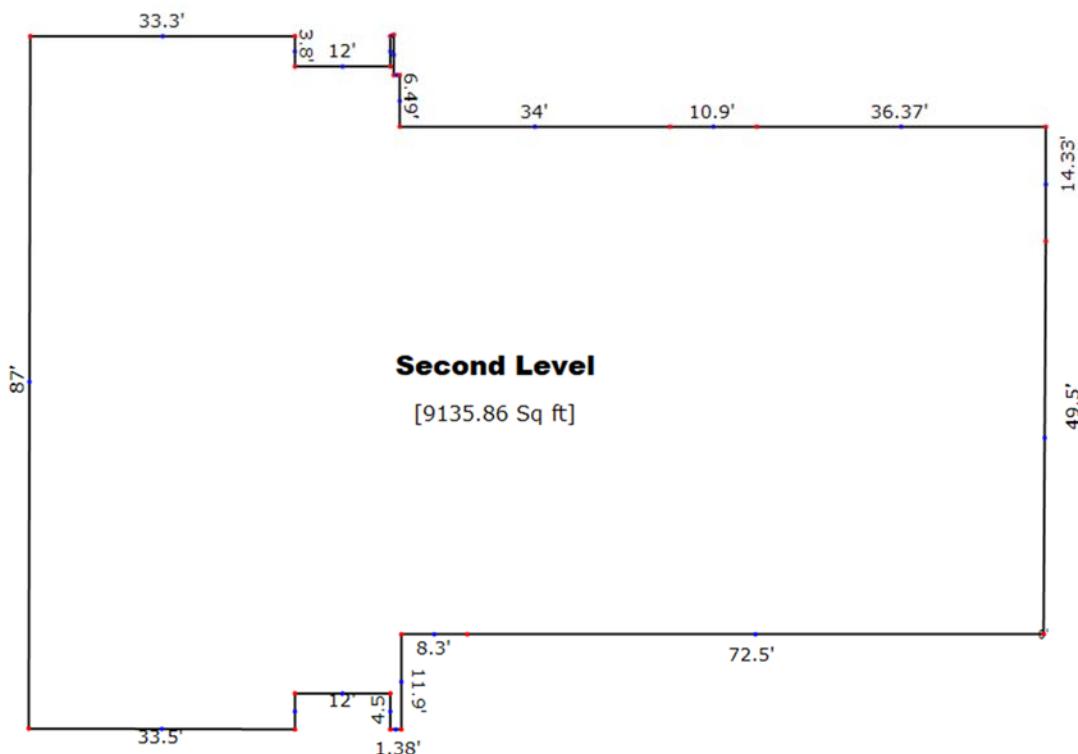
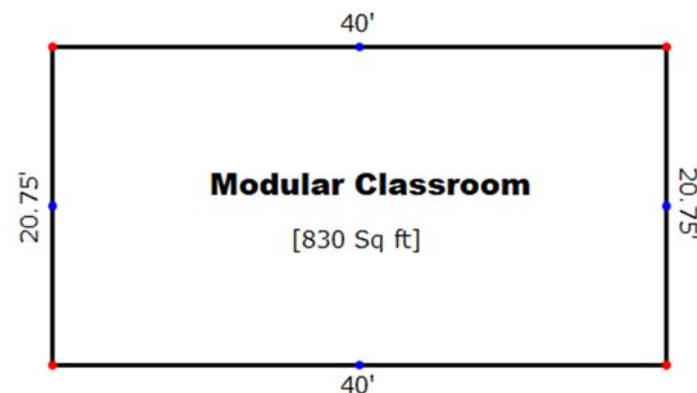
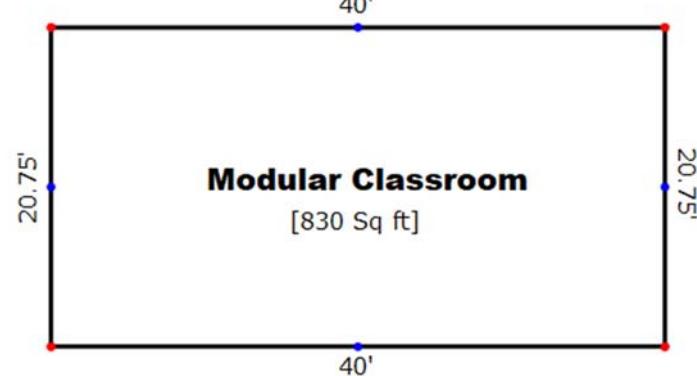
Sketch: A sketch of the primary school building and two modular classroom buildings is provided on the following pages.

The garden level sketch above includes the basement level enclosed crawl space (~700 SF) that is not actually included in the gross building area.

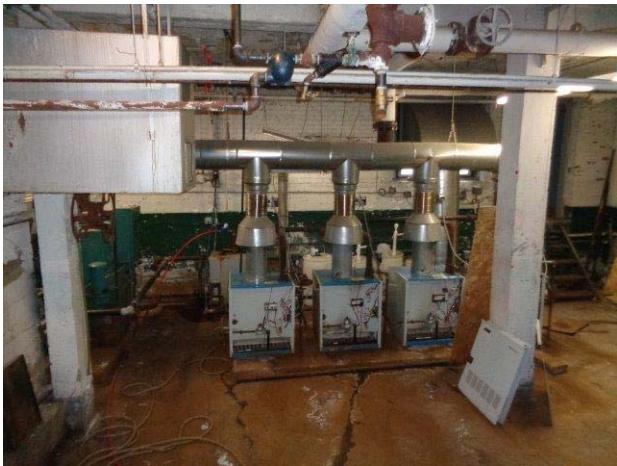
Garden Level Mechanical Room: The mechanical room is located at garden level, and has a water heater, and 4 boilers (model GXH-300 HEDDZ). The gas fired boilers and gas fired water heater operational, and are in good condition.

Garden Level Boiler Room

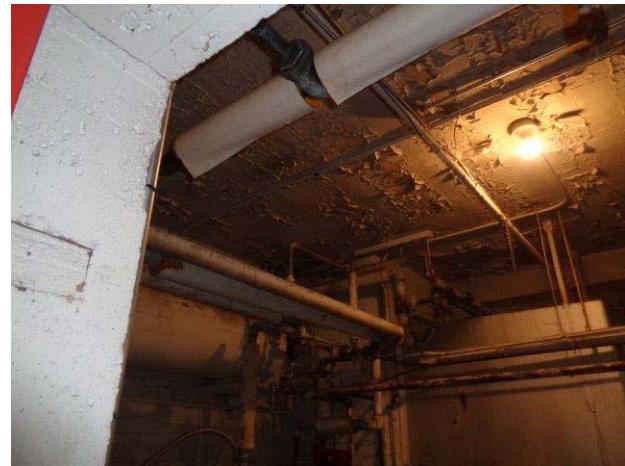
Garden Level Boiler Room Ceiling – Peeling Paint

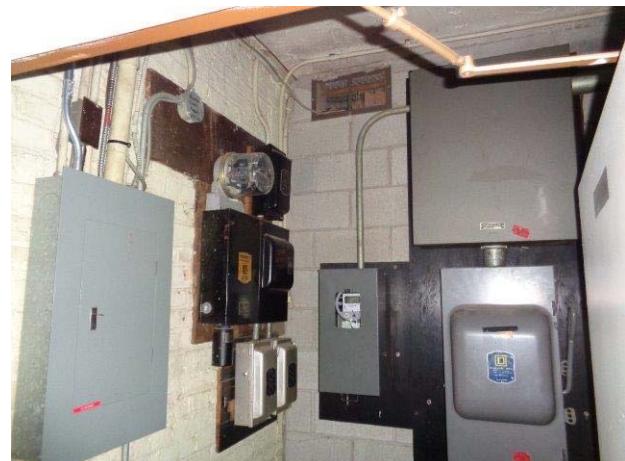
Hallways: One of the hallways at garden level has a long row of metal lockers. The other levels have hallways with painted concrete block and painted drywall walls. The ceilings typically feature a mix of lay-in acoustical ceiling tiles with fluorescent tube lighting. The electrical service is 400 Amperes, 3 phase and 240 VAC. Another electrical service box contains 600 Amps and 600-volt service. The electrical service is located at garden level.

Garden Level Electrical Power Supply

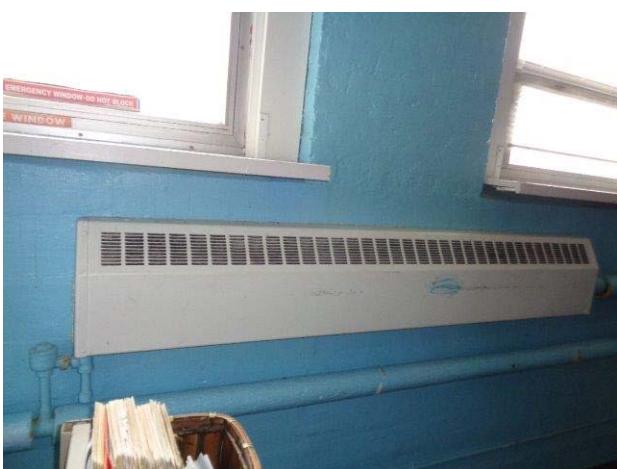
Typical Classroom Heating Unit

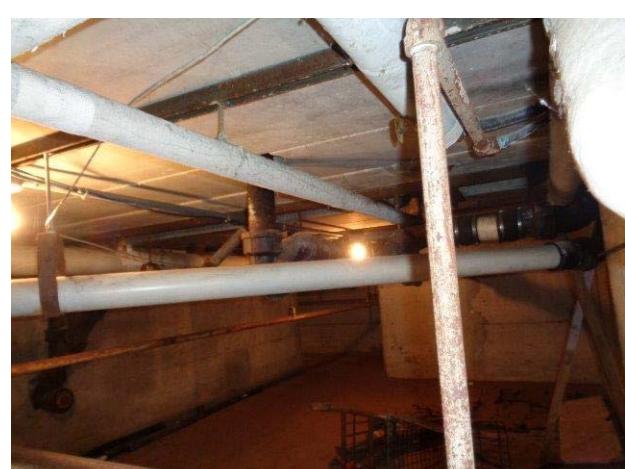
Basement Level Crawl Space: The basement level has an enclosed crawl space and is about 700 square feet. It was omitted from the gross building area calculation. It is built with concrete flooring and concrete walls, and an exposed metal floor joist and concrete ceiling. This crawl space area contains metal plumbing pipes, and a very low ceiling (4.88 feet high).

View of the Garden Level Low Crawl Space

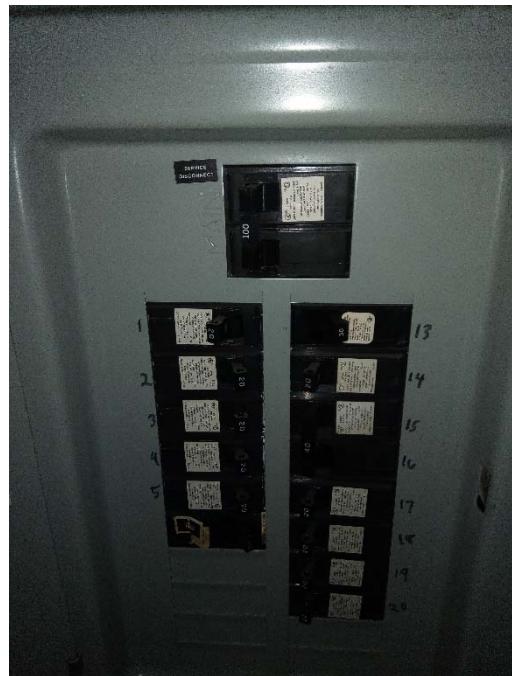
Typical Electrical Service of Modular Classroom
