**WOOD DESTROYING PESTS AND ORGANISM INSPECTION REPORT**

Building No. <b>2718</b>	Street <b>Kollmar Drive #28-40</b>	City <b>San Jose</b>	ZIP <b>95127</b>	Date of Inspection <b>5/17/2025</b>	Number of Pages <b>Page 1 of 9</b>

**AUTHORIZATION AGREEMENT**  
**WOOD DESTROYING PESTS AND ORGANISIMS CONTRACT**  
**2718 Kollmar Drive #28-40, San Jose - Report No. 657757**

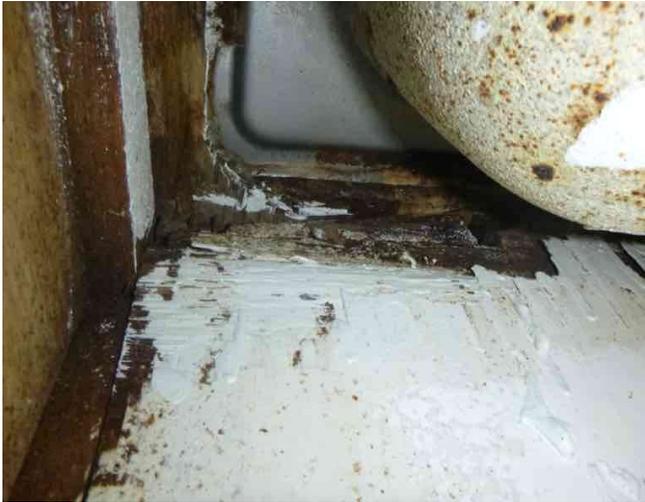
Photo 01

**1A.** FINDING: Water has penetrated through the countertop at the Unit 40 kitchen sink, and has caused fungus damage. (See Photo 1) (See Photo 2)

RECOMMENDATION: Remove the existing counter top and replace any fungus damaged wood *Estimated Cost* members. Install a new ceramic tile counter top in this area. Unless prior arraignments have been made all tile is bid using a builder's grade, neutral color tile with a tight white grout joint. It should also be noted that all tile work regardless of color selection will be done with a tight white grout joint unless specified differently. We at HomeGuard Incorporated are upgrade experts and can provide proposals that include tile, marble, granite, upgraded fixtures, upgraded windows and doors or any other option you may desire. If additional contributing moisture conditions are found then a supplemental report and bid will be issued.  
\*\*\*\*\* (SECTION 1 ITEM) \*\*\*\*\*

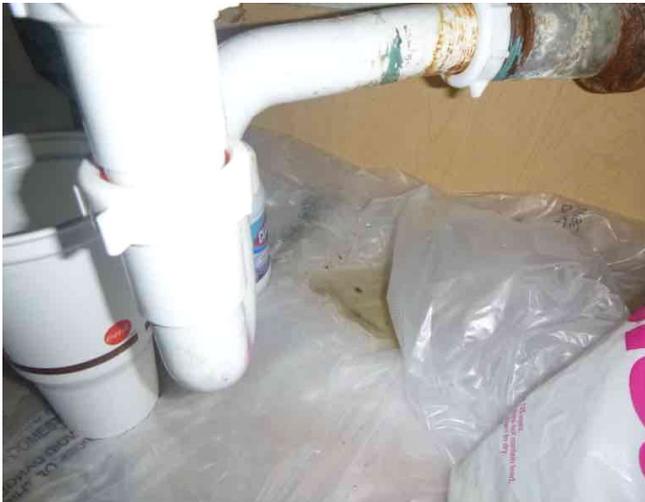
Photo 03

**2C.** FINDING: There is a plumbing leak at the Unit 34 kitchen sink drain. (See Photo 3)

RECOMMENDATION: Reseal or repair this leak in the most practical way.

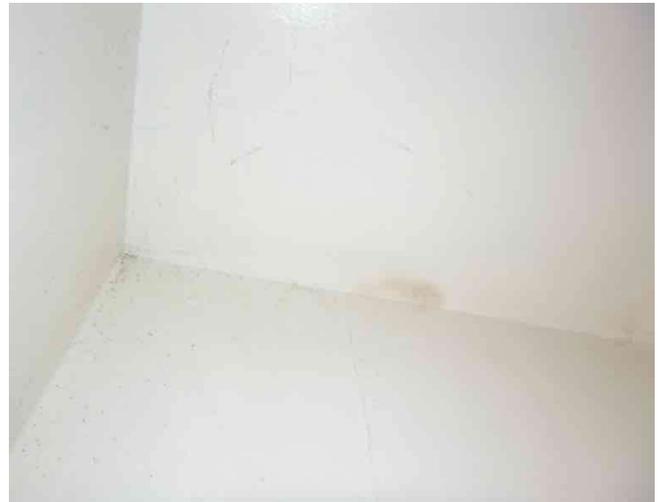
Photo 04

**3C.** FINDING: Water stains were noted on the ceiling in the Unit 34 hall closet. (See Photo 4)

RECOMMENDATION: Open this area to determine the source of these stains and if any damage exists.

*Estimated Cost* All findings, recommendations, and bids will be issued in a supplemental report. This bid is to open the area and further inspection only.

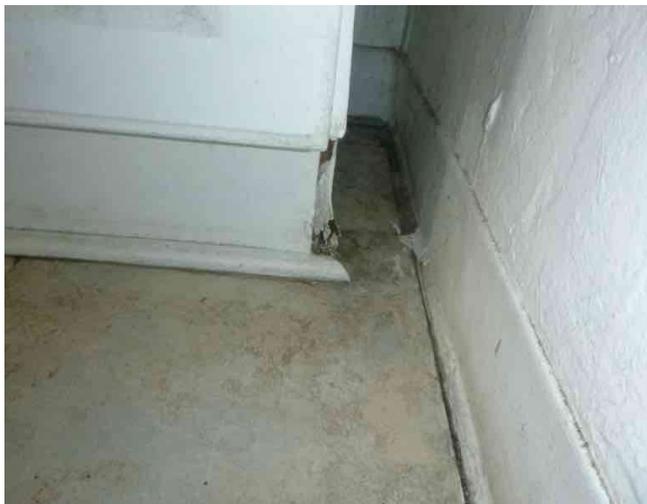
*Photo 07*

**1C.** FINDING: The vanity at the Unit 29 hall bathroom has been damaged by fungus. (See Photo 7)

RECOMMENDATION: Remove and replace the vanity to eliminate this condition. We intend to reuse the *Estimated Cost* existing counter top and fixture. An exact size match of the existing vanity cannot be guaranteed. If during the course of our repairs to the vanity it becomes necessary to modify/repair the adjacent plumbing a supplemental report and bid will be issued. It may also be necessary for the owner to paint the wall directly adjacent to the vanity upon completion of our repairs. We at HomeGuard Incorporated are upgrade experts and can provide proposals that include tile, marble, granite, upgraded fixtures, upgraded windows and doors or any other option you may desire.  
\*\*\*\*\* (SECTION 1 ITEM) \*\*\*\*\*

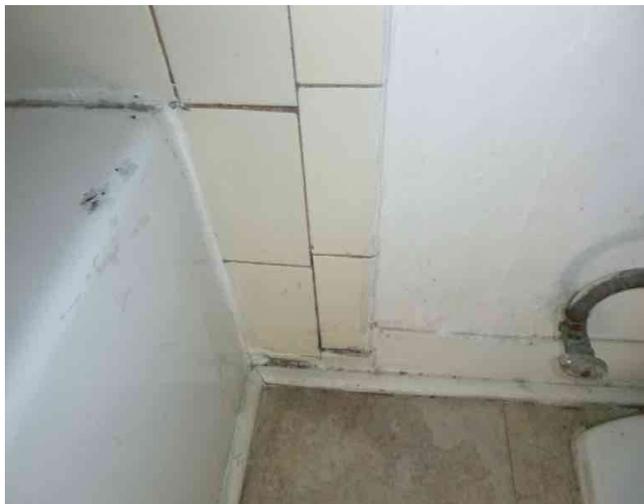
*Photo 08*

**3B.** FINDING: There are loose ceramic tiles in the Unit 29 hall bathroom bathtub walls. (See Photo 8) (See Photo 9)

RECOMMENDATION: Remove the loose tiles to allow for further inspection. All findings, *Estimated Cost* recommendations, and bids will be issued in a supplemental report. Note: If no damage is found the above bid includes reinstalling the existing tile if this is not possible because of breakage there will be additional cost to the owner. If the tile breaks an exact match of existing tiles may not be possible.

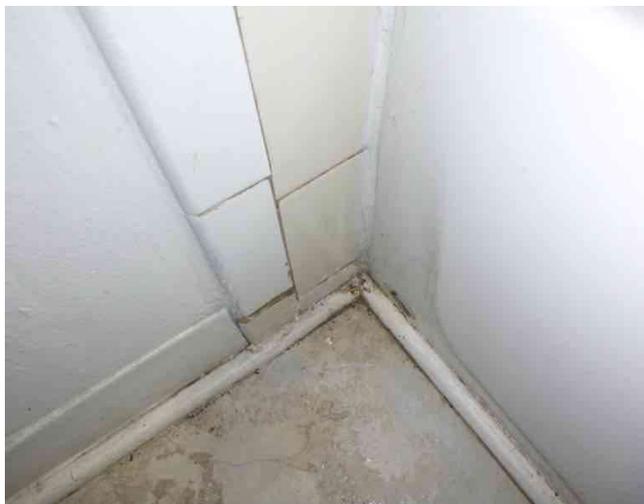
*Photo 10*

**3A.** FINDING: The waterproof wall covering is loose and unbounded at the Unit 34 hall bathroom bathtub. (See Photo 10)

RECOMMENDATION: Remove the loose wall coverings to allow for further inspection. All findings, *Estimated Cost* recommendations and bids will be issued in a supplemental report. This bid includes removal of the wall covering and further inspection only.
