**RE: SHORT FORM PHASE I ENVIRONMENTAL SITE ASSESSMENT OF THE OFFICE  
BUILDING, 103 FORT SALONGA ROAD, FORT SALONGA, SUFFOLK COUNTY,  
NEW YORK**

## SHORT FORM ENVIRONMENTAL SITE ASSESSMENT

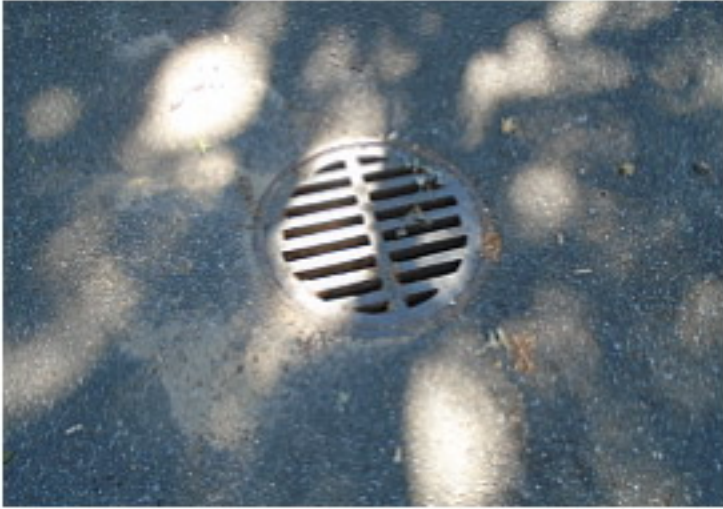
Drywell

Sumps / Drywells	Y	X	N		A sump was noted in the building, which discharges to dry wells located on site. No petroleum-type sheen or odors noted in the sump.
ACM	Y	X	N		Based on the age of the building, ACM may be present.
Hydraulic Lifts	Y		N	X	
Poor Housekeeping	Y		N	X	
Incinerators	Y		N	X	
Transformers	Y		N	X

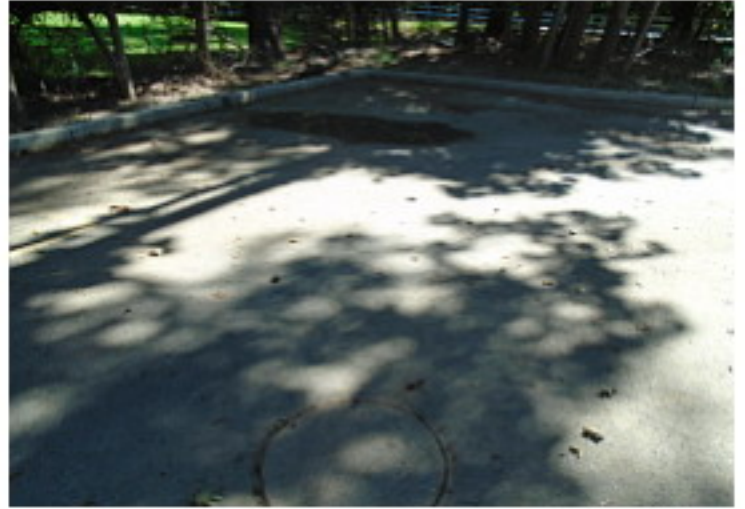
Northern yard - paved driveway and septic system location

The current water and heating service does not pose an environmental concern, as no staining or spillage was noted on or underneath the AST. Please note, all septic systems pose a potential concern for environmental impact. Although no chemical use at the site was identified, if desired by PB, an assessment of the system can be performed via an intrusive soil boring or test-pitting study, although there is no regulatory obligation to conduct and investigation.

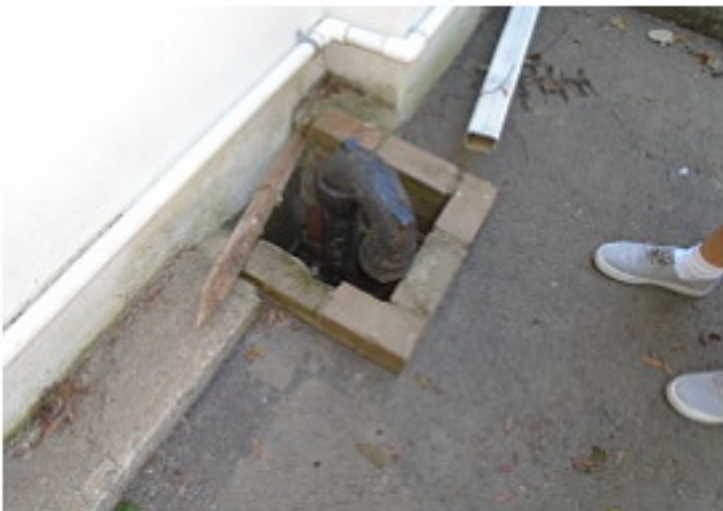
Disconnected pipe

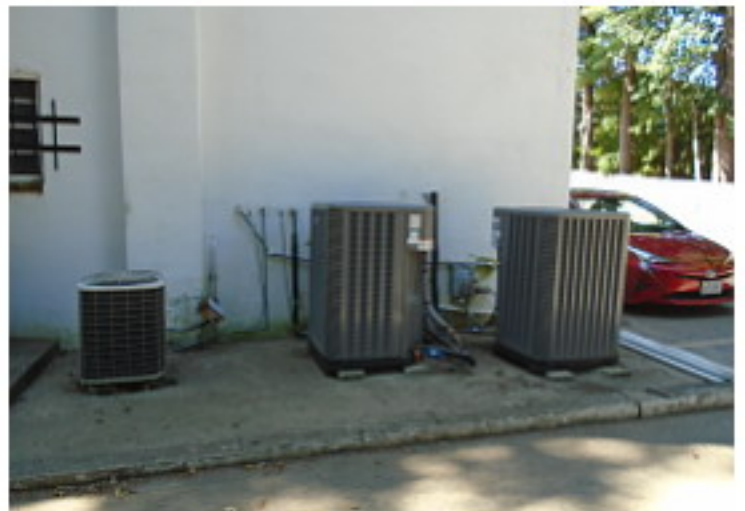
HVAC units

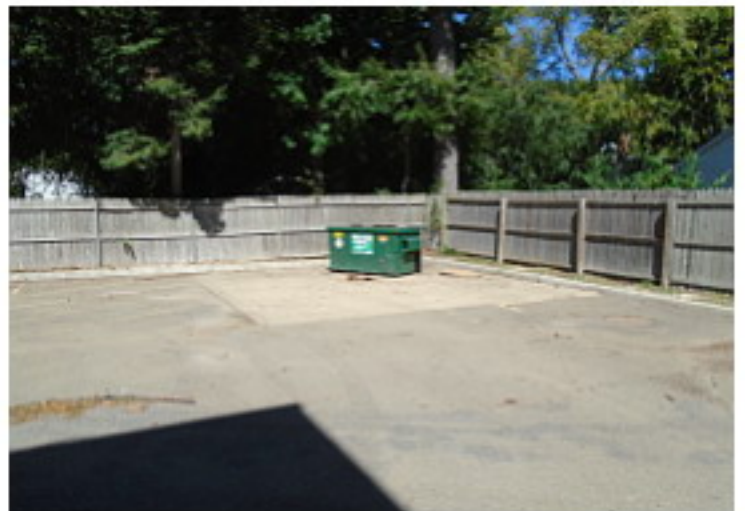
Solid waste staging

Transformers	Y		N	X	
Lagoons	Y		N	X	
Detention Basins	Y		N	X	
R.R. Siding / Tracks	Y		N	X	
ASTs	Y		N	X	
Fill Disturbed Areas	Y		N	X	
Waste Piles/Soil Piles	Y		N	X	
Housekeeping	Y		N	X	
Incinerators	Y		N	X	
Roof Runoff	Y		N	X	
Landfills	Y		N	X	
Dumpsters/Waste Disposal	Y	X	N		One dumpster was noted in the northern yard located on a concrete pad. No hazardous wastes or evidence of concern was identified.

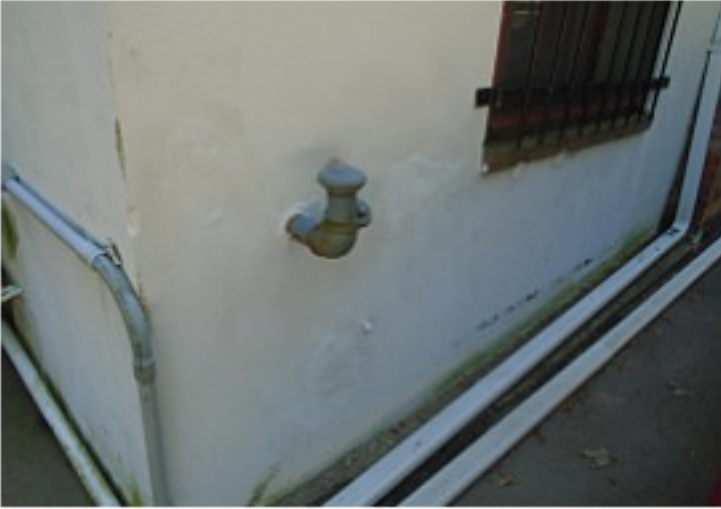
Tank fill port/vent pipe

USTs, Vents, Fill Pipes	Y	X	N		Vent/fill pipes associated with fuel oil AST located on western exterior sidewall. Former UST removed in 2012, with discharge identified and remediation performed.
Septic Systems	Y	X	N		The building's septic system/cesspool is located in the northern yard.
Drywells	Y	X	N		A few drywells are located on the property which receive stormwater runoff.
Wells	Y		N	X	
Vaults / Pits / Patches	Y		N	X	
Denuded / Stained Areas	Y		N	X	
Dense Vegetated Areas	Y		N	X	
Wooded Areas	Y		N	X	
Storage Trailers	Y		N	X	
Loading / Unloading Areas	Y		N	X	
Pads	Y	X	N		HVAC units located on concrete pad in the northern yard; no staining, or other obvious environmental issues were observed.
Drum Storage Areas	Y		N	X	
Wetlands	Y		N	X	
Water Bodies	Y		N	X	
Floor Drains	Y		N	X	
ACM	Y	X	N		Based on the age of the building, ACM may be present.
Inaccessible Areas	Y		N	X	
Storm Sewers	Y		N	X	
Sanitary Sewers	Y		N	X

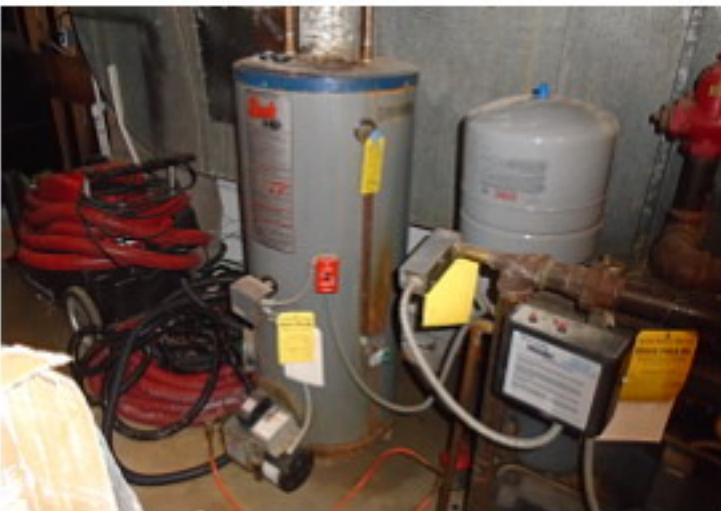
Basement - water heater

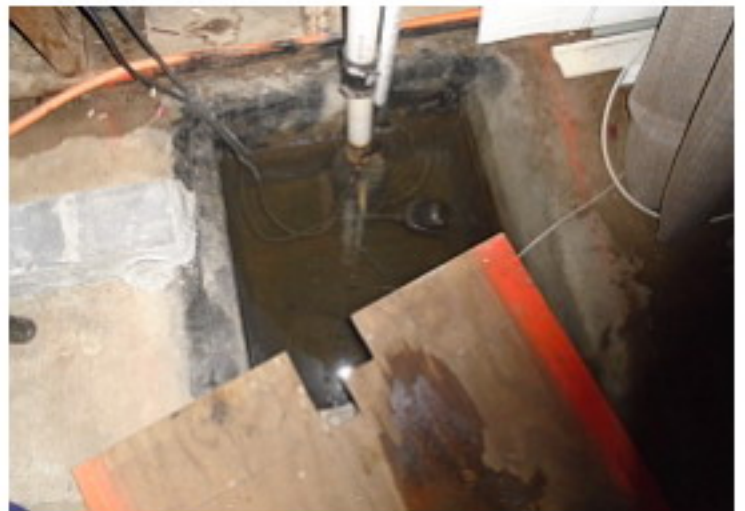
Sump pit - no obvious concern

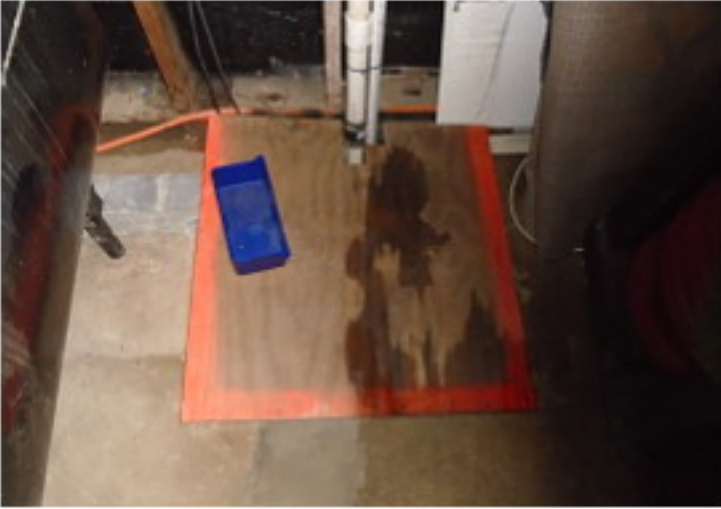
Fuel oil AST to left

USTs / ASTs	Y	X	N		Fuel oil AST located in the utility room; no obvious environmental concerns identified.
Floors Drains / Slop Sinks	Y		N	X	
Radon / Air Quality	Y	X	N		Suffolk County radon average is less than 2 pCi/l (Zone 3); no concern identified.
Floor Patches / Stains / Spills	Y		N	X	
Air Discharge / Spray Booth	Y		N	X	
Lead Based Paint (LBP)	Y	X	N		Based on the age of the building, LBP may be present.
Inaccessible Areas	Y	X	N		Not all of the commercial units were accessible during the time of the inspection.

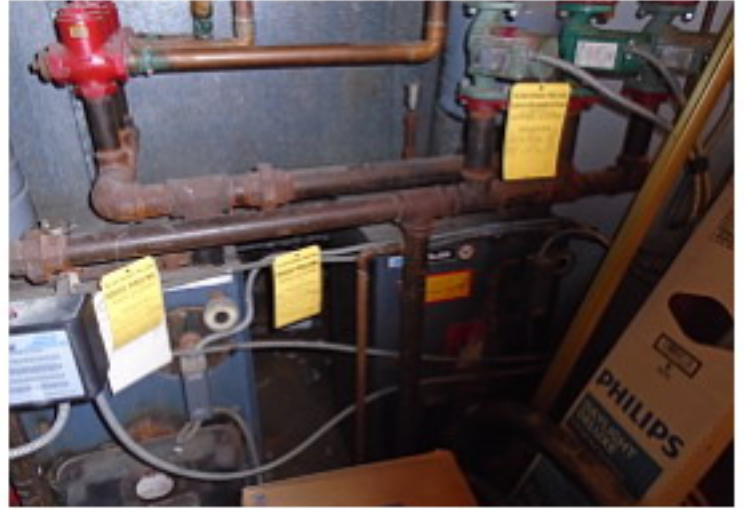
Fuel oil furnace and sprinkler system
