Subject: **Letter of Findings**
Western Lane Site
Richland County, South Carolina
PEC Project No. 24-2246

Palmetto Environmental Consulting, Inc. (PEC) is pleased to submit this correspondence to you regarding the approximately 8.5-acre Western Lane Site, generally located just northwest of the intersection of Western Lane and North Wingard Road in Richland County, South Carolina (Richland County Tax Map R04000-05-38). PEC performed a site visit on August 26, 2024, to determine if the referenced site contained wetlands/waters. The purpose of this letter and attached documentation is to summarize our findings and to document onsite observations related to waters/wetlands.

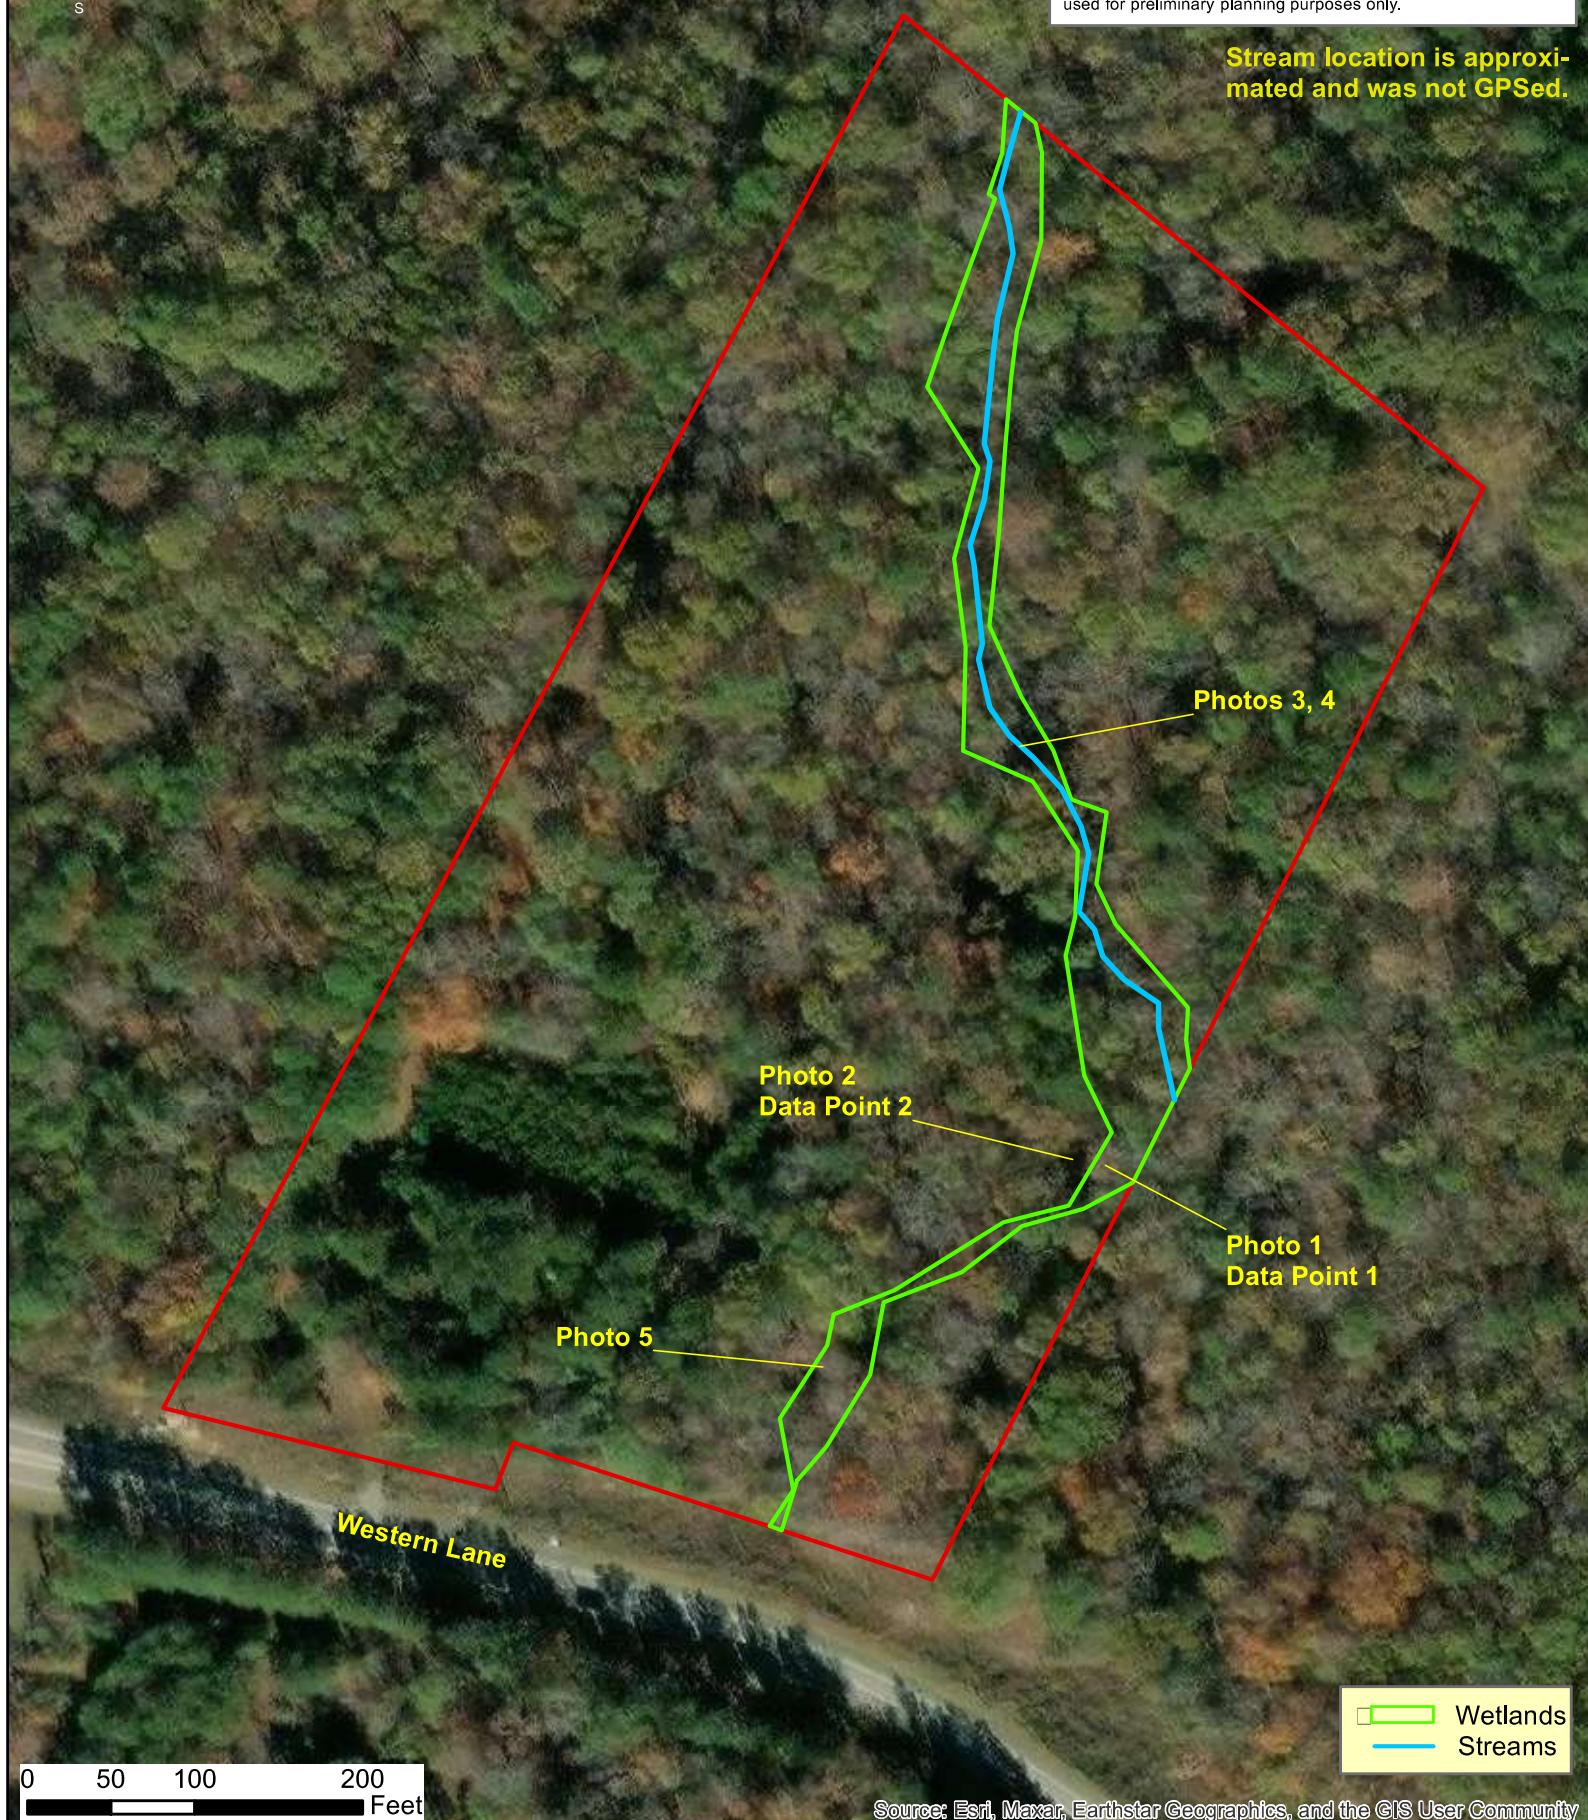
Figure 6. Waters Map
Western Lane Site
Richland County, SC
August 28, 2024

Note: Waters were delineated by PEC in August 2024. Wetlands were flagged with pink WETLAND BOUNDARY flags. Flags were located with Trimble Geo 7X Unit but had not been surveyed or verified by the US Army Corps of Engineers. This map should be used for preliminary planning purposes only.

Stream location is approximated and was not GPSed.

Based on our field investigations, PEC has determined the topographic draws contain waters/wetlands of the US, that is, waters/wetlands that likely would be under the jurisdiction of the USACE. The draw from the southeast corner of the site contains wetlands, which exhibited flowing water in spots during PEC's August 26 field visit. This draw flows toward the east central portion of the site, where it joins with a larger draw coming from offsite; this larger draw contains a stream with adjacent wetlands (see attached Figure 6). The stream, an unnamed tributary to Moccasin Branch, varies in width from two to over six feet, while most of it is three to four feet wide. Some deeper pockets of water (six to eight inches) were present in parts of the stream while other locations had only a damp bed with no surface water.

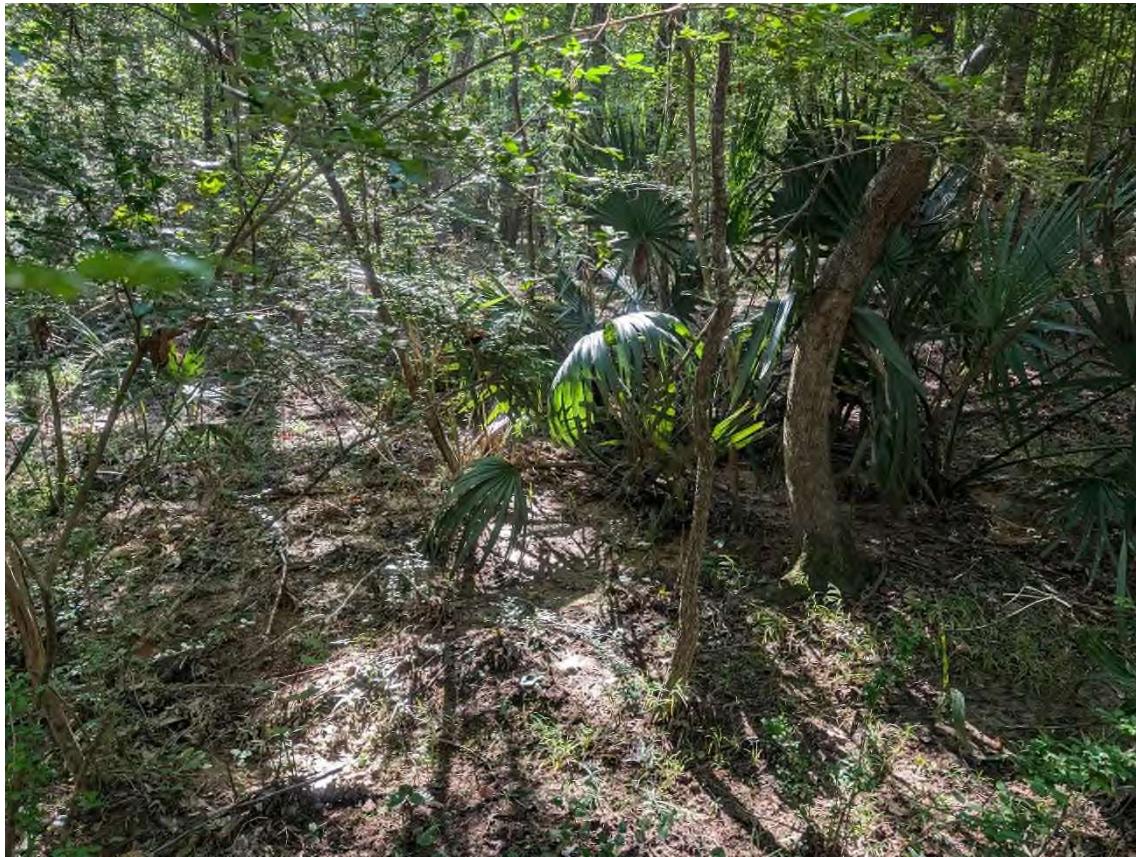
Photo 1. Wetland A, facing N. Data Point 1 taken here.

This data point appears to be located in wetlands.

This data point appears to contain wetland hydrology.

This data point appears to contain hydric soils

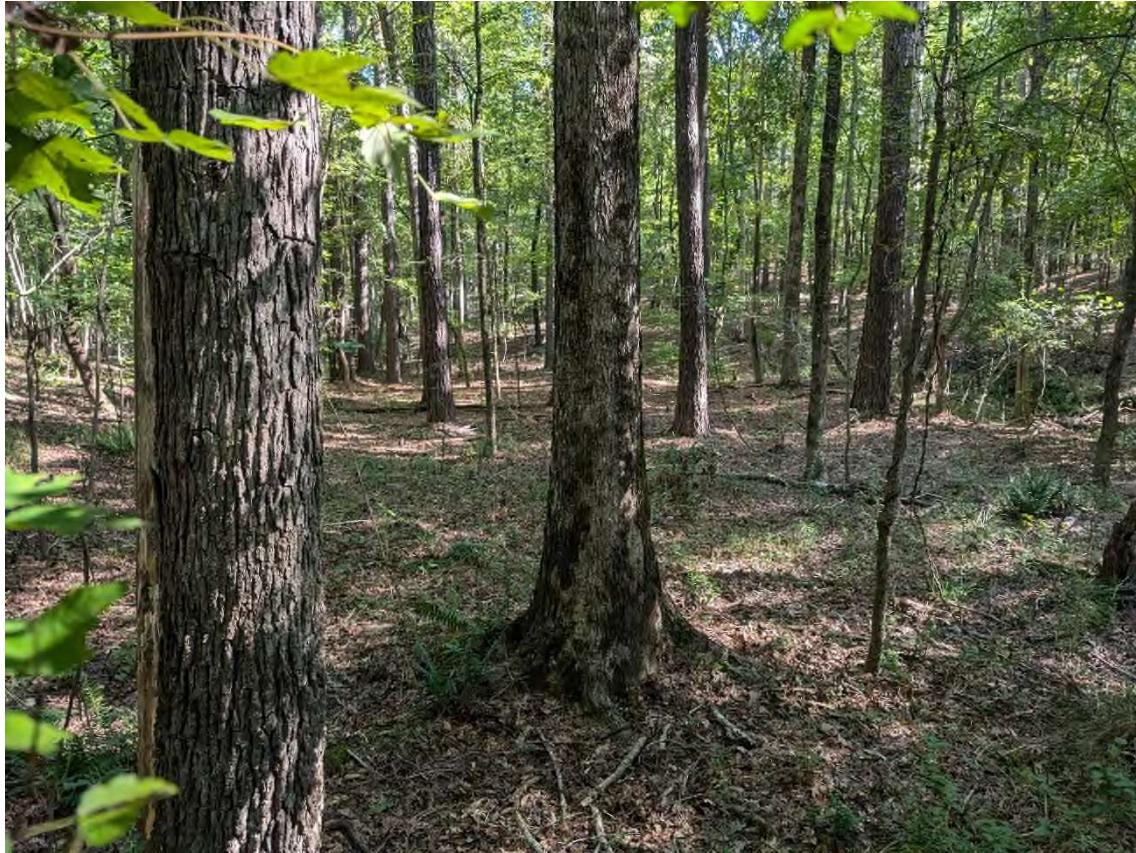
Photo 2. Uplands adjacent to Wetland A, facing NE. Data Point 2 taken here.

Remarks:
This data point appears to be located in uplands.

This data point does not appear to contain wetland hydrology.

This data point does not appear to contain hydric soils

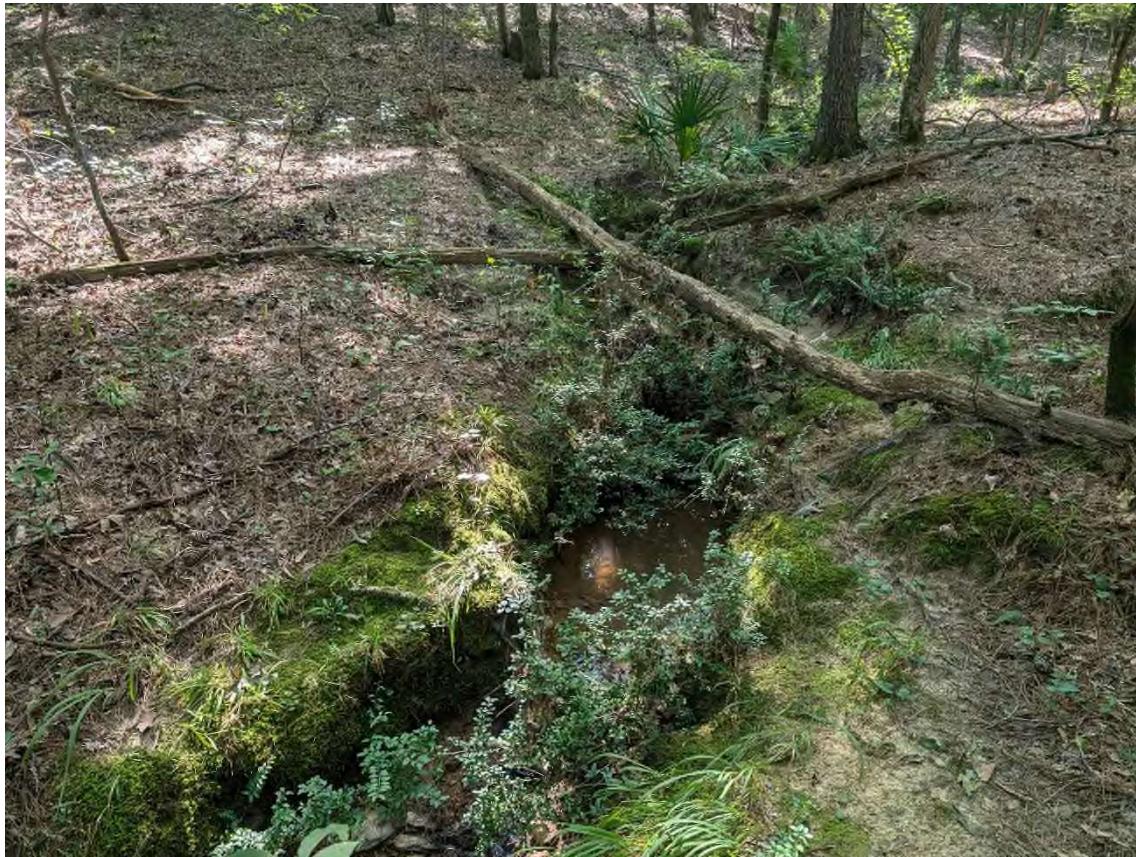
Photo 3. Stream within Wetland A, facing SE (upgradient).

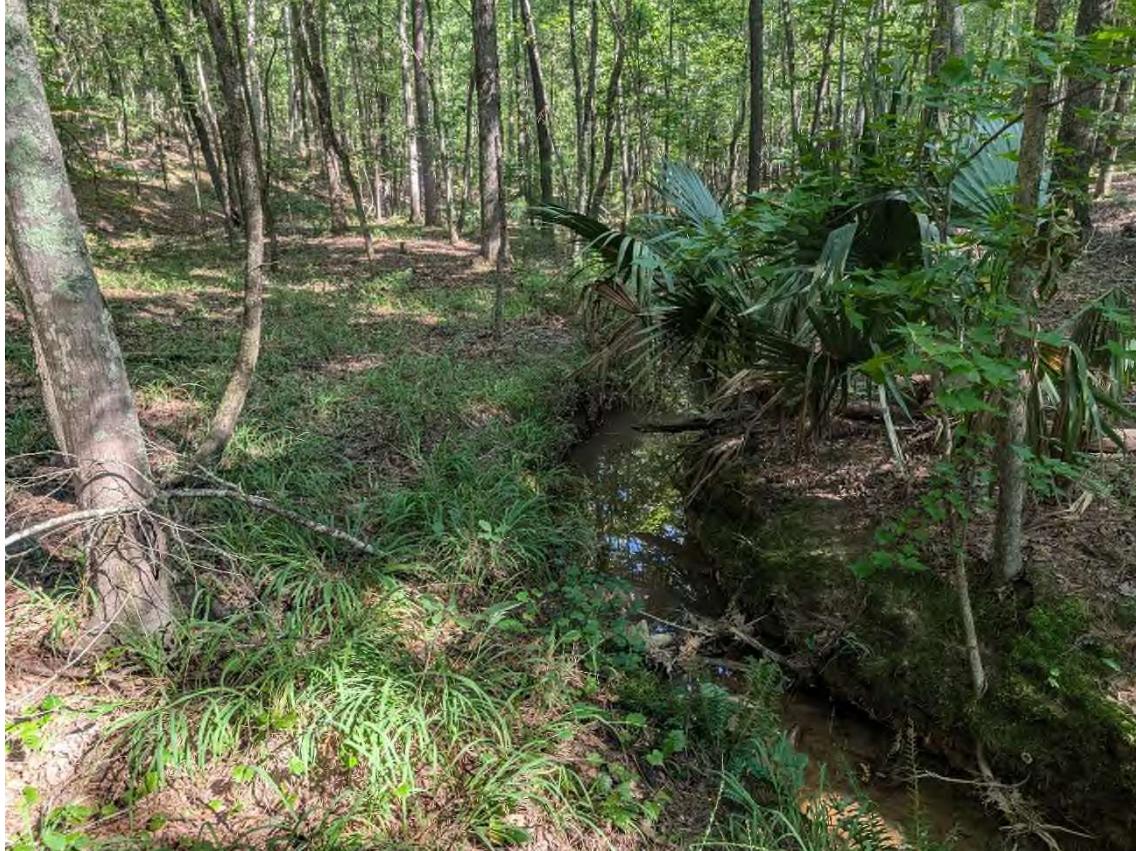
Photo 4. Same location as Photo 3, facing NW (downgradient).

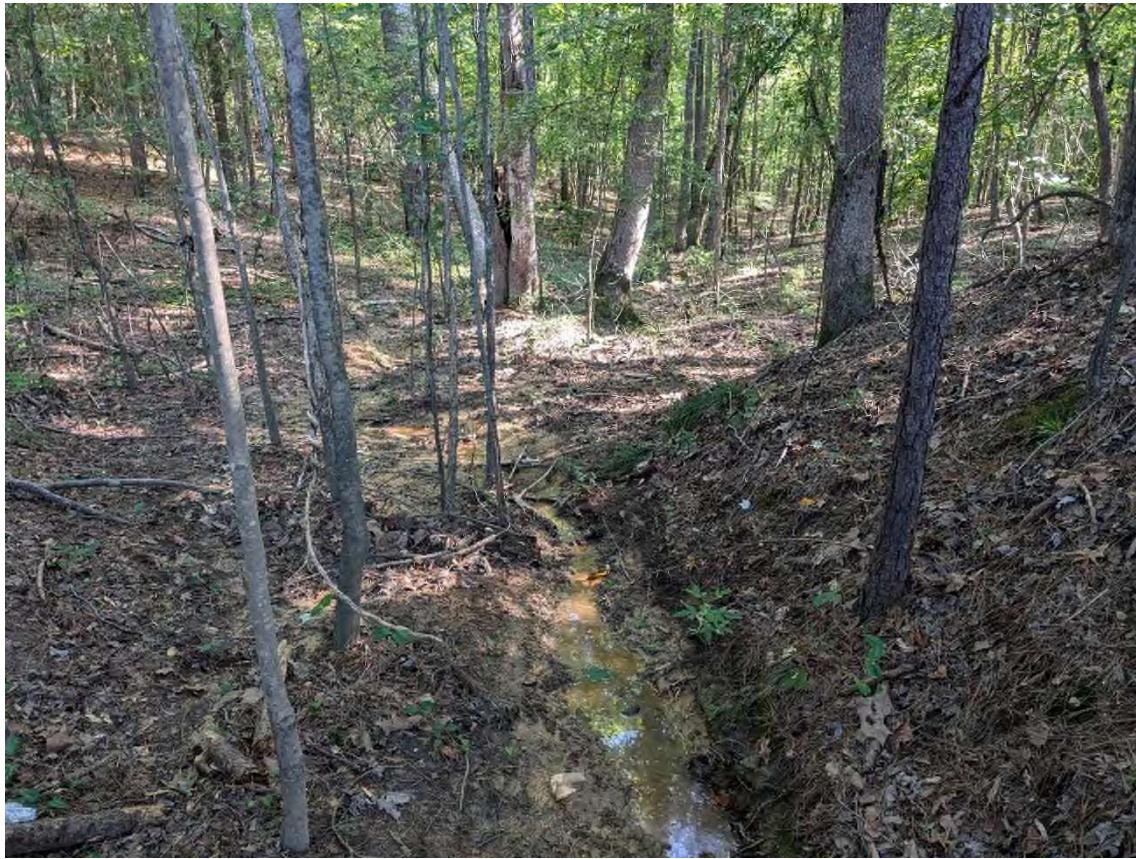
Photo 5. Upgradient end of Wetland A, facing NE (downgradient).
