Phase II Environmental Site Assessment Report

Madison Apartments: 1109 6th Avenue N

Great Falls, Cascade County, Montana

May 24, 2023

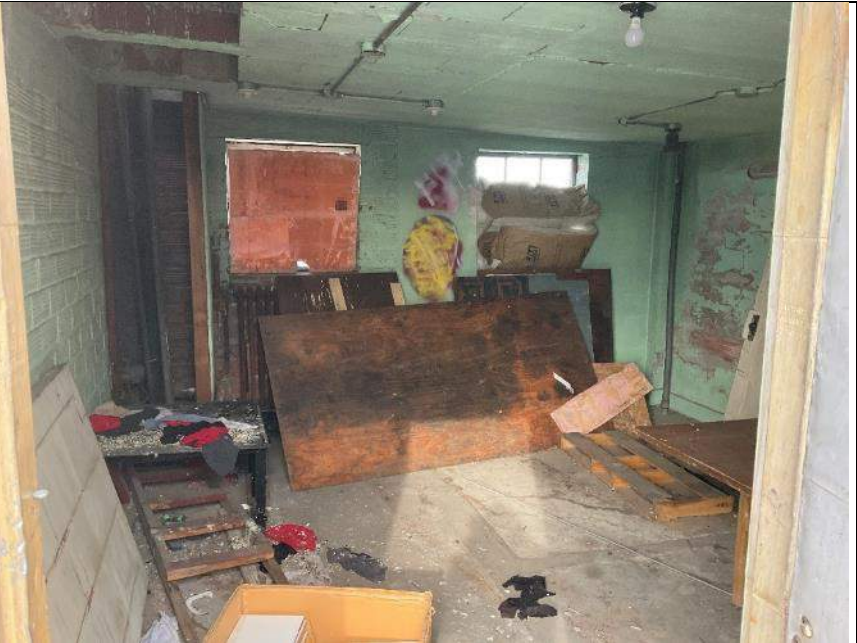
Photo: 14

A photograph showing the interior of a small room on a rooftop. The room is cluttered with debris, including a large wooden board leaning against the wall, a pallet, and various pieces of trash. The walls are light green and appear to be in poor condition. There is a window in the background and a door on the left. The floor is concrete and covered with dirt and debris.
Direction: W	
Description: The interior of the small room on the roof of the building.	
Date: March 31, 2023

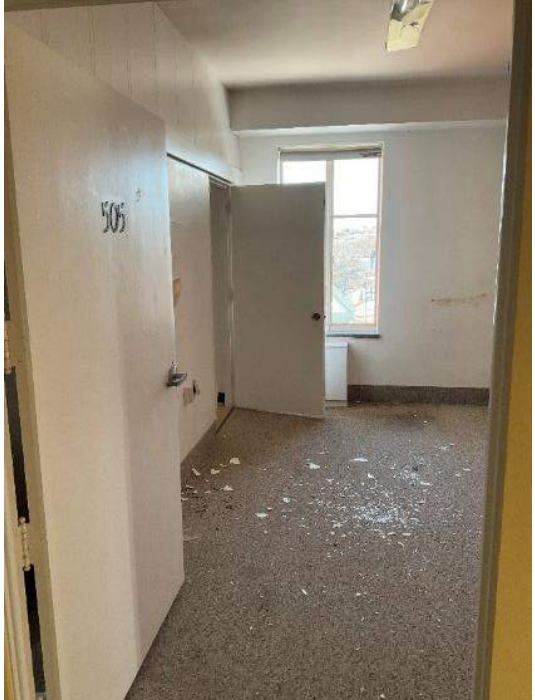
Photo: 28

Direction: NA	
Description: The view of room 505 from the hallway. Elevated lead levels were found in this room.	
Date: March 31, 2023

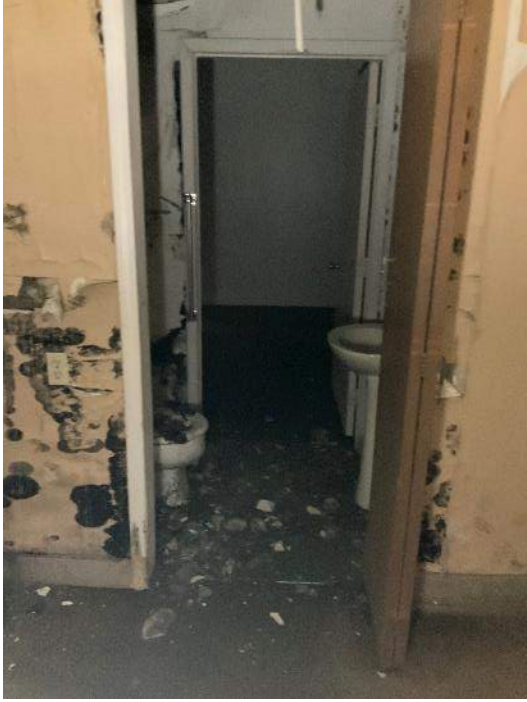
Photo: 66

Direction: E	
Description: 1 st floor bathroom. Water is leaking in from the roof and has flooded the bathroom.	
Date: March 31, 2023

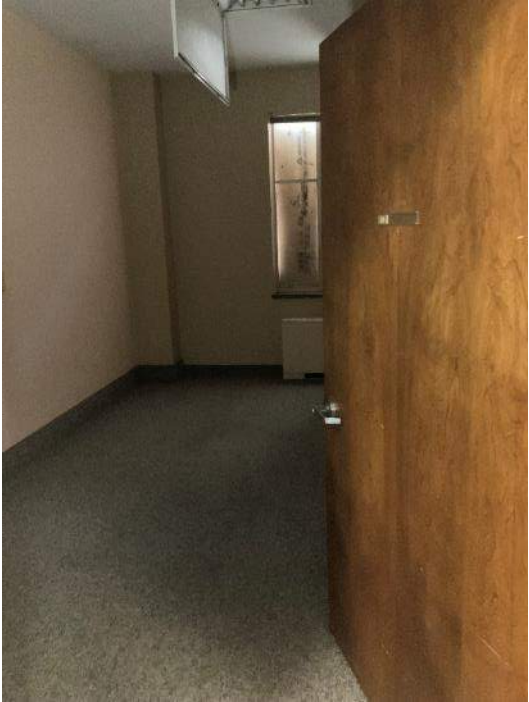
Photo: 67

Direction: S	
Description: The view of room 119 from the hallway. Elevated levels of lead were detected in this room.	
Date: March 31, 2023

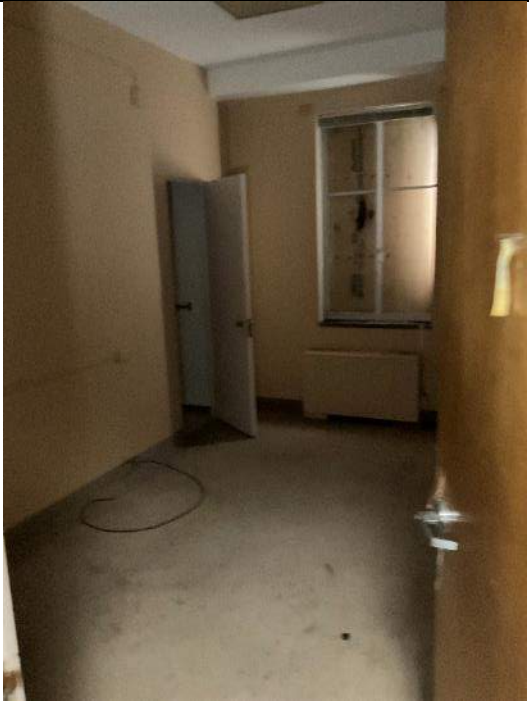
Photo: 68

Direction: S	
Description: The view of room 120 from the hallway. Elevated levels of lead were detected in this room.	
Date: March 31, 2023

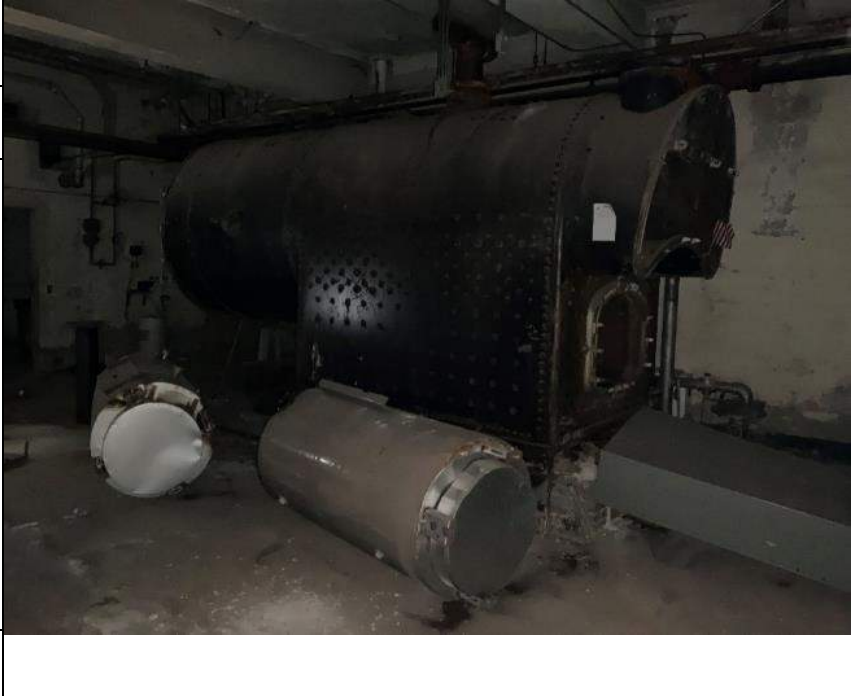
Photo: 113

Direction: N	
Description: Basement boiler room. The largest boiler/ furnace in the basement. The radiological survey was conducted within.	
Date: March 31, 2023

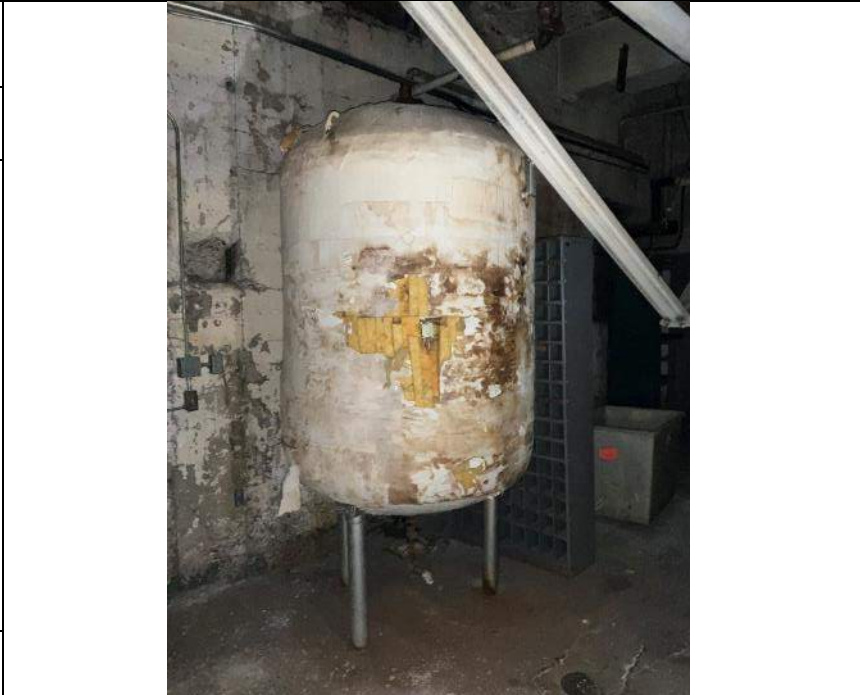
Photo: 114

Direction: S	
Description: Basement boiler room. Large tank with exposed insulation.	
Date: March 31, 2023

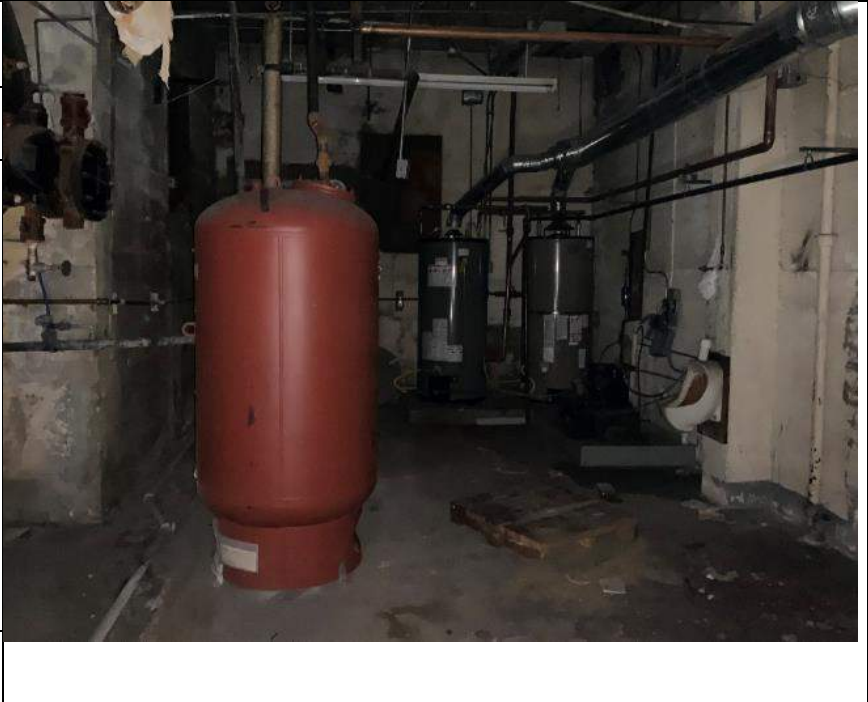
Photo: 118

Direction: E	
Description: Basement view of the hot water heaters.	
Date: March 31, 2023

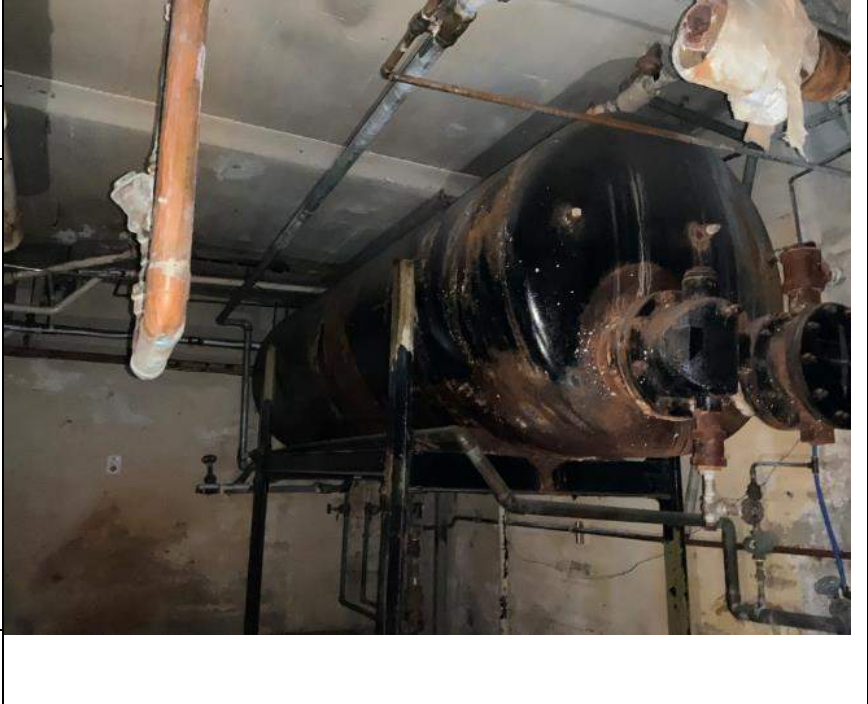
Photo: 119

Direction: SW	
Description: Basement main room. Pictured is a historical fuel oil tank.	
Date: March 31, 2023

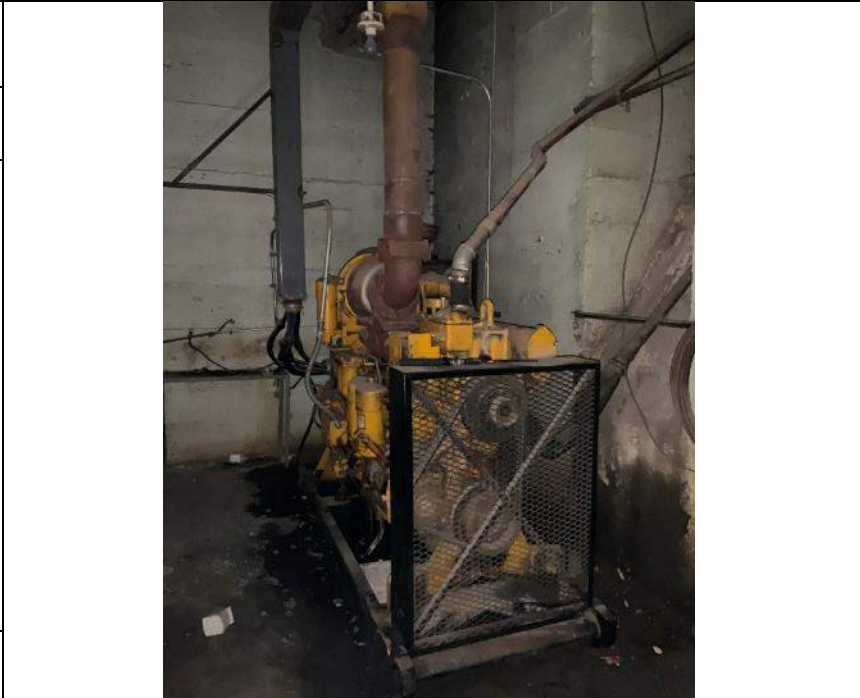
Photo: 122

Direction: NW	
Description: Basement generator room with diesel generator and day tank. This room contained open containers of fuel and fuses.	
Date: March 31, 2023

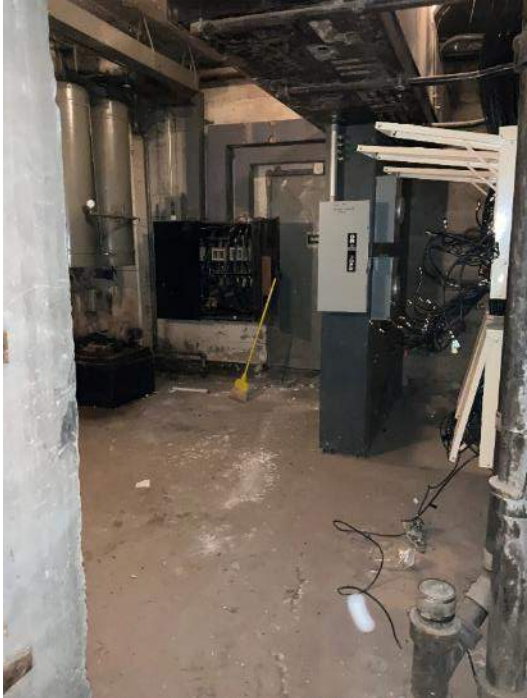
Photo: 123

A photograph of a basement breaker room. The room contains several large electrical panels, some with doors open, and various pipes and conduits. The floor is concrete and appears somewhat cluttered with debris and a broom.
Direction: E	
Description: Basement breaker room.	
Date: March 31, 2023

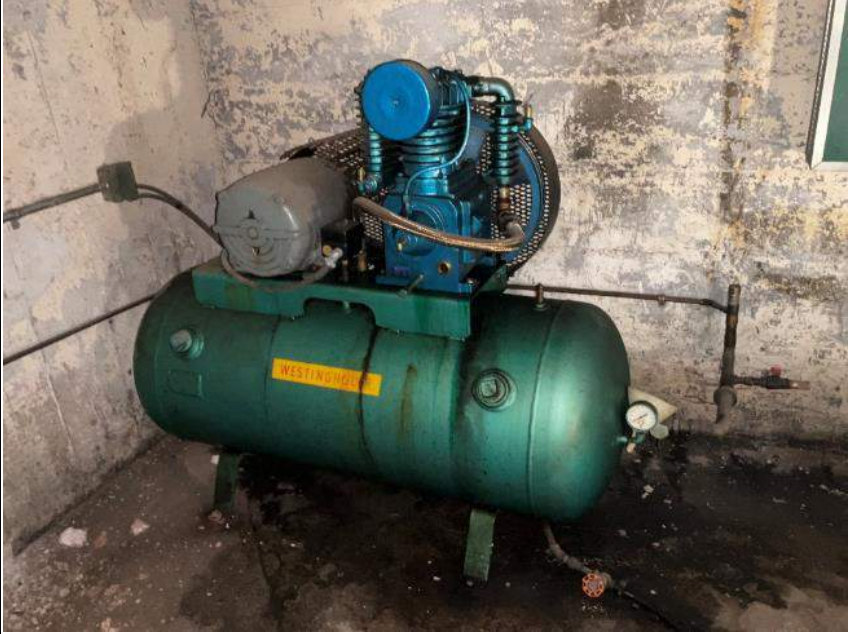
Photo: 124

A photograph of a generator unit in a basement breaker room. The generator is green and blue, with a large green cylindrical tank at the base. It is mounted on a concrete floor against a wall with peeling paint. Various pipes and electrical connections are visible around the unit.
Direction: NA	
Description: Basement breaker room.	
Date: March 31, 2023

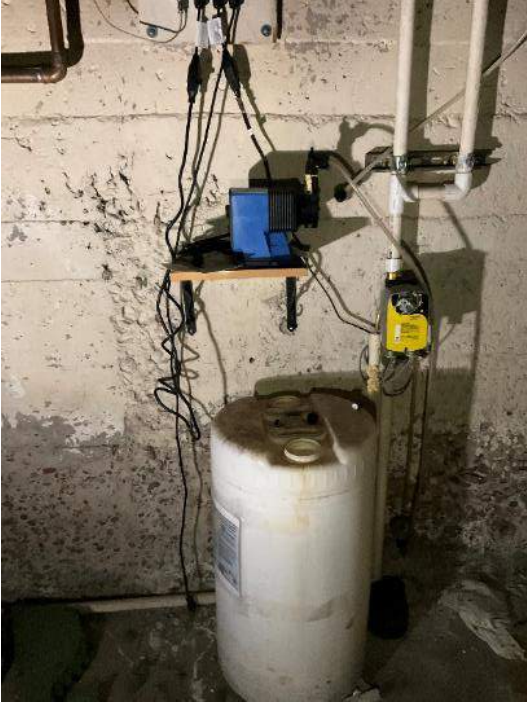
Photo: 126

Direction: W	
Description: Basement boiler room. Corrosive container found.	
Date: March 31, 2023

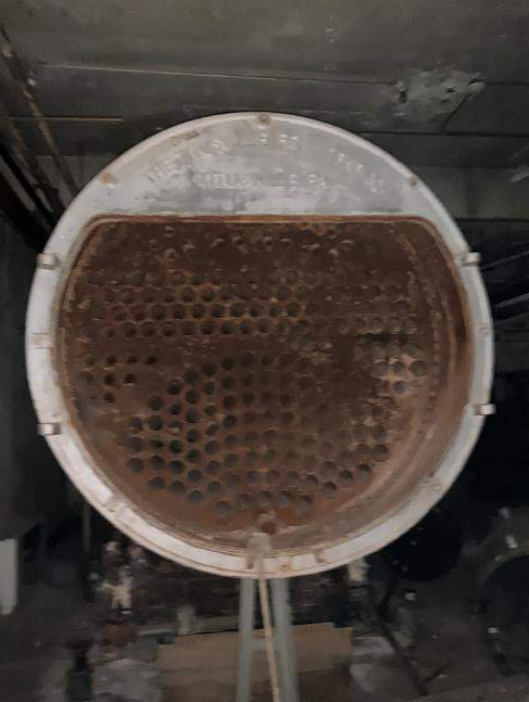
Photo: 128

Direction: E	
Description: One end of the largest boiler/ furnace in the basement.	
Date: March 31, 2023

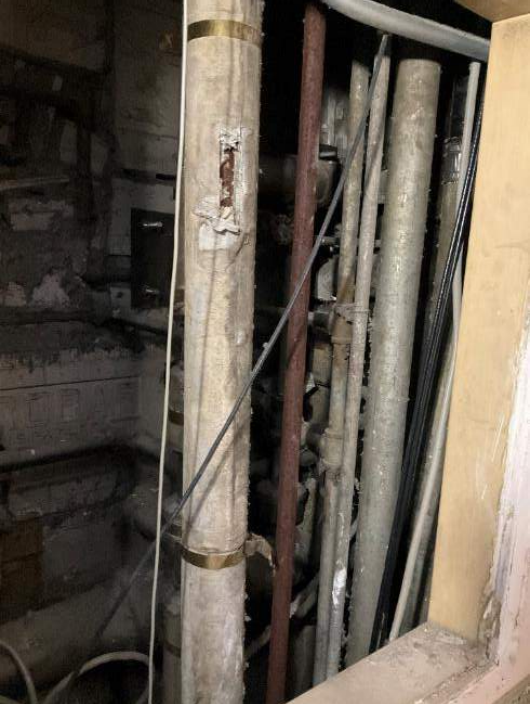
Photo: 129

Direction: NA	
Description: Pipework in the walls.	
Date: March 31, 2023

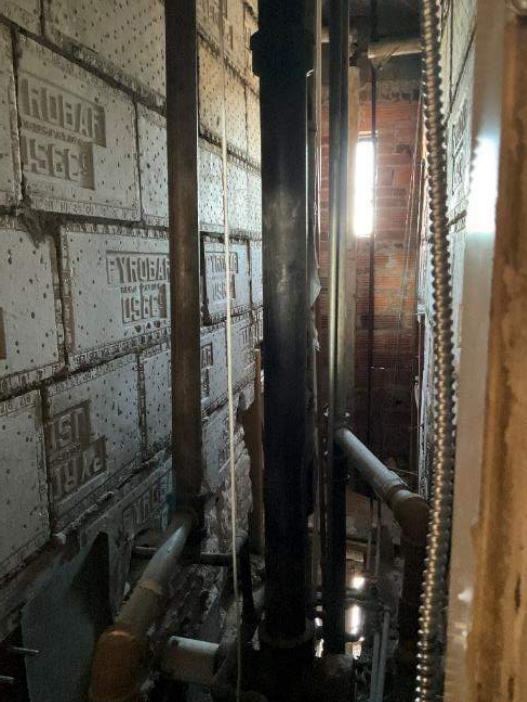
Photo: 132

Direction: N	
Description: Pipework in gap in the walls. 4 th floor.	
Date: March 31, 2023

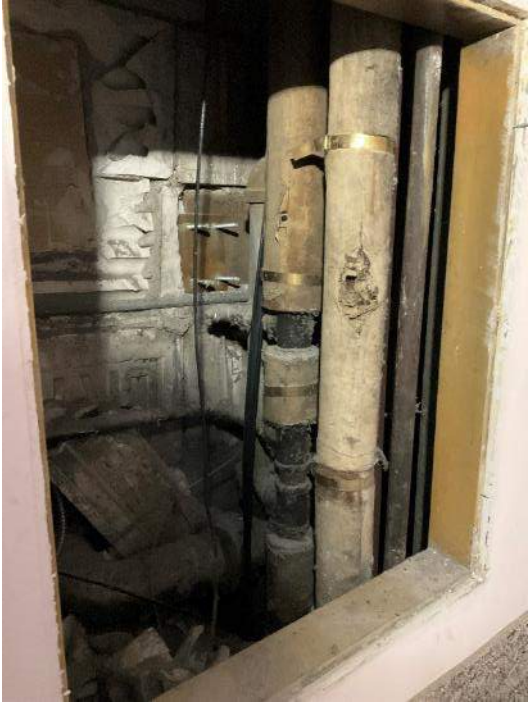
Photo: 133

Direction: NA	
Description: Pipework behind the wall. 3 rd floor.	
Date: March 31, 2023

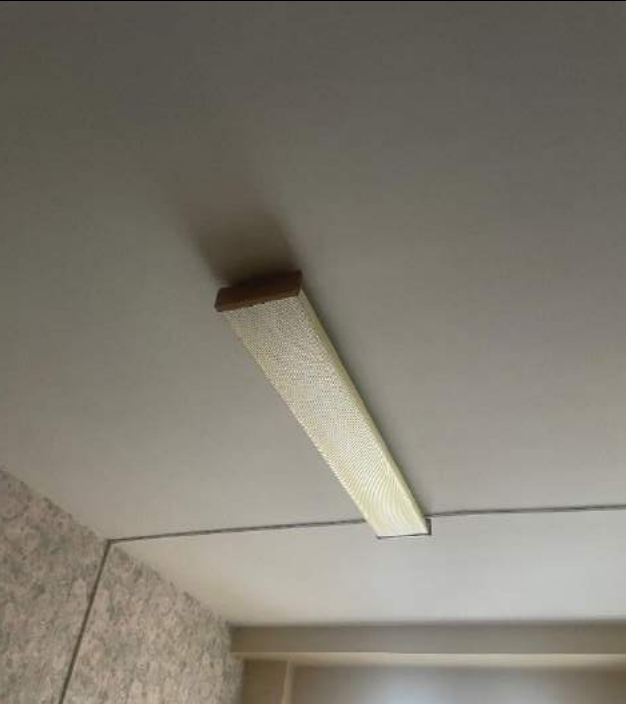
Photo: 134

Direction: NA	
Description: Typical style light fixture found in multiple rooms that contains PCB's.	
Date: March 31, 2023

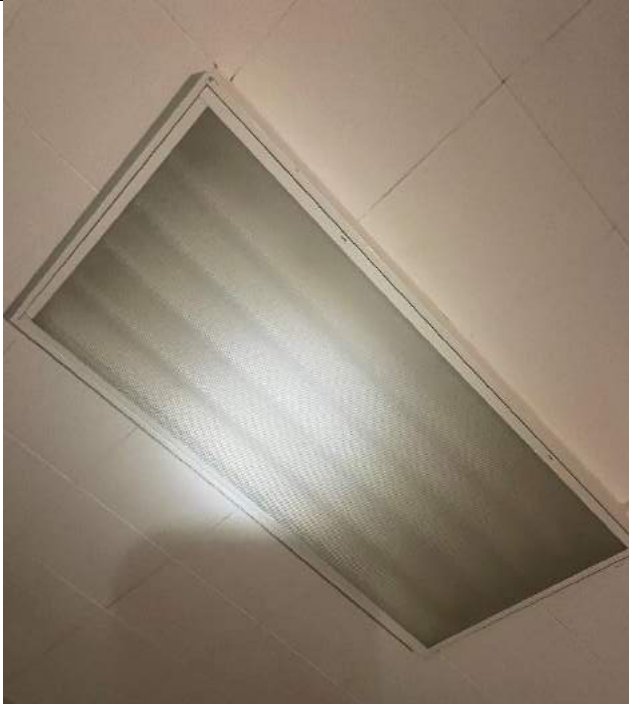
Photo: 136

Direction: NA	
Description: Typical style light fixture found in multiple rooms that contains PCB's.	
Date: March 31, 2023

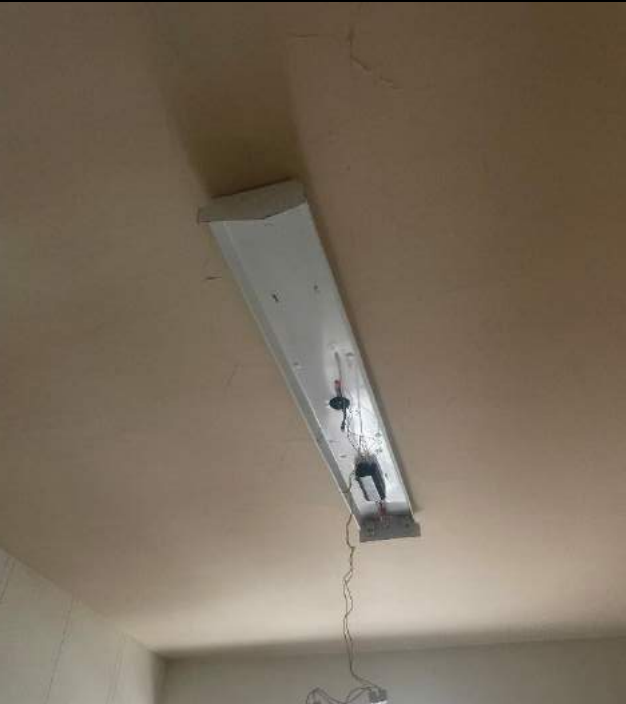
Photo: 137

Direction: NA	
Description: Typical style light fixture found in multiple rooms that contains PCB's.	
Date: March 31, 2023

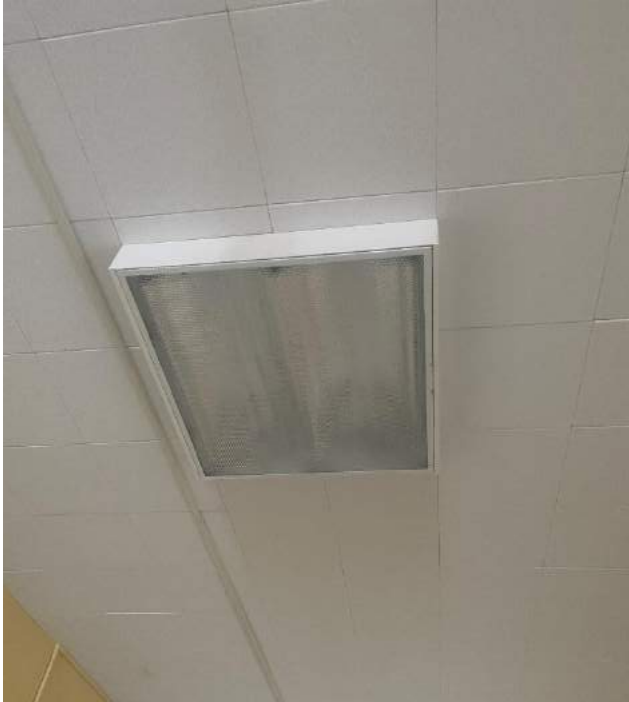
Photo: 139

Direction: NA	
Description: Typical style light fixture found in most hallways that do not contain PCB's	
Date: March 31, 2023

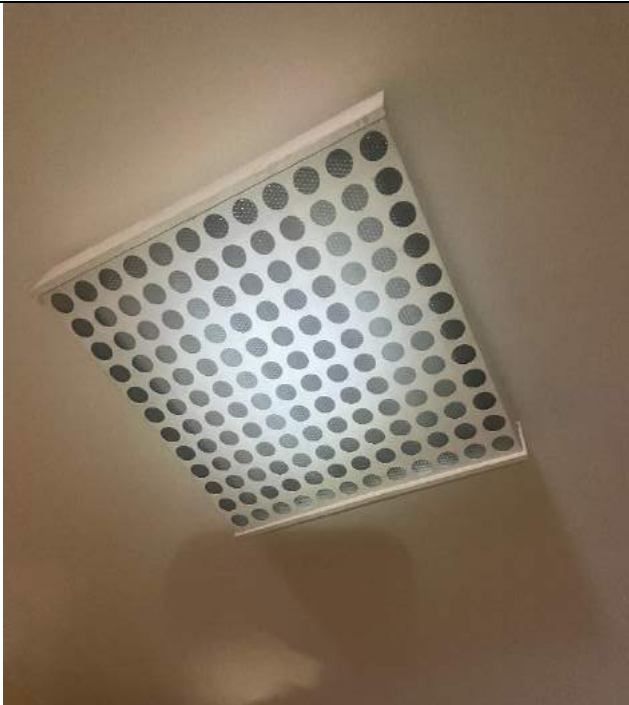
Photo: 140

Direction: NA	
Description: Typical style light fixture found in hallways on floor 1 that do not contain PCB's	
Date: March 31, 2023
