## TEXAS OFFICIAL WOOD DESTROYING INSECT REPORT

201 Covala Dr

Cedar Park

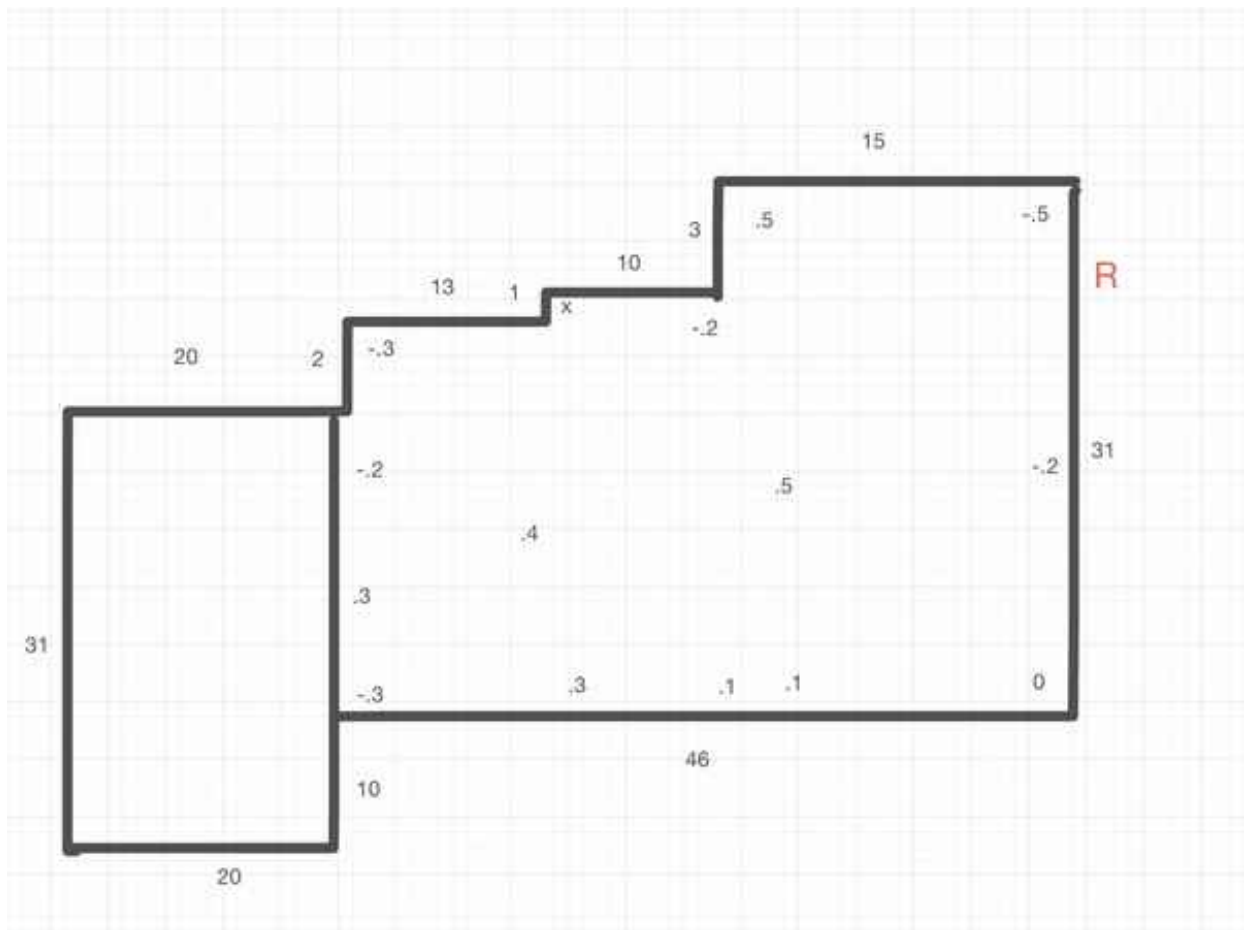
Diagram of Structure(s) Inspected

Specify reason: Cut back fence board on left side of home to create an air gap between the fence and home

The inspector must draw a diagram including approximate perimeter measurements and indicate active or previous infestation and type of insect by using the following codes: E-Evidence of Infestation, A-Active; P-Previous; D-Drywood Termites; S-Subterranean Termites; F-Formosan Termites; C-Conducive Conditions; B-Wood Boring Beetles; H-Carpenter Ants; Other(s) - Specify \_\_\_\_\_

12B. A preventive treatment and/or correction of conducive conditions as identified in 10A & 10B is recommended as follows: Yes ☒ No ☐
