## RESIDENTIAL INSPECTION

1050 Pennsylvania Ave  
Elmira, NY 14904

Vineyard Capital Partners  
10/28/2025

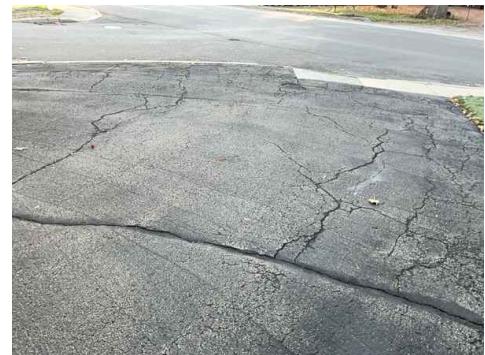
#### **MINOR CRACKING AT DRIVEWAY**

I observed indications of minor cracking at the driveway.

Correction and further evaluation is recommended.

Contact a qualified concrete contractor.

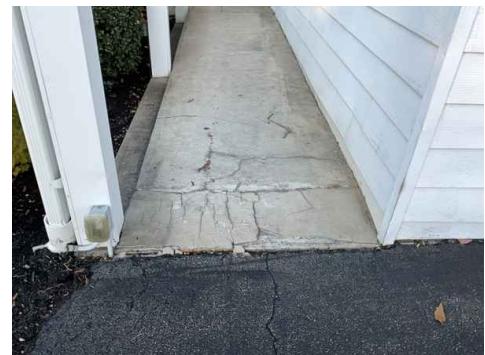
### 2.2.2 Walkways & Driveways

#### **MINOR CRACKING AT WALKWAY**

I observed minor cracking and no major damage at the walkway.

Monitoring is recommended.

Contact a handyman or DIY project

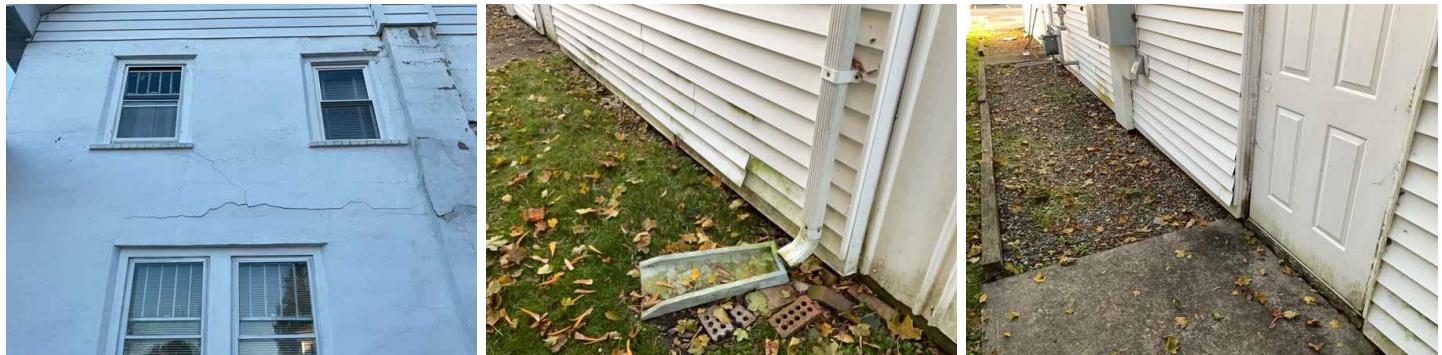
#### **MINOR WALL COVERING DAMAGE**

Wall covering had minor damage such as peeling paint, areas of loose siding, or age related deterioration. Recommend monitoring or repair of these areas to prevent moisture intrusion.

Contact a qualified professional.

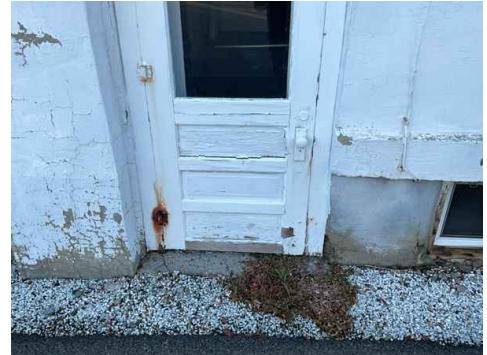
## 2.10.1 Exterior Doors

**EXTERIOR DOOR SURFACE IN POOR CONDITION**

I observed that the surface of the exterior door was in poor condition.

Correction and further evaluation is recommended.

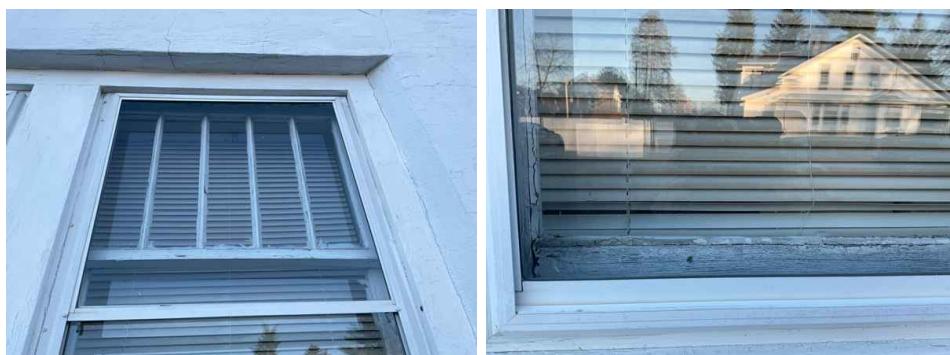
## 2.11.1 Windows

**MINOR DAMAGE TO WINDOWS**

Minor damage such as peeling paint and/or age related deterioration is present. Recommend monitoring and or repair by a qualified contractor.

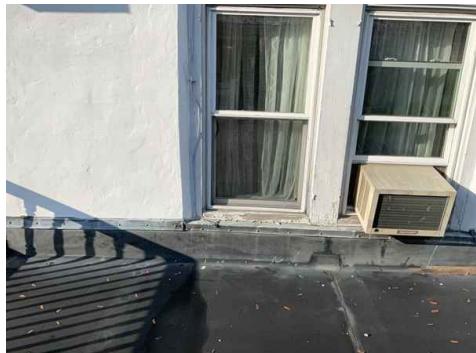
## 2.11.2 Windows

**PEELING PAINT**

Windows and/or trim around windows have peeling paint. Recommend scraping and painting to prevent further deterioration of wood components.

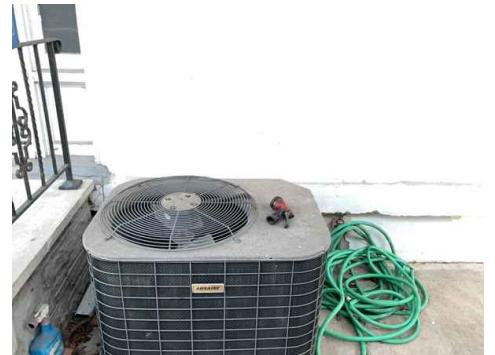
I observed that the disconnect means was not within sight and not readily accessible from the equipment.

Contact a qualified HVAC professional.

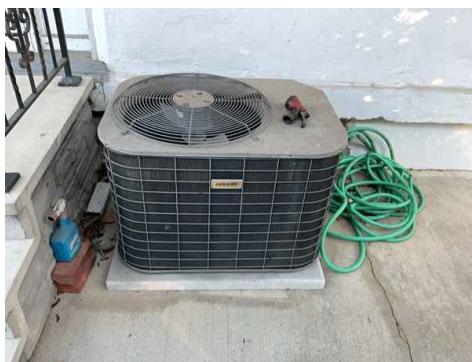
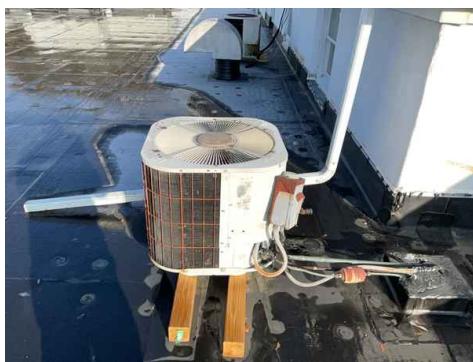
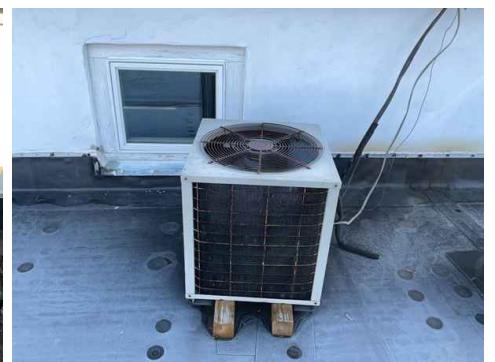
## 3.1.2 Cooling System Information

I observed during my inspection that the system appeared to be old and at or near the end of its service life. It may not be reliable. Ask the homeowner or occupant about its recent performance. Regular maintenance and monitoring of its condition is recommended. Budgeting for repairs and future replacement is recommended. [InterNACHI's Standard Estimate Life Expectancy Chart for Homes](#)

Recommend monitoring.

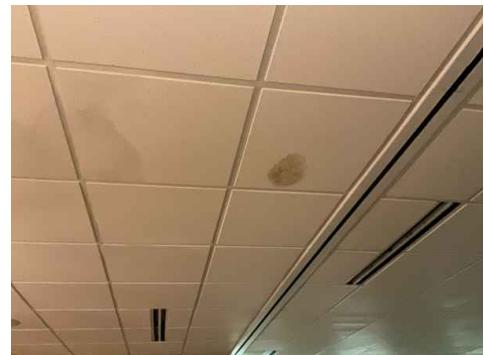
### **STAIN(S) ON CEILING**

There is a stain on ceiling/wall that requires repair and paint. Source of staining should be determined.

Contact a qualified professional.

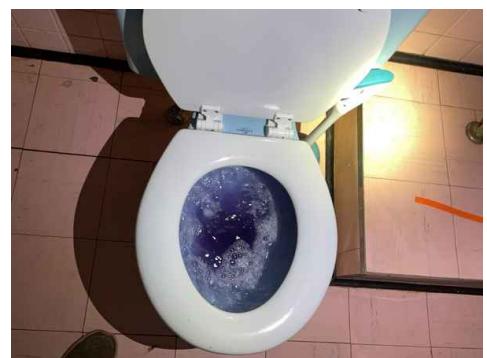
I observed that the toilet did not flush as expected. Recommend evaluation by a qualified professional.

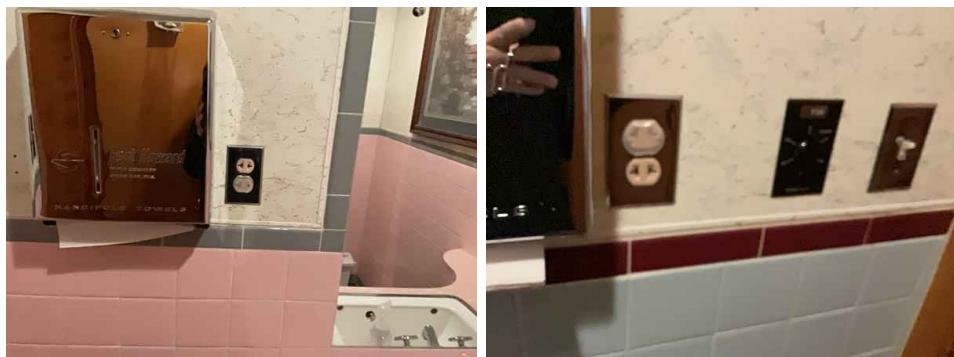
### 7.4.1 GFCI & Electric in Bathroom

#### RECEPTACLE IS NOT GFCI PROTECTED

I observed that the receptacle in the bathroom is not testing as being GFCI protected. This is a hazardous condition.

Contact a qualified electrical contractor.

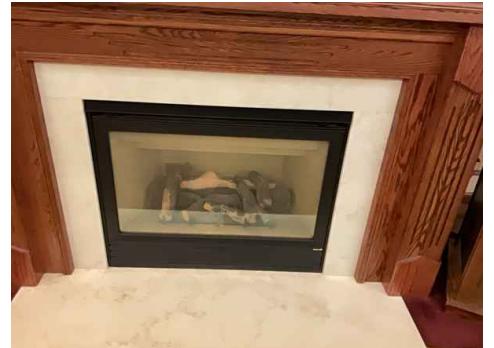
### **GAS INSERT - DID NOT INSPECT**

I did not inspect the gas fireplace insert unit. This was beyond the scope of my home inspection. I recommend the homeowner or a professional inspect further and confirm it's safe operation and functionality.

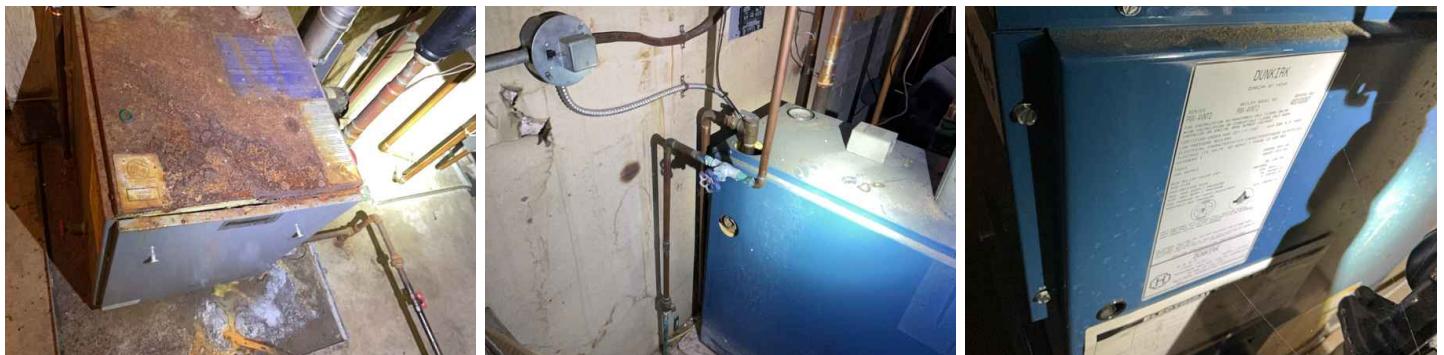
### **CORROSION & RUST**

I observed areas of corrosion and rust at the heating system distribution lines and connections. Recommend evaluation by a qualified professional.

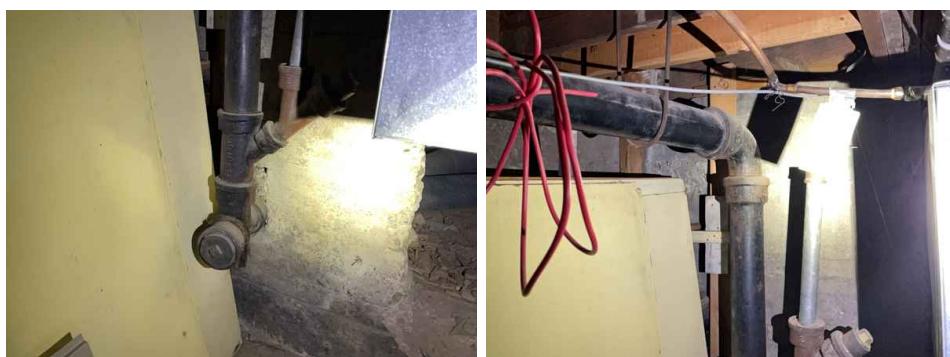
## 13.6.1 Drain, Waste, &amp; Vent Systems

**AGE RELATED DETERIORATION**

Contact a qualified plumbing contractor.

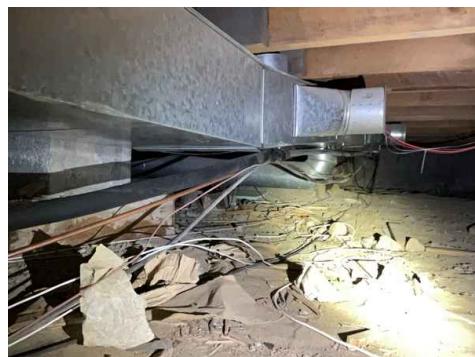
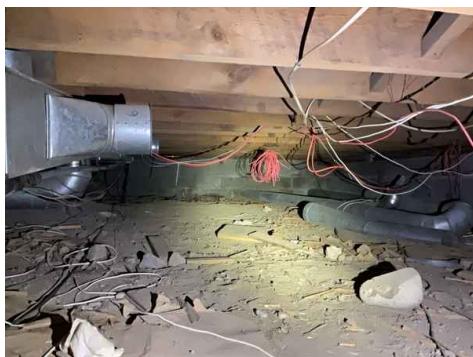
## 14.5.1 Under-Floor Crawlspace

**MISSING SOIL COVER**

Contact a qualified professional.
