Environmental Survey Report

Wetland Delineation and Listed Species

Volusia County, Florida Property Address; 401 South Volusia Avenue in Orange City
Alt Key Parcel 2374802

February 17, 2024

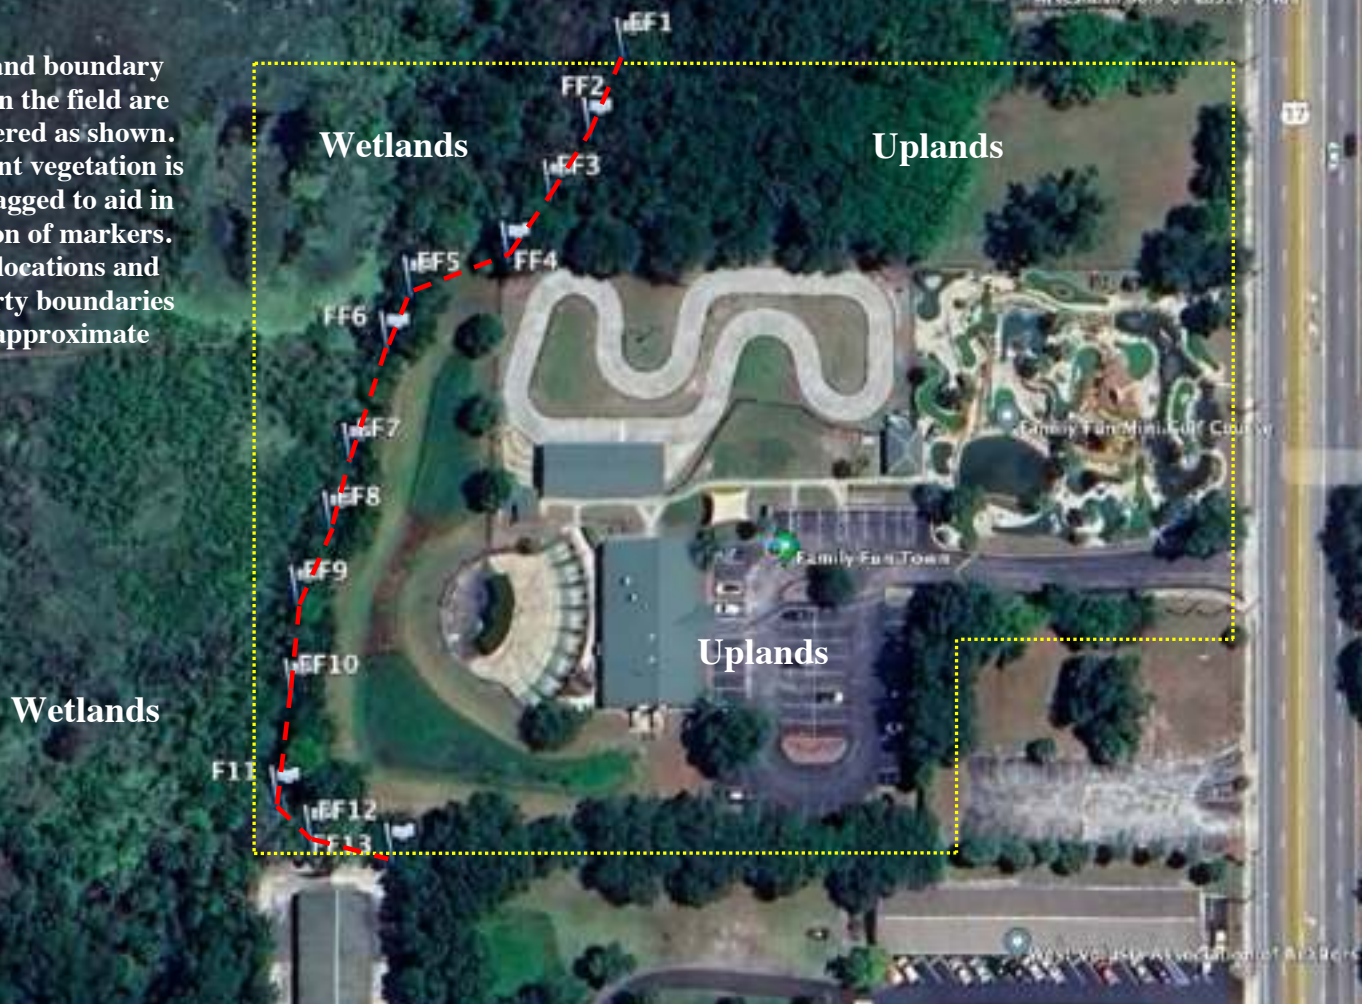
Wetland Delineation Aerial Sketch

Wetland boundary flags in the field are numbered as shown. Adjacent vegetation is also flagged to aid in location of markers. Flag locations and property boundaries are approximate

On February 14, 2024, Palmer Biological staff ecologists visited the subject property and performed a wetland delineation. The presence or absence of wetlands was determined using available wetland and upland vegetation ID, soil analysis and hydrologic indicators. A wetland boundary was delineated in the field (**Wetland Delineation Aerial Sketch**).

We recommend having our wetland flags located by a registered land surveyor and placed to scale on a boundary survey of the property. The boundary survey map with the wetland boundary included can be used to plan development on the site. All wetland delineations are subject to regulatory review. Please check with local authorities concerning any setbacks or buffers prior to any construction, clearing, or filling. Please contact our office for questions or for additional information concerning the data presented in this report.

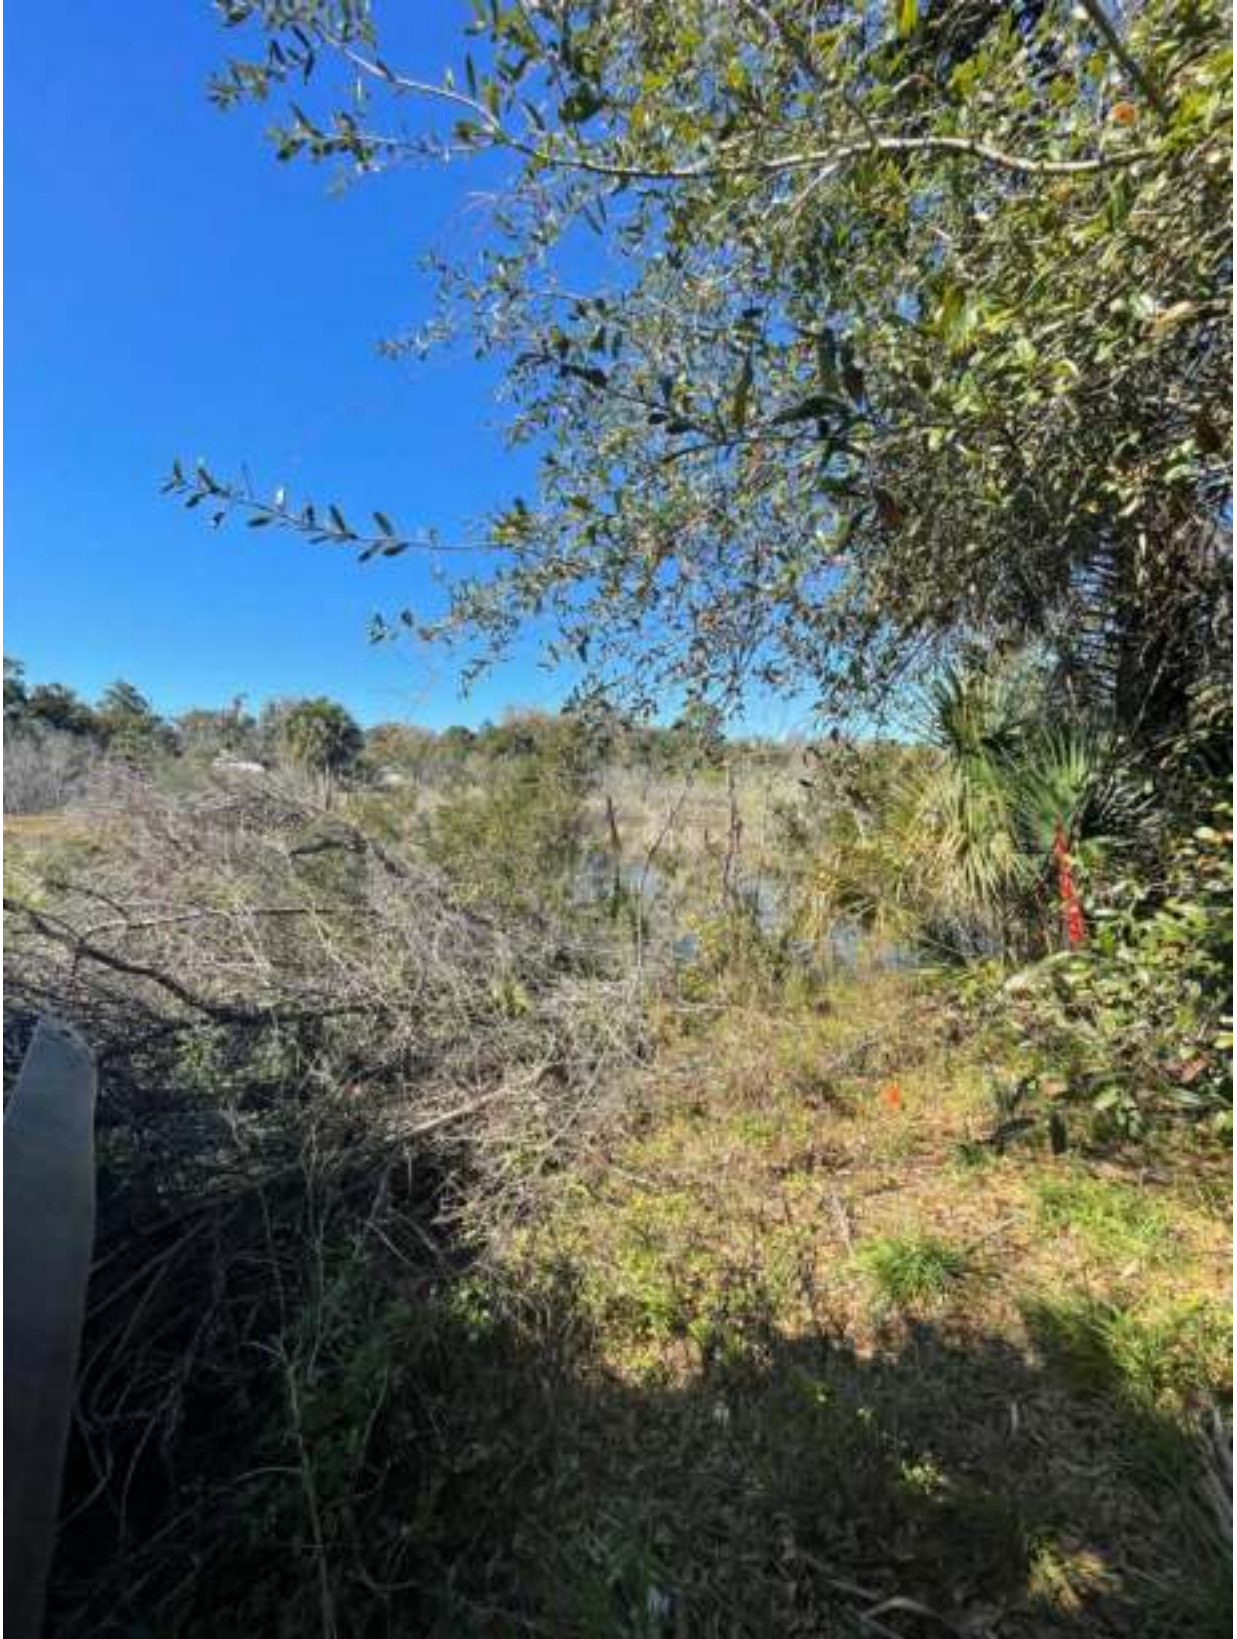
Fig 1. – view of wetlands west of the subject property

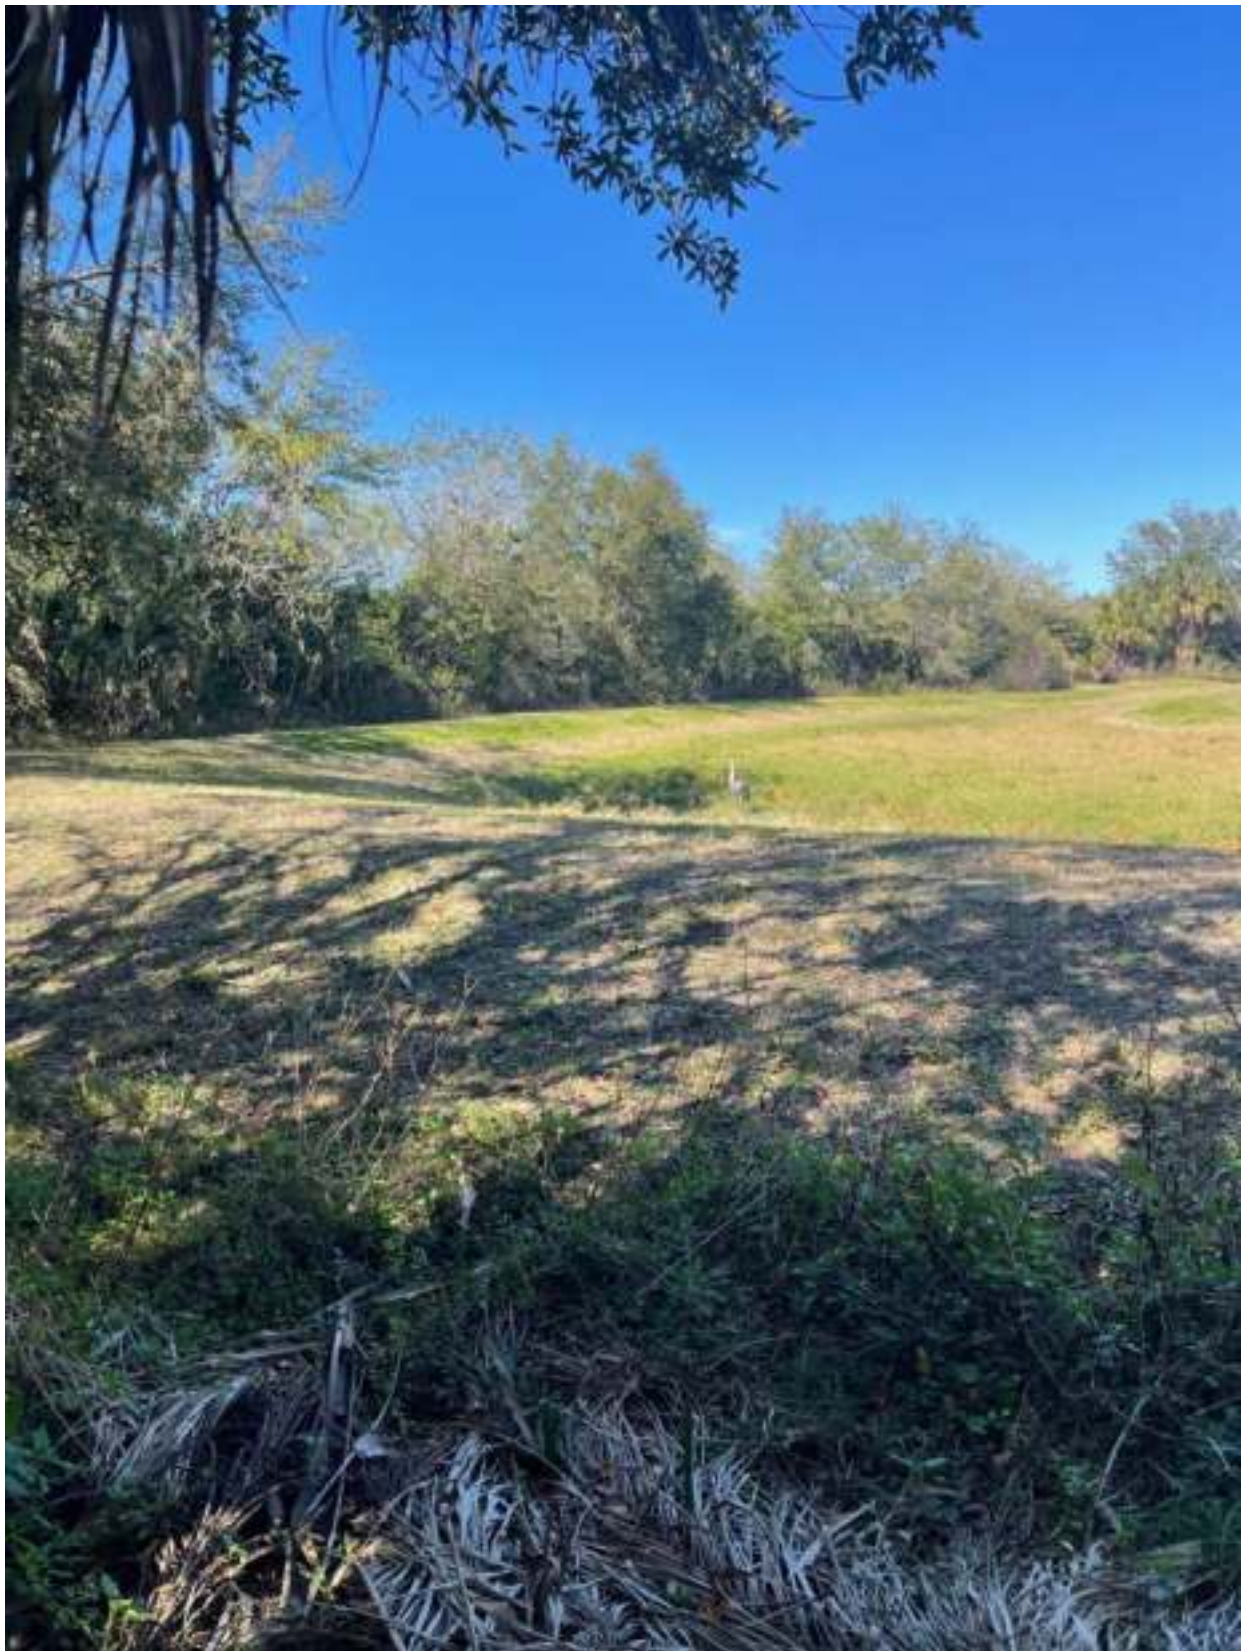
Fig 2. – view of retention pond from south property boundary
