**PHASE I  
ENVIRONMENTAL SITE ASSESSMENT**

**ONE TRACT OF UNIMPROVED LAND, 63.86 ACRES  
HARRELL ROAD & SCHNEIDER ROAD  
HOWE, GRAYSON COUNTY, TEXAS 75459**

**TERRA-SOLVE PROJECT NO. 22690**

May 12, 2022

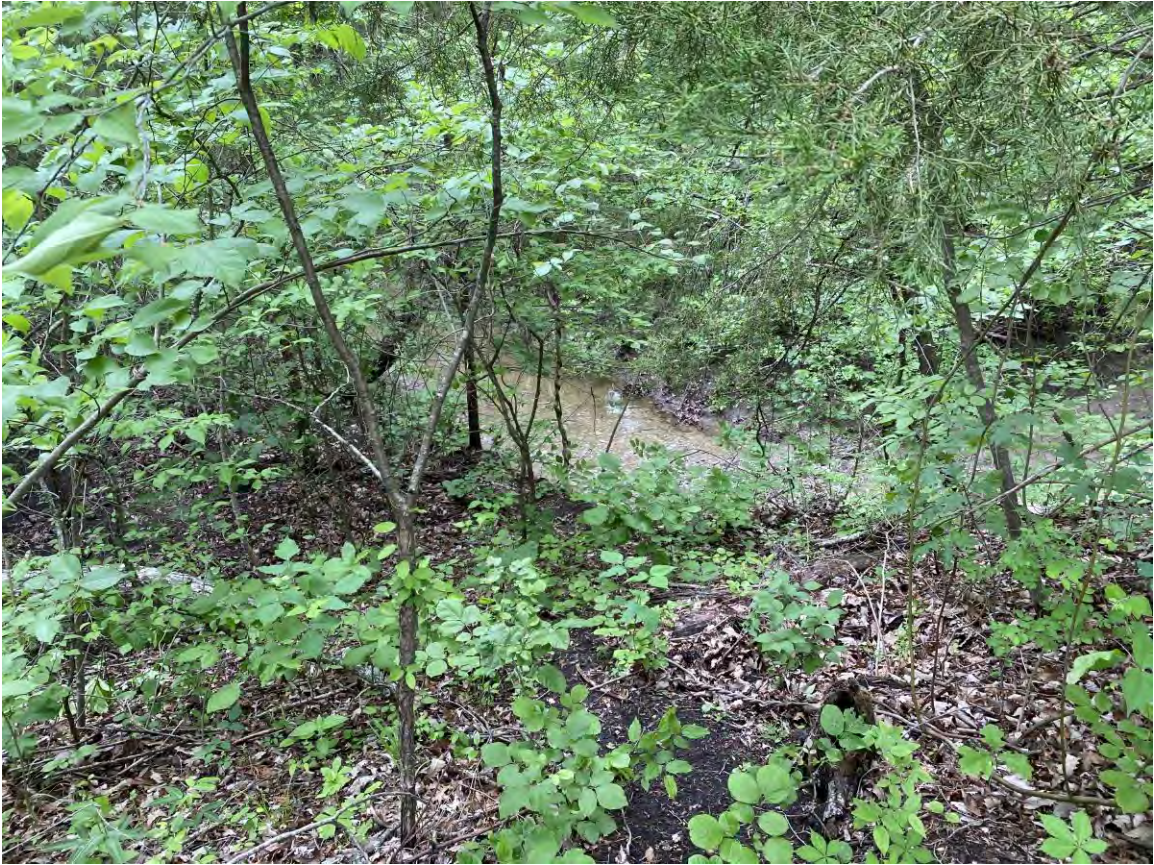
Photograph 13: View looking west of the creek on the western border of the site with the wooded area beyond.

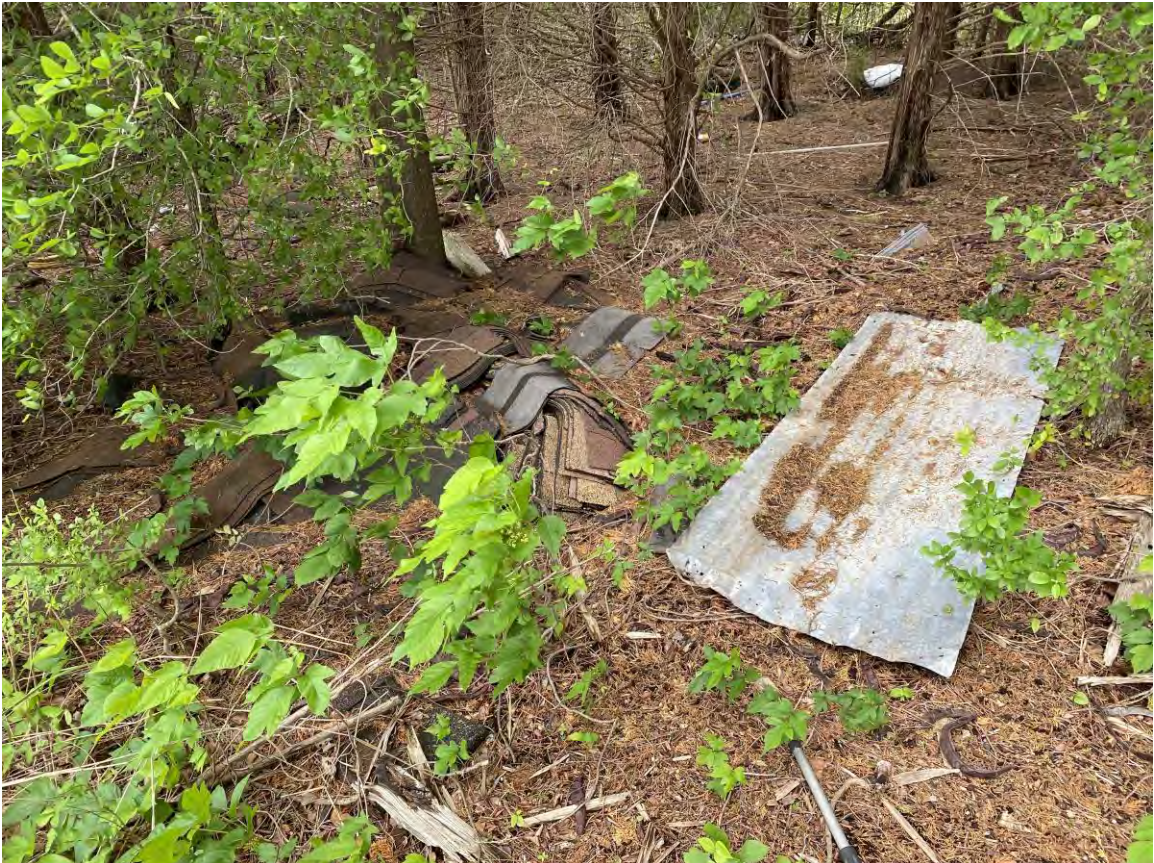
Photograph 14: View of the shingles and building material debris located in the tree line on the north-central portion of the site.

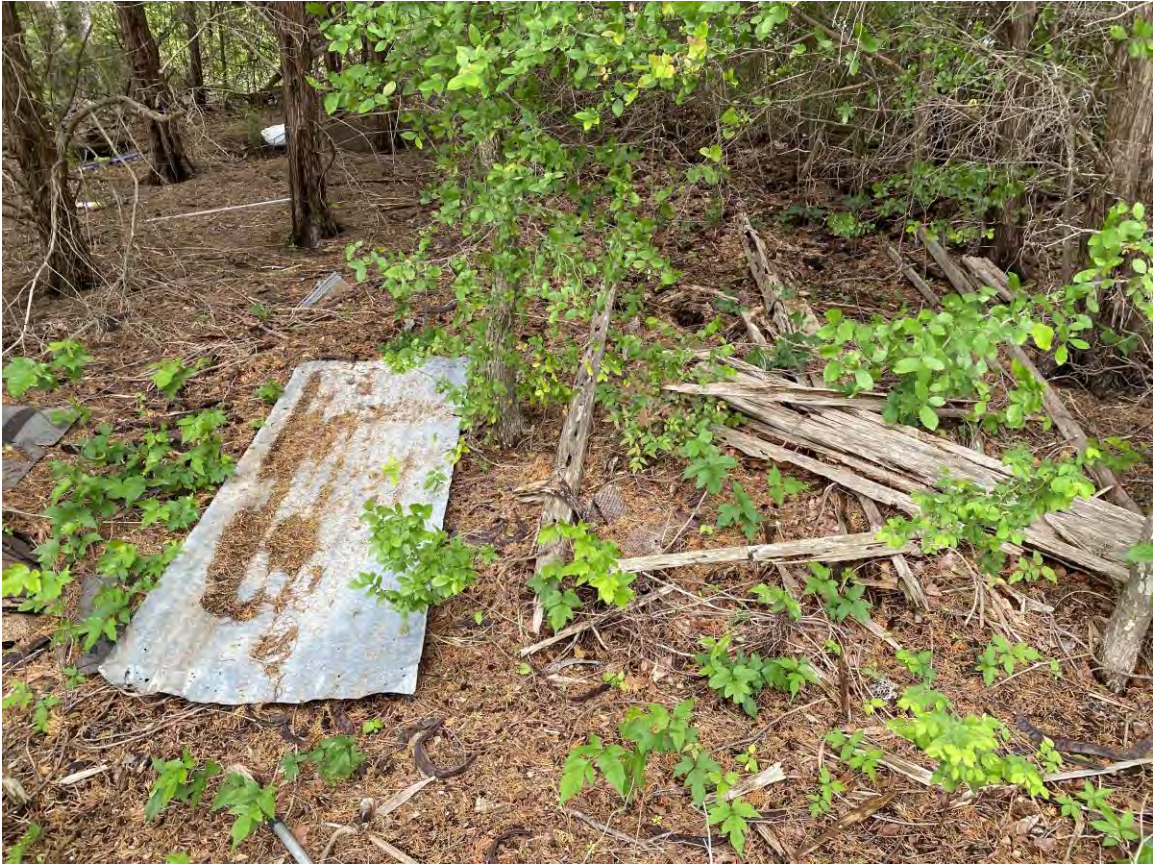
Photograph 15: View of the shingles and building material debris located in the tree line on the north-central portion of the site.

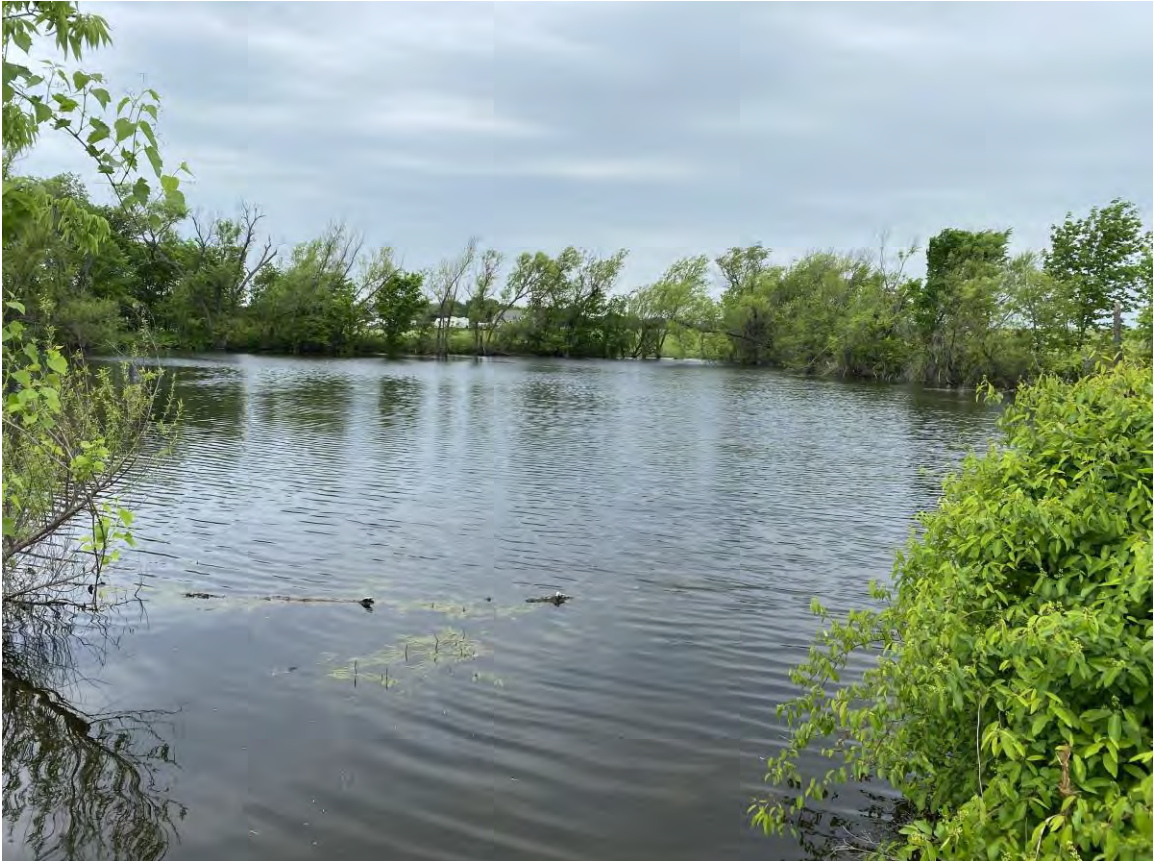
Photograph 16: View looking north of the pond on the southeastern portion of the site.

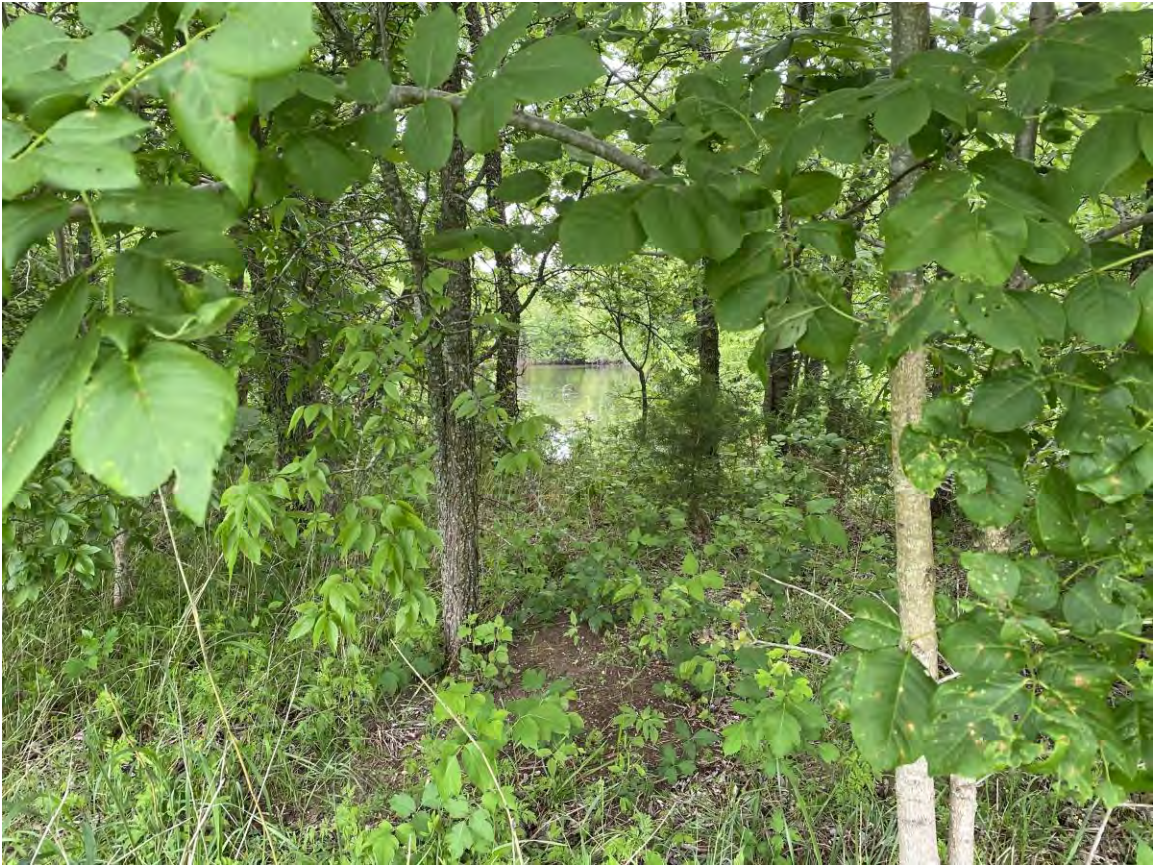
Photograph 17: View looking east showing the pond located on the east-central property line.

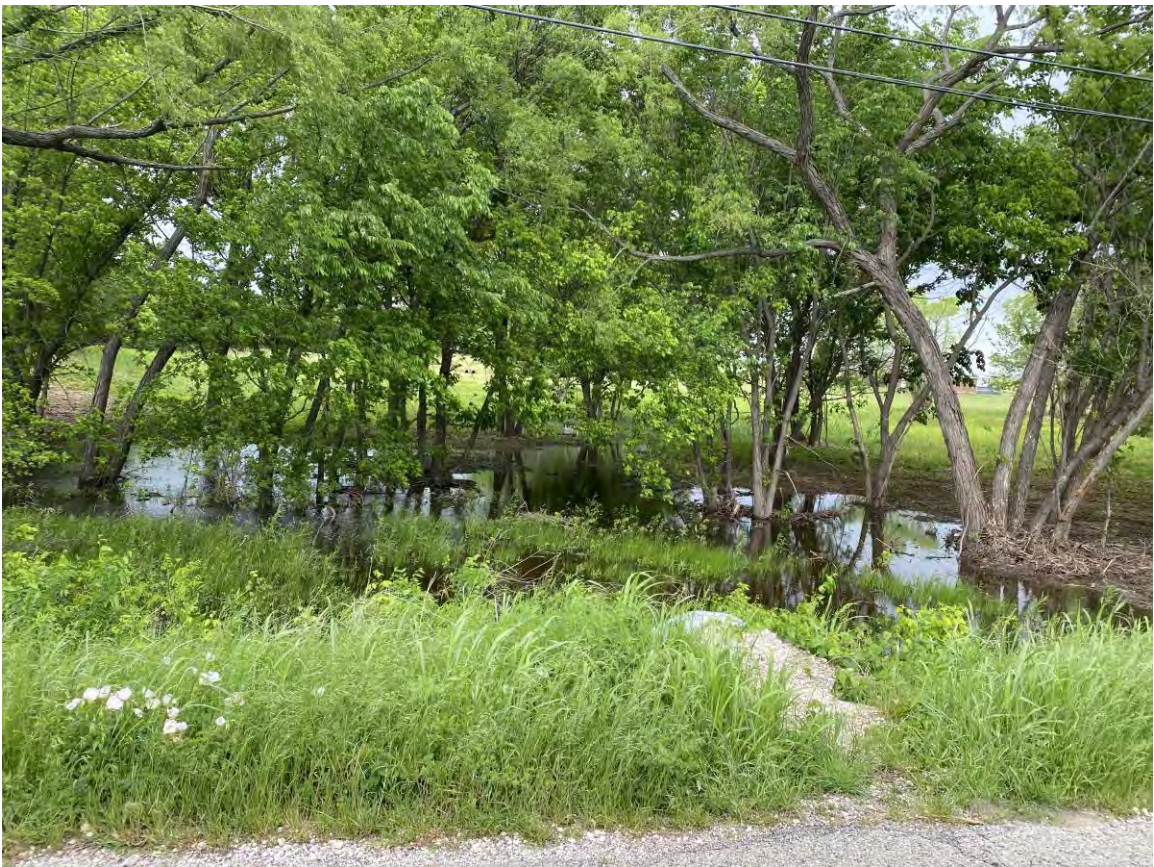
Photograph 18: View looking west of the inundated creek area at the southeastern corner of the site.

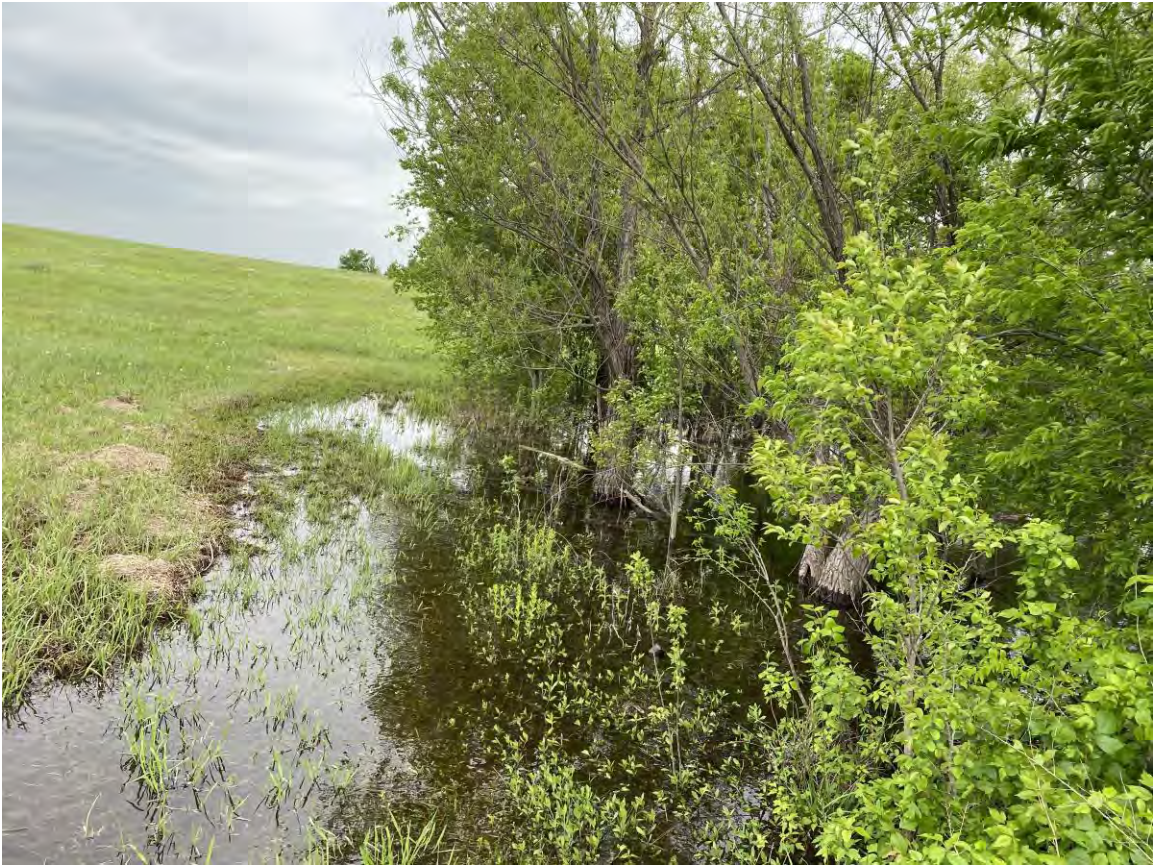
Photograph 19: View looking northwest showing the stream leading from the pond located on the southeast portion of the site.

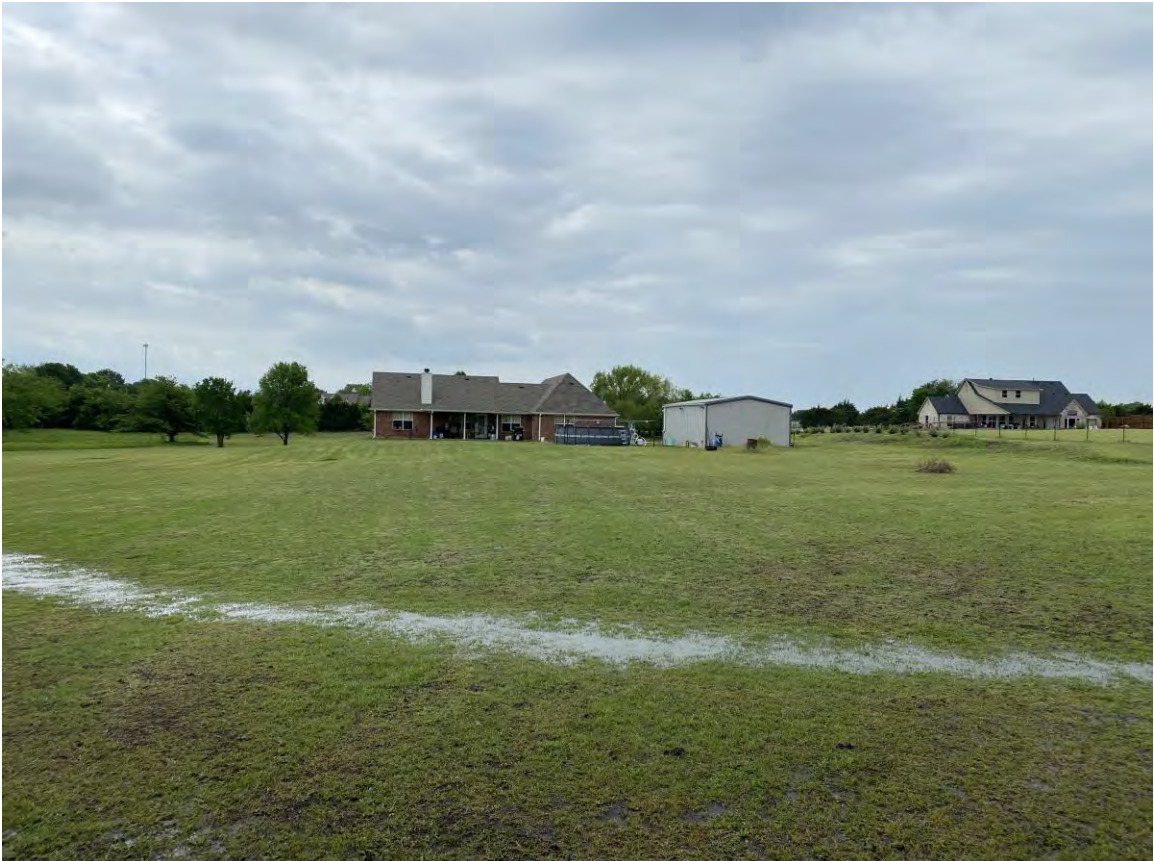
Photograph 20: View south of the drainage depression leading from the pond located on the southeastern corner of the site.

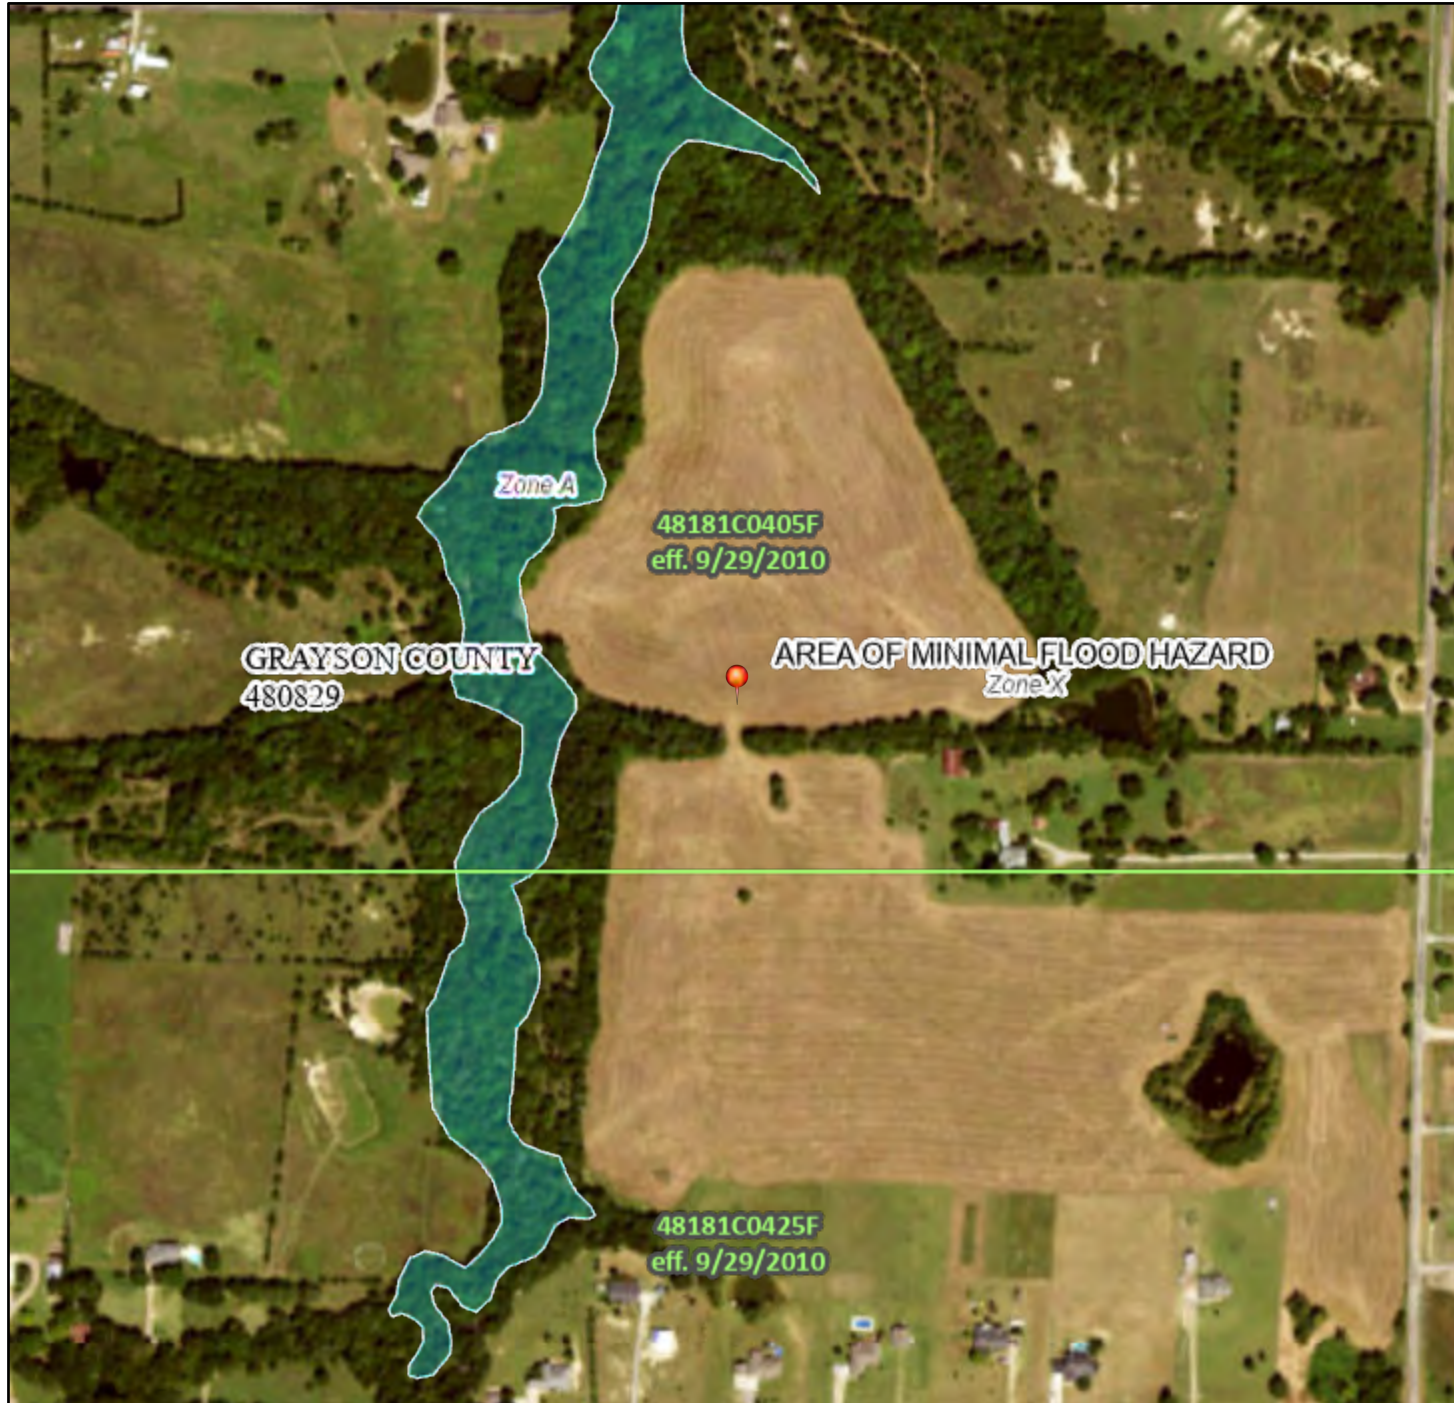
Terra-Solve reviewed the Federal Emergency Management Agency (FEMA) Flood Insurance Rate Maps (FIRM) for Grayson County, Texas, and Incorporated Areas, Panel Numbers 48181C0405F and 48181C0425F dated September 29, 2010. From the maps, it is apparent that while the vast majority of the site is located within Zone X, defined as an area of minimal flood hazard, the westernmost portion of the site (about 9 acres) is located in Zone A, defined as the hundred-year flood zone. This designation is considered to present a concern to future development of this portion of the site and should be considered during any development of the site. A copy of the FEMA map is located in **Appendix K**.

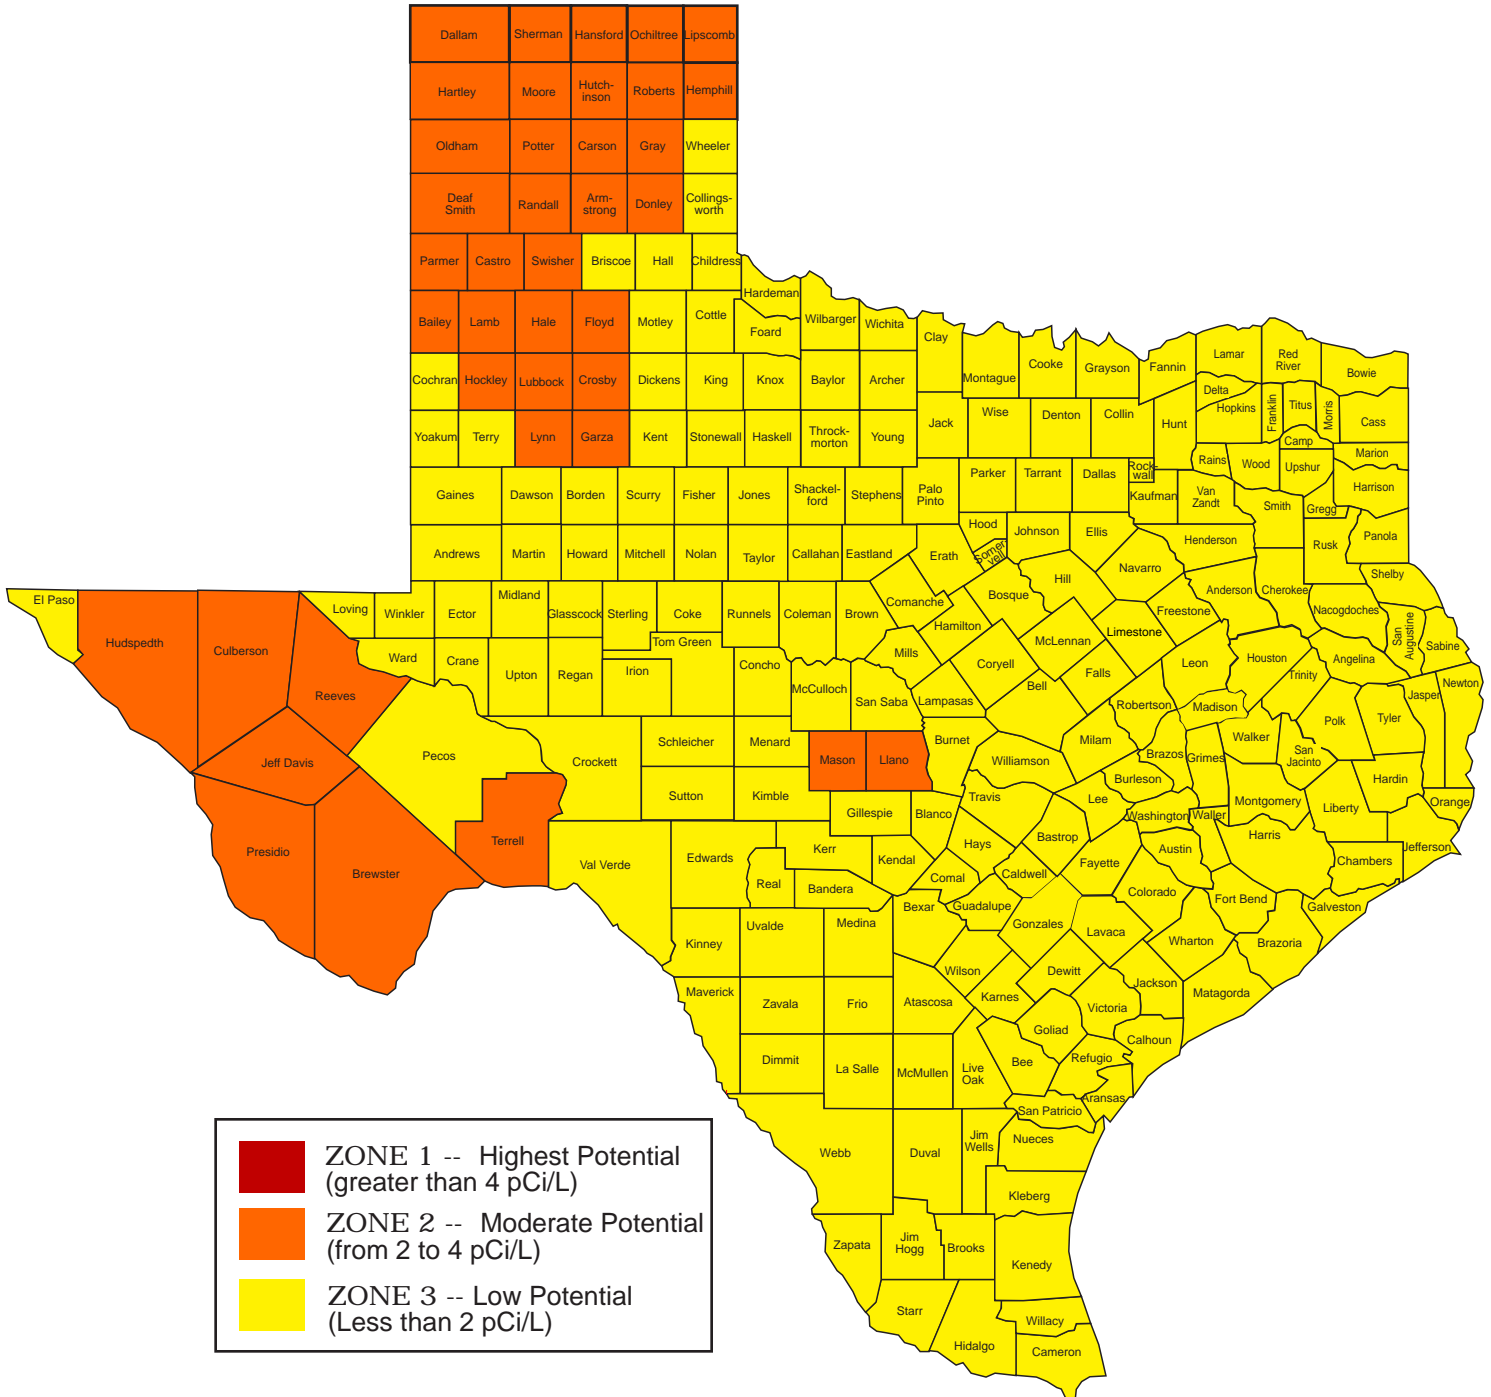
# TEXAS MAP OF RADON ZONES

Terra-Solve's review of published propensity data revealed that the property is located in USEPA Radon Zone 3, which indicates that the average indoor level of radon is predicted to be <2.0 pCi/L. Documentation of this information is provided in **Appendix K**. Based on this information and the unimproved nature of the property, it was not necessary to conduct radon tests and no additional investigation with regard to radon is recommended at this time.
