Texas Commission on Environmental Quality **Investigation Report**

Investigation #1376799

PSTREMOVE - Investigation of UST

Mac's Beer & Wine

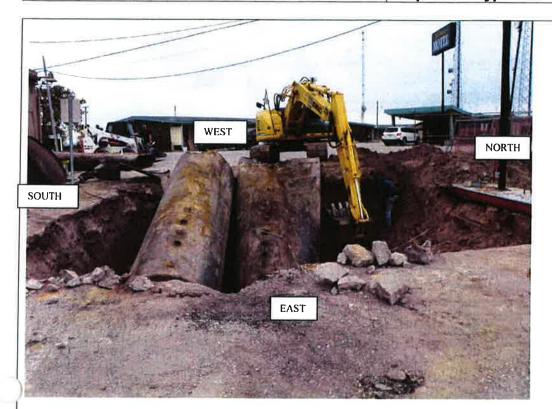
Photograph: 5
Date/Time: 11/22/16
Comments:

Photographic documentation of the tank excavation pit.

All three USTs measured 18-feet in length with a 5-foot diameter with an estimated 2,643 gallon capacity.

All three USTs were bare steel tanks without corrosion protection.

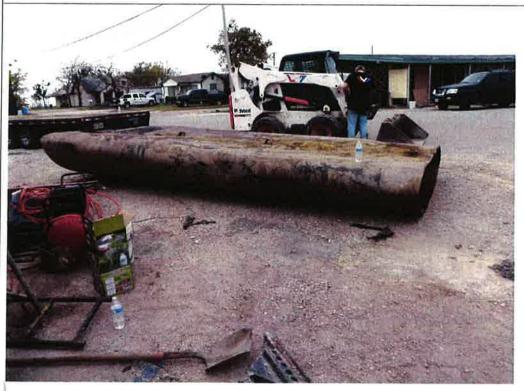
Photograph: 6 Date/Time: 11/22/16 Comments:

Photographic documentation of the north tank.

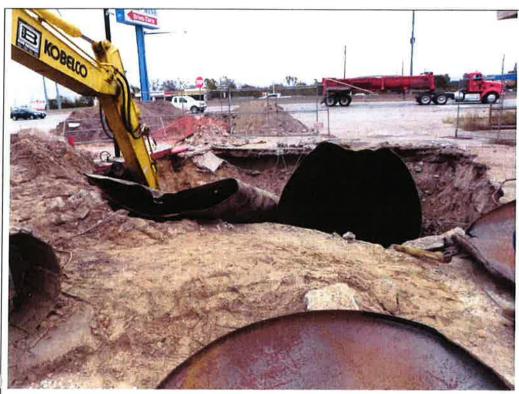
Photograph: 7 Date/Time: 11/22/16 Comments:

Photographic documentation of the end of the USTs.

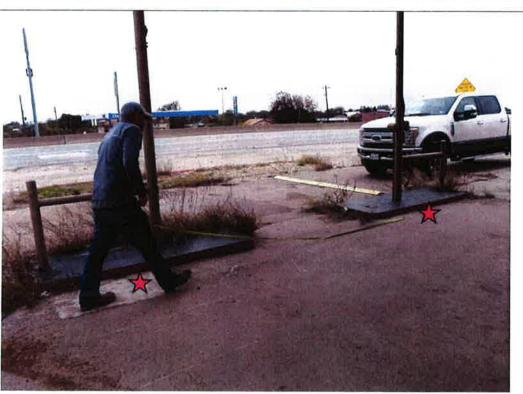
The two dispenser islands measured 9-feet apart.

One soil sample was collected in front of each dispenser.

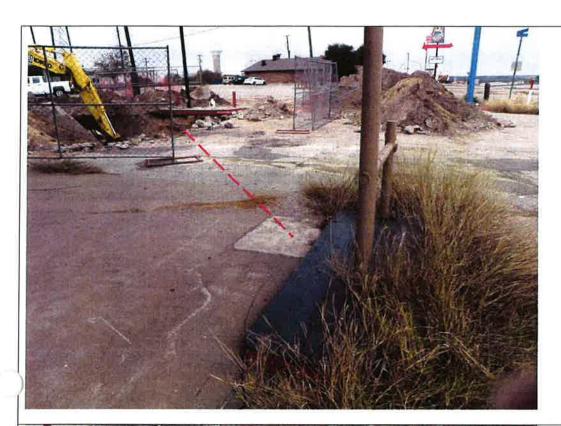
Photograph: 9 Date/Time: 11/22/16 Comments:

Photographic documentation of the pipe chase from the east tank pit wall to the north east dispenser.

One soil sample was called at 20-feet.

The product piping was washed, capped, and left in place.

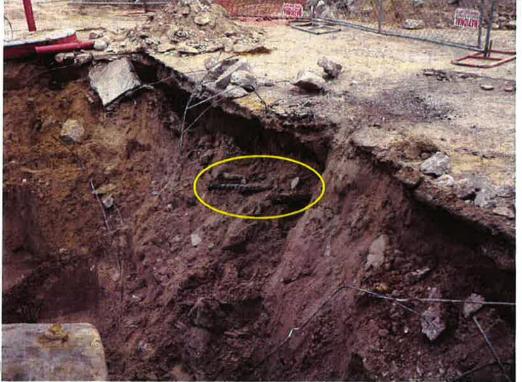
Photograph: 10 Date/Time: 11/22/16 Comments:

Photographic documentation of the single-walled, steel piping with a dielectric tape.

The product piping was not equipped with corrosion protection.

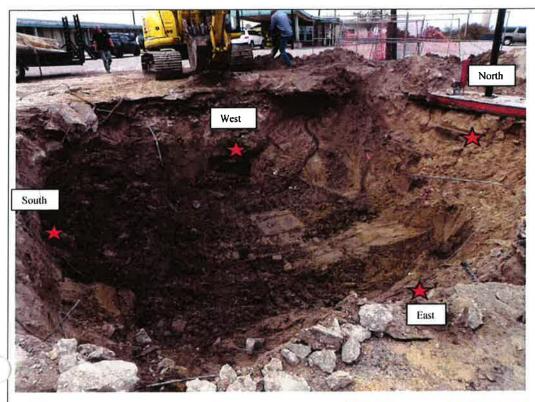
Photograph: 11 Date/Time: 11/22/16 Comments:

Photographic documentation of the tank excavation pit and the north dispenser island.

No groundwater or petroleum odors were noted in the excavation pit.

Since the tank bottom and side walls are solid bedrock, the contractor collected four side wall samples.

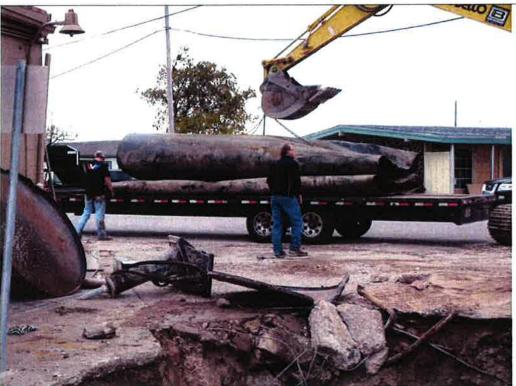
Photograph: 12 Date/Time: 11/22/16 Comments:

All tanks were crushed on-site to prevent re-use.
